**Capsize of an unnamed Bayliner Capri 2000 speedboat,  
resulting in the loss of three people off Lowestoft**

**10 March 2014**

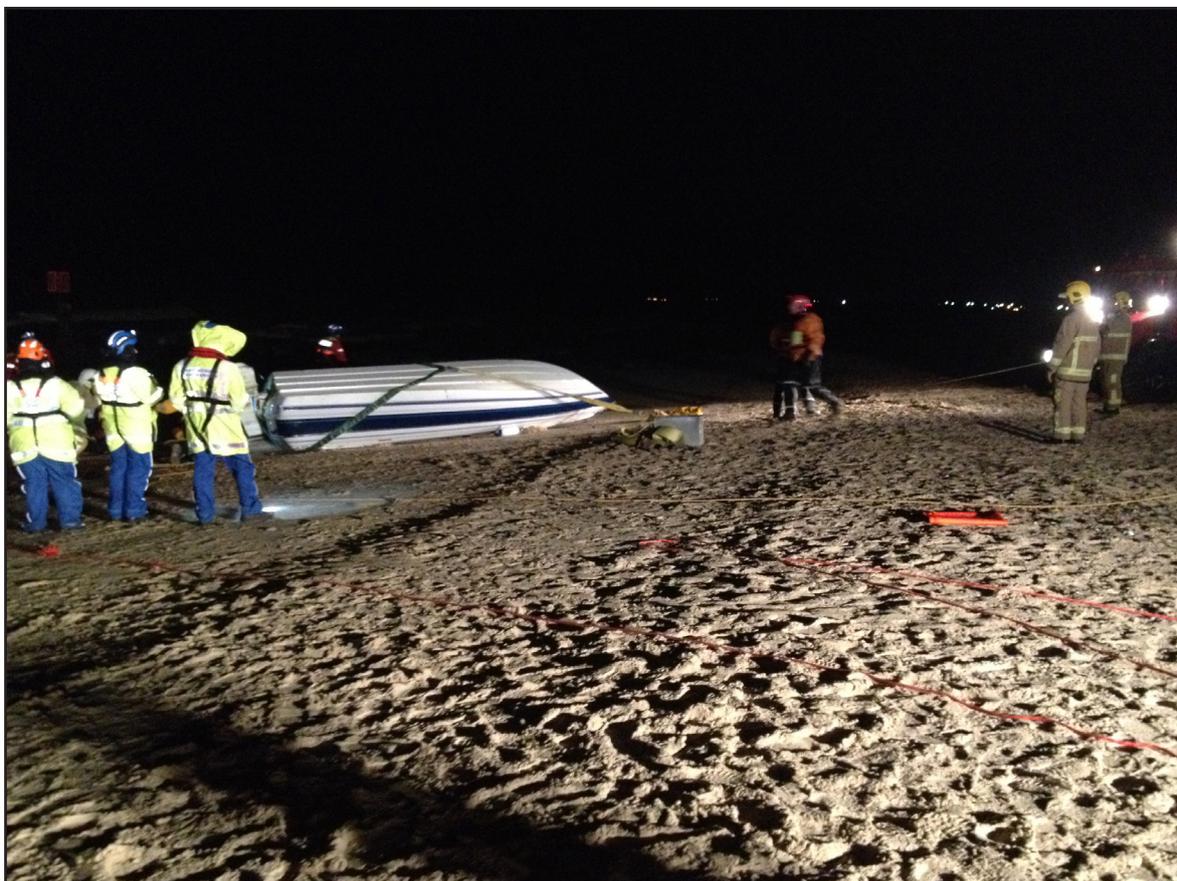
**Figure 4:** Boat recovered onto the beach

There was a gash in the hull near the engine, with red coloured paint at its edges consistent with the antifouling applied to the Lowestoft lifeboat's hull. Other damage observed was to the propeller blades, the engine casing and the boat's topside, all of which was consistent with the righting and recovery of the boat onto the beach at Lowestoft.

No damage was found to the hull other than that consistent with the contact made by the lifeboat during the recovery and the subsequent hauling of the boat up the beach.

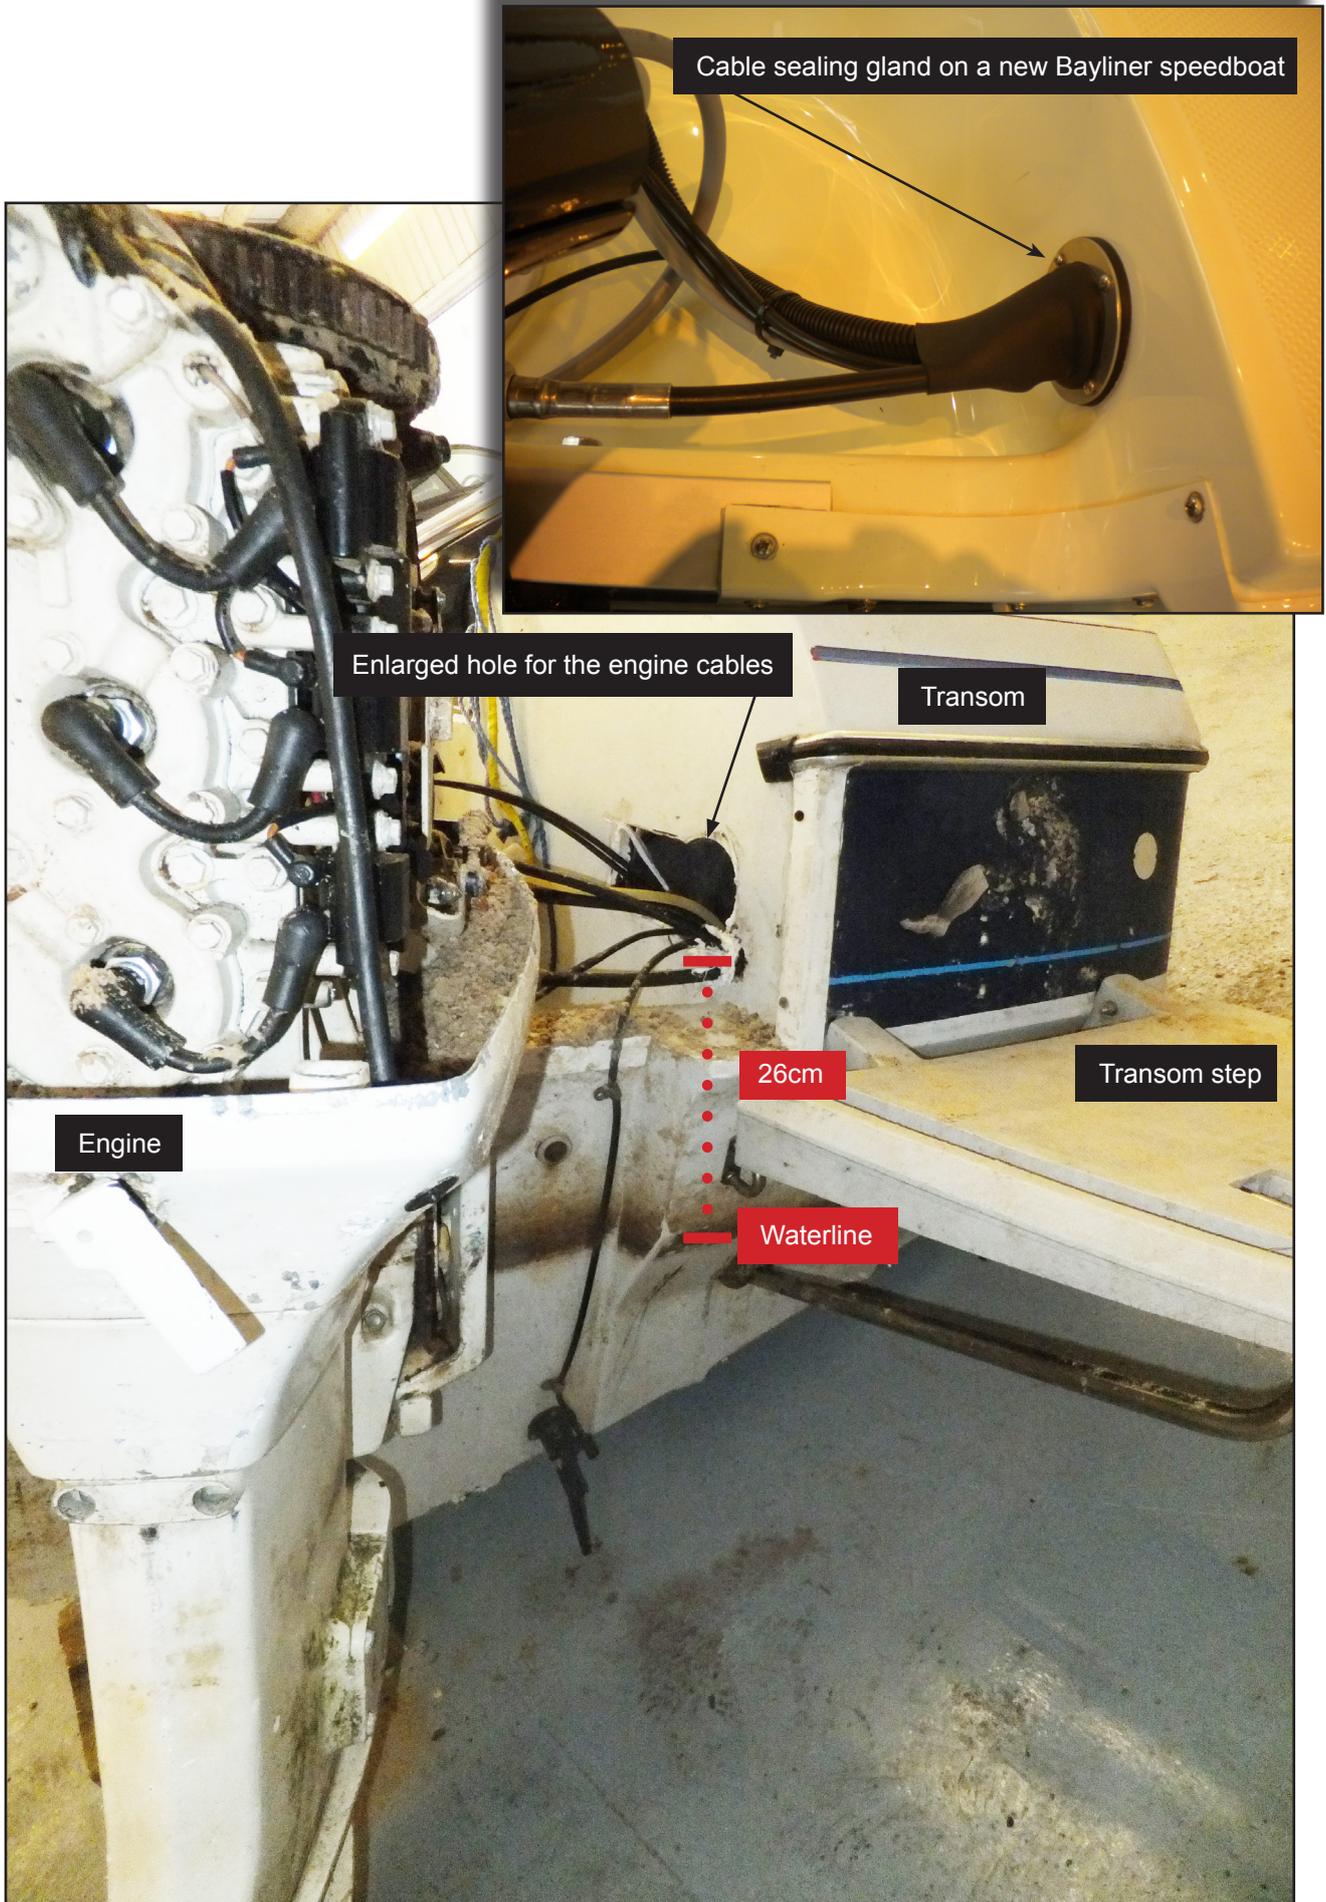
The stern freeboard of the boat was 36cm. However, the original hole in the transom for the engine control cables and fuel pipe had been enlarged into an irregularly shaped 18cm x 12cm opening (**Figure 5**). A partial patch had been fitted to this opening. The CCTV recording of the boat leaving harbour on the morning of 10 March appears to show the patch in place, but when the boat was inspected following its recovery the patch was no longer present, although some silicone-based sealant was found loosely attached to the edges of the opening. The lower edge of this opening was 26cm above the waterline.

**Figure 5:** Stern view showing enlarged hole cut in transom for engine cables (inset: showing cable seal on a new boat)

At some point after manufacture, the hole in the stern through which the control cables and fuel pipe for the outboard engine were fed through a sealing gland, as seen on a new, similarly sized Bayliner (**Figure 5 inset**), had been altered. The hole had been enlarged, the gland had been removed and a partial cover had been secured in place using silicone-based sealant. This partial cover was missing following the

accident. Although it is not known exactly when the cover detached, the silicone-based sealant used to fix it in place was not appropriate given that the plate was essential to maintaining adequate freeboard at the stern.
