## Grounding of the liquefied gas carrier *Navigator Scorpio* on Haisborough Sand, North Sea 3 January 2014

### SUMMARY

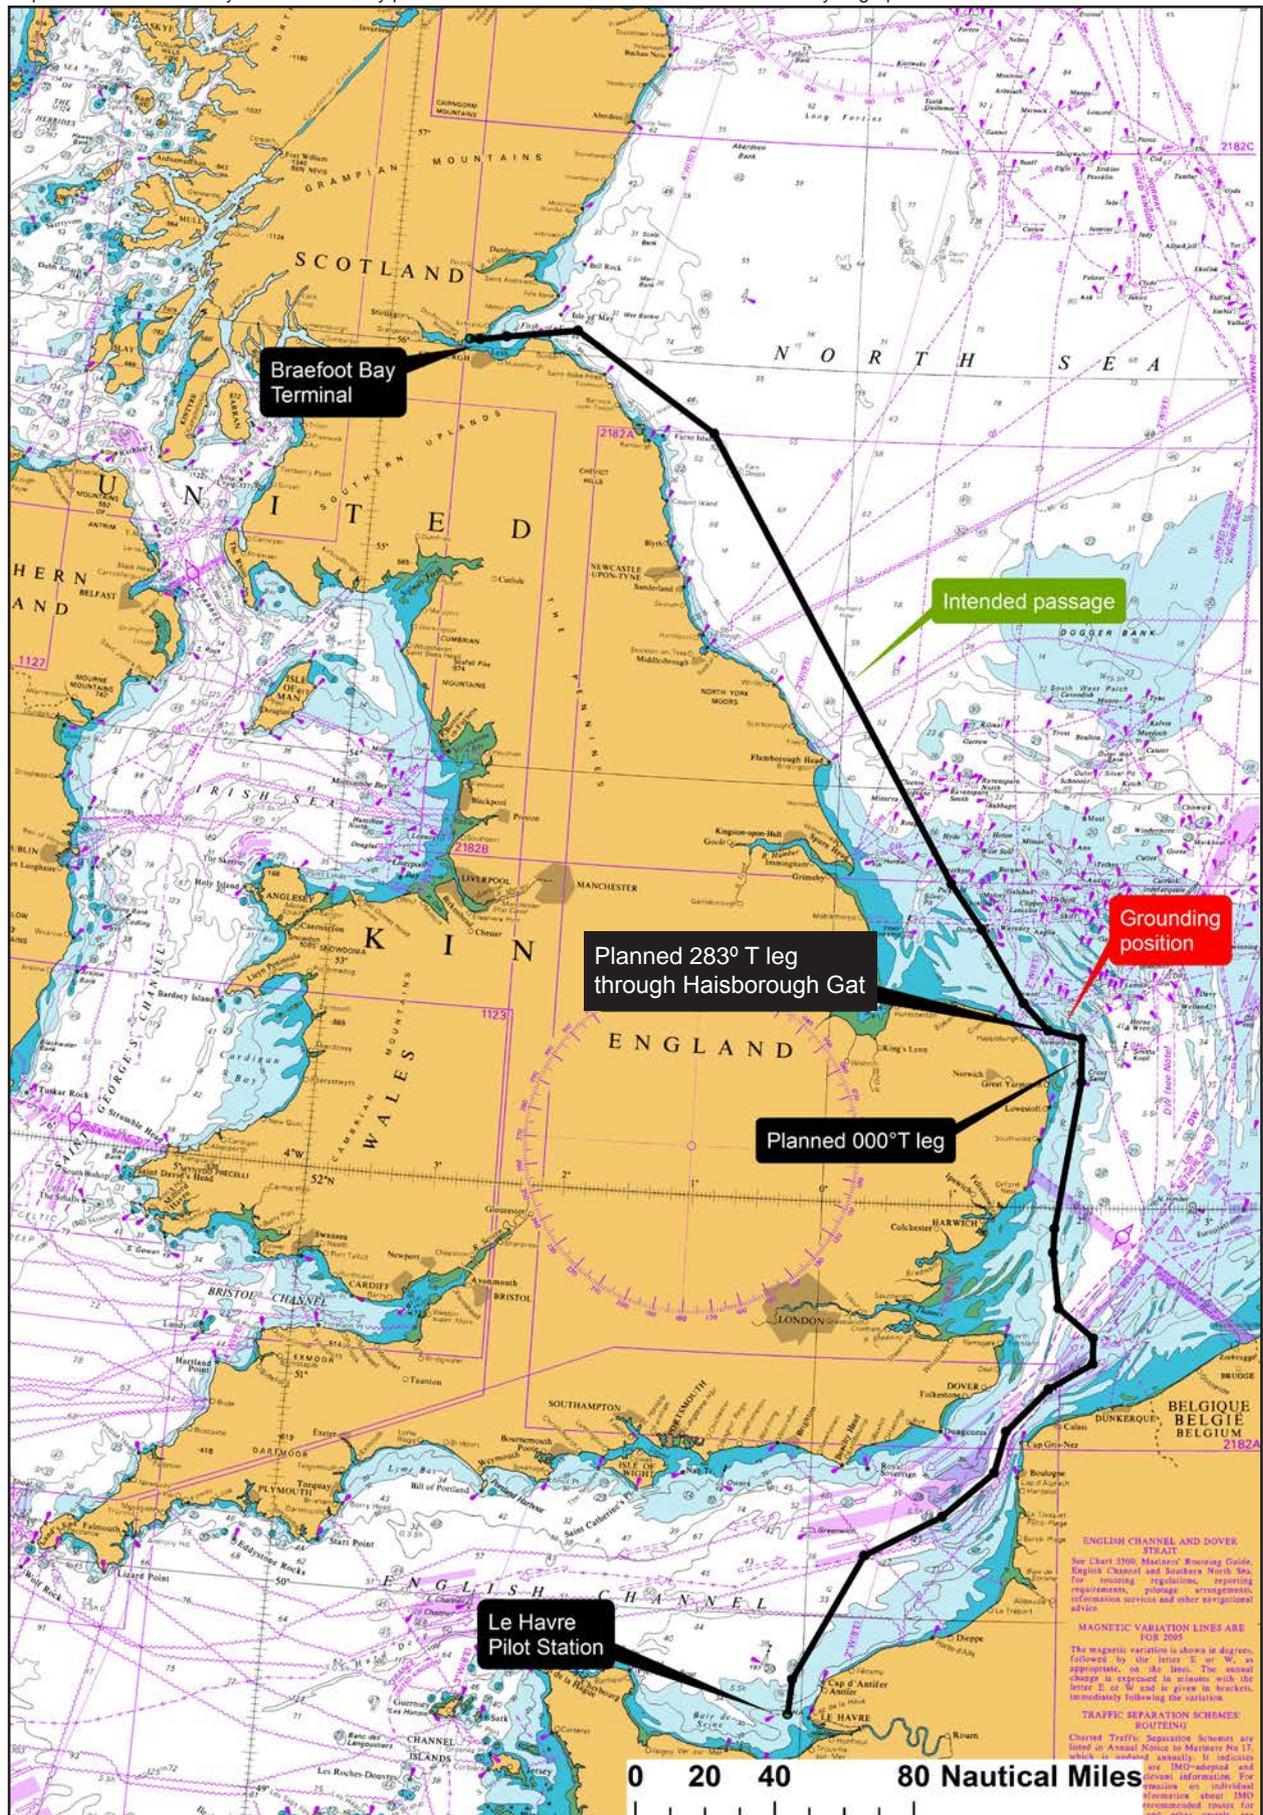
Figure 1: Intended passage from Le Havre to Braefoot Bay

On 30 December 2013, the master of *Navigator Scorpio* was notified by its owners that the vessel's schedule had been changed and that the next port of call would be Braefoot Bay in the Forth Estuary, Scotland (**Figure 1**). The following day, the master advised the vessel's managers that additional North Sea coastal charts were required in order to plan the amended passage. The charts, which were not up to date with the latest corrections, were delivered to the vessel in Le Havre, France at around 1500 on 2 January 2014. At 1848 the same day, the vessel got underway in a ballast condition. The newly delivered charts had not been corrected prior to sailing and the passage plan, which was incomplete, had not been checked by the master.

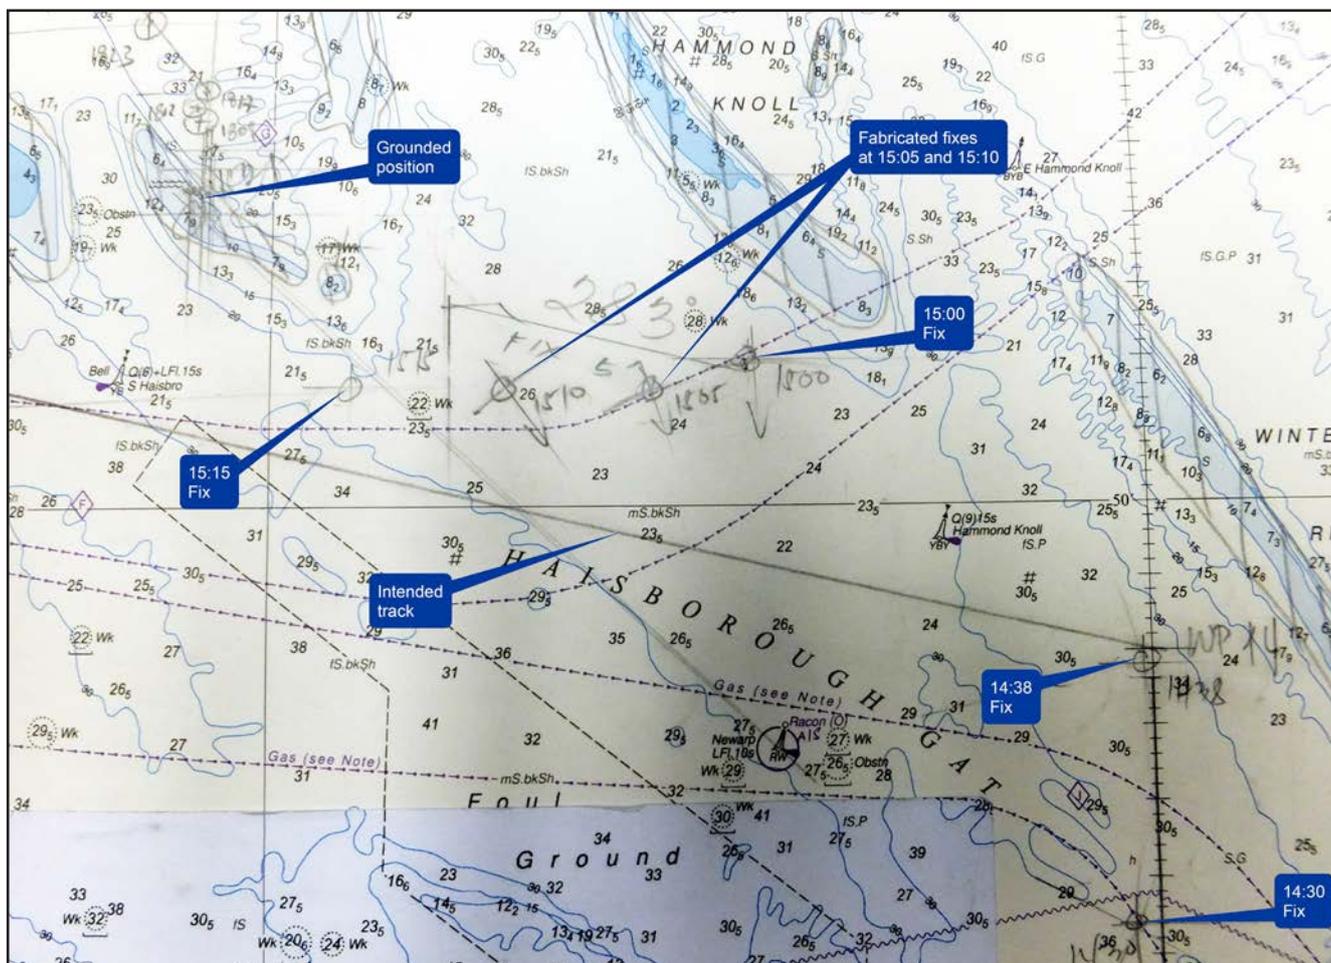
**Figure 2:** Image of chart in use during grounding

At 1430, the 2/O fixed and plotted the vessel's position (**Figure 2**) but he did not calculate the predicted time for the impending alteration to 283°T. At 1437, a radar alarm sounded indicating that the vessel was 5 cables (c) south of the waypoint marking the start of the 283°T leg. The 2/O acknowledged this alarm and decided to fix the vessel's position. Using global positioning system (GPS) data and a range and bearing from Newarp racon buoy, he plotted a fix, shown on the chart at 1438 (**Figure 2**), then continued with his chartwork.

At some point after the vessel grounded, the 2/O added the fixes on the chart shown at 1505 and 1510 (**Figure 2**). At 1756, unaided on the rising tide, *Navigator Scorpio* refloated and continued its passage to the Forth Estuary. On 6 January 2014, a dive survey in Rotterdam confirmed that the hull was undamaged.

Having realised the vessel was aground and concerned that he had not followed the master's instruction to fix at 5 minute intervals, the 2/O fabricated two fixes on the chart, shown at 1505 and 1510 (**Figure 2**). The 2/O's intent was to create a chart which showed fixes at 5 minute intervals to give the impression that he had followed the master's instructions.

The post-grounding actions of the 2/O are not uncommon; similar chart alterations post-casualty are often discovered during MAIB accident investigations. The chart in use at the time of a marine casualty is critical evidence and, in the interests of safety and in accordance with accident reporting regulations<sup>10</sup>, should not be altered after the grounding.

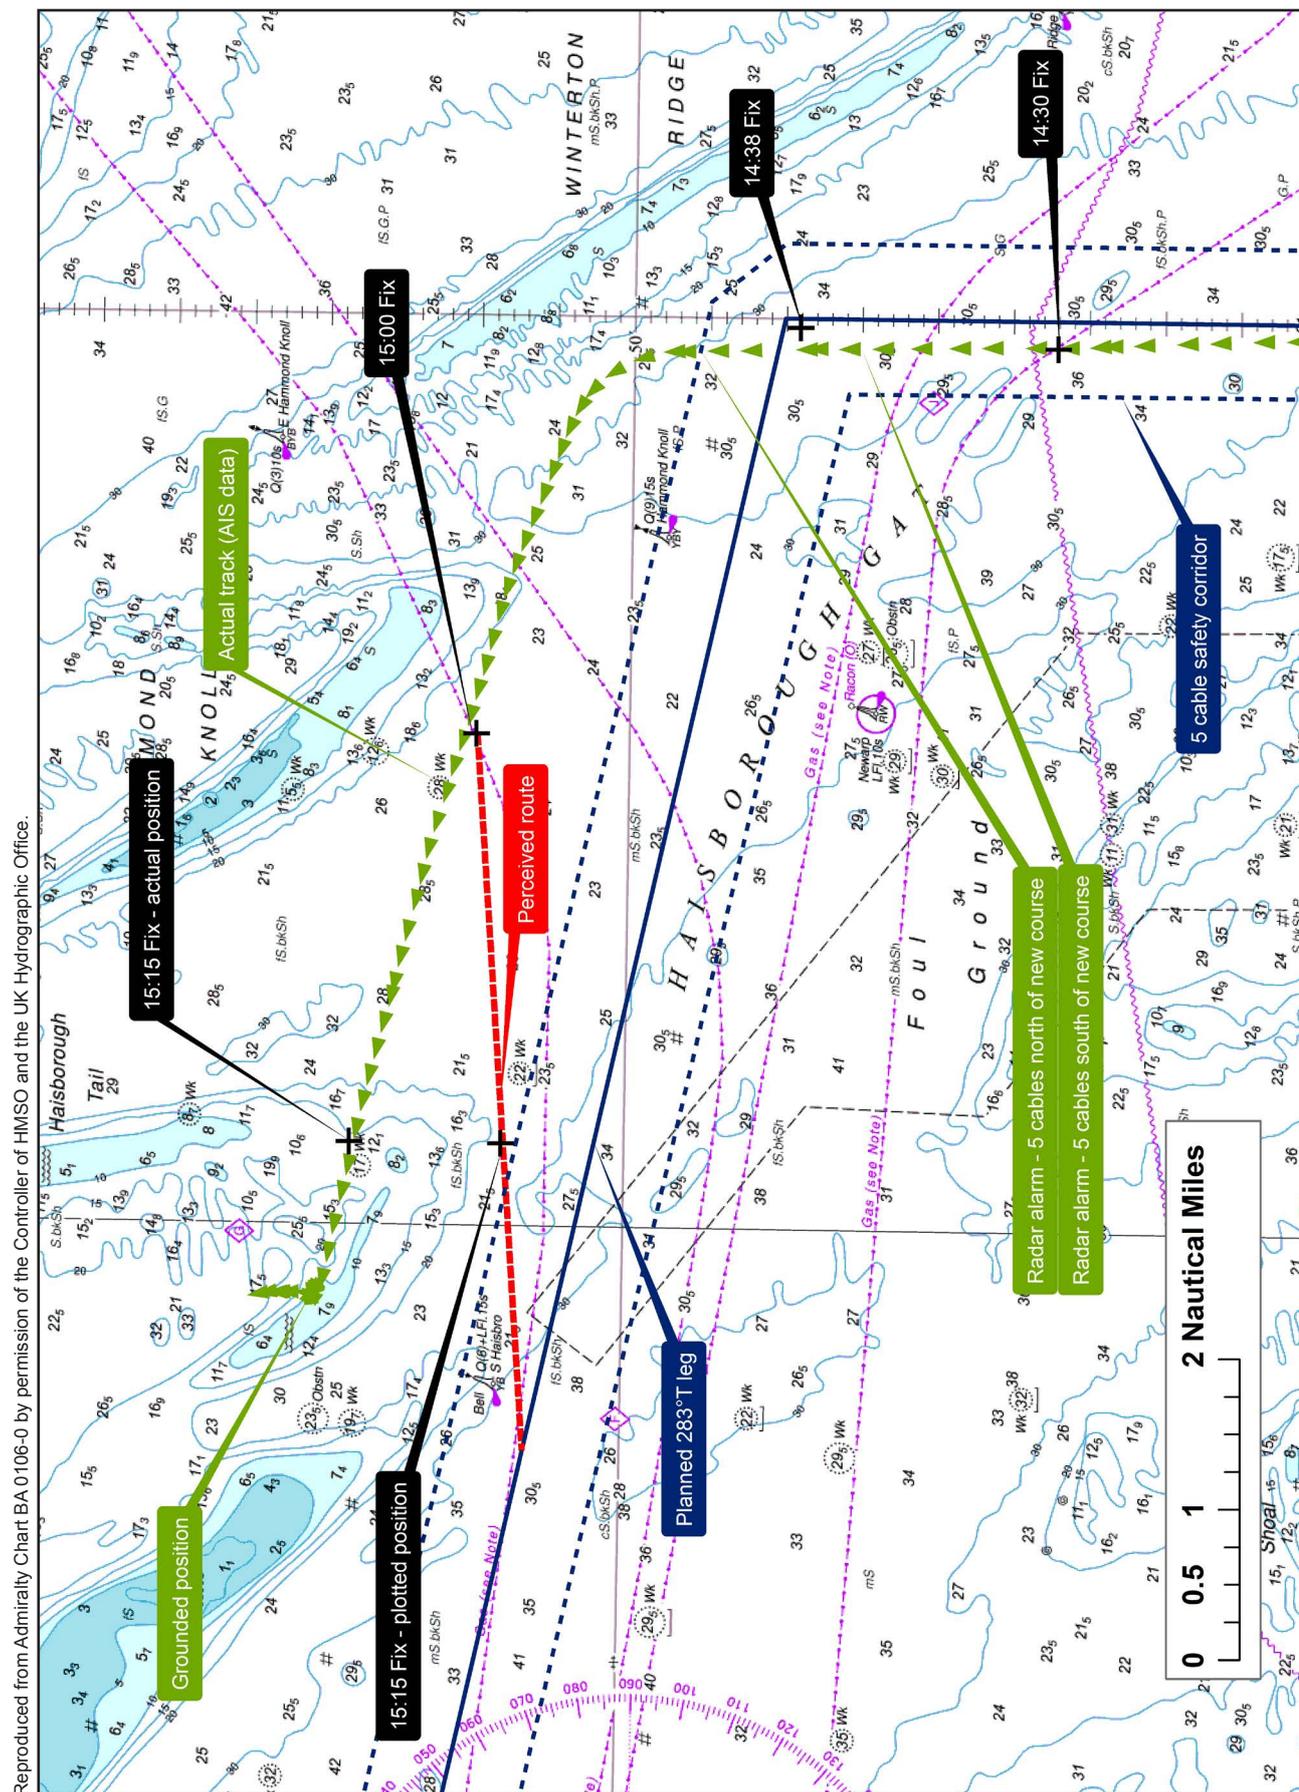
**Figure 3: Analysis of perceived route**

Although it was correctly recorded in the log, the fix taken at 1515 was incorrectly plotted 1 mile to the south of the vessel's actual position. When plotting the fix, the OOW's understanding of the situation was that the vessel was regaining track. As a result, it is highly likely that he plotted the fix where he perceived the vessel to be based on this incorrect assessment (**Figure 3**).

- Unaware of the significant northerly set, the 2/O assessed that the intended track was being regained and plotted the 1515 fix where he perceived the vessel to be.

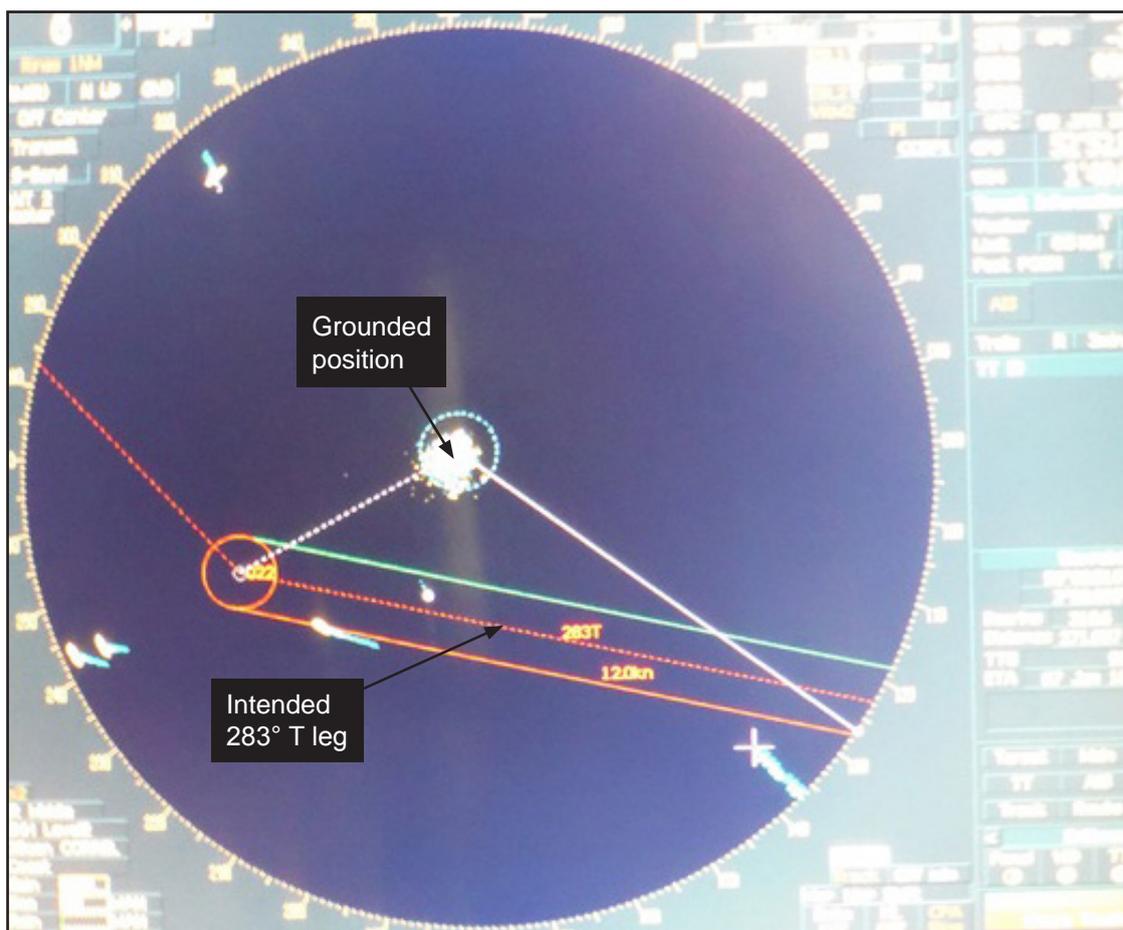
**Figure 4:** Image of S-band radar display at time of grounding

Other clues that the vessel was not regaining the planned track were available. Had the 2/O correlated visual observations with the chart, it would have been readily apparent that South Haisbro buoy was on the port bow when it should have been to starboard. The S-band radar picture would have clearly shown the vessel's actual track diverging away from the intended track. This is evident from an image of the radar display (**Figure 4**) when aground. The GPS display would also have shown the course and speed over the ground which, if compared with the course and speed through the water, would have indicated a very significant difference. Radar parallel indexing techniques were understood and could also have been used to accurately monitor the vessel's position relative to track.
