Report on the investigation of the collision between

***Paula C***

***Darya Gayatri***

on 11 December 2013

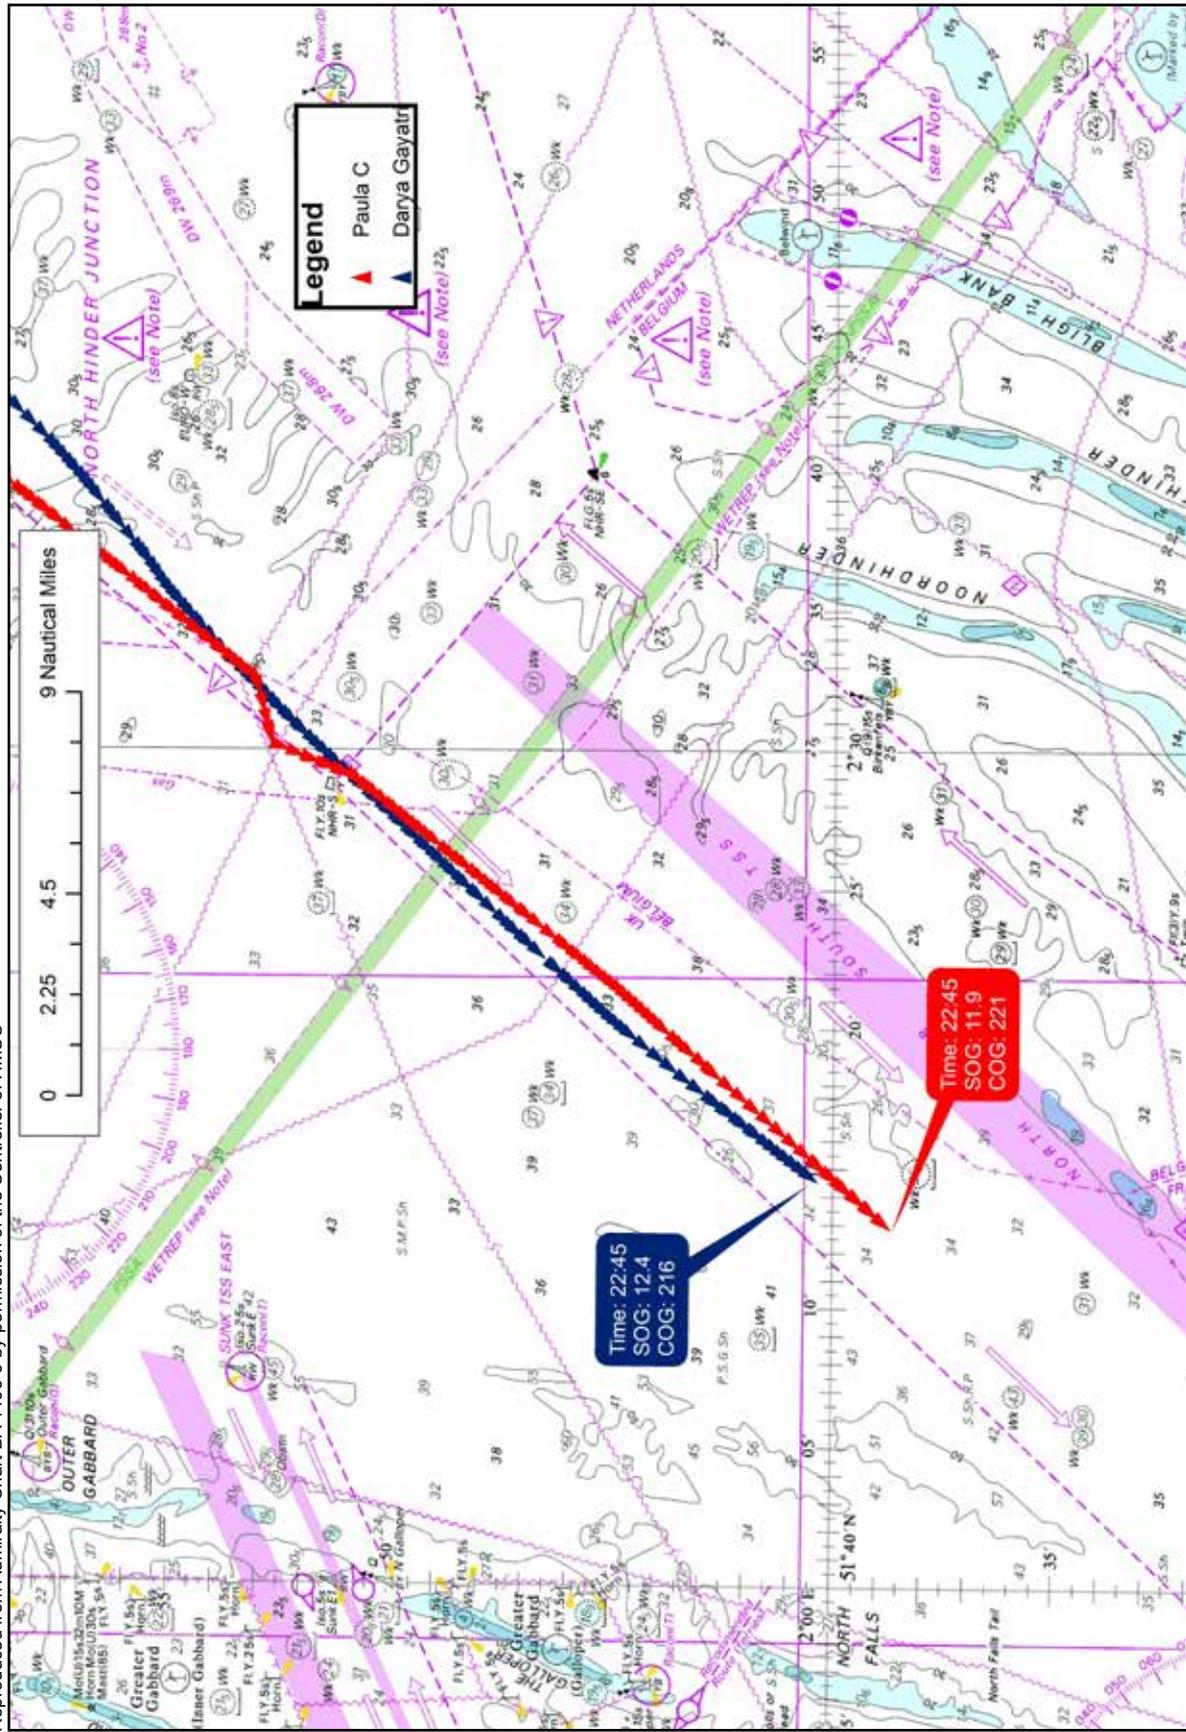
Figure 1: Positions of Paula C and Darya Gayatri at 2245

a course over the ground (COG) of 216° at a speed of 12.4kts and was overtaking *Paula C*. The closest point of approach (CPA) between the vessels was 0.5nm in 88 minutes time.

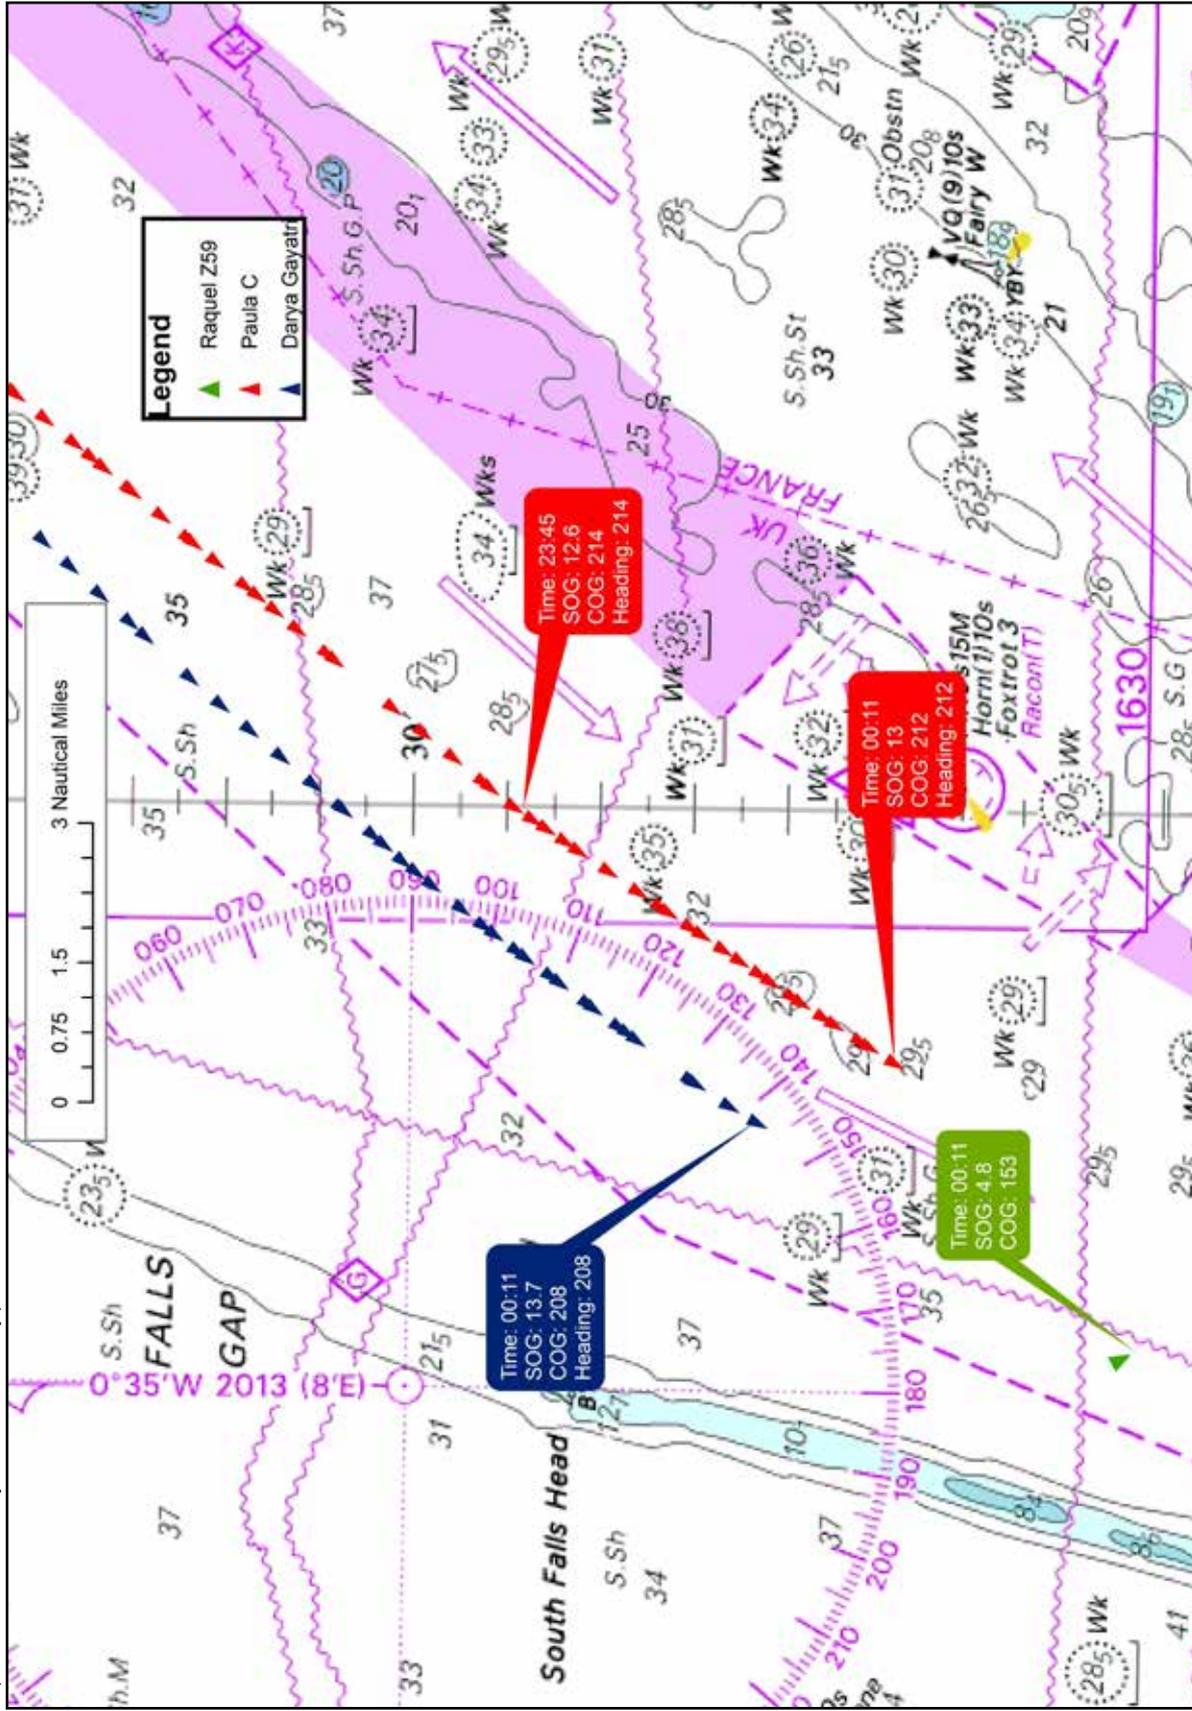
Figure 2: Positions of vessels at 0011

The vessel ahead of *Paula C* was the Belgium registered beam trawler *Raquel*, which was towing its nets on a COG of 153° at a speed of 4.8kts (**Figure 2**). *Raquel* was displaying the appropriate lights for a power-driven vessel underway and engaged in trawling<sup>4</sup>; the vessel's deck lights were also switched on. The beam trawler's AIS was transmitting static and dynamic information, including its status (engaged in fishing), SOG and COG. However, no heading information was broadcast.

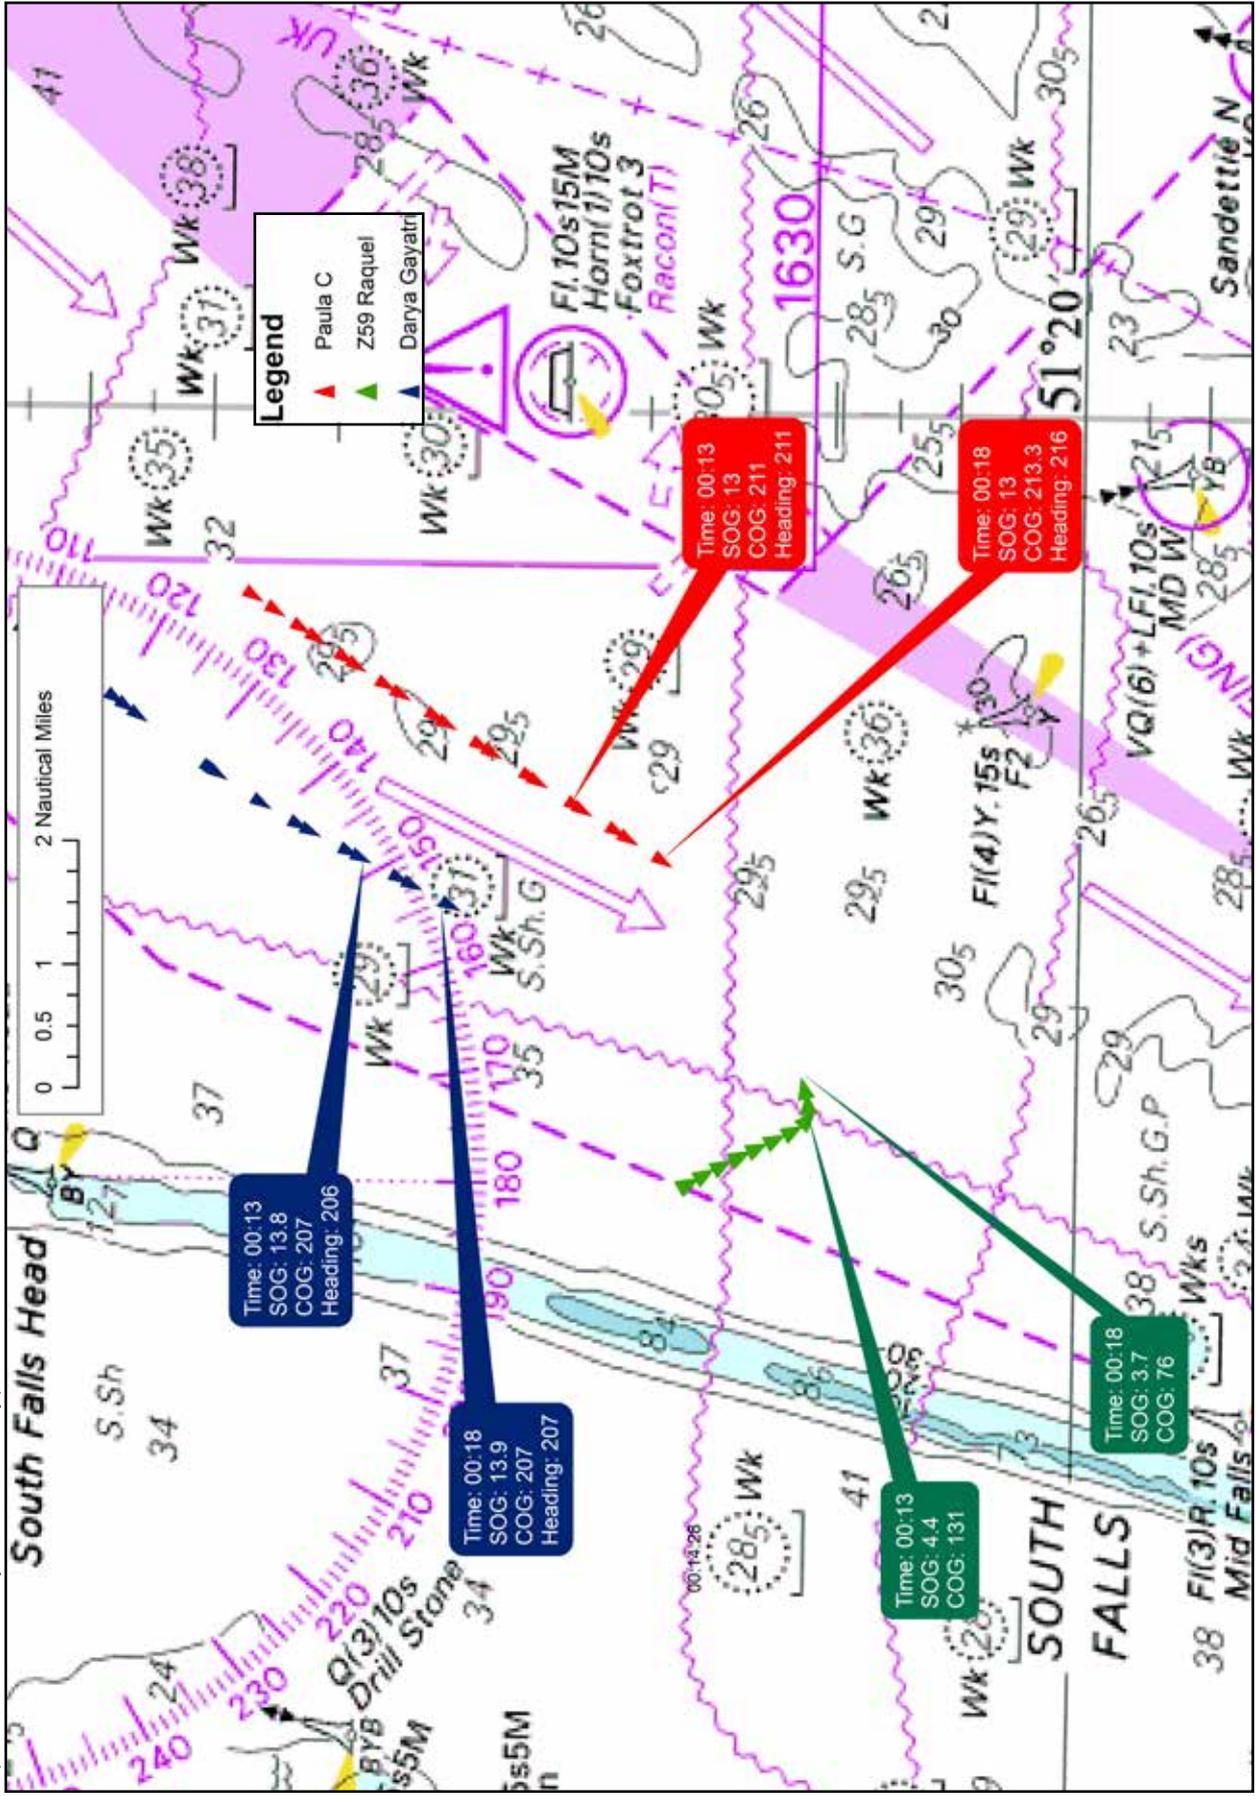
Figure 3: Positions of vessels at 0013 and 0018

As *Paula C* steadied onto its new heading, the second officer noticed that the heading of *Raquel*, which was now almost directly ahead, had changed to the north-east. In response, the OOW adjusted *Paula C*'s heading further to starboard. By 0022 *Paula C*'s heading was 266° and the fishing vessel was about 30° off *Paula C*'s port bow at a distance of 1.1nm; *Darya Gayatri* was on the cargo ship's starboard beam at a distance of 0.98nm.

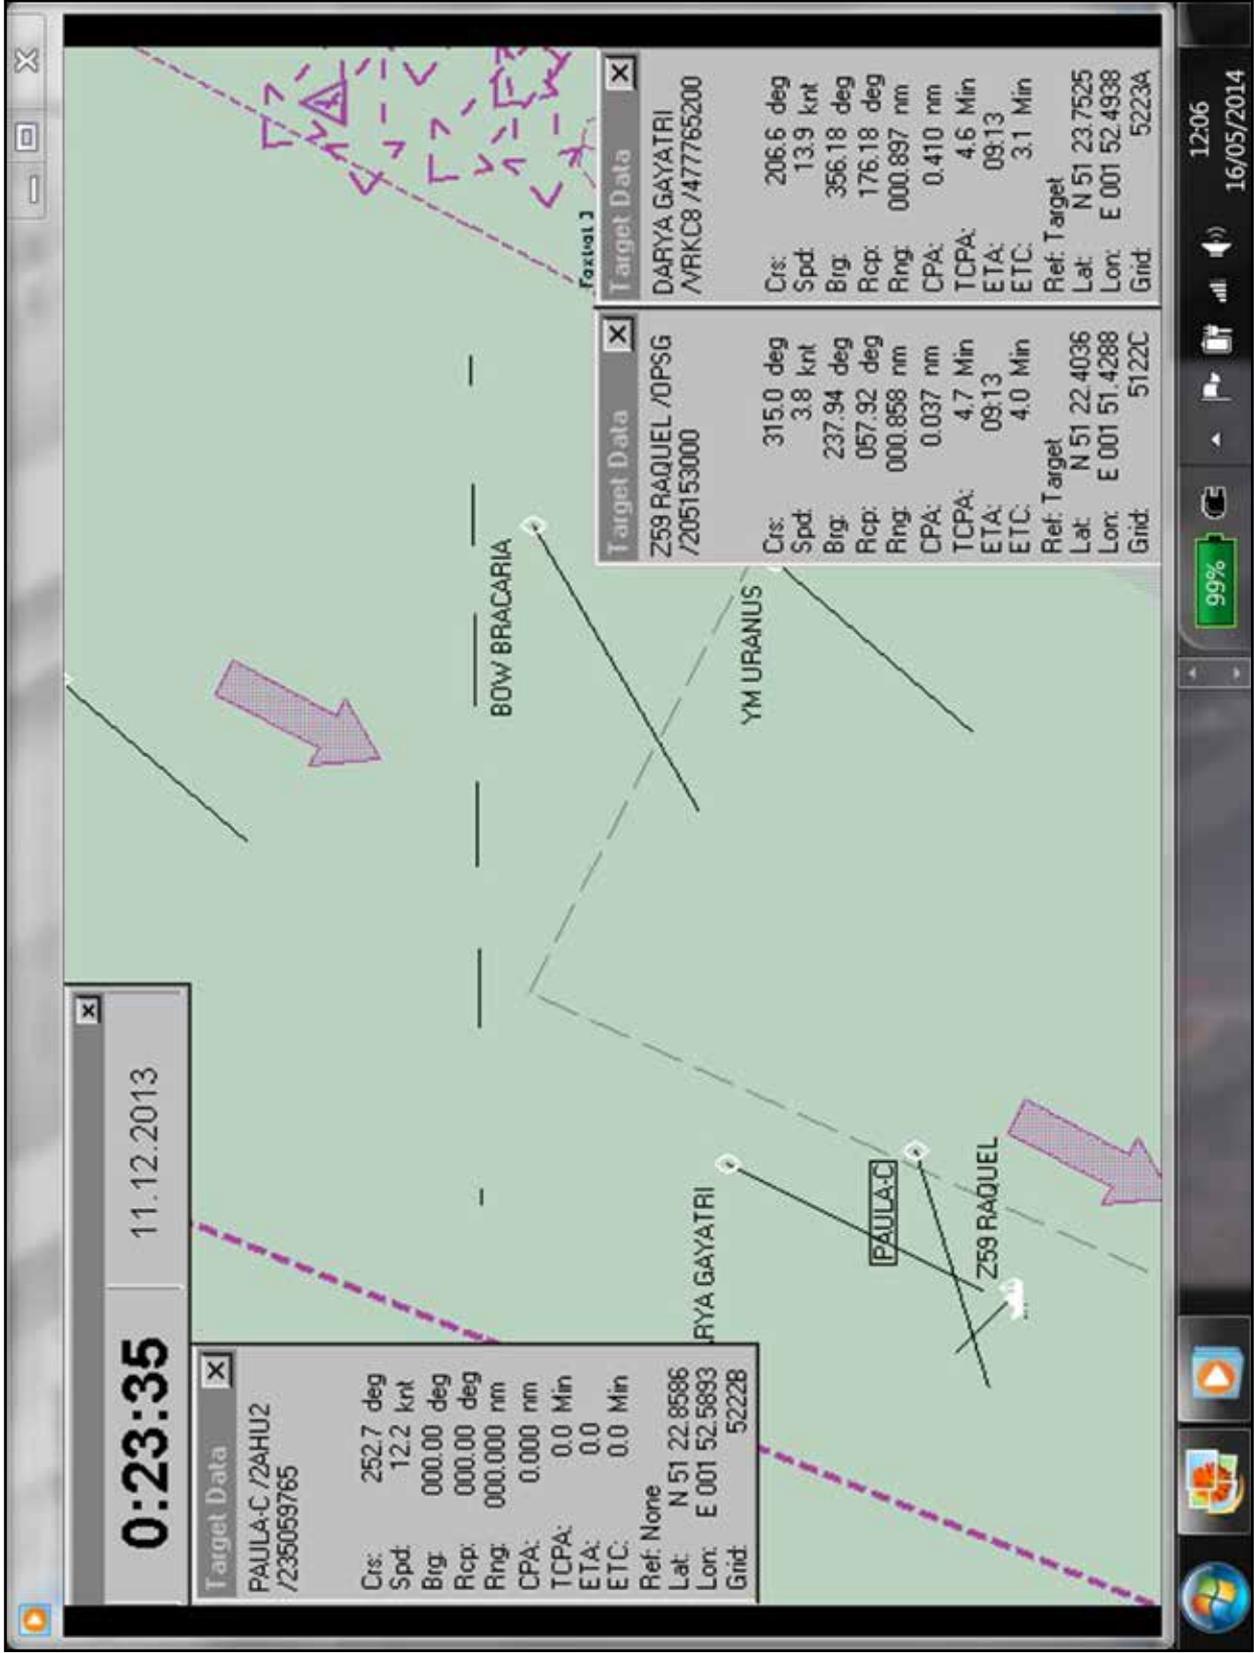
Figure 4: Dover Coastguard radar plot

*Paula C*'s movements were also seen on radar (**Figure 4**) by the duty Dover Coastguard watch officer. He called *Paula C* via very high frequency (VHF) radio channel 11 in order to clarify the OOW's intentions. The transcript of the resulting conversation is at **Table 2**.

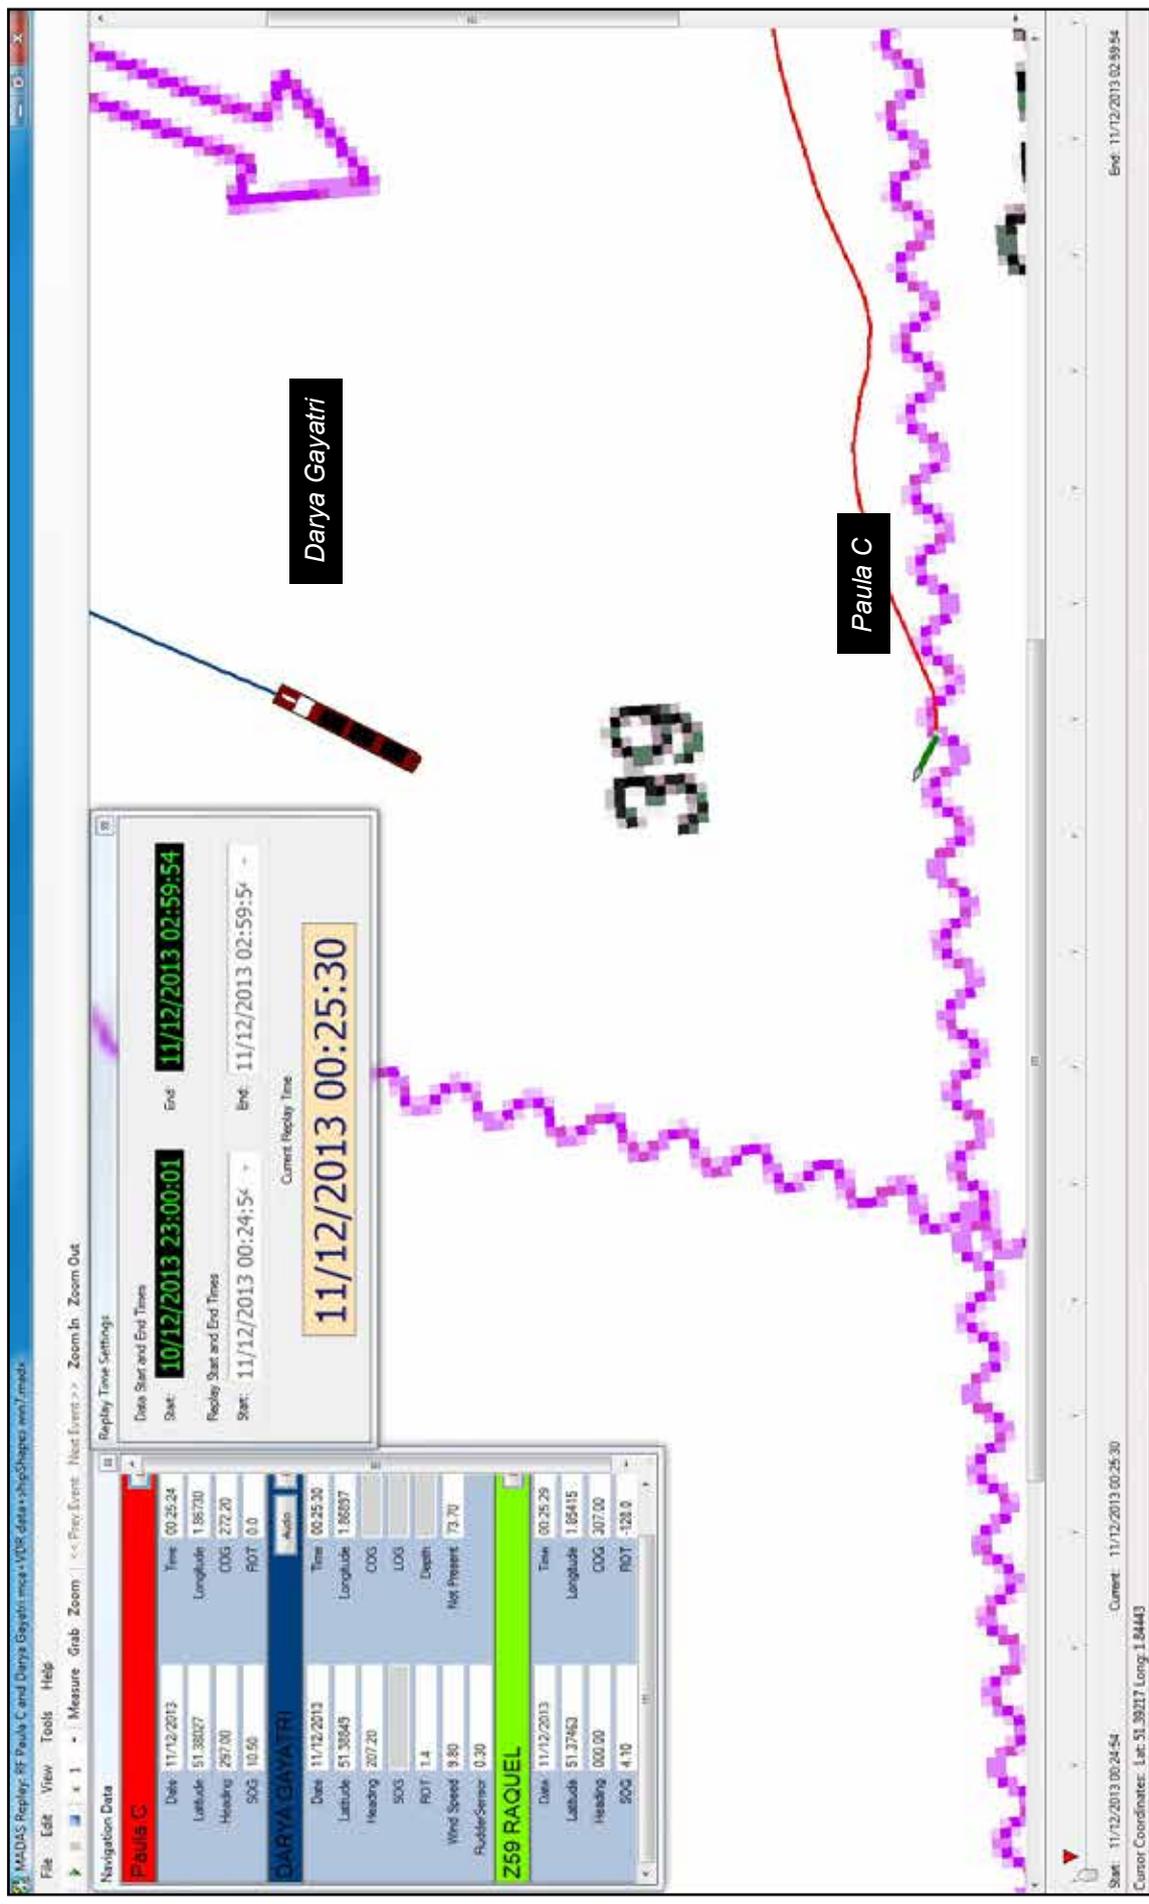
Figure 5: Paula C turning to starboard

During the VHF conversation, *Paula C*'s OOW adjusted the cargo ship's heading from 287° to 253°. Immediately after the VHF exchange, he selected hand-steering and applied 35° of starboard helm. *Paula C* started to turn quickly to starboard (**Figure 5**). The OOW did not check visually or by radar that the intended manoeuvre was safe or make a sound signal to indicate he was turning to starboard. He was unaware that *Darya Gayatri* was 511m off *Paula C*'s starboard beam.

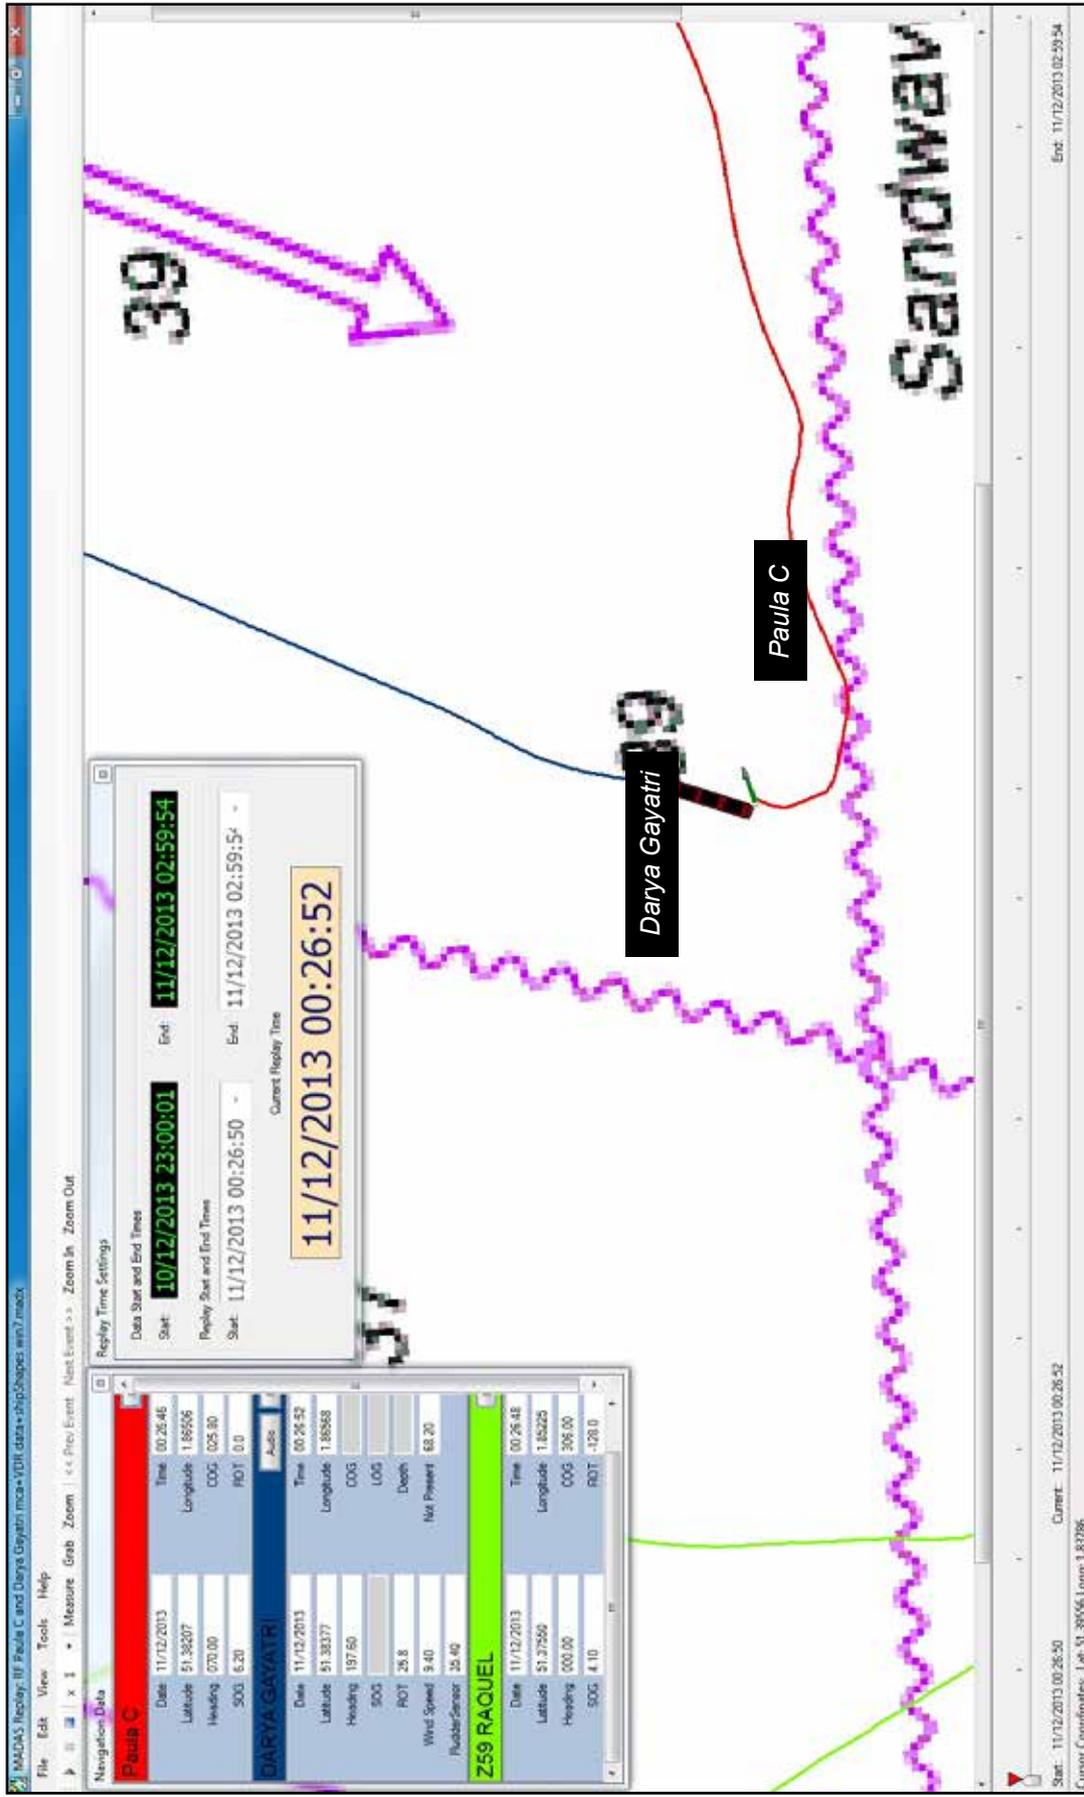
Figure 6: The collision

*Darya Gayatri*'s master arrived on the bridge just as *Paula C*'s port bridge wing collided with *Darya Gayatri*'s port anchor. At the point of contact, which was at 0026:52, *Darya Gayatri* was heading 198° at 12.9kts; *Paula C* was heading 070° at 6.2kts (**Figure 6**).

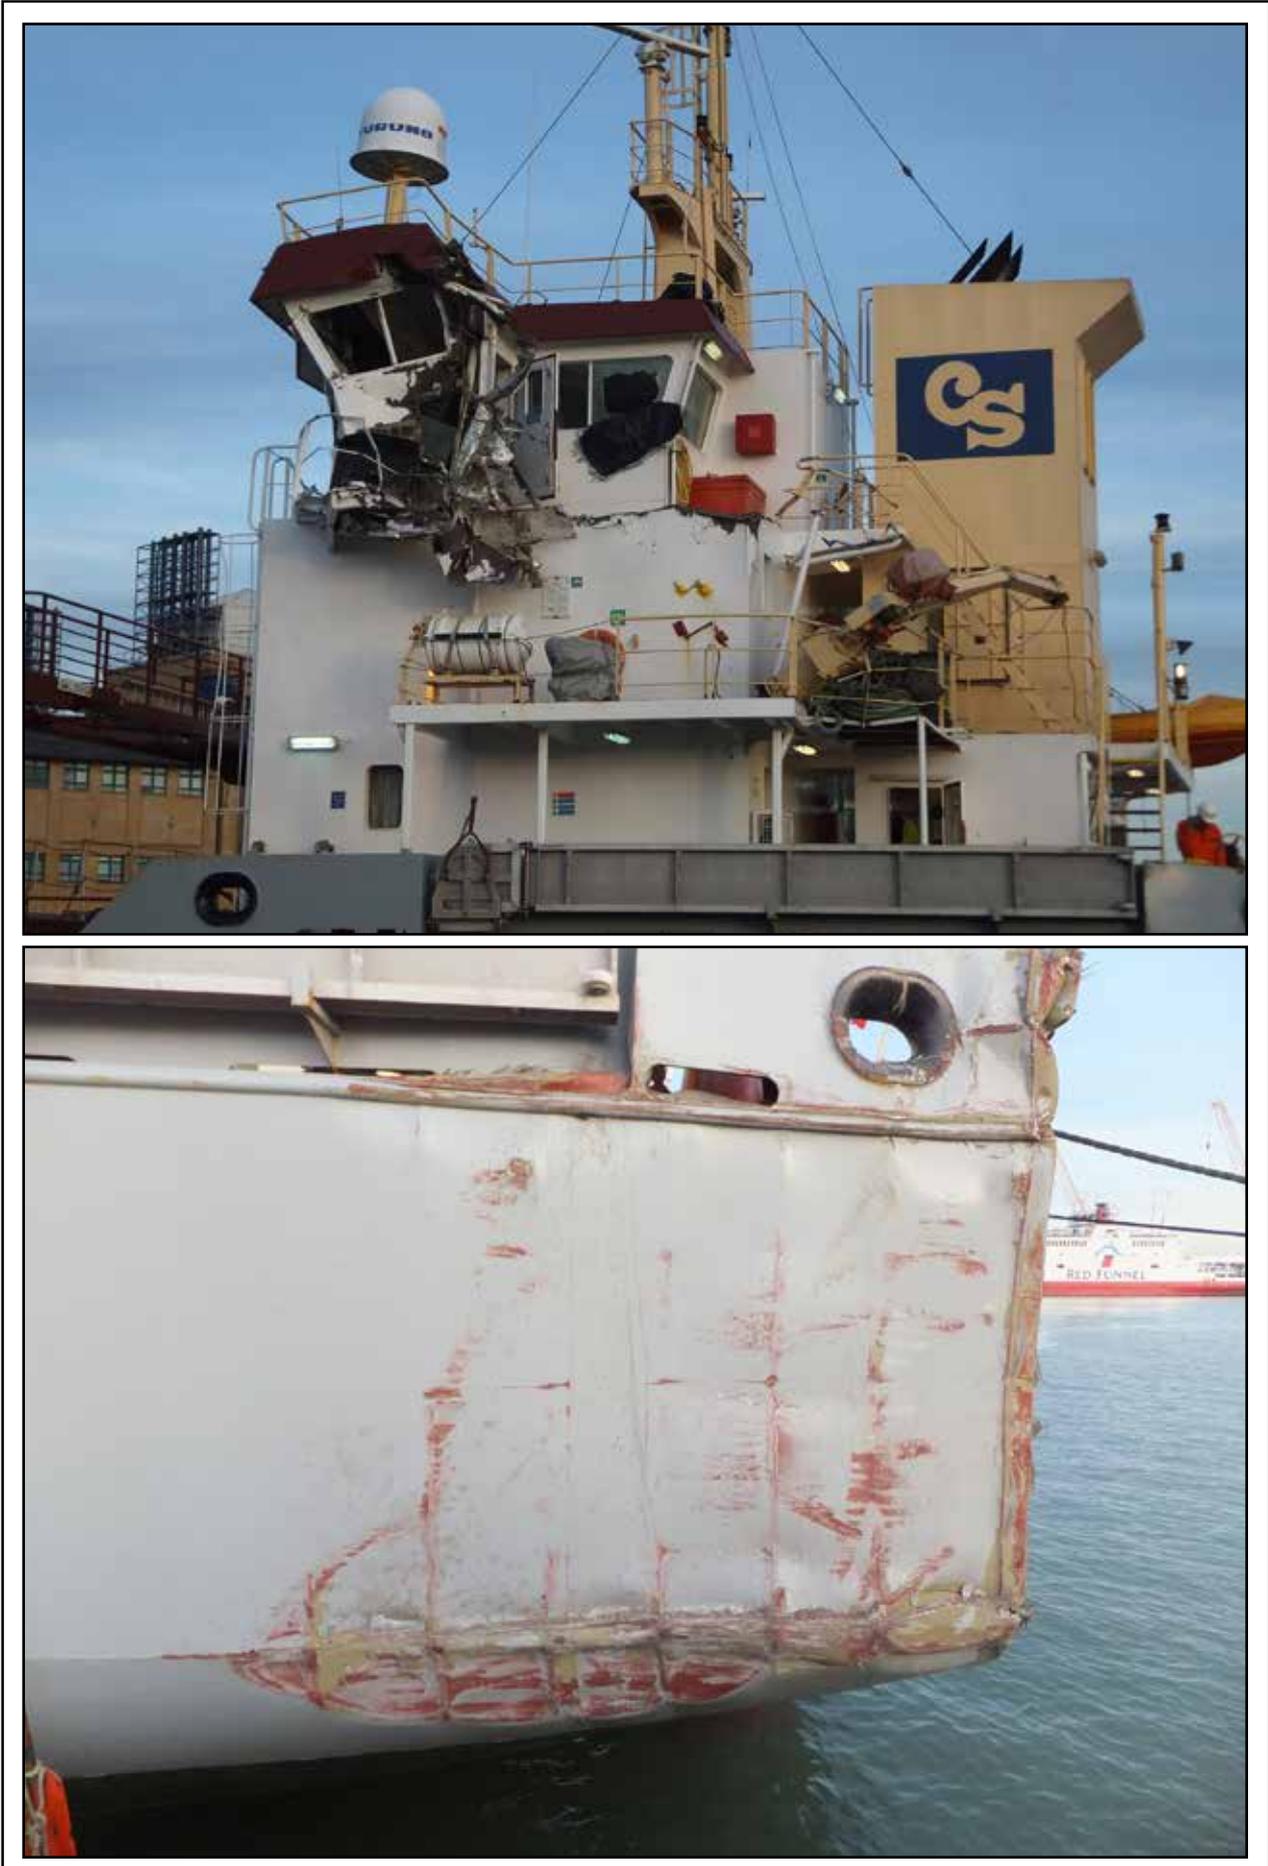
Figure 7: Damage to *Paula C*

*Paula C* suffered significant damage to her port bridge wing and port side accommodation and port quarter (**Figure 7**). In particular:

- The railings on the port side of the accommodation were dented and partially removed.
- The port quarter poop deck and shell plating was dented and holed.

Temporary repairs were made to *Paula C* in Southampton. Permanent repairs were subsequently completed in Rotterdam, Netherlands.

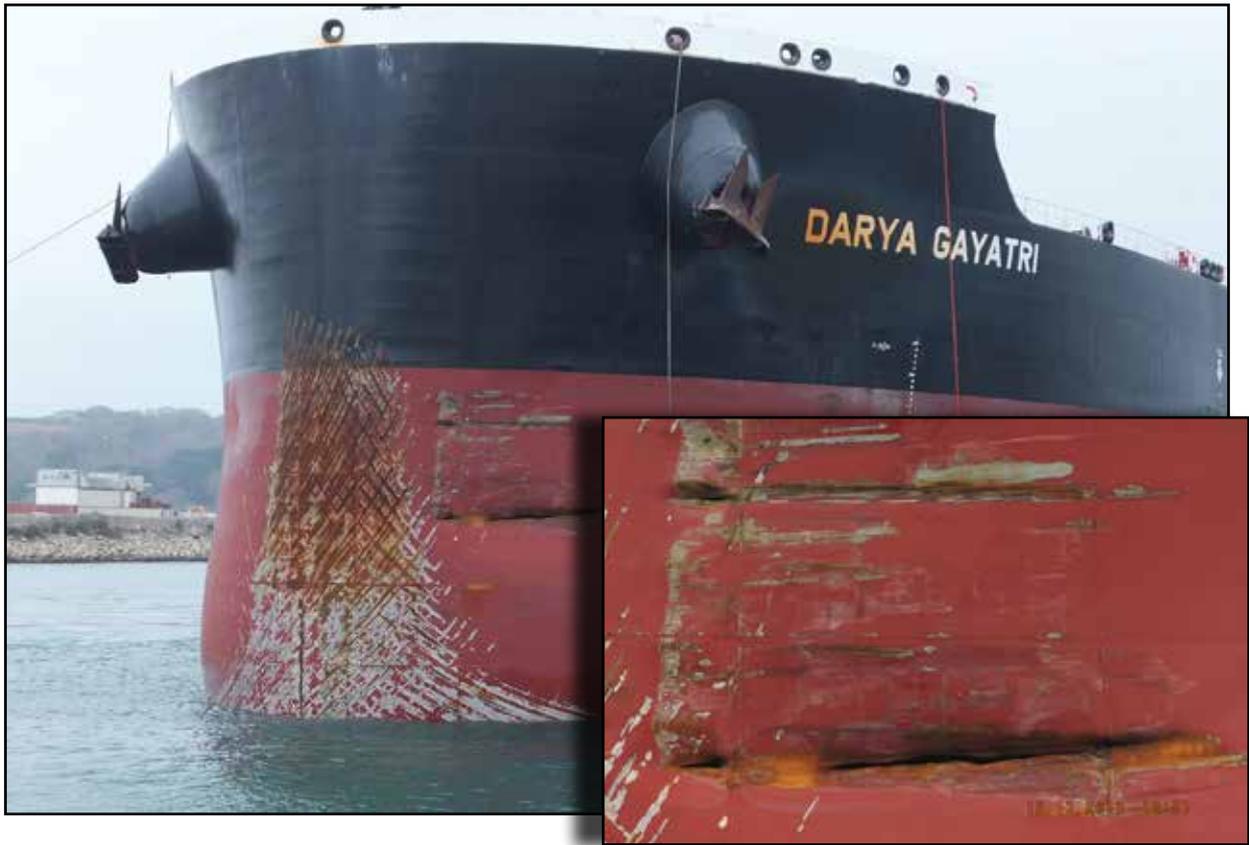
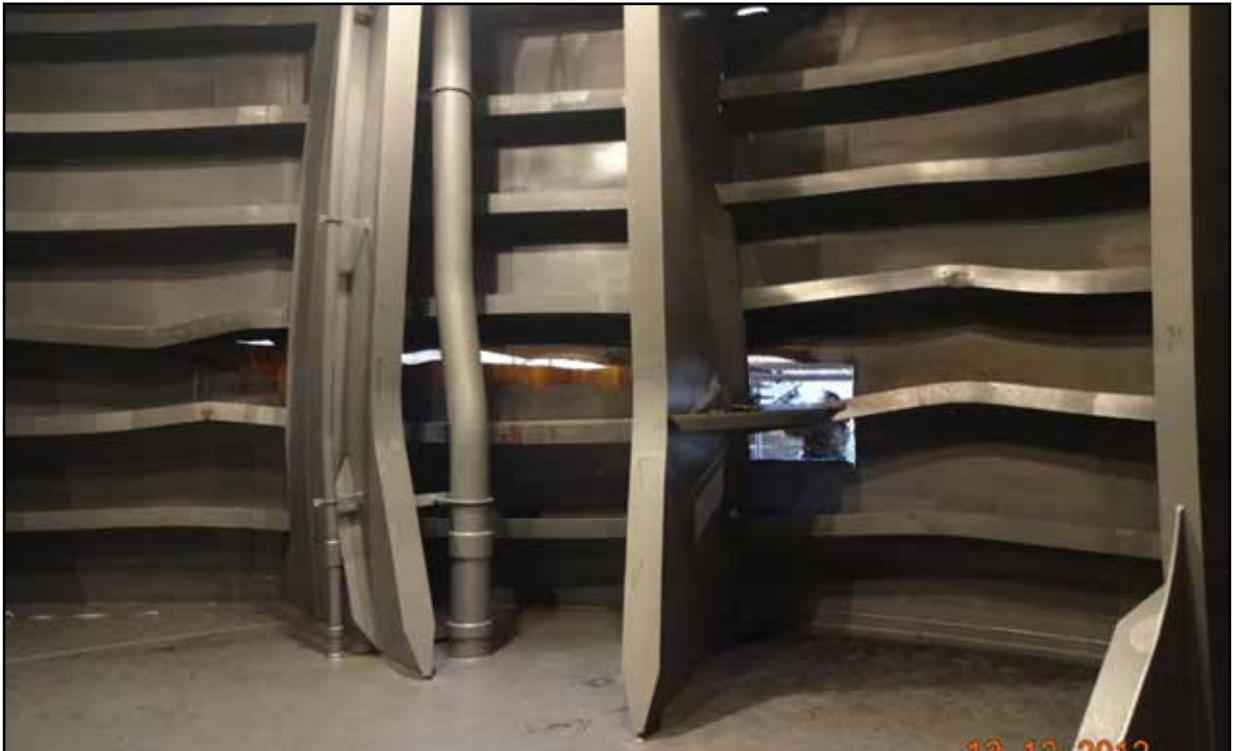
**Figure 8:** Damage to *Darya Gayatri*

Damage to *Darya Gayatri's* port bow comprised indentations and a 5m gash above the waterline in way of the forward void space (**Figure 8**). Permanent repairs were completed in Falmouth.
