Fatal man overboard from the recreational fishing boat **AMY JANE** Near Cadgwith, Cornwall 4 December 2013

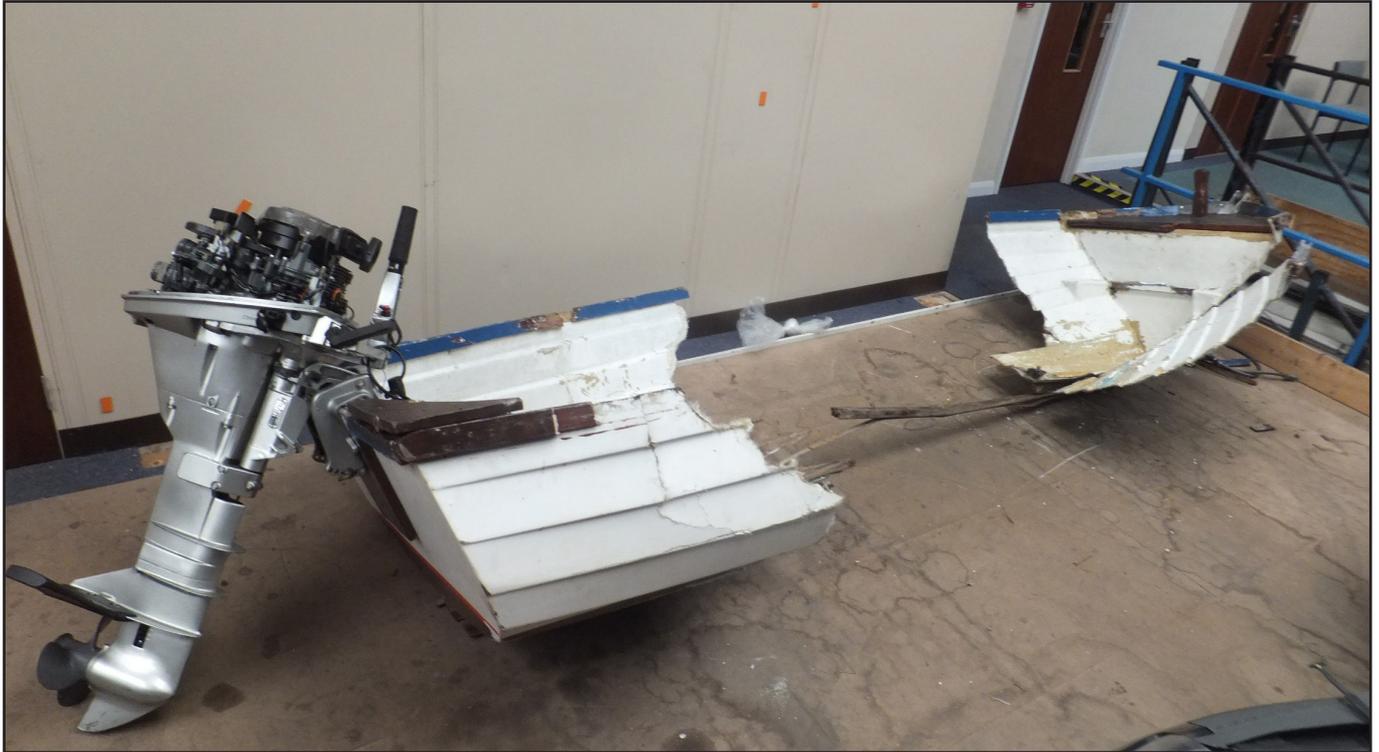
Figure 3: *Amy Jane* recovered sections

When the fore and aft sections of the boat were recovered by the lifeboat crew, its outboard engine was still attached to the transom (**Figure 3**). A 1.2m central section of the hull and the outboard engine's top cover were missing. The engine cover lock lever was found to be very stiff and was difficult to operate. The engine kill cord⁸ was still connected to the kill switch and was wrapped around the engine mounting frame. The engine gear selector was in the 'ahead' position with the throttle set to about 75% (**Figure 4**). The steering friction adjuster⁹ was slack and the engine was very loose to turn on its mounting.

It was apparent from the impact damage seen on the recovered sections of *Amy Jane* that the boat had probably been struck by a larger boat or ship. Inspection of local AIS¹⁶ data shows only two small commercial fishing vessels in the inshore area, but their timings and positions indicate little opportunity for either of these vessels being in the same place as *Amy Jane* at any stage.

The two separate sections of the boat were found floating close together, which would suggest that it had been damaged not long before discovery. Taking this into account, and the location of the debris, it is considered that *Amy Jane* was damaged several days after Chris had fallen overboard.

- Had he been wearing a PLB, and been able to activate it on entering the water, it is highly likely that he would have survived.
- The damage to *Amy Jane* was probably the result of the boat being run over by a larger vessel several days after the accident.

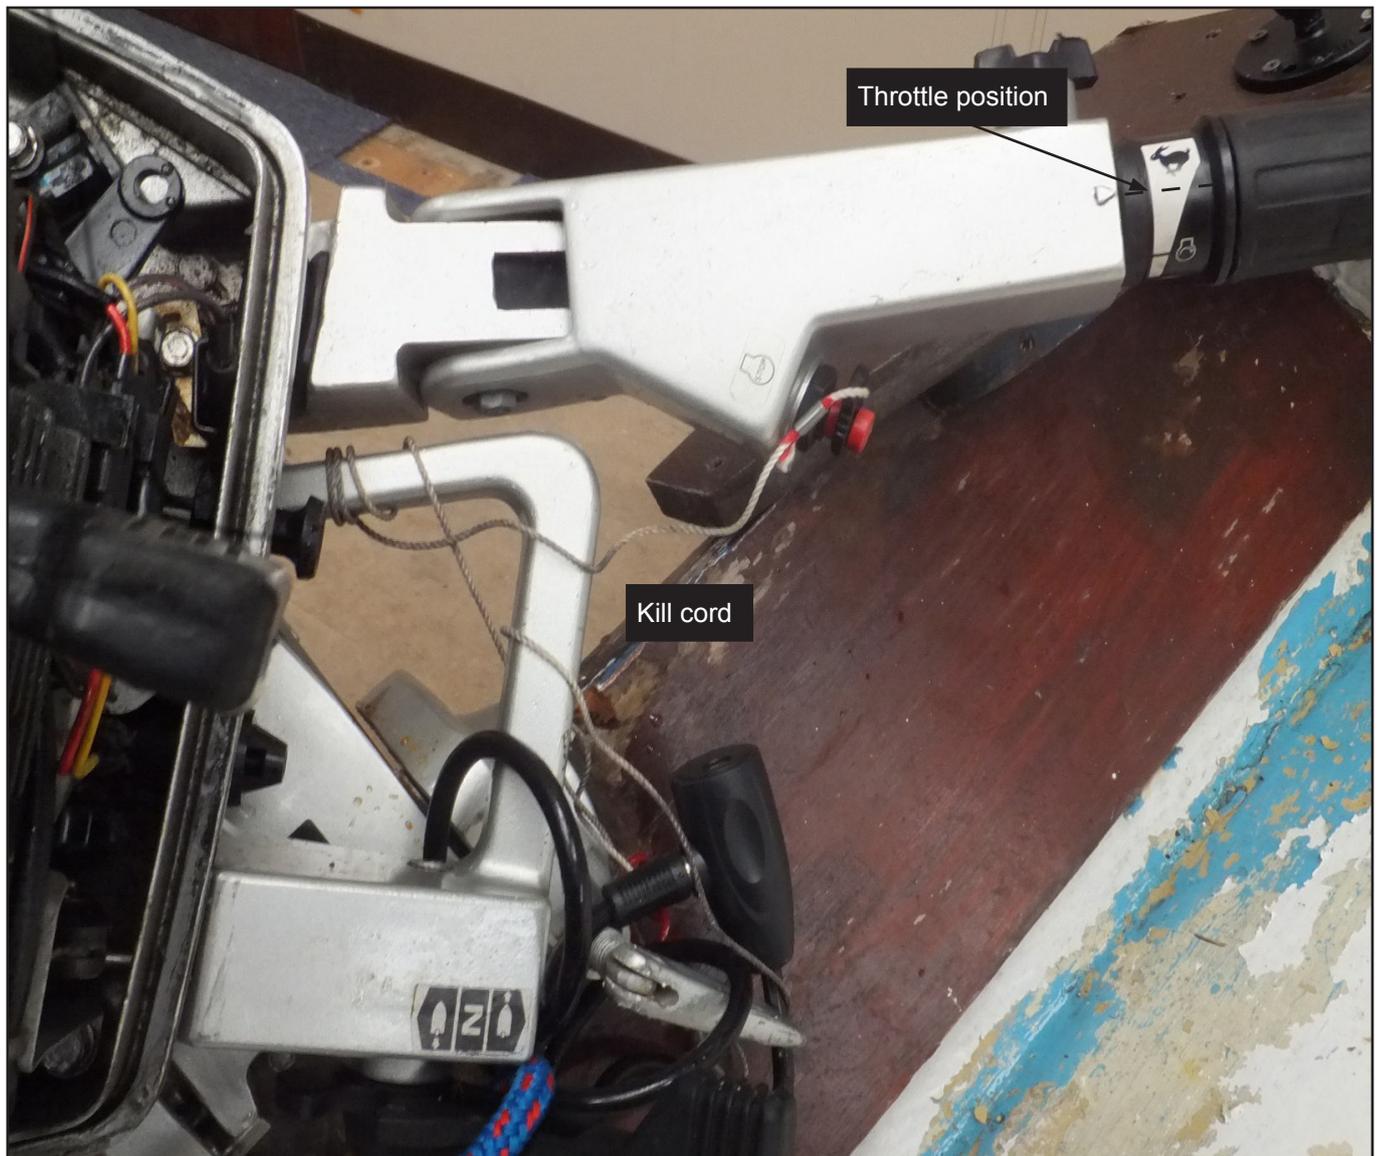
Figure 4: Kill cord and throttle

It was apparent that the outboard engine's kill cord was not attached to Chris when he fell overboard. This meant that he lost the opportunity to attempt to re-board his boat or retrieve any equipment that could have assisted him, such as a light, flares or his mobile telephone. Having said that, the debilitating effects of the cold water immersion, his physical size and fitness, and the boat's construction would have made this extremely difficult for him to climb back on board.

- The sea angler was not wearing the engine kill cord prior to falling overboard; as a result, the boat continued to motor for several hours. This removed any opportunity he might have had of climbing back into the boat, or of retrieving any equipment that might have aided his survival.
