Fatal man overboard while climbing on board the fishing vessel *New Dawn* to access the fishing vessel *Horizon II* at Royal Quays marina, North Shields on 9 November 2013

SUMMARY

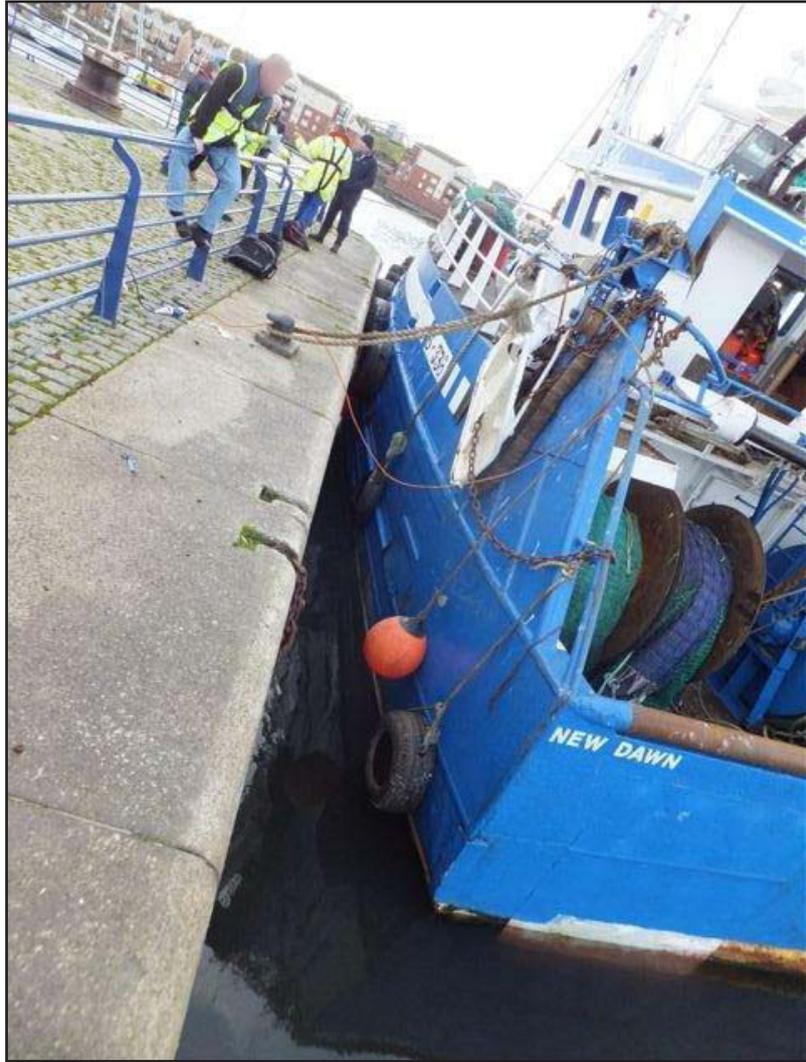
Figure 3: Middle pier and safety railings

In order to gain access to and egress from the fishing vessel berths on the middle pier, the fishermen had to climb over a 1m high safety rail. The safety rail was permanently fitted 1.5m away from the pier's edge, and was there to reduce the risk of members of the public falling into the water. There were no gaps in the railings or gates to allow access to the pier's edge or vessel berths. It was an accepted practice for the fishermen to climb the middle pier safety railings to gain access to the vessel berths.

To access the fishing vessels' berths the fishermen had to climb over a 1m high steel safety rail. The safety railings around the edges of the Royal Quays marina middle pier had been put in place primarily to prevent members of the public accessing the pier's edge; there were no gaps or gates to allow access to berthed vessels indicating that the middle pier was not originally intended to be used for berthing vessels.

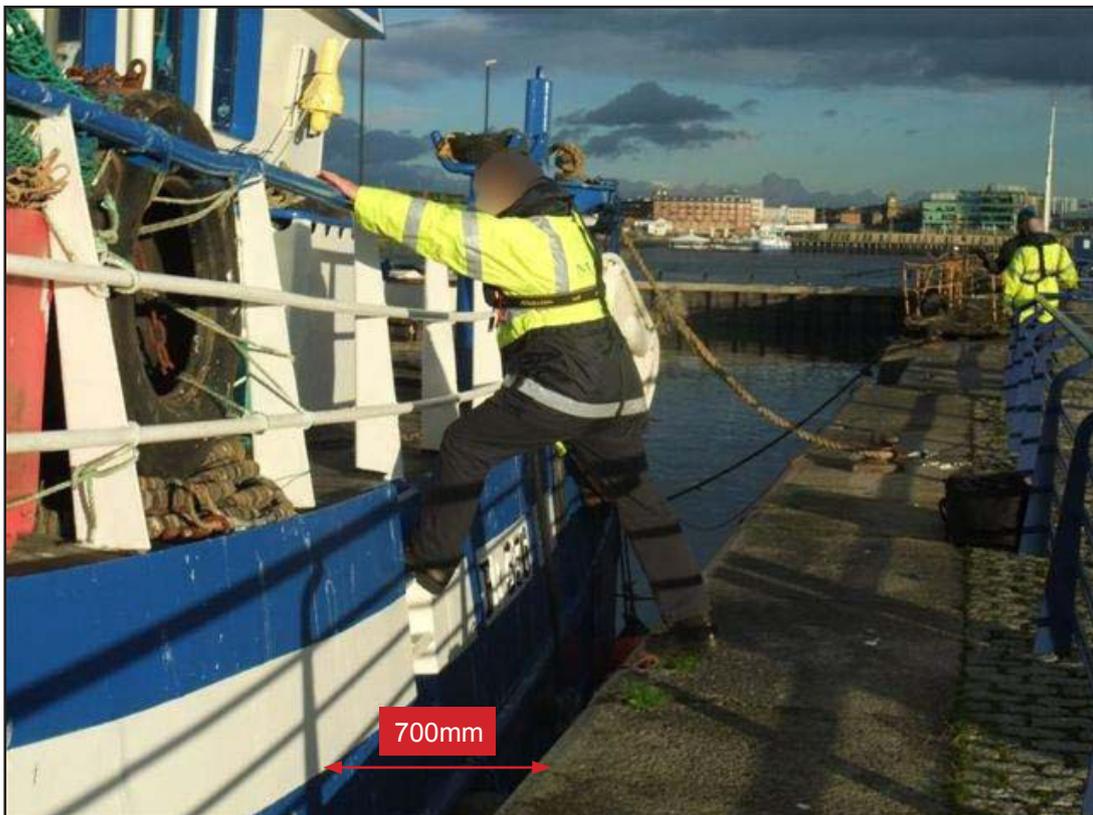
Figure 4: Gap between *New Dawn* and Middle pier

James grabbed hold of *New Dawn's* weather deck guardrails and stepped across the 700mm gap from the pier's edge to the rungs of the boarding ladder inset into *New Dawn's* hull (**Figure 4**). He then climbed up the ladder (a distance of about 1.4m) to the vessel's weather deck. At 0044, with his right foot on the lower horizontal guardrail, and holding onto the top rail, James attempted to swing his left leg over *New Dawn's* 1m high guardrails (**Figure 5**). As he did so, he appeared to lose his balance and pivoted backwards about his right foot. James lost his grip on the wet bulwark guardrail and fell between *New Dawn* and the pier and into the water. As he fell, he struck his head on one of the pier's coping stones (**Figure 6**).

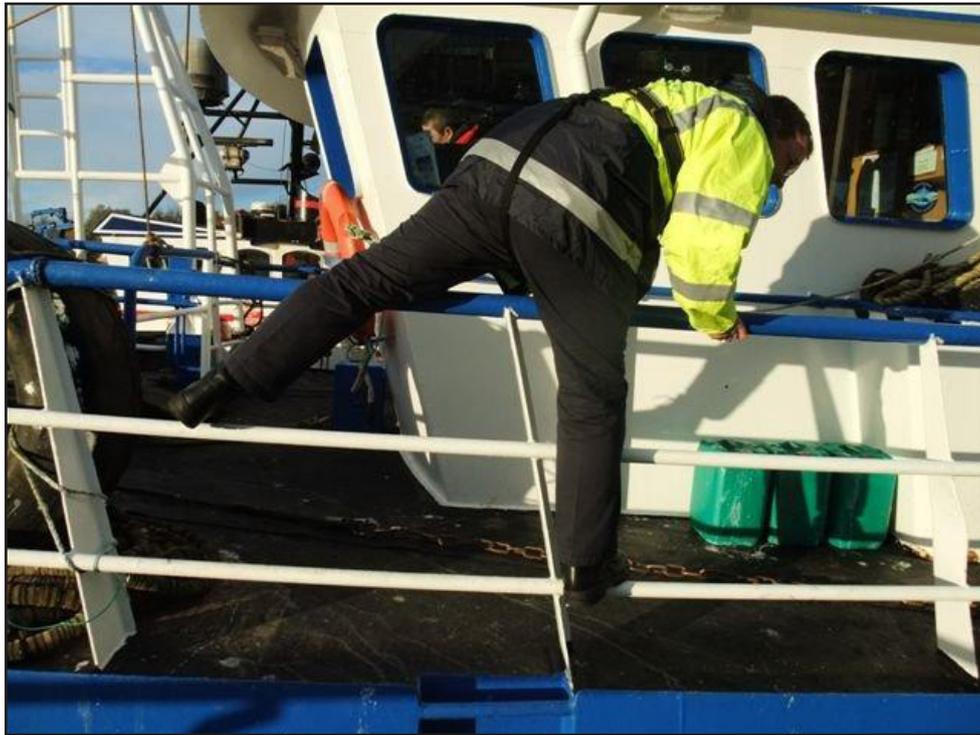
Figure 5: Climbing over *New Dawn's* guardrail

Even though James was wearing suitable footwear, it is likely that condensation on *New Dawn*'s smoothly painted steel guardrails caused the foot he was standing on to slip from under him and contributed to him losing his grip on the top rail. Although James was understood to be medically fit, it is possible that the effects of an ankle sprain he had sustained earlier in the year had an influence on him losing his balance.

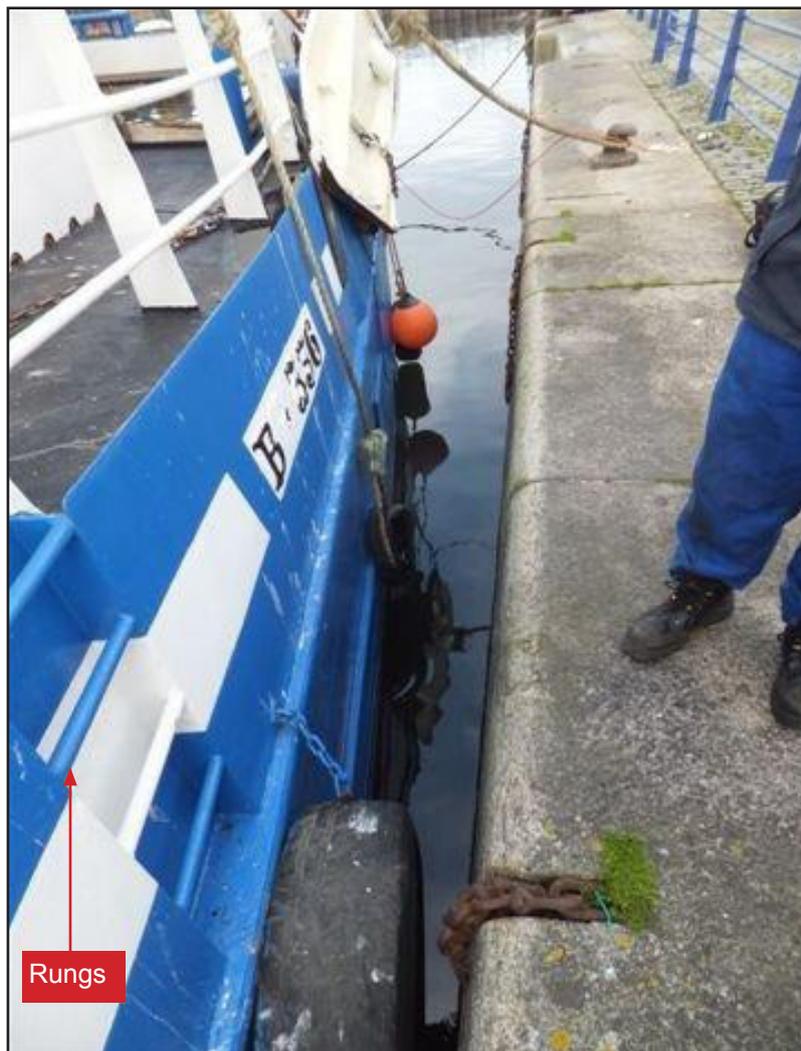
Figure 6: Gap between *New Dawn* and Middle pier

The berthing master retrieved a spare set of keys and went to his office to collect a torch. At about 0100, the berthing master, who by then had been joined by police, located James in the water. James was mostly submerged and was wedged between *New Dawn’s* hull and the pier wall (**Figure 6**).

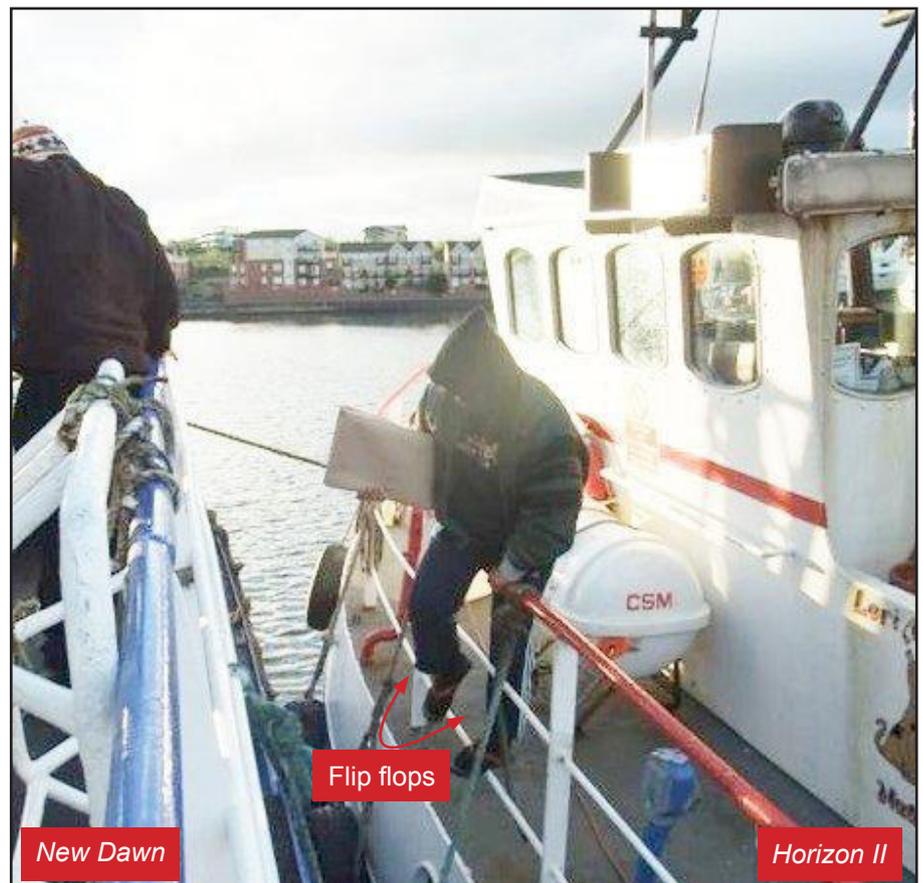
Figure 8: Crewman climbing between *Horizon II* and *New Dawn*

Horizon II’s owner was required to comply with the Fishing Vessels (Safety of 15-24 Metre Vessels) Regulations 2002 and the Code of Safe Working Practice for the construction and use of 15-24 metre fishing vessels as set out in Merchant Shipping Notice (MSN) 1770 (F)⁵. In accordance with MSN 1770 (F), fishing vessel owners were required to take precautions to prevent crews from falling into the water by providing a gangway or other appropriate and safe means of boarding the vessel. On the day of the accident, access to *Horizon II* was achieved by boarding *New Dawn*, crossing the deck, climbing over *New Dawn*’s outboard guardrails, stepping across the gap between the vessels and then climbing over *Horizon II*’s guardrails (Figure 8).

No additional lighting had been provided at the boarding points for either *Horizon II* or *New Dawn*. Furthermore, during the MAIB investigation, some crew members were observed climbing on and off the vessel while wearing flip-flops (**Figure 8**).
