FV PROSPECT

Grounding on Skibby Baas and foundering in the north entrance to Lerwick Harbour, Shetland Islands

5 August 2013

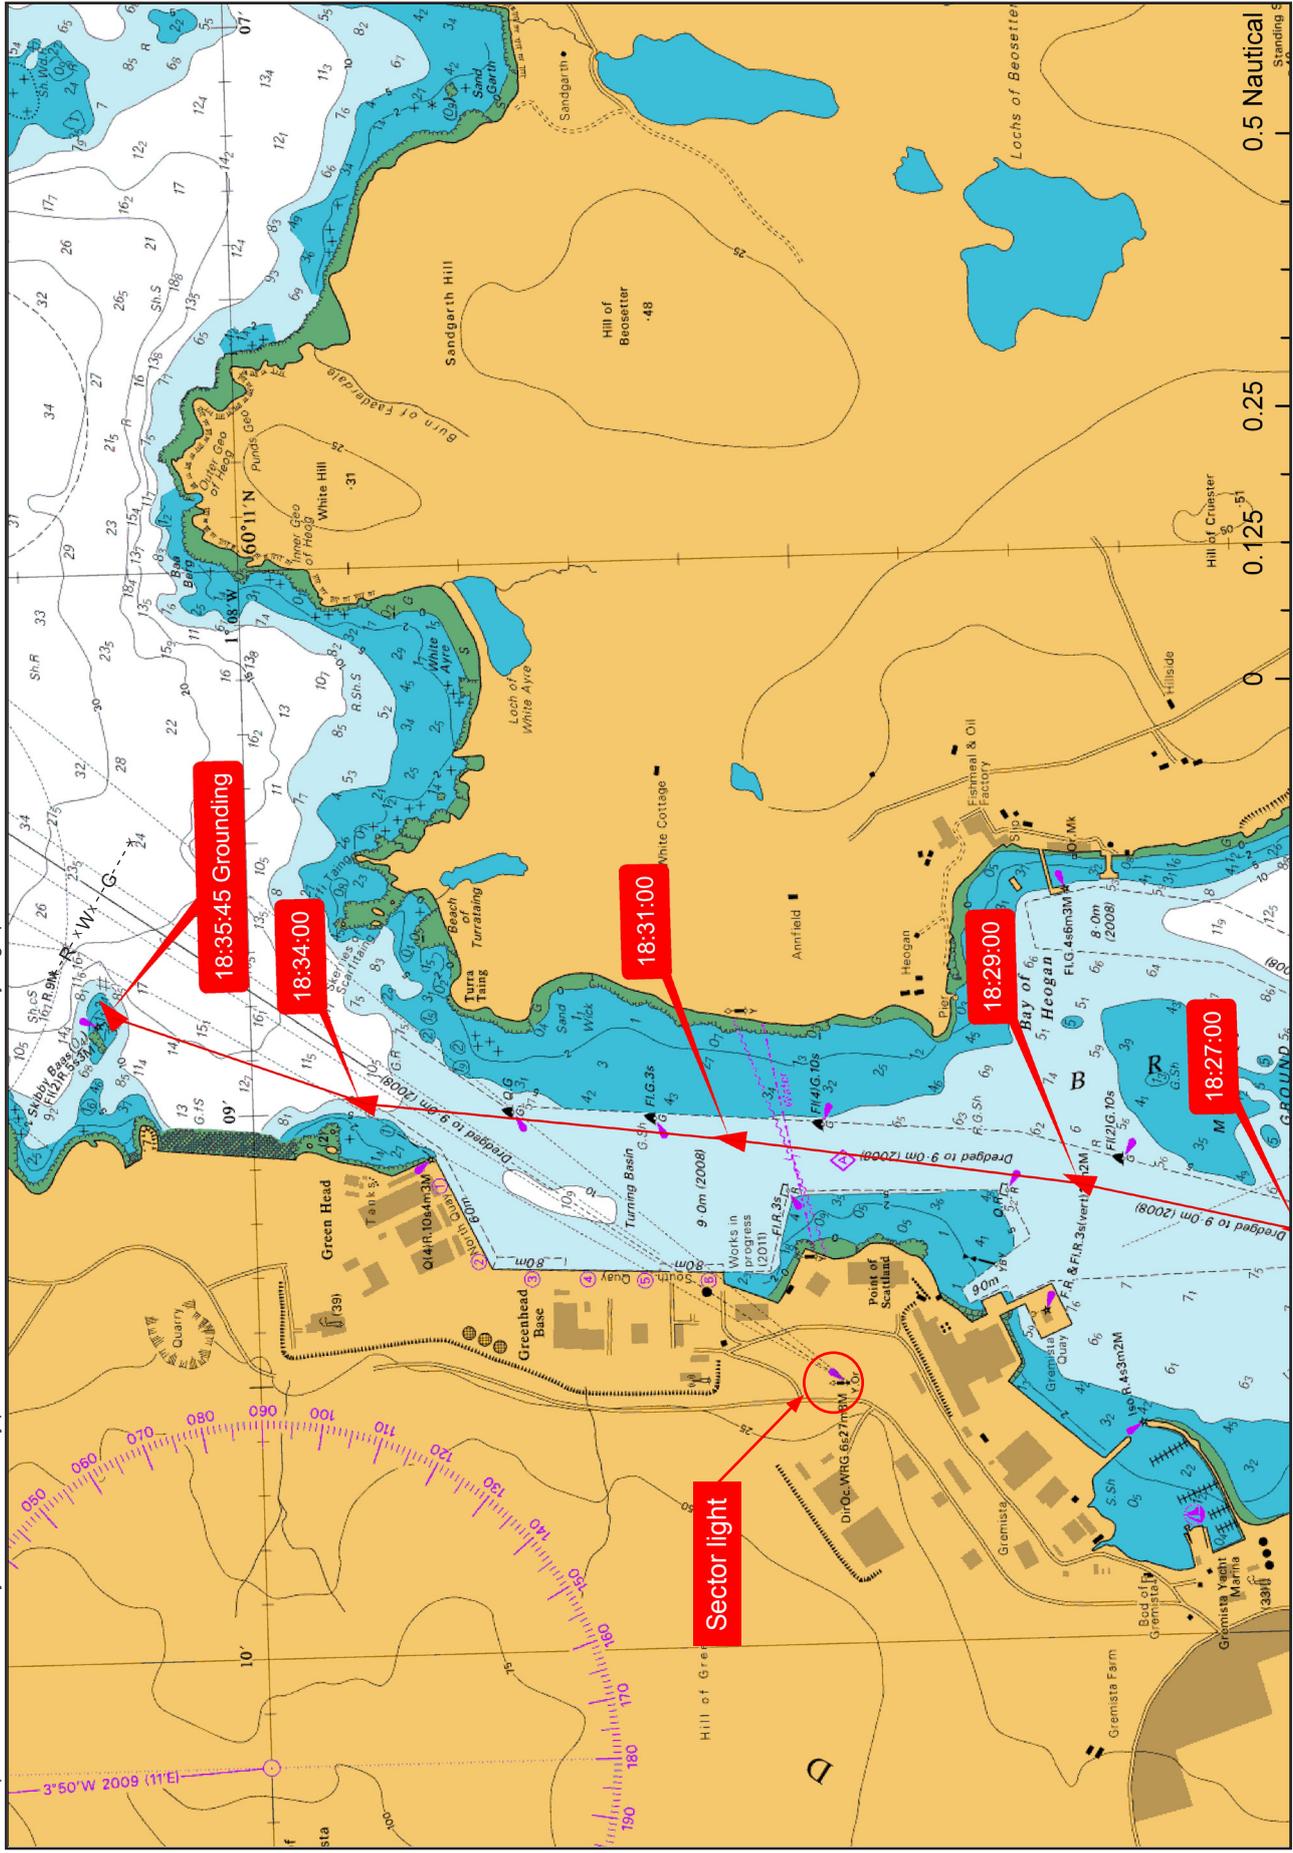
Figure 2: Chartlet BA2371 showing Prospect's AIS track

At 1835:45, *Prospect* grounded on Skibby Baas. The fish hold bilge alarm sounded in the wheelhouse as the vessel immediately listed about 15° to port. A chartlet showing the vessel's track is at **Figure 2**.

The grounding occurred because the skipper, being the sole lookout, lost positional awareness after making the course alteration at 1834. He believed that *Prospect* would pass clear of Skibby Baas because the turn to starboard had put the beacon fine on the vessel’s port bow. Although he was reportedly aware of the rate and direction of the predicted tidal stream, he did not take sufficient account of its potential influence in setting the vessel towards Skibby Baas. The skipper then became distracted by continuing a telephone conversation, the risks of which are highlighted comprehensively in MGN 299 (M+F), which compromised his monitoring of the vessel’s track. It is likely that the tidal stream set the vessel onto the rocks, east of the beacon.

After passing Greenhead Base, the skipper's planned track was well to the west of the recommended route and placed the vessel at unnecessary risk of grounding. Without reference to appropriate nautical charts and publications, the skipper did not appreciate that Skibby Baas beacon was positioned about 8m from the eastern extremity of the rocks, and he was unaware of the existence of the sector light. A suitable passage plan should have consisted of altering course onto a heading that ensured the vessel was in the white sector of the sector light. Once in the white sector, which was clearly visible in daylight, the skipper would only have had to keep within the sector so as to make a COG of 035°(T) and thereby safely clear Skibby Baas.

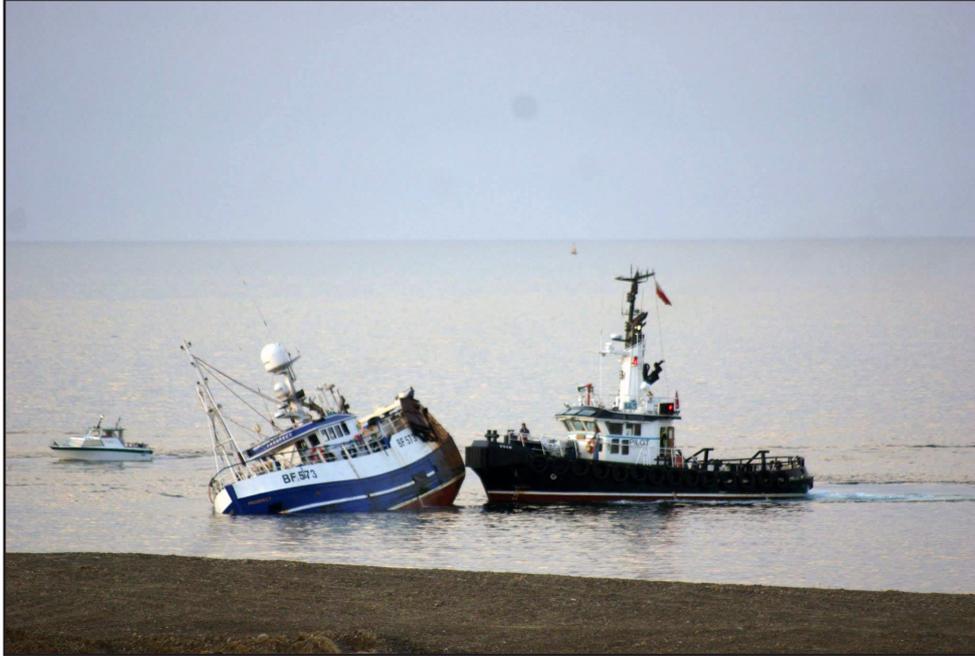
Figure 3: *Knab* pushing *Prospect* into shallow water

At 2102, the ALB connected a towline to *Prospect*'s bow and towed the vessel slowly in a northerly direction with *Knab* in close attendance. The tow was difficult to control as *Prospect* adopted an angle of loll. The AHM advised the ALB's coxswain to tow the vessel west after it had cleared Skibby Baas so that its condition could be determined clear of the entrance to the main channel. However, *Prospect* then rolled "lazily" to port and the ALB's coxswain, concerned about its stability, cut the towline. *Knab* then went alongside *Prospect* and carefully pushed it towards shallow water near to the bank (**Figure 3**). However, before the vessel could be beached, it sank in 15m of water, to the north of Skibby Baas, settling on its starboard side.

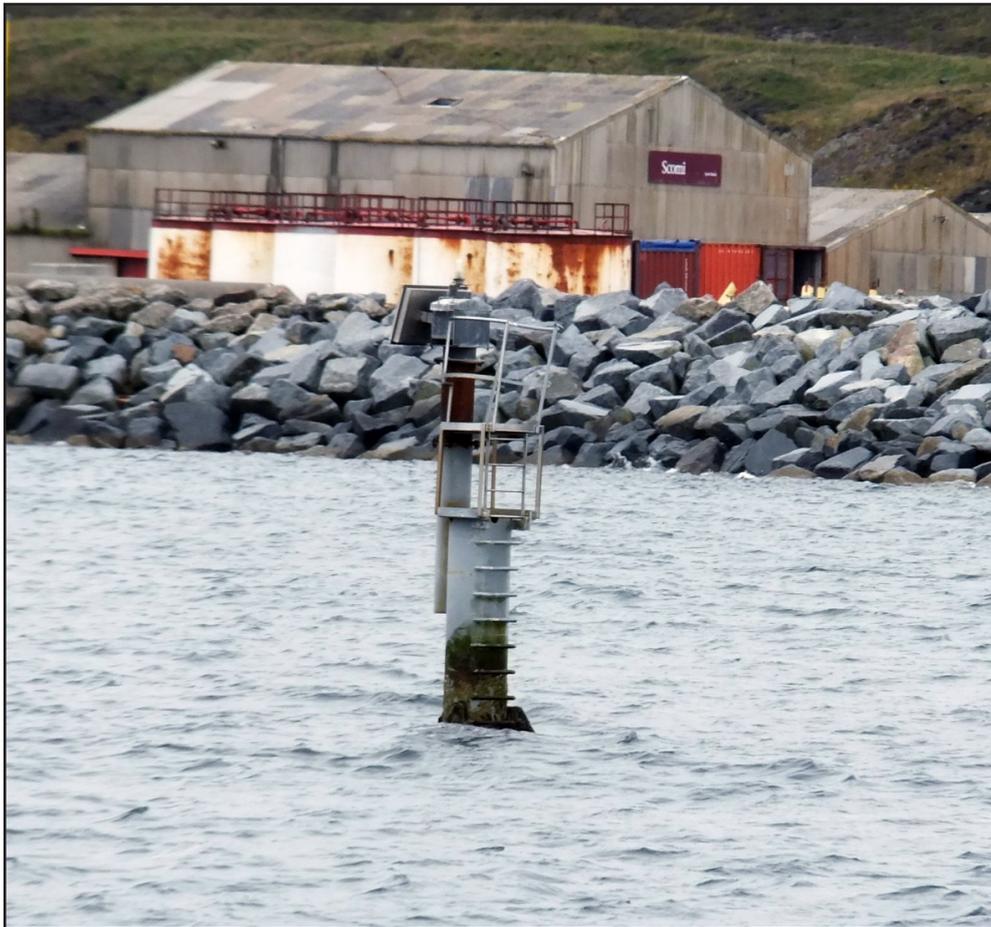
Figure 4: Skibby Baas beacon

Skibby Baas is a 45 metres (m) long, drying outcrop of rocks situated 120m from the western coastline in the north entrance to Lerwick Harbour. It is marked by a beacon with a 3-mile range red light that flashes twice every 5 seconds in low ambient light conditions. A radar reflector and solar-charging panel are fitted to the grey-painted supporting post (**Figure 4**). The beacon was fitted to Skibby Baas in 1999; because of instability of the rock formation, it was located approximately 8m from the most easterly point of the outcrop.

The steel post supporting the Skibby Baas beacon is preserved with a grey paint scheme. From certain viewing points, during daylight, the beacon blends in with the grey rocks forming the sea defences on reclaimed land at Greenhead Base. Although not contributory to the accident, the beacon's prominence could be improved if its supporting post were painted a high-visibility colour.

- Scheduled a site visit to investigate the viability of using high-visibility paint on the Skibby Baas beacon support post to improve its prominence.
- Fitted high-intensity lamps to the north entrance sector light to improve visibility against background lighting, and painted a “keep clear” zone on the quayside of Greenhead Base to highlight where the sector arcs pass in the vicinity of the berths.
- Planned a review of a requirement for LPA vessels to carry portable pumps for use on third-party vessels in the event of flooding.
- Arranged for a review of the co-ordination and command roles with Shetland CG for incidents occurring within the LPA port limits.
