Grounding of **FRI OCEAN**

2½ miles south of Tobermory

14 June 2013

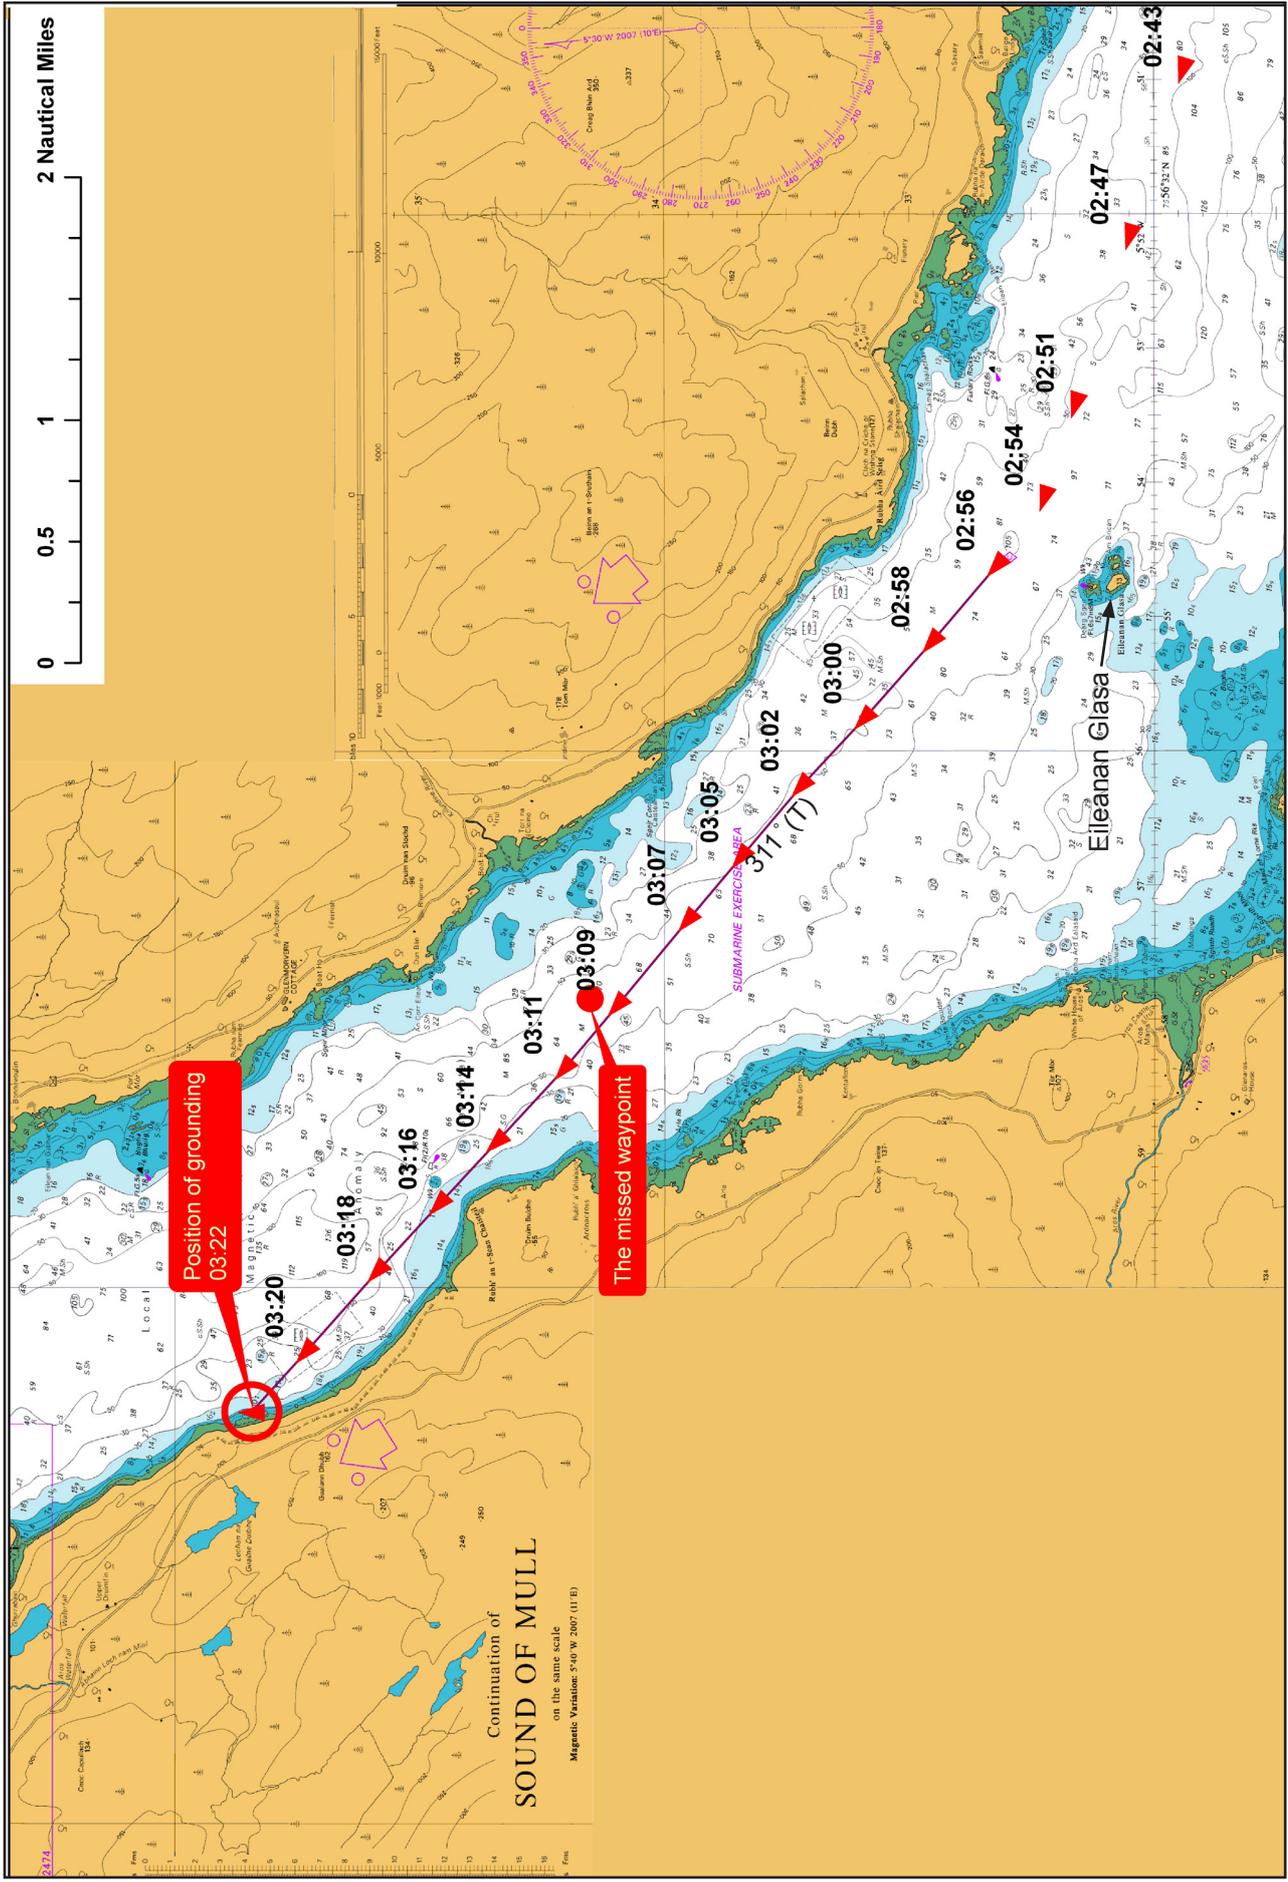
Figure 2: Fri Ocean's position AIS history track

Shortly afterwards, the second officer fell asleep. The vessel passed the next planned waypoint and maintained her course for just over 2½ miles, at about 10.5 knots, until the second officer then woke up.

Sensing the close proximity of land, the second officer immediately moved the engine control to neutral, and then full astern, before *Fri Ocean* grounded at 0322 (**Figure 2**).

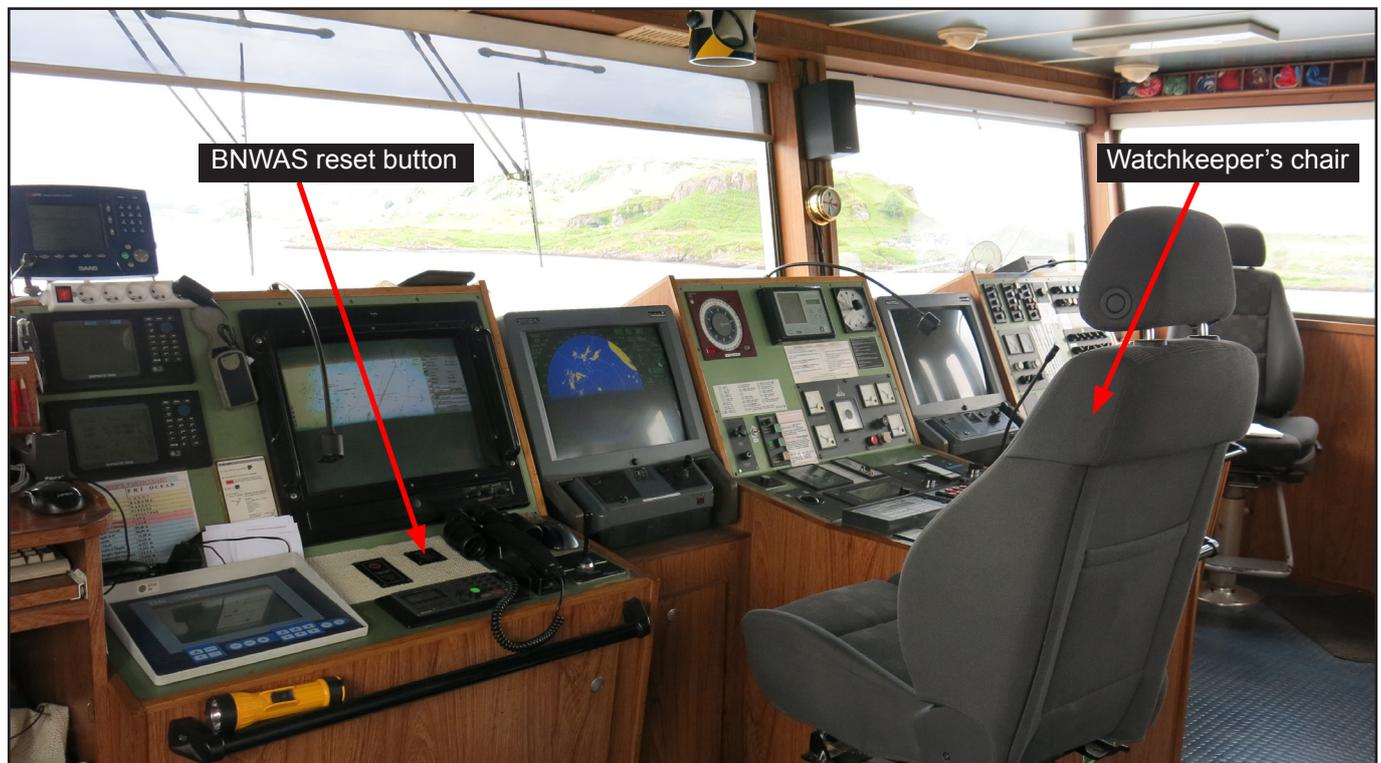
Figure 3: *Fri Ocean*'s wheelhouse

Fri Ocean's bridge layout was designed to enable an OOW to monitor the vessel's position using electronic navigational aids while seated in the port bridge chair. It was also possible to adjust the vessel's course, using either manual or automatic steering, without leaving the chair.

While ergonomically efficient, the design enabled the second officer to conduct much of his watch sitting down, which increased the potential for him to fall asleep.

To reset the BNWAS from his seated position, the second officer would have had to lean forward, reach across the console and press the reset button (**Figure 3**). It is unlikely he would have achieved this while asleep.

As the alarms were working correctly, it is concluded that the BNWAS was probably not switched on during the period leading up to the grounding.

- Emphasising the value of lookouts, and to specifically require that a lookout is present on the bridge at night while the vessel is at sea.
- Providing guidance on fatigue management and the effective use of crew.
- Instructing masters to detail their own specific requirements with regard to passage planning and monitoring, including the extent to which particular electronic navigational aids should be used.
- Providing instructions on when, and the manner in which, the BNWAS should be used while the vessel is at sea.
