Report on the investigation of  
the fire on board  
***Celtic Carrier***

24 miles west of Cape Trafalgar, Spain  
on 26 April 2013

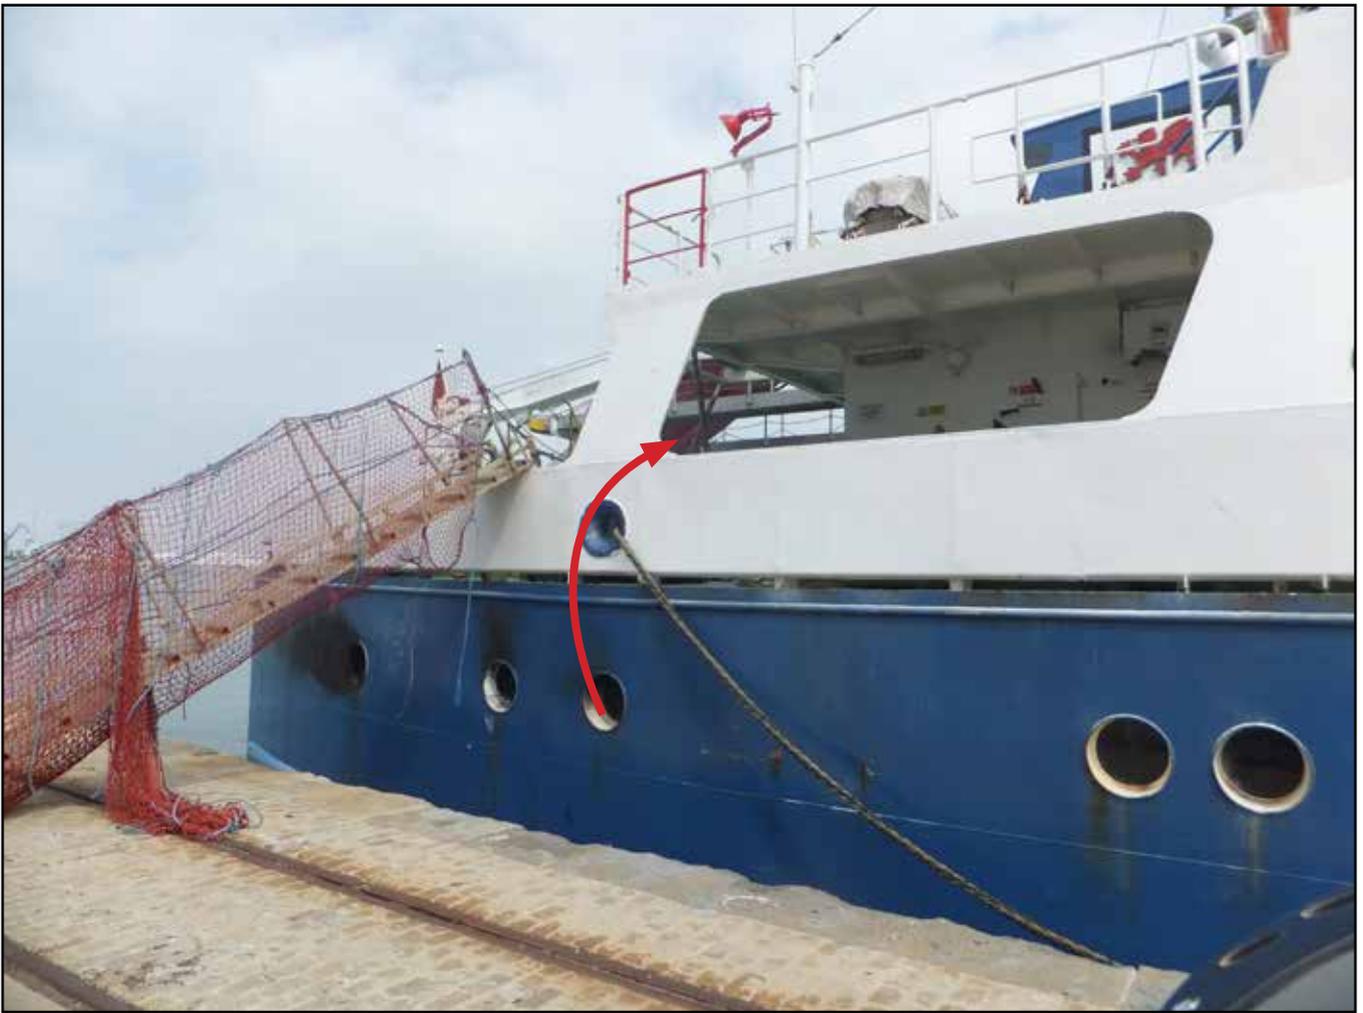
AB1 was woken by what he thought was the sound of a small explosion and the noise of electrical circuit breakers tripping open. He smelled burning plastic and then heard the fire alarm. In the darkness of his cabin, he got out of bed and opened his cabin door. The alleyway was dark and he sensed thick smoke. He closed the door, crossed the cabin and opened the porthole. Then, in his pyjama bottoms, AB1 climbed out of the porthole opening and pulled himself up the vessel's side and over the poop deck bulwark (Figure 4).

**Figure 4:** Starboard side crew cabin portholes showing AB1's escape route

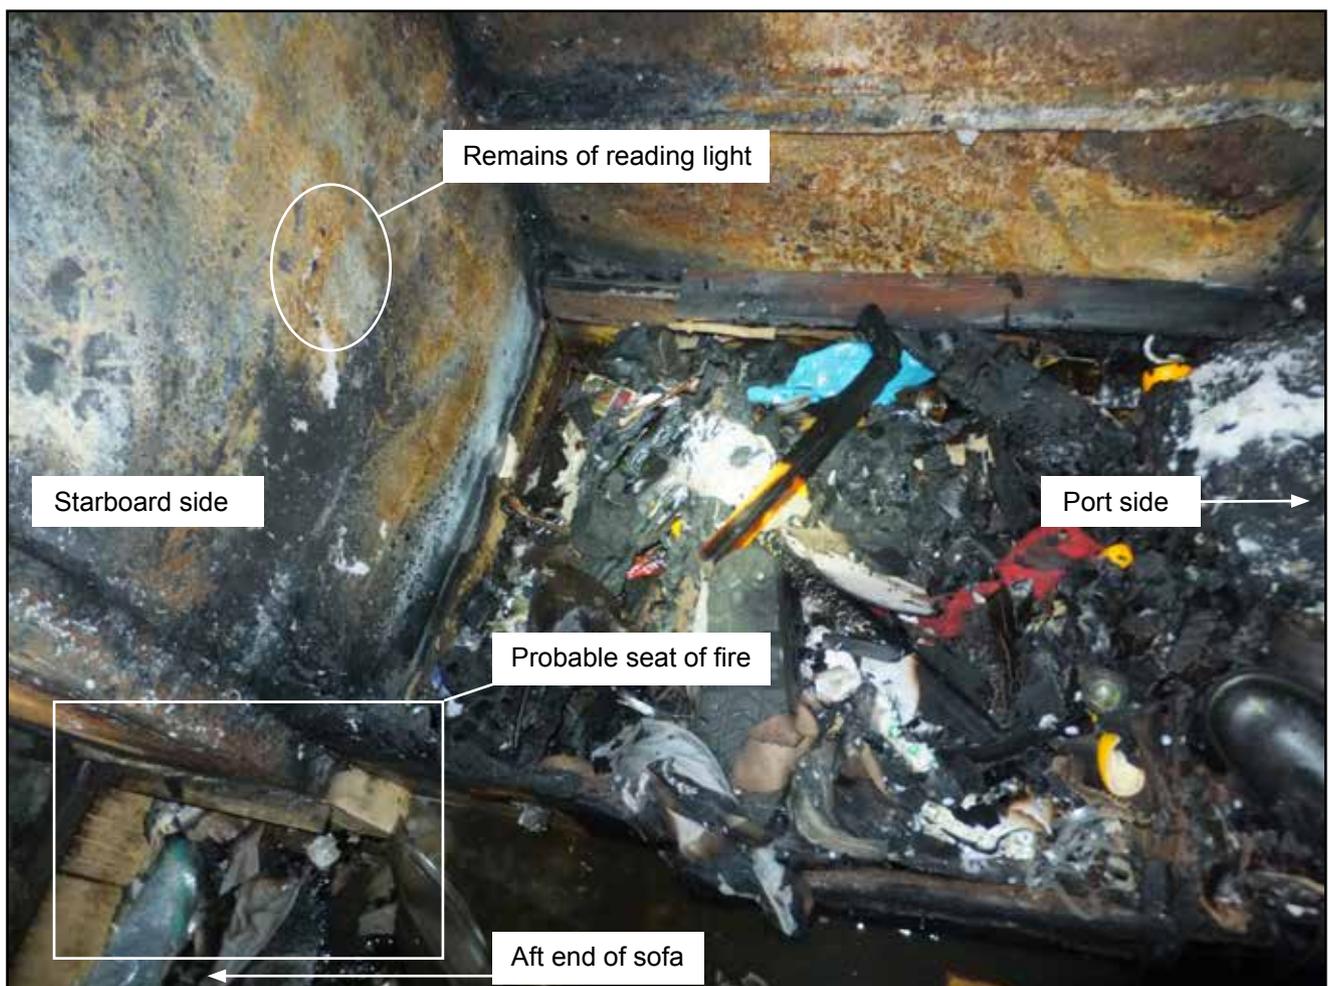
In conjunction with an independent fire investigator, AB2's cabin was methodically excavated to ascertain the probable cause of the fire. The layout of the cabin is shown at **(Figure 3)**. Most of the furnishings were made from wood or had wood framing, and the seat and back of the sofa were made of foam with a vinyl covering. Much of this was consumed in the fire, leaving only the lower section of the bunk (including the underbunk drawers) **(Figure 6)**; the fixed table support post **(Figure 7)**, and the lower parts of the sofa's wooden frame below the porthole **(Figure 8)**. The electrical sockets and light fittings were all severely damaged, with the remains of the electrical wiring from the fluorescent light hanging down from the fitting. The remains of wires for a mobile phone charger and an electric fan heater were still connected to the sockets. The cabin door was buckled and severely heat damaged on both sides and along the door jamb, with the inner door handle and key partly melted away. The steel deckhead panel was partially dislodged above the door.

**Figure 6:** AB2's cabin fire-damaged bunk

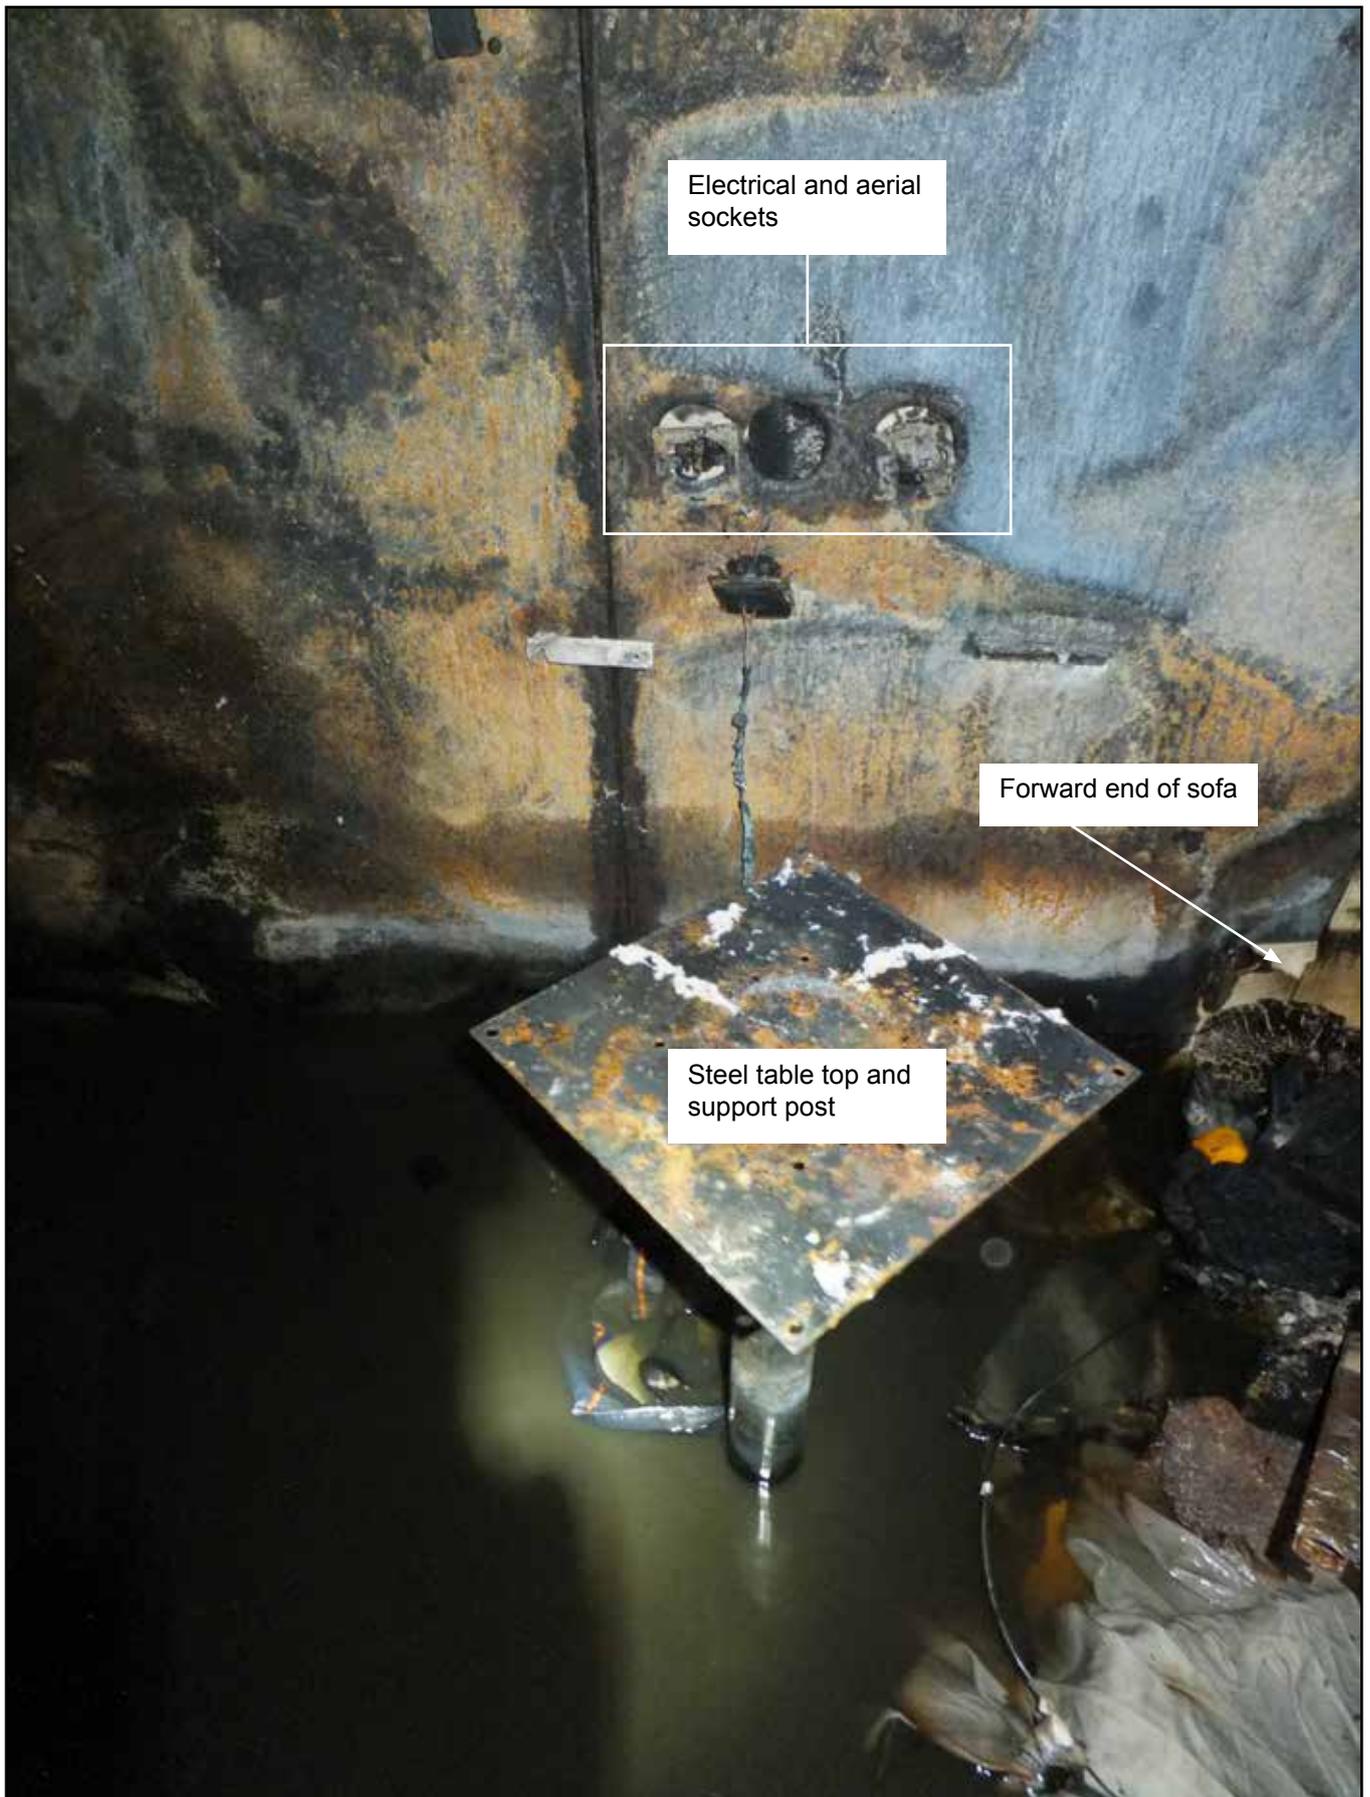
**Figure 7:** AB2's cabin fire-damaged table

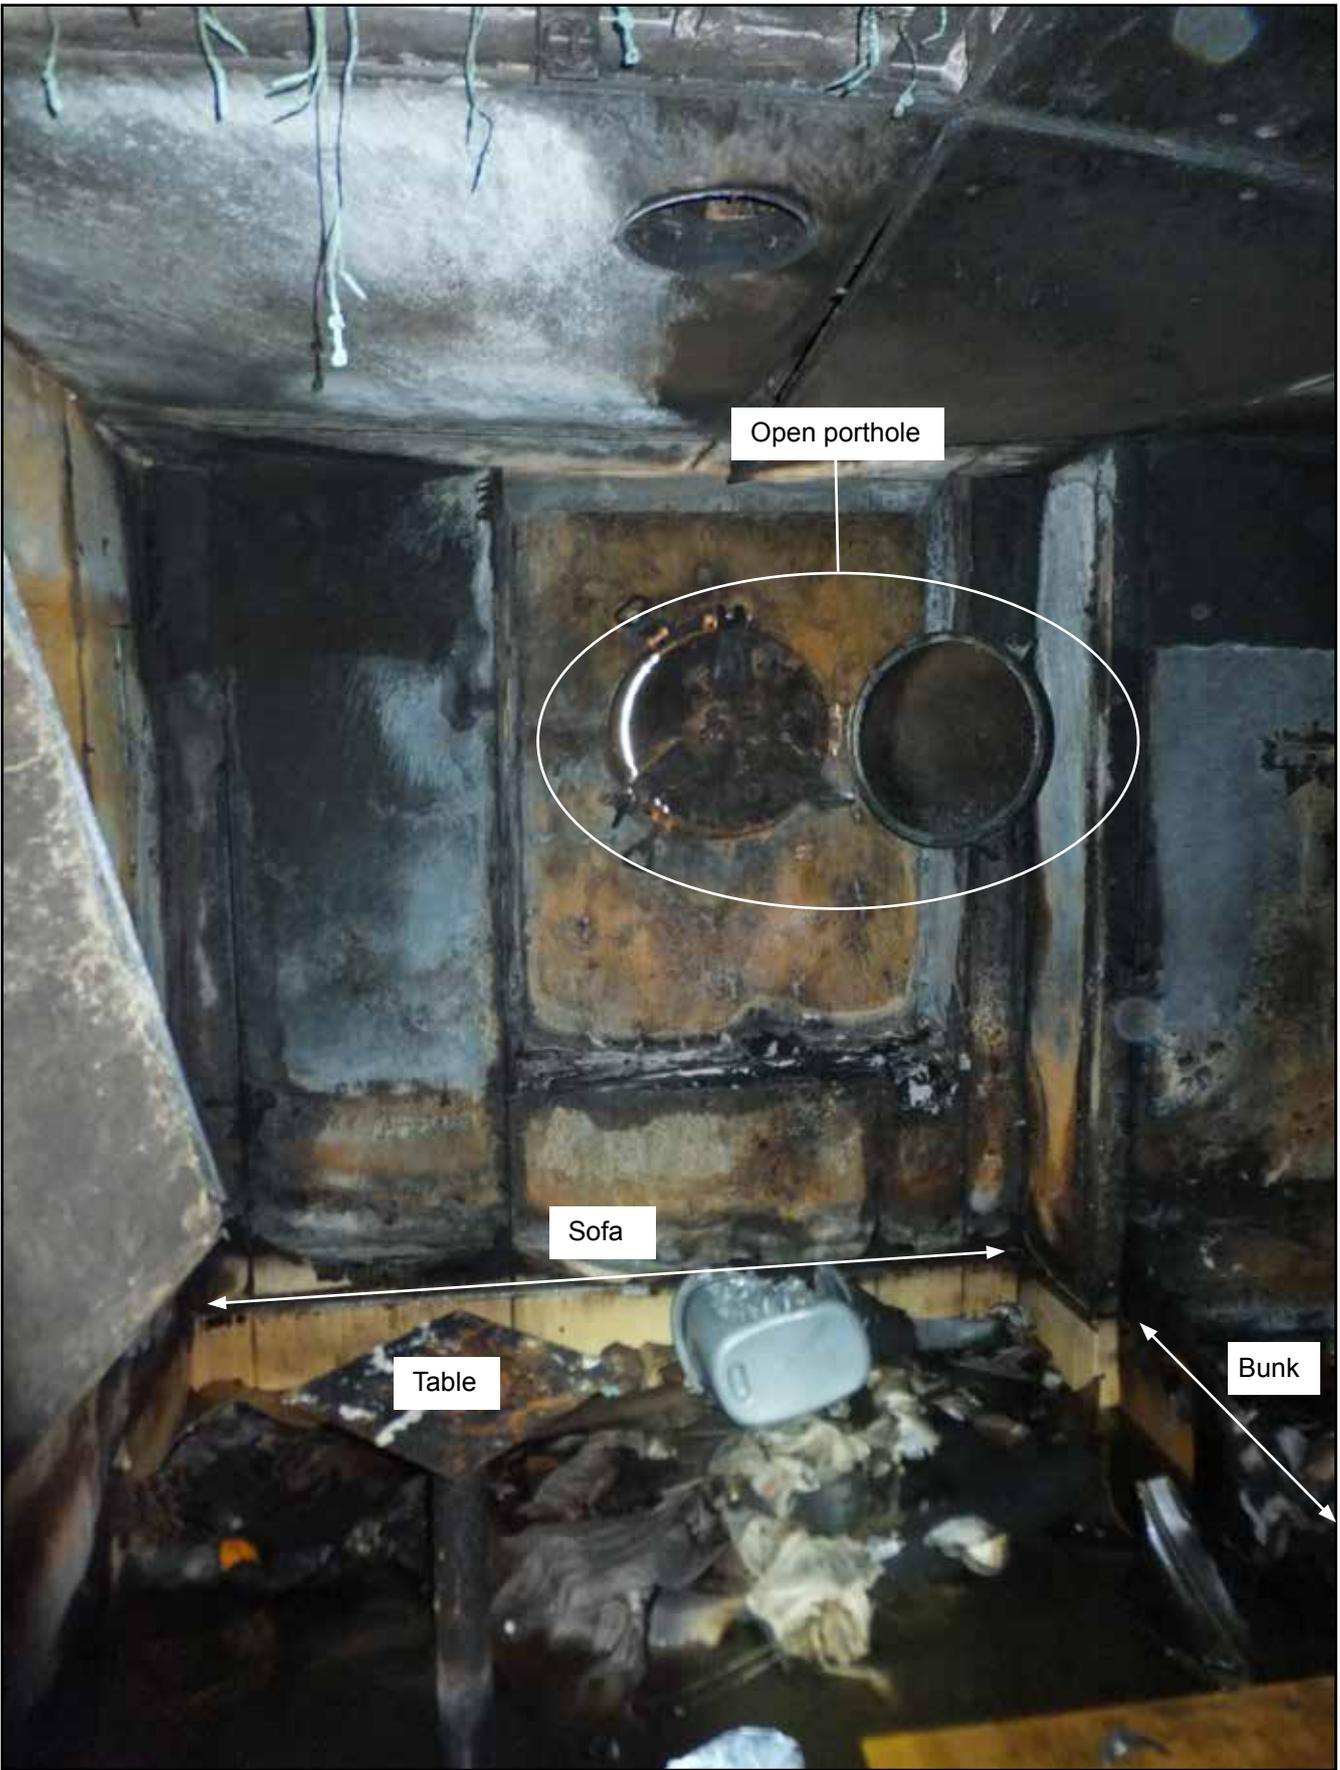
**Figure 8: AB2's fire-damaged cabin**

Apart from the container of paint thinners, the majority of these items were accounted for during the excavation. In addition, empty beer cans and beer bottles were found, and a large quantity of cigarette butts.

The remains of a 2kW electric fan heater were located on the deck; the heater was completely melted. As a potential source of ignition, the remains of the heater and the attached carpet tile were carefully removed from the cabin and examined. By comparison with an undamaged heater, the thermostat control and the two stage heat switch were identified. The heat switch was set on the 1kW (lower heat) setting, and the thermostat was adjusted to the minimum (5°C frost stat) heat setting. The remains of the wiring for the fan, heat elements and thermostat were undamaged.

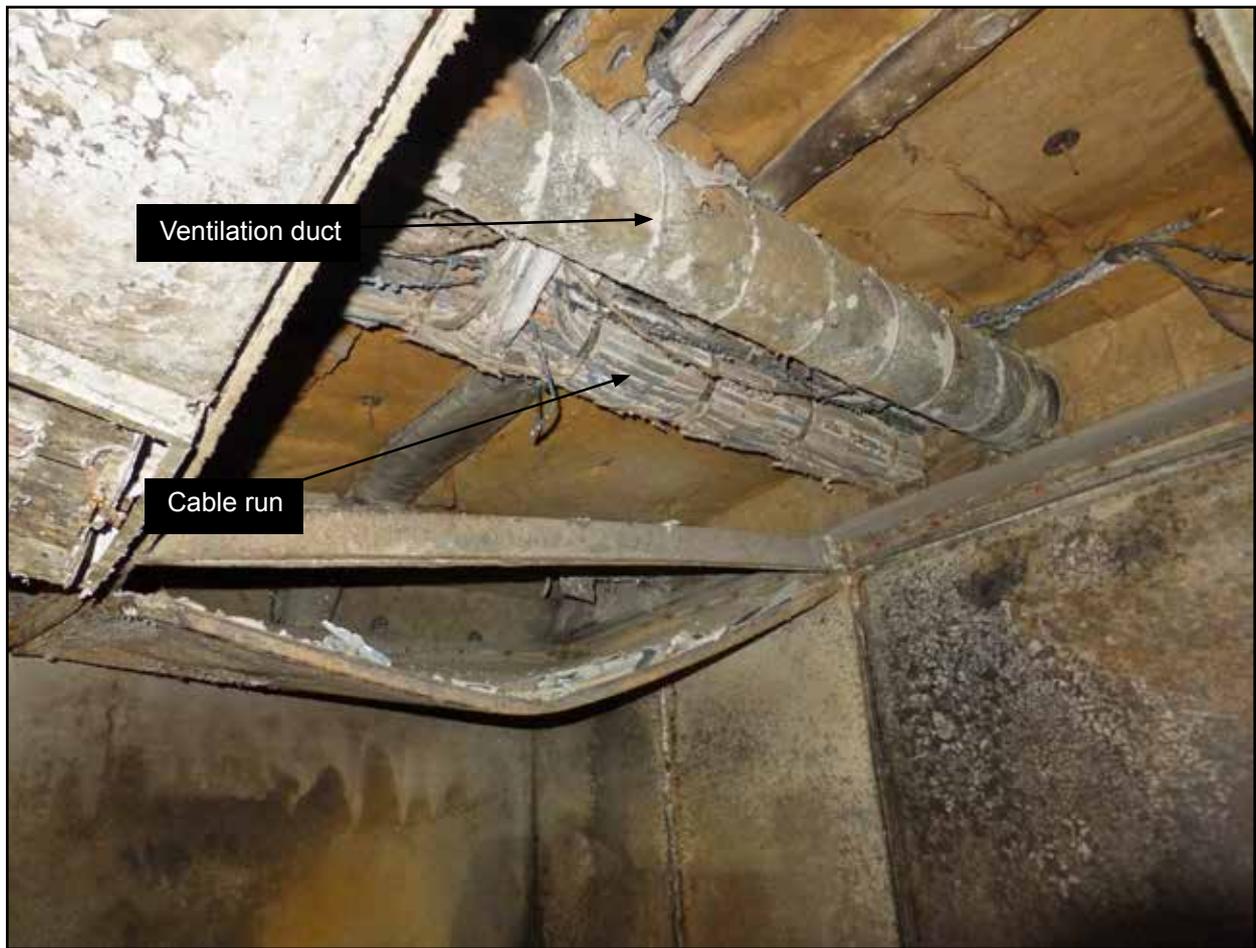
The motorman's cabin had also been severely affected by the fire. Damage had occurred to all items within the cabin above about 180mm from the deck, equating to the approximate depth of water in the cabin, and little remained of the original fixtures and fittings. The steel support framework for the deckhead panels had partially buckled and several panels had fallen down, possibly as a result of the fire-fighting. In the void space above the deckhead panels were electrical cable bundles. These were orientated fore and aft, and included the power cables for the steering gear (**Figure 9**). The porthole glass was broken, with glass fragments found on the deck below the porthole.

**Figure 9:** Void space above motorman's cabin and cable run

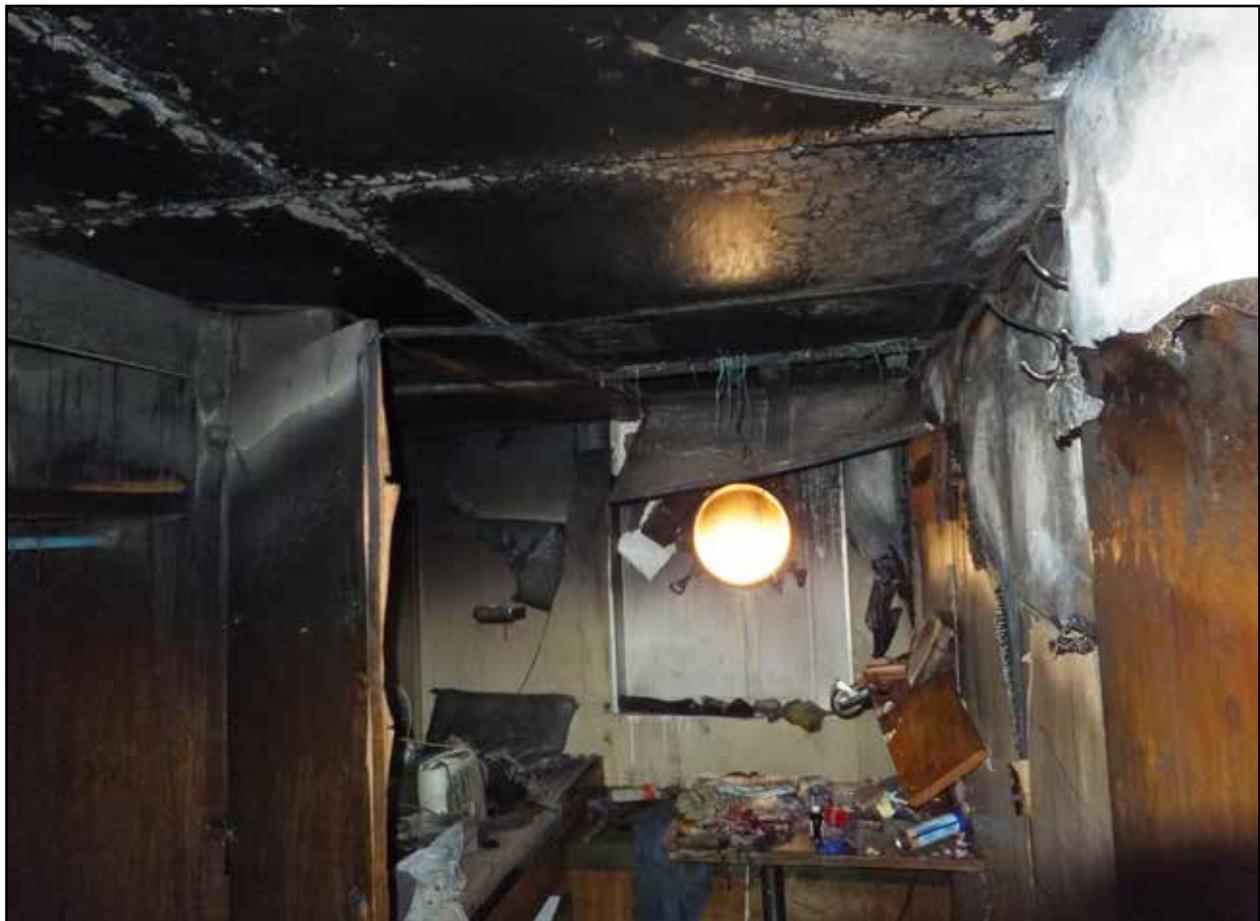
AB1's cabin was the least fire-damaged (**Figure 10**). It had suffered heat damage to the upper third which had stripped the surface finish off the cabin bulkheads and deckhead. The upper section of the door jamb was also heat-marked. The lower sections, including the bunk, sofa, table, chair and lower parts of the storage cupboard were physically undamaged.

**Figure 10:** AB1's cabin - post fire

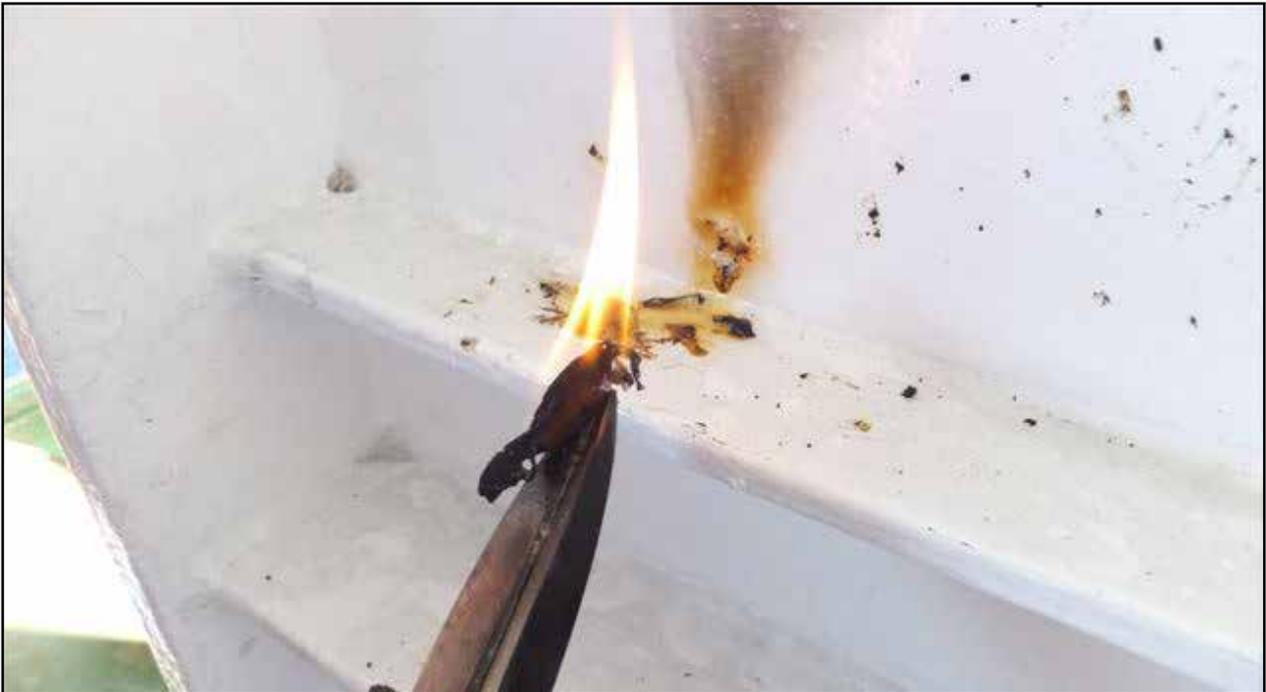
The undamaged sofa from AB1's cabin was identical in manufacture to AB2's. Ignitability tests were carried out to the sofa's vinyl covering and foam filling, and also to the mattress foam (**Figure 11**). The tests found that a naked flame held to the vinyl covering caused the vinyl to melt and produce black smoke. The foam within the vinyl covering, and the foam mattress, both ignited easily and produced intense black smoke as they continued to burn, without further need of an external heat source.

**Figure 11:** Cabin mattress and sofa ignitability test

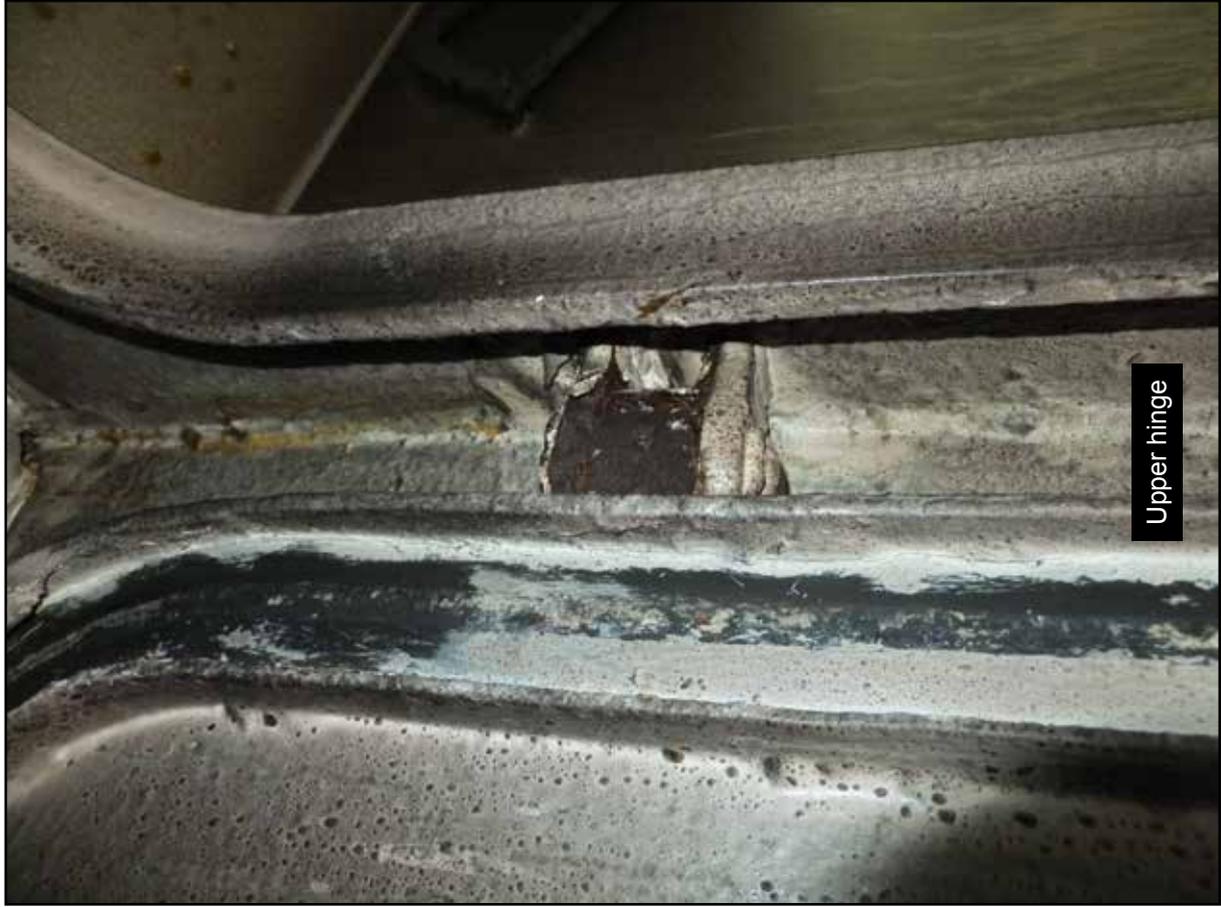
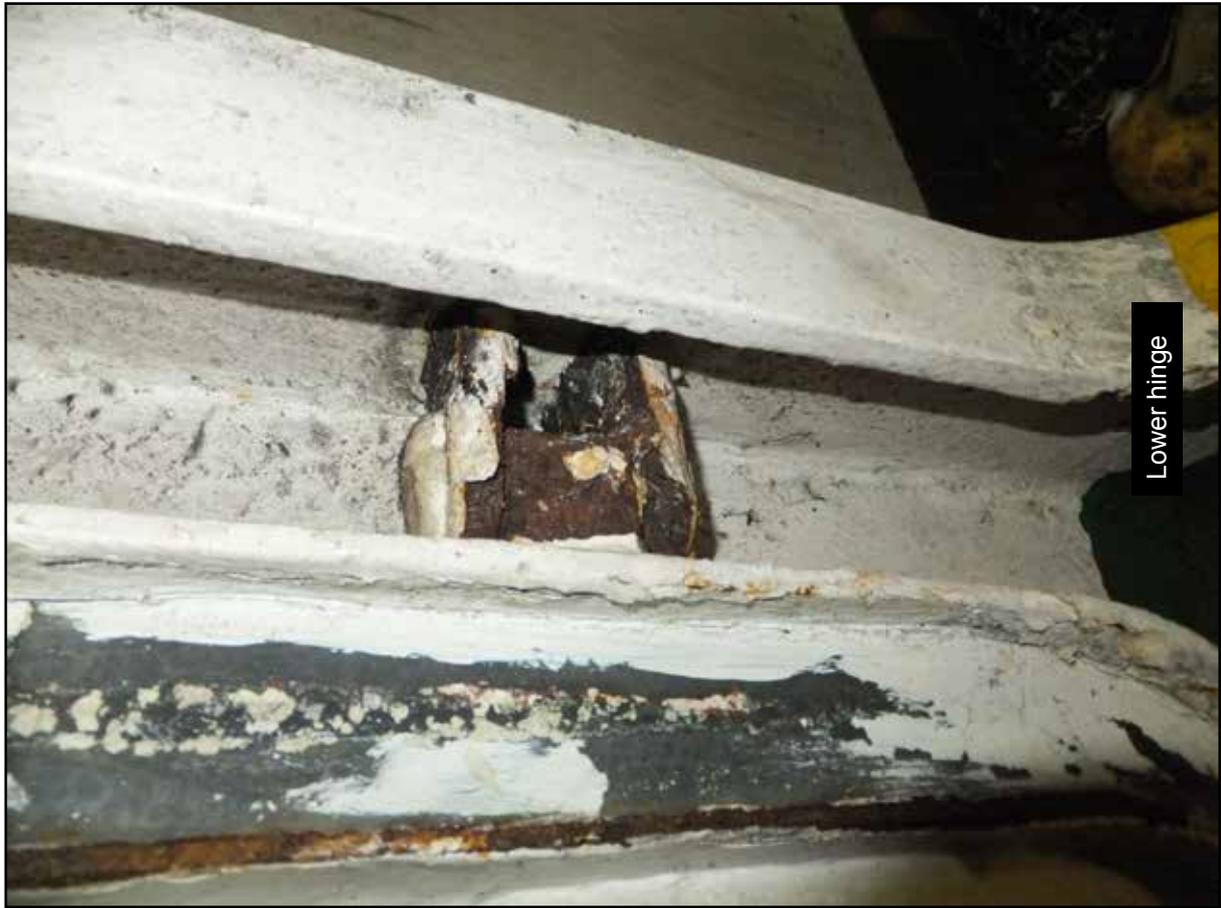
On 30 April 2013, the steering gear access door was found open and hooked back with its hinges rusted and seized (**Figure 15**).

Figure 15: Steering gear door hinges

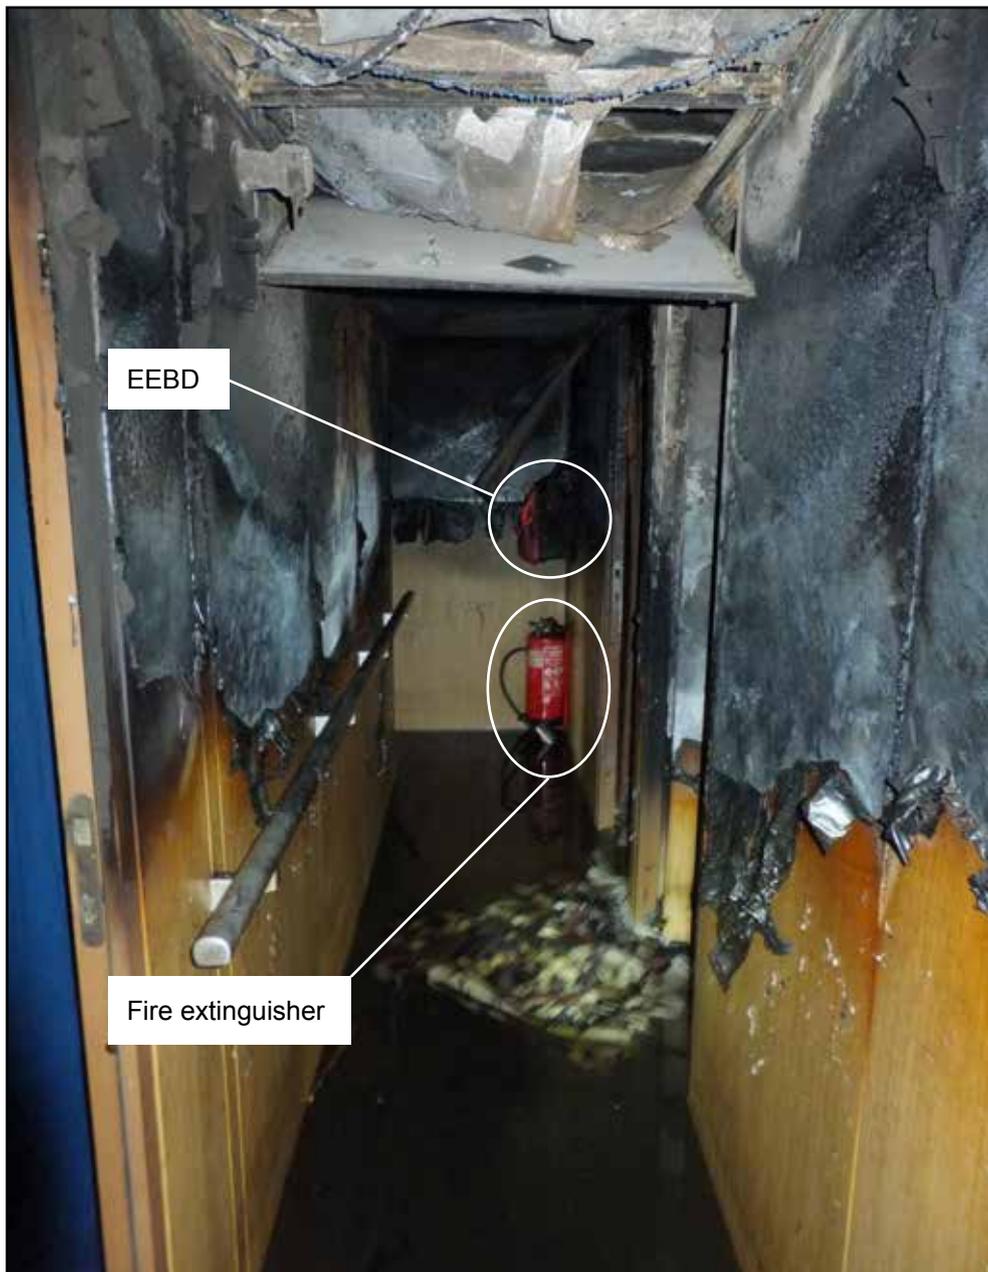
**Figure 16:** Deck 2 starboard alleyway - post fire showing fire extinguisher and EEBD
