Foundering of the fishing vessel **SPEEDWELL** with the loss of her skipper Firth of Lorn 25 April 2013

SUMMARY

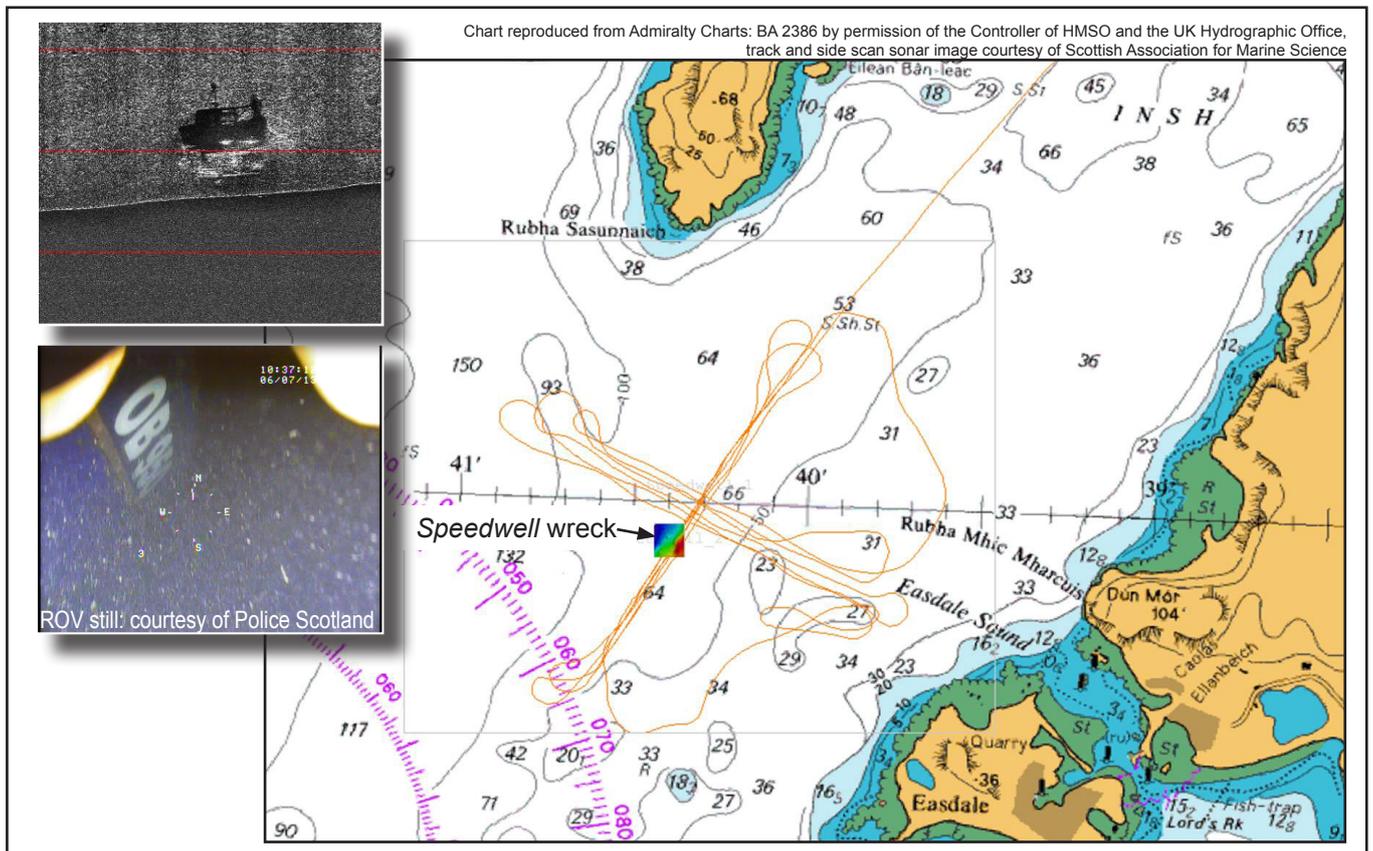
Figure 2: Chart showing the side scan sonar track with inset still from ROV footage and side scan sonar image

Speedwell's wreck was eventually located 5 cables south of Insh Island by local fishermen on 25 May. Side-scan sonar images of the wreck were obtained by *Calanus* 3 days later, and the wreck was positively identified on 7 June by a remotely operated underwater vehicle (ROV) arranged by the police. *Speedwell* was seen to be upright and apparently intact in 83m of water (**Figure 2**).

- The vessel was listed by between 5° and 10° to starboard.
- The deck was clear of equipment (baskets etc).
- All the hatch lids were present apart from the lid to the engine room access hatch.
- A short length of 1.5" diameter reinforced hose was protruding from the engine room access hatch.
- The wheelhouse door was open.
- The VHF microphone was attached to its cable but was lying on the wheelhouse floor.
- The liferaft valise was on the wheelhouse floor and was unopened.

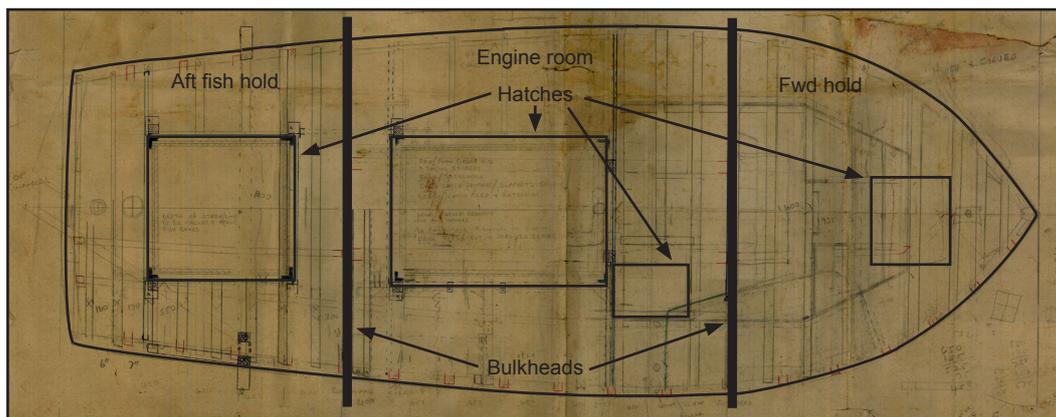
Figure 3: Original drawing of *Speedwell* with compartments and hatches highlighted

The hull under *Speedwell's* deck was divided into three spaces: forepeak, engine room and the aft store (**Figure 3**) that was originally intended to be a fish room. The bulkhead between the forepeak and engine room was watertight but the bulkhead between the engine room and aft hold had various openings at deck head level through which pipelines and cables were routed.

The vessel had four through deck hatches. The forepeak hatch was hinged on the aft side and had been sealed shut. The engine room access hatch, immediately outside the wheelhouse door, was a lid without hinges or means of closure. In the centre of the vessel was a large hatch for engine removal and replacement; this was bolted down. The hatch to the aft store was a flush deck hatch, measuring approximately 1200mm x 1200mm, that was hinged at the aft side. It was not sealed and had no means by which it could be secured.

To make the aft store hatch cover flush with the deck when closed, the cover sat in a 'well' on the deck, the channels of which were fitted with small bore pipes to drain any accumulated water overboard. The drain pipes were reported to easily become blocked with debris, causing water in the channels to drain into the store below.

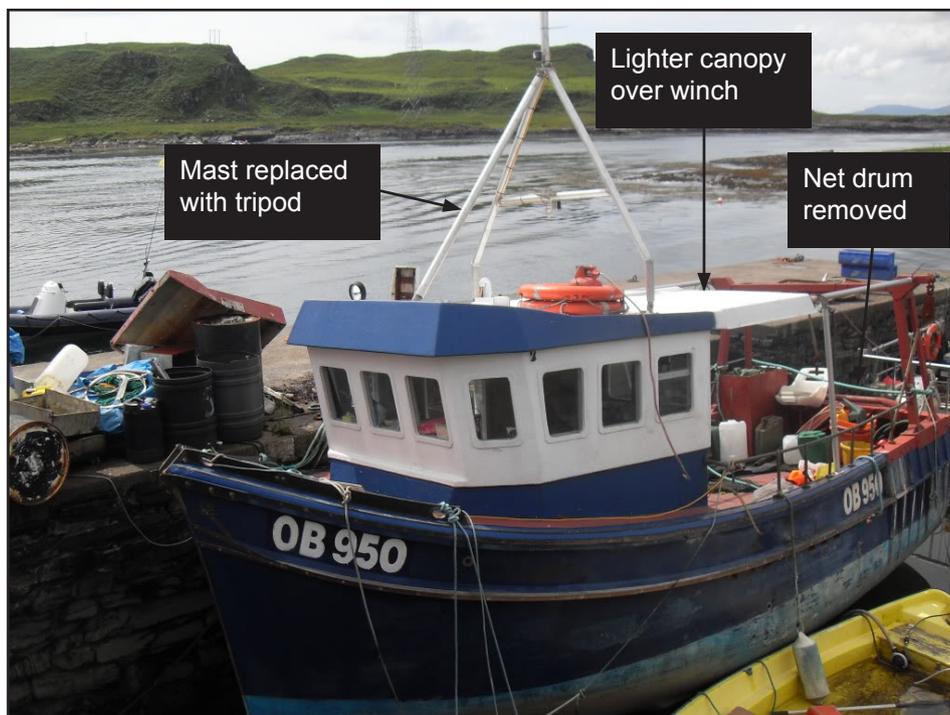
Figure 4: *Speedwell* alongside Cuan slipway

Over the following 3 years, *Speedwell* was predominantly moored at Cuan ferry slipway on Seil (**Figures 1 and 4**), which dried at low water. During this period, a number of modifications were made to the vessel, primarily with the intention of removing top weight which the vessel's owner had identified as a potential problem when shifting the vessel from Loch Sunart. The modifications included:
