Grounding of the general cargo ship *DOUWENT* Haisborough Sand 26 February 2013

SUMMARY

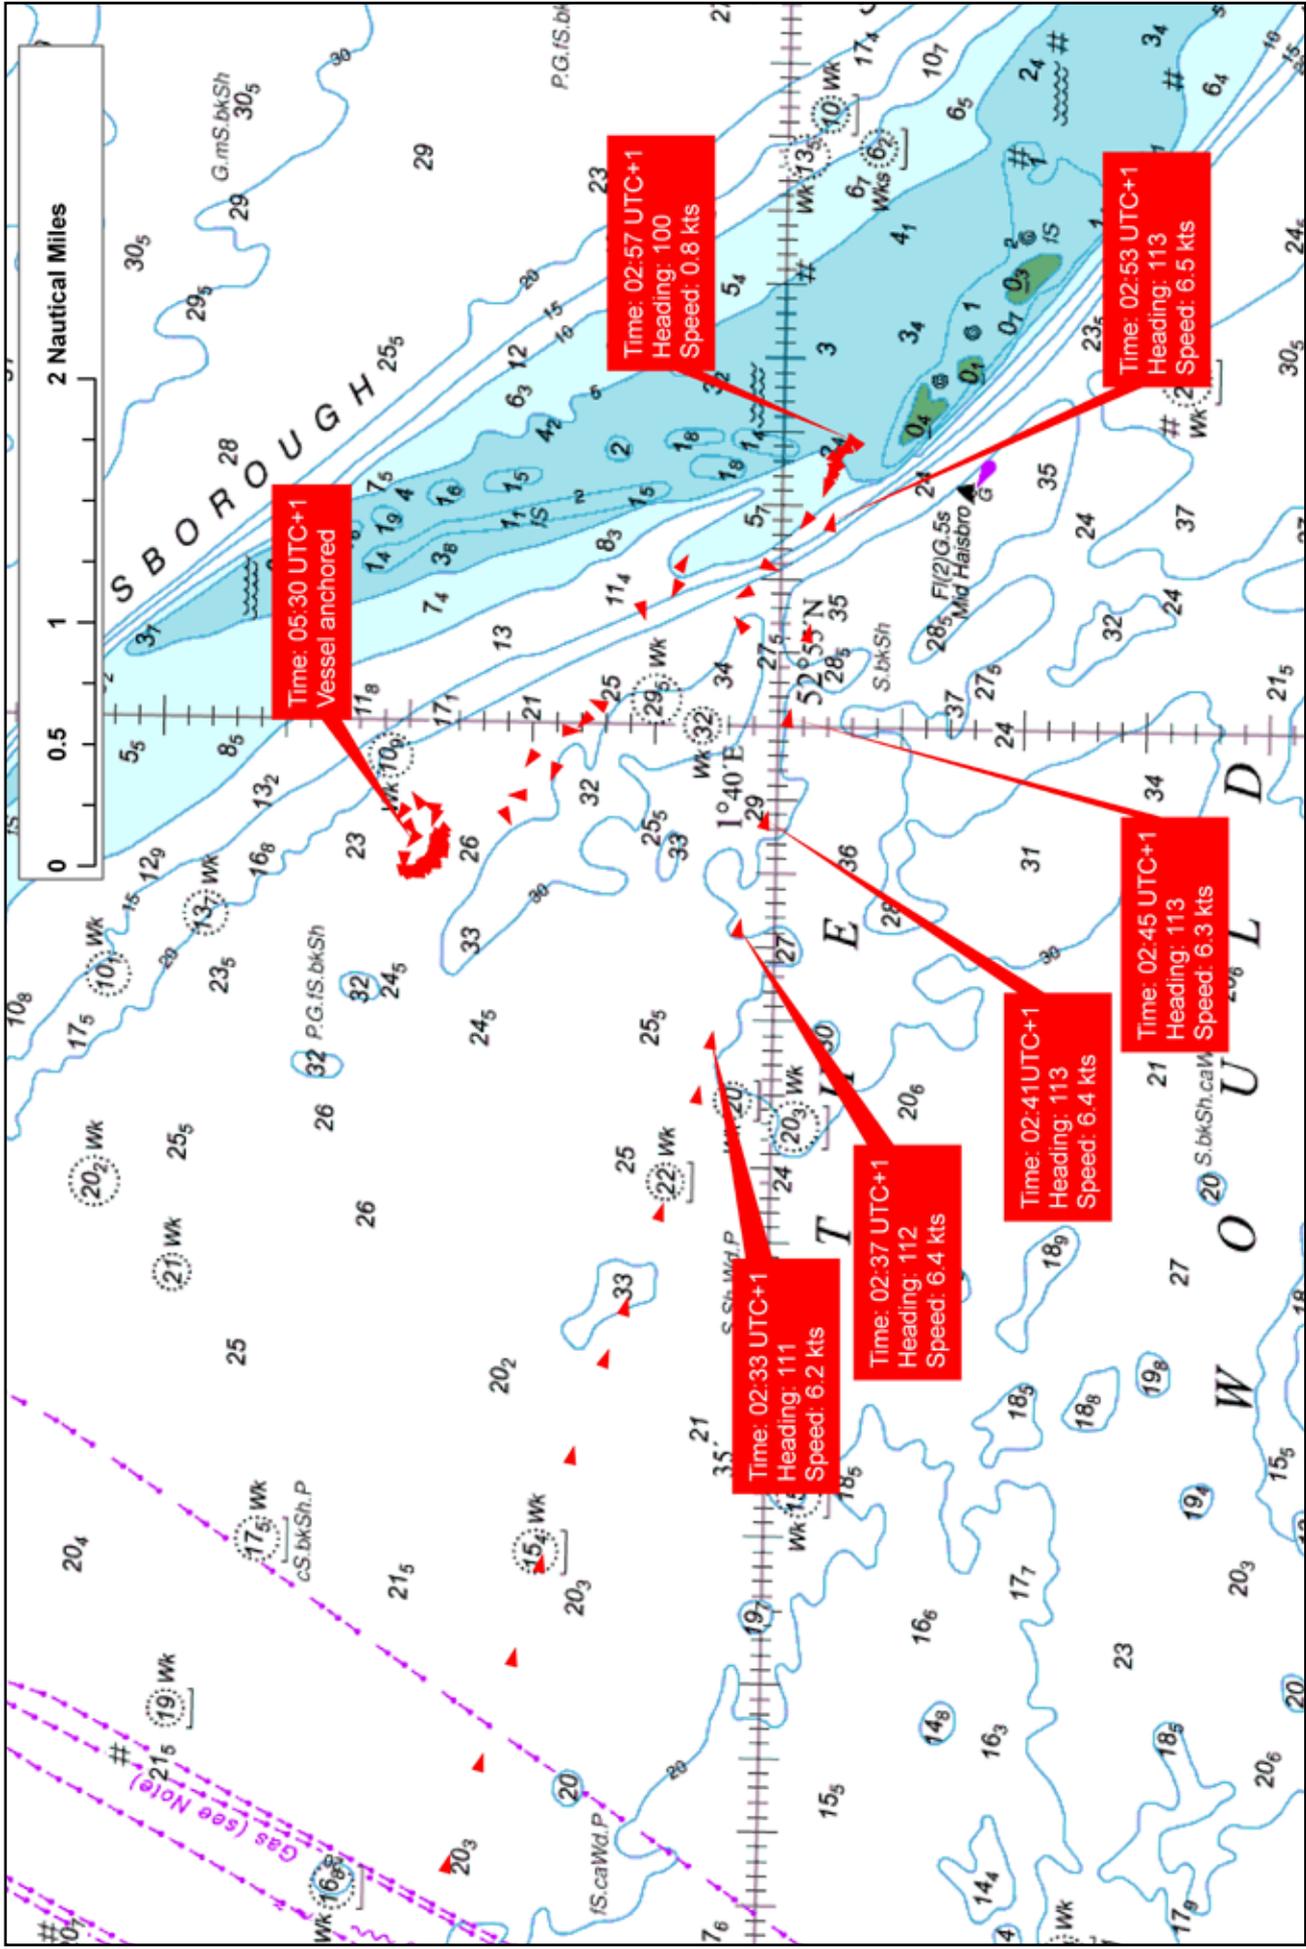
Figure 1: Extract of chart BA 106 with AIS overlay

At 0256, *Douwent*'s speed decreased rapidly as the vessel started to take the ground (**Figure 1**). By 0300, the chief officer had put the main engine to 'full astern' but the vessel was now stationary. The master and crew were woken by the change in the vessel's movement and also by the chief officer shouting. The master immediately went to the bridge and moved the engine telegraph to 'stop' and switched on the echo sounder. He then looked at the GPS receiver and noticed that the vessel's position was close to the track on the display. He also noticed that the destination was waypoint 90, not waypoint 48 as he had expected. The master plotted the position displayed on the GPS receiver onto the paper chart. This confirmed that the vessel was in very shallow water on Haisborough Sand.

In view of the lack of steering, *Douwent* was anchored at 0530 (**Figure 1**). At 0536, the master informed Yarmouth Maritime Rescue and Co-ordination Centre (MRCC) by very high frequency radio (VHF) that *Douwent* had anchored due to a problem with the rudder. He did not mention that the vessel had been aground.

When the master arrived on the bridge, his actions to stop the engine, switch on the echo sounder and plot *Douwent*'s position appear to have been positive and timely. However, it is evident that his attempts to re-float the vessel using maximum engine and helm orders resulted in the rudder coming into contact with the sandy bank with sufficient force to cause its loss. It is concluded that the rudder was not lost prior to the grounding as the vessel would not have been able to maintain the relatively steady course into the shallow water as shown at **Figures 1 and 2**.

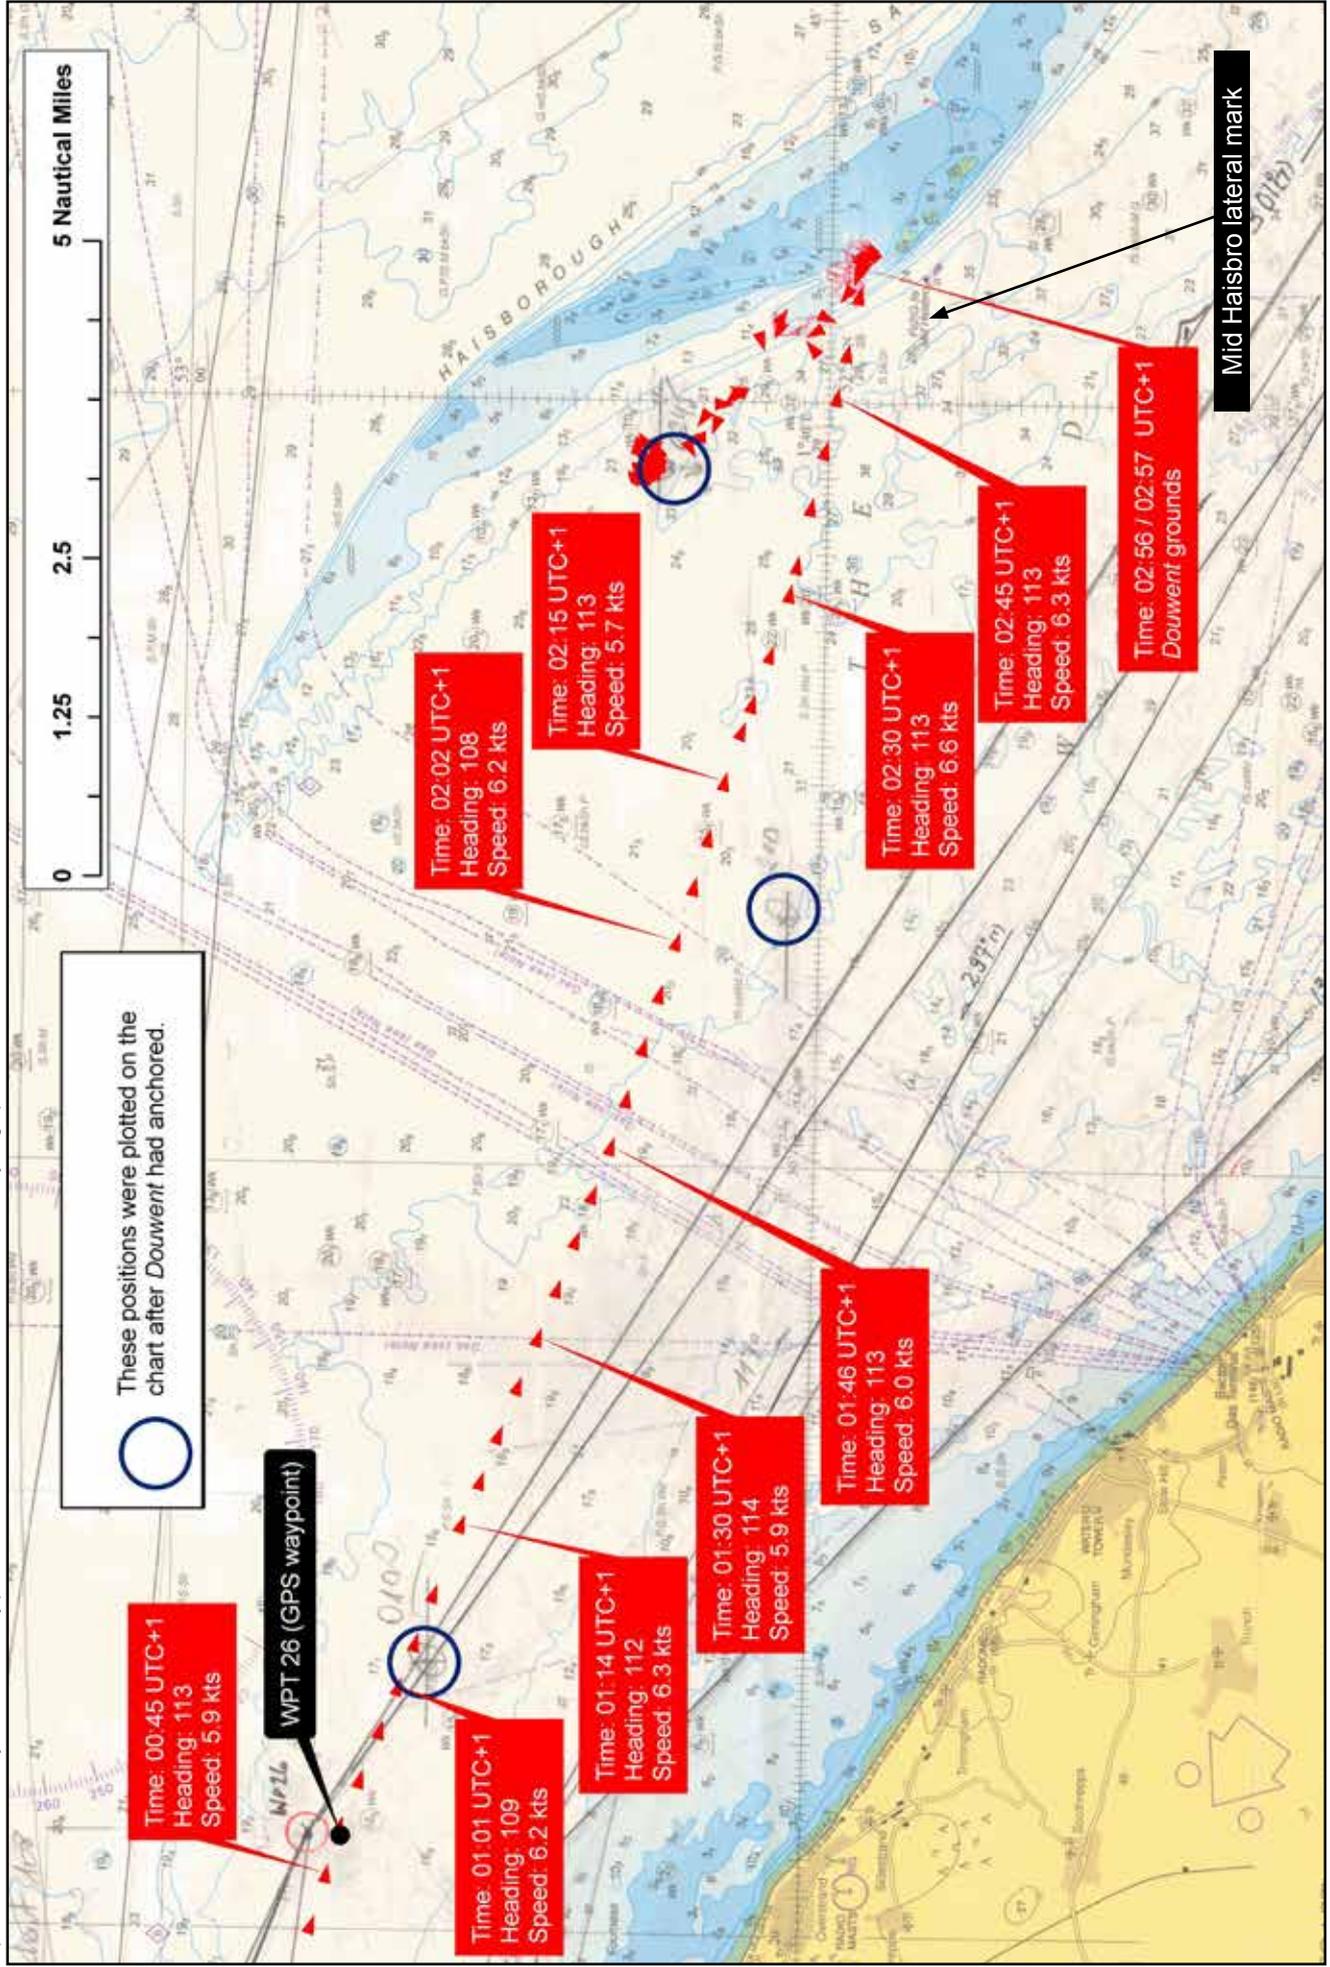
Figure 2: Extract of ships paper chart (BA 106) with AIS overlay

Positional information obtained from *Douwent*'s AIS transmissions from 0030 is shown at **Figure 2**. The vessel's heading, SOG and course over the ground (COG) at selected points have been overlaid on the vessel's paper chart. Examination of the data at approximately 30 second intervals indicates that the vessel's heading from midnight until taking the ground at about 0256 was generally between 111° and 113°.

The waypoints and tracks for the voyage, along with the waypoints and tracks for other regularly used routes between the UK and north-west Europe, had already been drawn on the navigation charts in ink (**Figure 2**).

Entries in the deck log included *Douwent's* latitude and longitude for 0100, 0200 and 0245. The 0245 entry also stated that the vessel had anchored due to problems experienced with the steering. The positions noted in the logbook corresponded to the positions plotted on the paper chart (**Figure 2**).

When *Douwent* was in the vicinity of Waypoint 26 at 0048 (**Figure 2**), the vessel's heading should have been altered to make good a course of 120° in order to follow the intended passage plan towards Waypoint 48. However, it is evident from the AIS data that *Douwent*'s heading remained between 111° and 113°. This was almost certainly because Waypoint 90, rather than Waypoint 48, had been displayed as the next destination on the GPS. The master noticed that Waypoint 90 was selected when he looked at the GPS shortly after he arrived on the bridge and *Douwent*'s COG between midnight until the vessel grounded was 107°, which was the course required between Waypoint 26 and Waypoint 90 (**Figure 5**).

The subsequent actions of *Douwent's* master and chief officer are also of concern. It is clear from the retrospective entries in the deck log and the positions plotted on the paper chart after the grounding (**Figure 2**), the failure to inform the coastguard that the vessel was or had been aground and the inaccuracies in the incident report forwarded to the ship's manager, that the master and chief officer attempted to cover up what had actually happened.

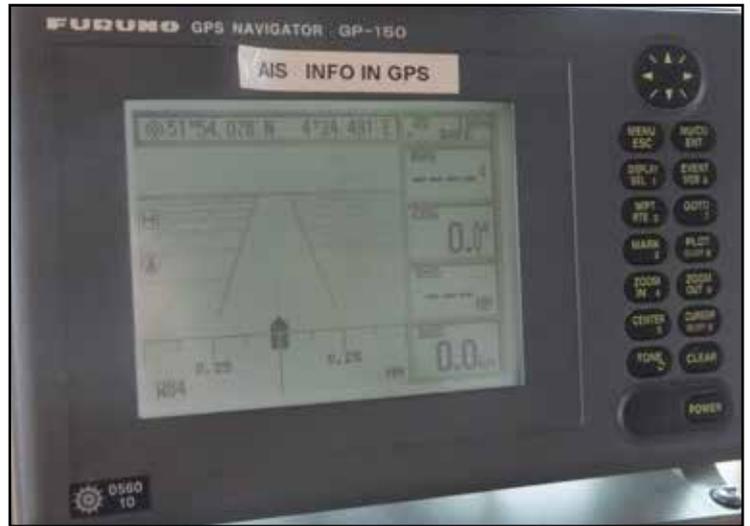
Figure 3: Furuno GPS Navigator GP - 150

In addition to radar information, the starboard radar display also showed information from the GPS Navigator GP-150 including the track and distance to the next selected destination. The destination could be set on the GPS receiver by cursor, by man overboard or event position, by waypoint and by route. The GPS was fitted with a cross track error facility but this was turned off. The receiver's arrival alarm was switched on and was set to activate at a radius of 200m from the destination waypoint.

As the destination set in the Furuno GPS could be selected by route or by waypoint, it is feasible that Waypoint 90 was set either because Waypoint 48 had been accidentally omitted from the route in the GPS (the resulting difference in the total distance was only about 1 mile) or because Waypoint 90 was selected instead of Waypoint 48 as the vessel passed Waypoint 26. The chief officer input the waypoints into the GPS route and he was also on watch on passing Waypoint 26. Therefore, both of these possibilities would have been the result of lapses on his part.

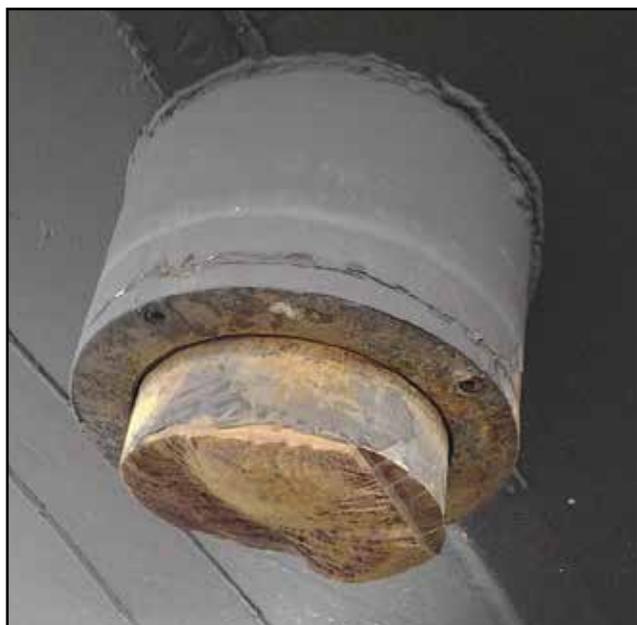
Figure 4: Broken rudder stock

Inspection of the rudder stock when *Douwent* arrived in Rotterdam confirmed that the rudder was missing (**Figure 4**). The MAIB arranged for the end section of the remaining post to be removed and analysed. The conclusions of the analysis included '*The fractured surface clearly shows a fatigue fracture. The large surface area of the final fracture (>90%) combined with the multiple origins implies that the rudder stock suffered from high loads.*' [sic]
