Foundering of the fishing vessel **ACHIEVE** and the death of a crew member north-west of the Island of Taransay, Western Isles 21 February 2013

SUMMARY

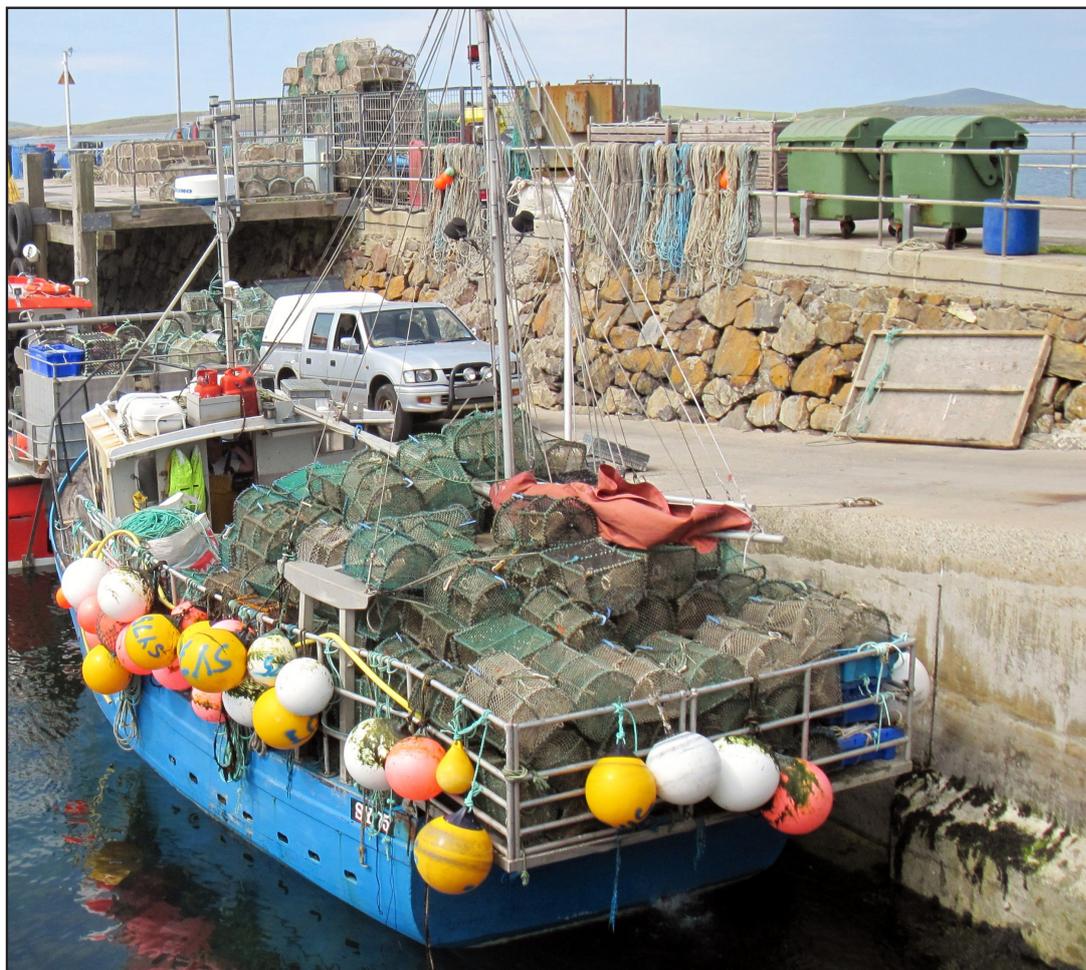
Figure 1: Fishing vessel *Achieve*

At about 1500 on 21 February 2013, the fishing vessel *Achieve* (Figure 1) foundered 6nm north-west of the Island of Taransay (Figure 2). Although all three of the vessel’s crew were rescued, one of them died later in hospital due to hypothermia.

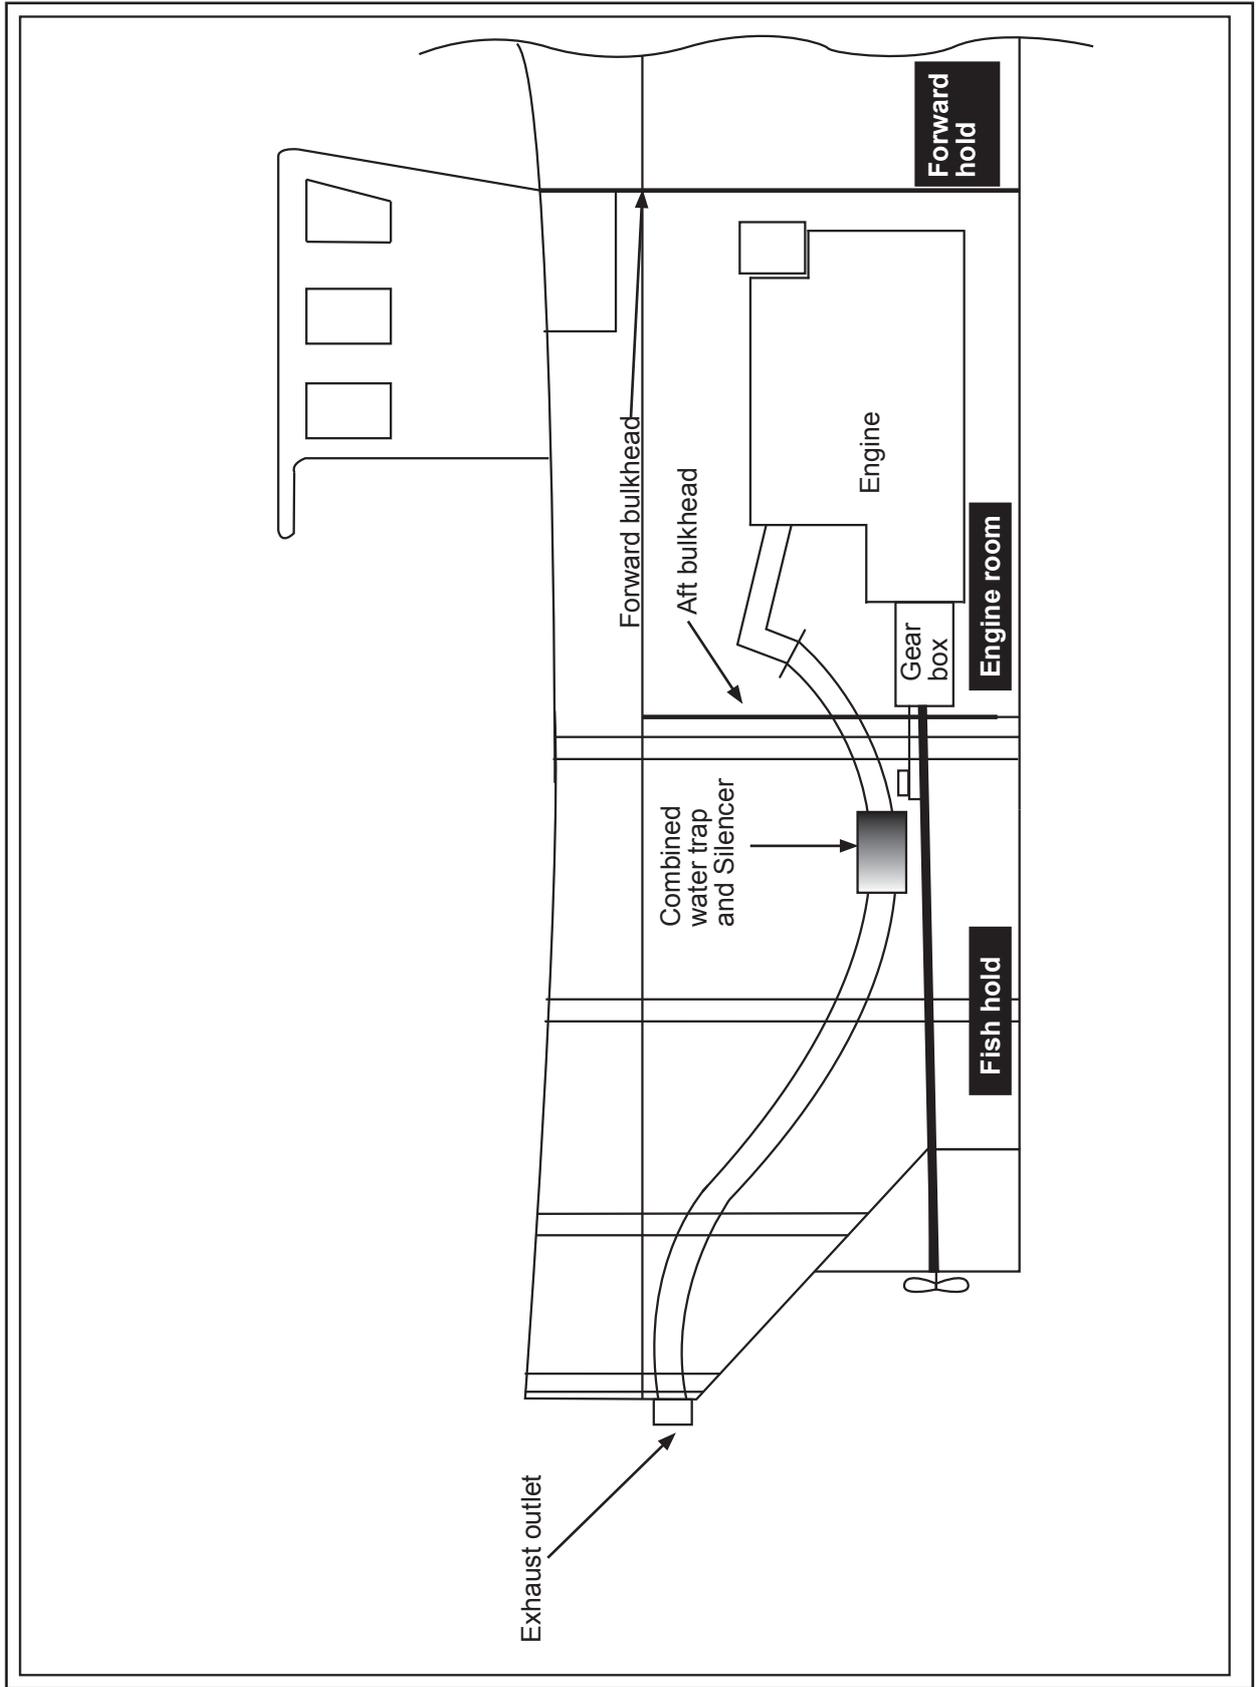
Figure 3: Schematic of *Achieve*, showing under-deck layout and exhaust system (segment of drawing, not to scale)

The vessel had three underdeck compartments: a forward hold under the wheelhouse, a machinery space, and an aft fish hold of approximately 6 cubic metres capacity (**Figure 3**). There was a watertight bulkhead between the forward hold and machinery space; the bulkhead between the machinery space and fish hold was not watertight because of several openings for shaft, pipelines and cables. Above the forward hold and accessed from the wheelhouse was the accommodation space, which housed three bunks.

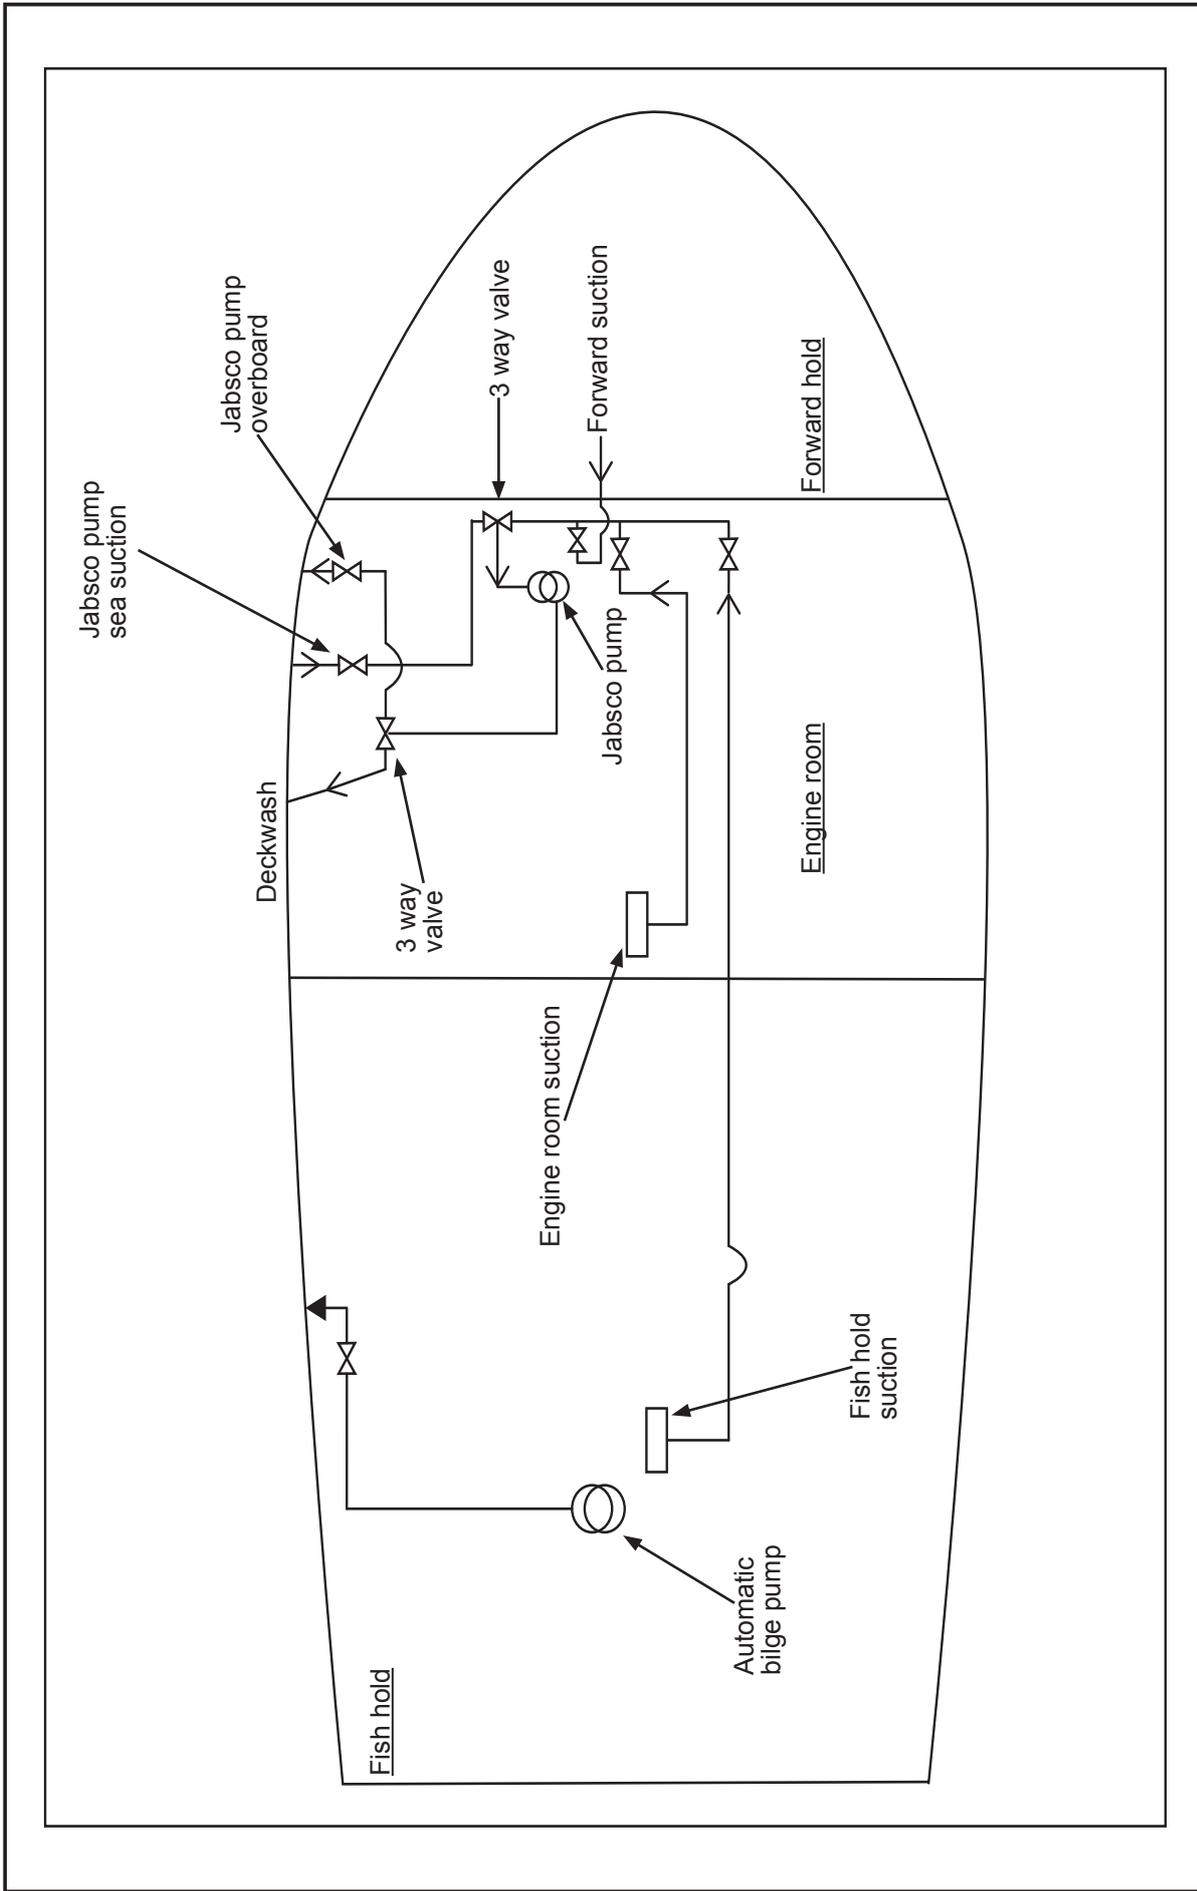
Figure 4: Bilge pumping systems (manual pump not shown)

Achieve had three bilge pumping arrangements: a manually-operated pump; a 126 litres/minute automatic bilge pump powered by a 24V direct current (DC) motor was located in the fish hold; and, an engine-driven, electrically-clutched JABSCO deckwash/bilge pump of 145 litres/minute capacity at 1100rpm (**Figure 4**).

The fish hold bilge pump was modified to work in automatic mode after *Achieve* was sold by its original owner. There was no indication in the wheelhouse to show the operational status of the pump. It discharged overboard through a 25mm bore flexible hose. A non-return valve was fitted before the overboard discharge to prevent any siphoning when the pump was not running. The skipper had tested the pump on the morning of 21 February by lifting its float switch by hand.

A bilge high level sensor was fitted forward of the engine. This alarm was last tested by the skipper a week before the accident. At the time of the accident, the bilge alarm fitted in the fish hold was not connected.
