## Foundering of FV *JCK* with the loss of her skipper; Tor Bay, 28 January 2013

### SUMMARY

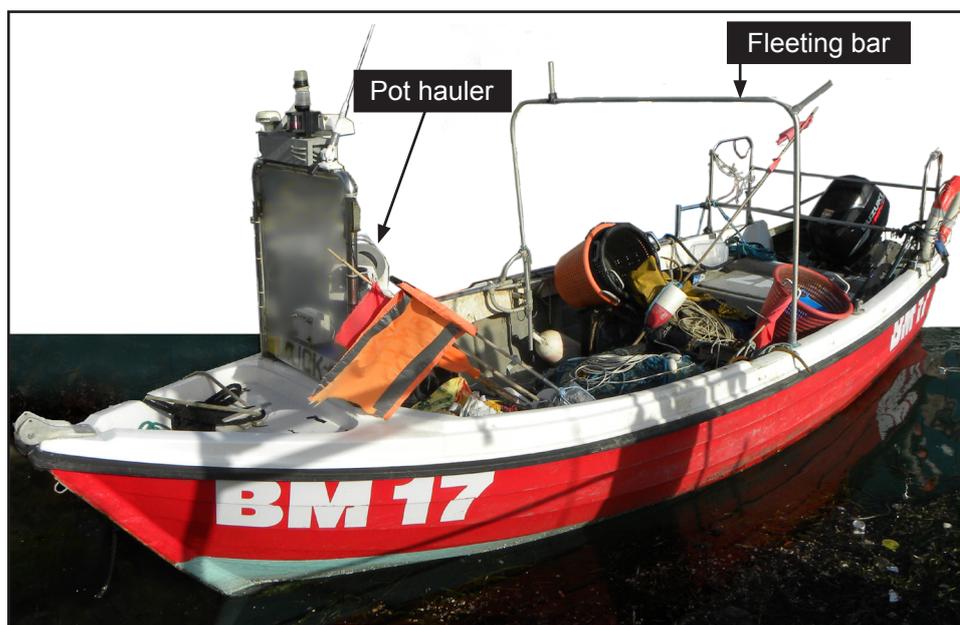
On 28 January 2013, the 6.45m single handed fishing boat *JCK* (**Figure 1**) failed to return to port, prompting a major search to be mounted by the coastguard. The RNLI recovered the skipper's body from the sea several hours later. Although some flotsam from *JCK* was found, the boat was not located and is believed to have foundered in rough seas and winds gusting in excess of 50 knots at around 1750 UTC.

**Figure 1:** *JCK* and equipment

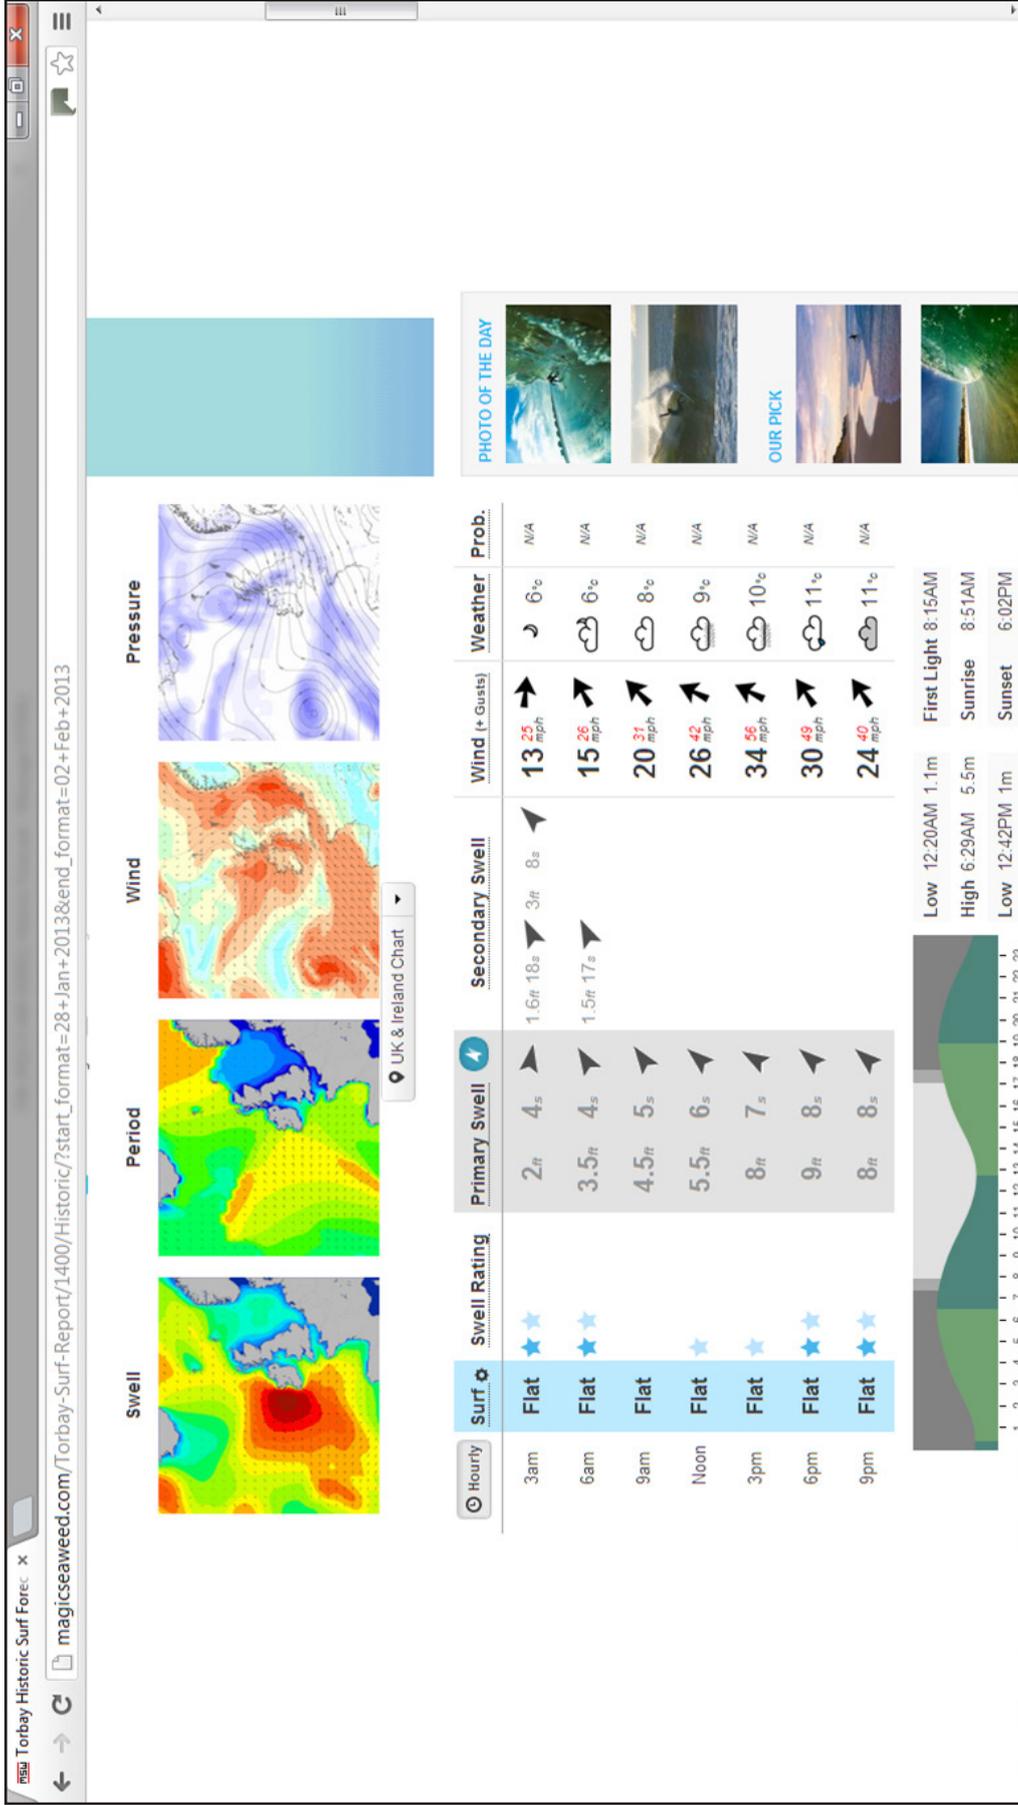
The Met Office forecast for the 24-hour period commencing at 0600 on 28 January 2013 predicted "very windy weather to all areas..." and, specifically between Lands End and Lyme Bay, "west backing southwest 5 to 7, increasing 7 to severe gale 9". The Magicseaweed internet site predicted generally south-westerly winds of 30 to 34mph with gusts reaching 56mph in the period from 1500 to 1800 (**Figure 5**).

Figure 5: Magicseaweed's forecast for the Torbay area, 28 January 2013

The weather forecasts from Magicseaweed and the Met Office predicted the conditions with considerable accuracy. Before sailing on the morning of 28 January, the skippers of *JCK* and *Bold Venture* evaluated these and other forecasts but perceived that they would be back in harbour before the forecast strong winds arrived.

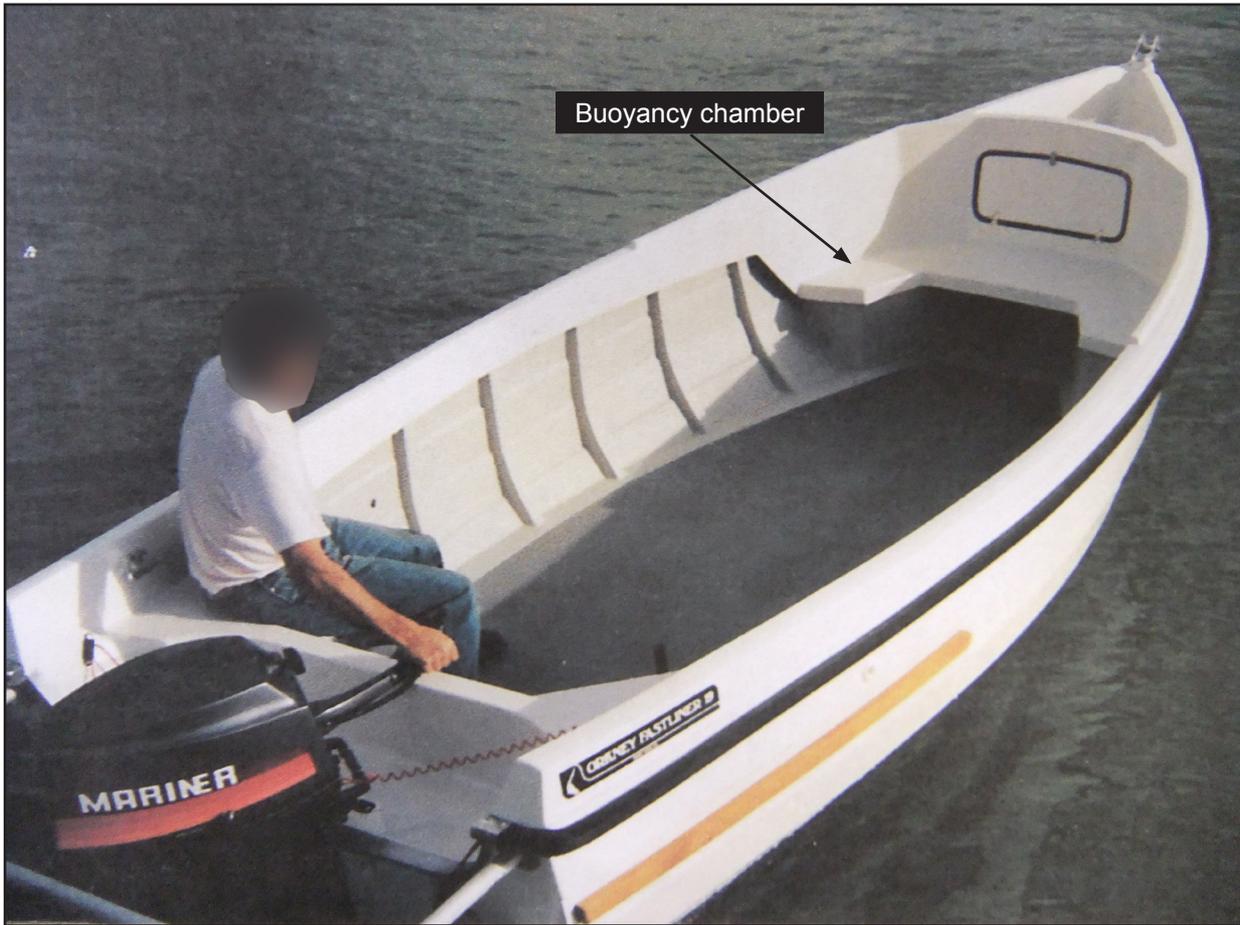
It is not known who fitted out the original boat, although the glass reinforced plastic (GRP) hull was most likely moulded by Orkney Boats Ltd as one of its commercial Fastliner 19 models. Orkney Boats Ltd also built similar Fastliner 19 models for the leisure sector that were lighter than, and not as strong as, the commercial models. In order to give more internal space, the commercial model Fastliner 19 (**Figure 6**) was not equipped with the side chambers and central thwart found on the standard model (**Figure 7**).

**Figure 6:** Orkney Boats Ltd, Commercial Model Fastliner 19.  
Note: no central thwart or side chambers

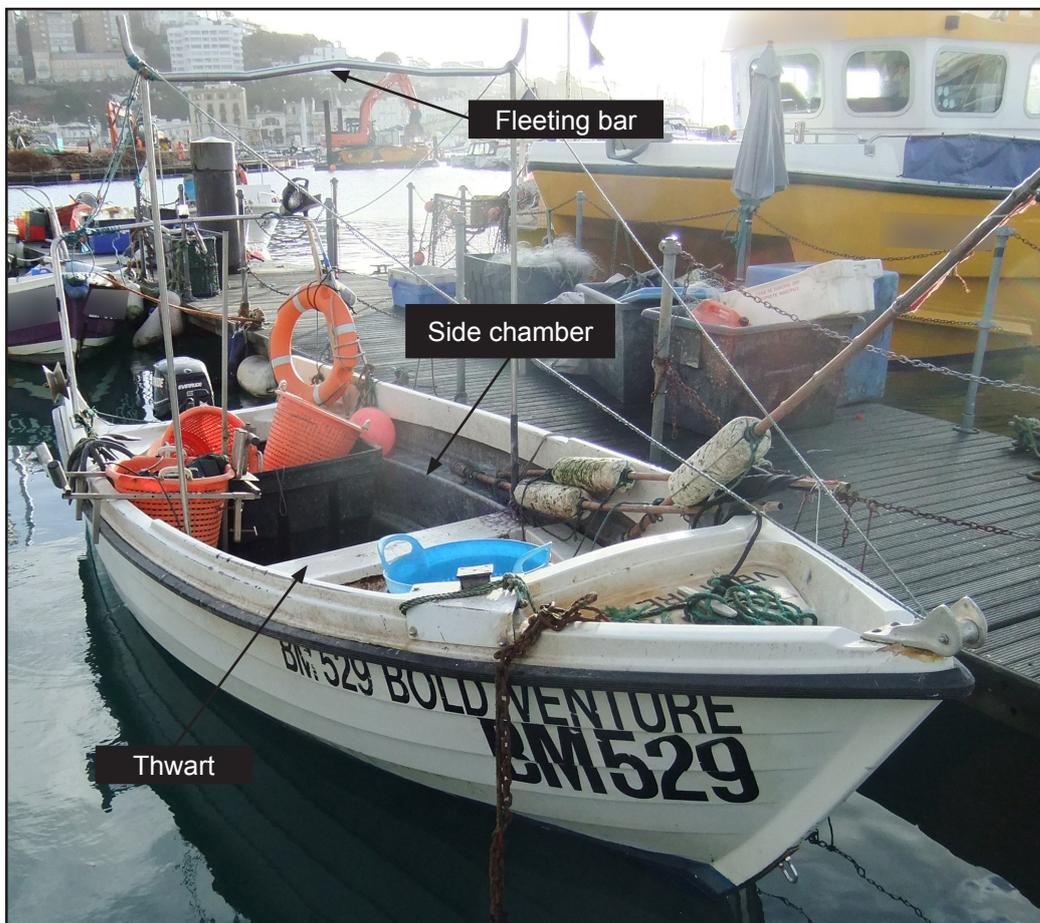
**Figure 7:** Bold Venture

*Bold Venture* was an Orkney Boats Ltd standard model Fastliner 19. Due to its lighter construction, *Bold Venture* sat higher in the water than *JCK* and could obtain more speed with its less powerful and lighter 25hp outboard engine.

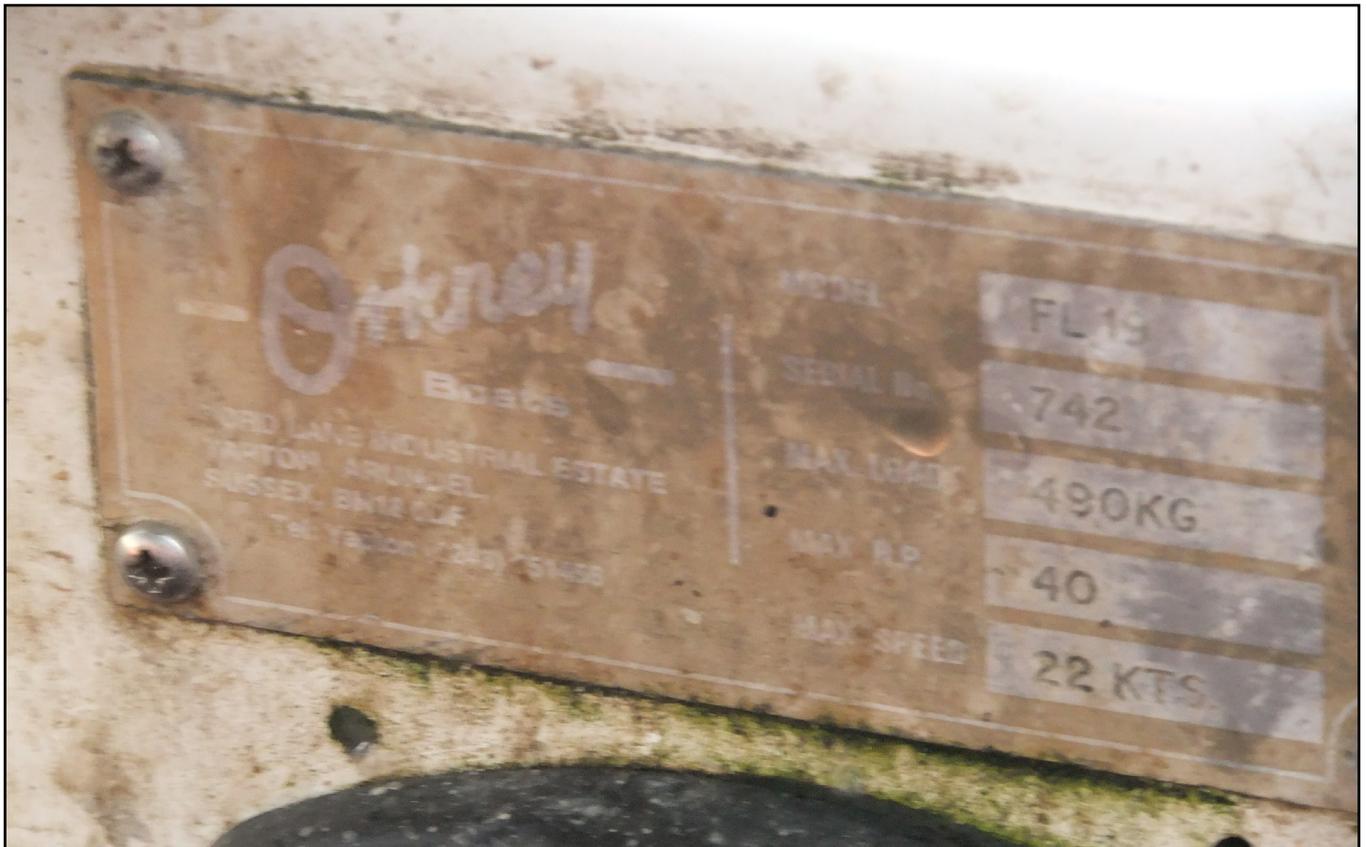
*Bold Venture* had a manufacturer's plate (**Figure 8**), which showed its maximum carrying capacity of 490kg and maximum recommended engine capacity of 40hp.

**Figure 8:** *Bold Venture*'s manufacturer's plate

On 28 January both boats were heavily laden with catch and gear on their return passage. It is considered that *Bold Venture* was carrying about 640kg while *JCK* was carrying about 735kg – between 30% and 50% more weight than Orkney Boats Ltd recommended for Fastliner 19s. Although both boats had over 300kg of catch on board, inspection of catch records showed they had regularly carried greater loads in good weather conditions. The difference in payload between the two boats on 28 January is attributed mainly to *JCK*'s heavier engine, additional battery and greater catch. These loads, in such conditions, would certainly have dampened the boats' abilities to rise to oncoming seas and would have reduced their overall sea-keeping abilities.
