**Engine room fire on board
FV AMY HARRIS III
South of the Isle of Arran
16 January 2013**

SUMMARY

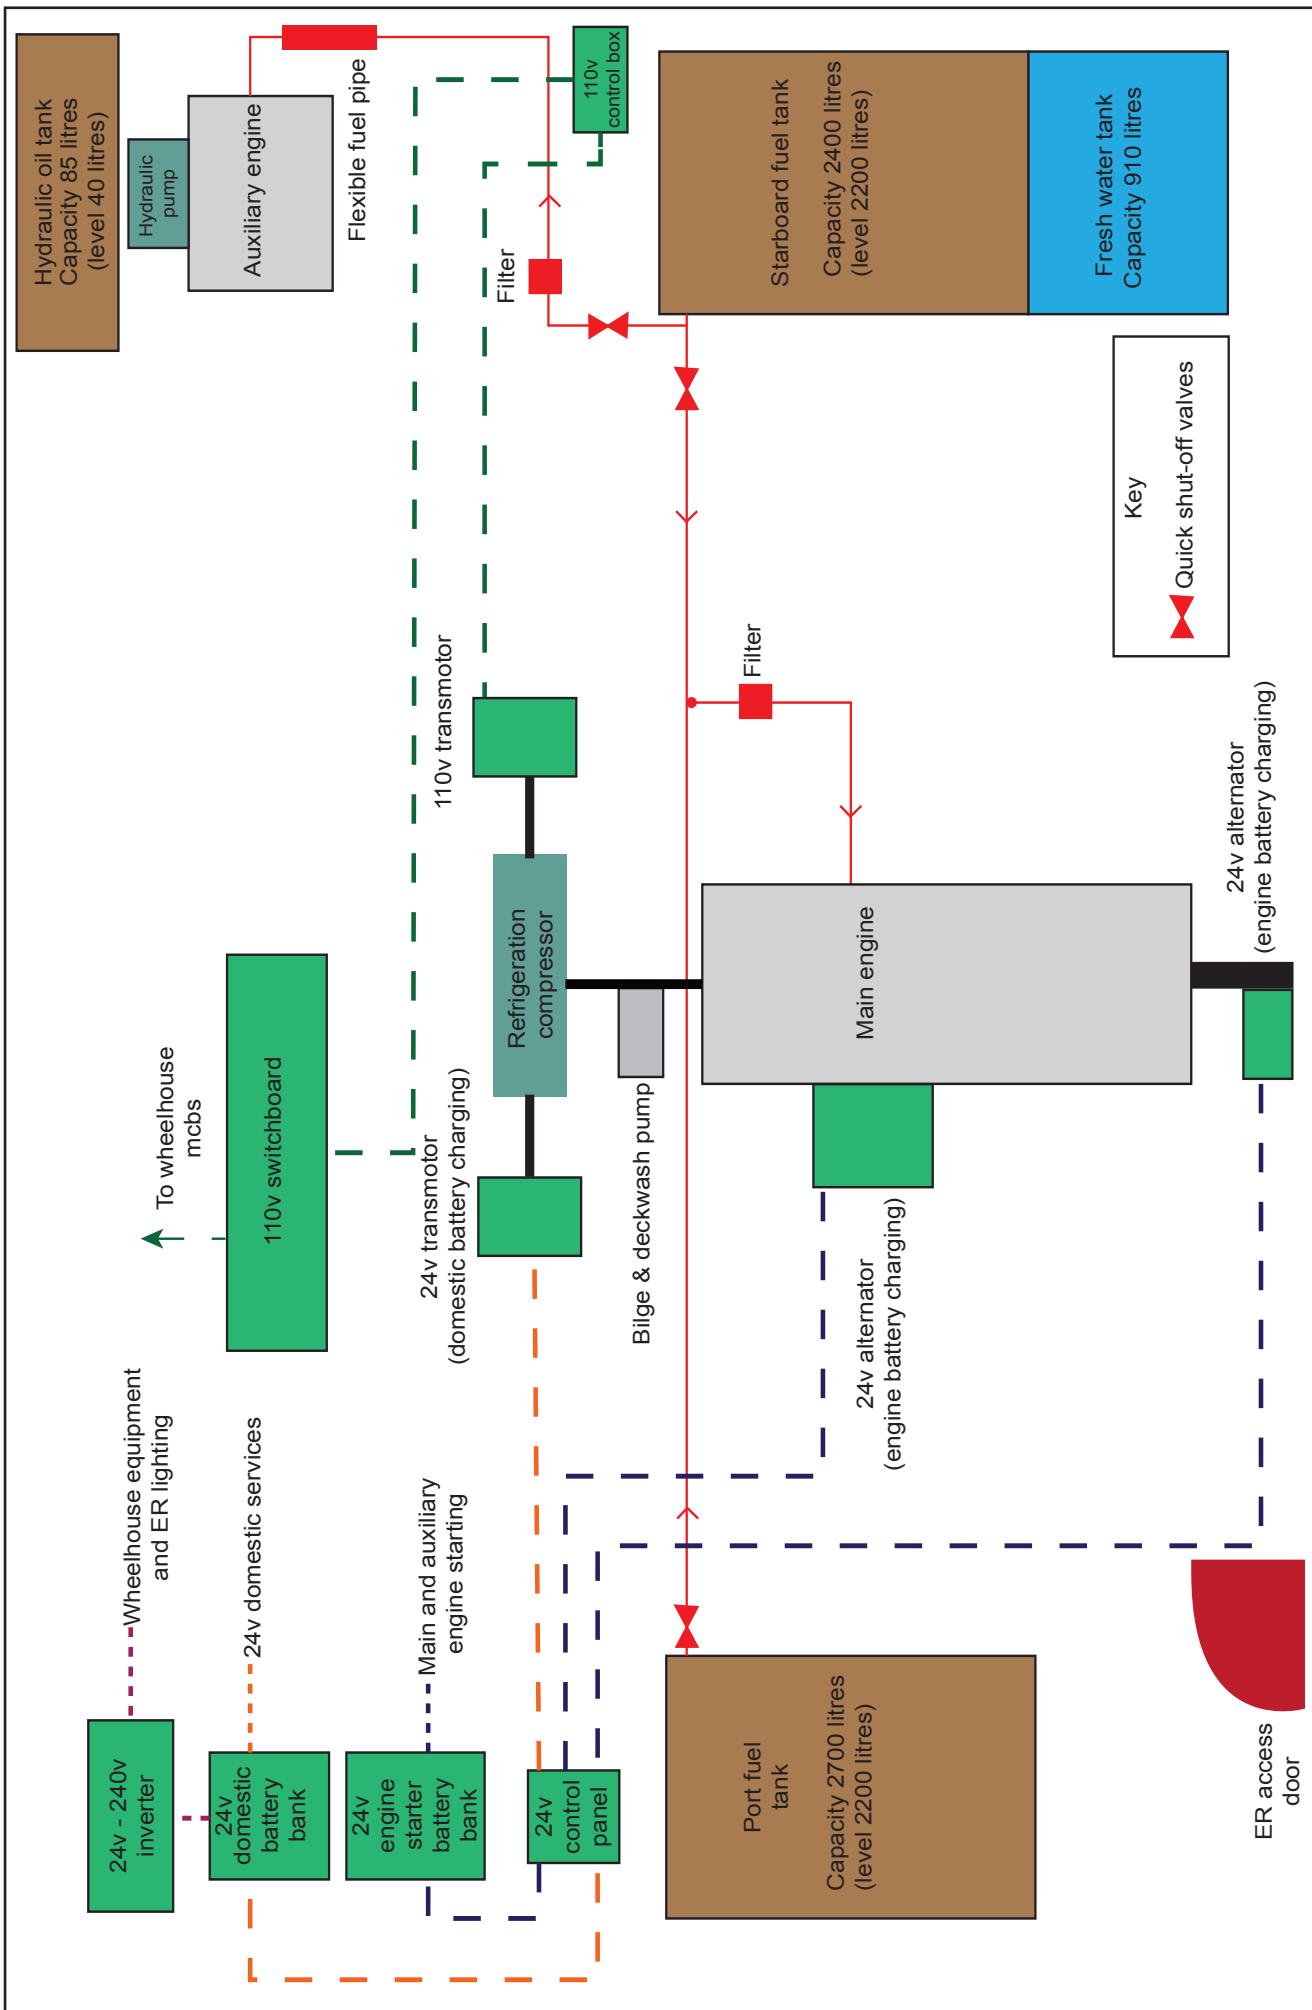
Figure 2: Schematic of the engine room layout, and fuel and electrical systems

A schematic of the engine room layout, and fuel and electrical systems is at **Figure 2**. On sailing, the main and auxiliary engine fuel supplies were provided from the starboard fuel tank. The port fuel tank supply valve was shut. Notably, the copper pipe supplying fuel to the auxiliary engine was unsupported throughout its length.

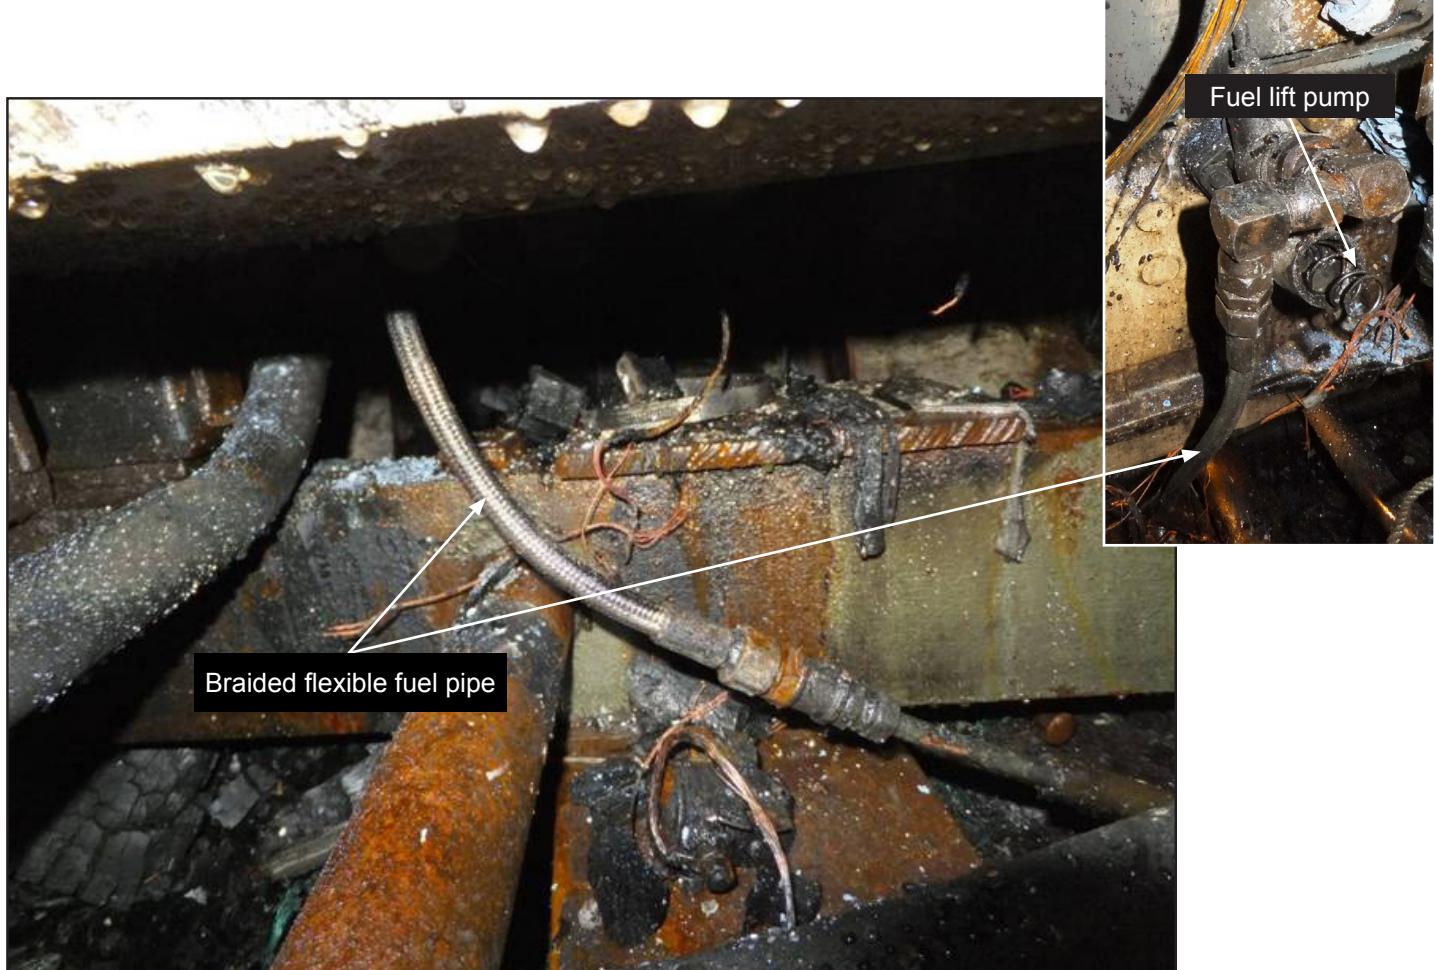
Figure 3: Auxiliary engine braided flexible fuel pipe

When the auxiliary engine fuel quick shut-off valve was opened, diesel fuel oil, under the pressure of gravity, flowed into the bilge from the braided, flexible pipe that connected the starboard fuel tank to the engine fuel lift pump (**Figure 3**). The flexible pipe, located on the outboard side of the engine and therefore out of the line-of-sight of the skipper and mate, was easily disconnected from the engine lift pump but was tight at its junction to the copper pipe running from the starboard fuel tank. Following the accident, the copper pipe passed a 20 psi pressure test, but laboratory examination of the flexible pipe determined it had suffered severe chafing in numerous areas. This was due to the connecting copper pipe being inadequately supported, which had allowed the fuel supply pipework to move excessively. There were also many areas of electrical arc damage, with copper

deposit inclusion, to the outer stainless steel braiding. This is likely to have been caused when the electrical cables fell from the cable trays above the auxiliary engine as the fire developed. While the areas of chafing and electrical arc damage did not fully penetrate the bore of the polymer pipe, a section of the polymer pipe in the vicinity of the lift pump end connection had melted. Because of the absence of material, it was not possible to determine if there was also pre-existing damage in this area.

In summary, it is most likely that the fuel source for the fire originated from leakage from the auxiliary engine's flexible fuel supply pipe. This was ignited by arcing deposits from the 110 volt positive supply cable when the insulation was abraded against the sharp edges of the steel cable carrier.

- Fuel supply and other high-risk pipework is properly supported to prevent chafing and fatigue.
- As far as practicable, electrical cabling insulation is protected against abrasion from sharp surfaces.
- Monthly emergency drills are carried out and recorded.
- Salvage pumps are regularly tested and maintained for immediate use, and associated petrol canisters are stowed in accordance with Section 5.1.8.8.4 of The Code of Safe Working Practice for the Construction and Use of 15 Metre Length Overall to Less Than 24 Metre Registered Length Fishing Vessels.
- Risk assessments are undertaken and control measures applied.
- The standard of housekeeping is improved to reduce the risk of fire and personal injury.
- The MCA's publication - Fishermen's Safety Guide – is brought to the attention of skippers and crew.

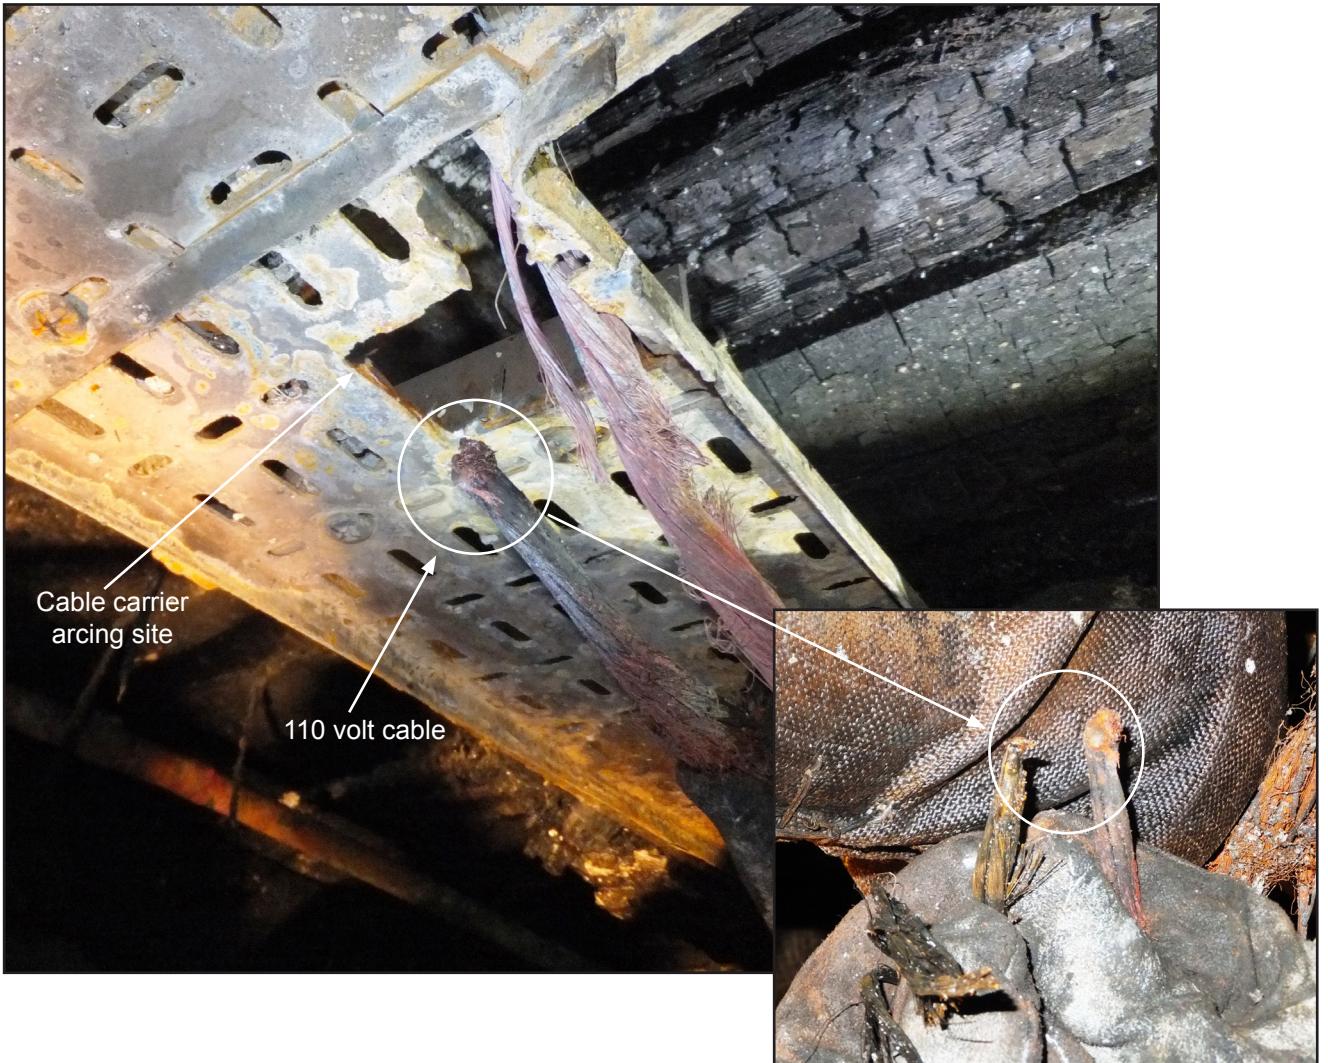
Figure 4: 110 volt cable carrier and cable beading

The auxiliary engine had been shut down for over 2 hours before the fire was discovered. The engine room was well ventilated and, while there would have been some residual heat, this would have been mainly around the area of the engine exhaust, which was distant from the area of probable fuel oil leakage. However, above the fire site, there was evidence of heavy arcing of the steel cable carrier where the 110 volt positive supply cable, from the control box to the switchboard, changed direction around a sharp

edge of the carrier. The cable core had melted through causing heavy beading to the exposed ends (**Figure 4**). The molten material from the cable is considered to be the possible source of ignition.
