Death of a recreational diver after a fall on board **MV JEAN ELAINE** 15nm NW of Cape Wrath 14 August 2012

SUMMARY

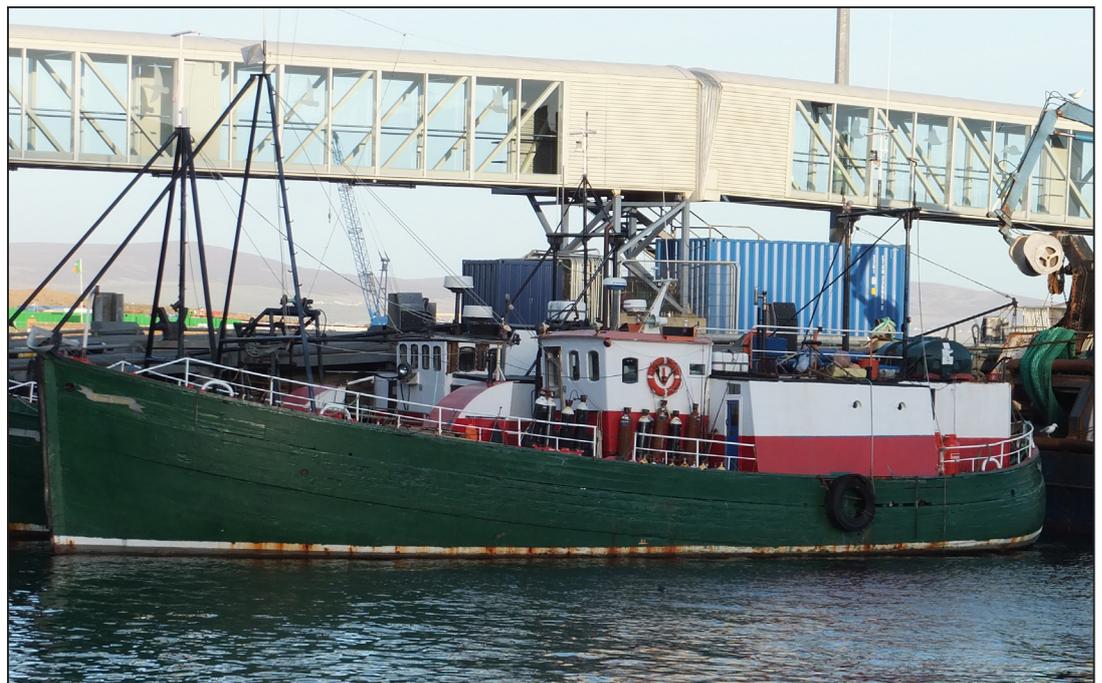
Figure 1: *Jean Elaine*

At 1607 (UTC+1) on 14 August 2012, Mr Lex Warner, an experienced recreational diver, fell onto the deck of the dive workboat *Jean Elaine* (Figure 1). When he fell, Lex was fully dressed and prepared for diving to a depth of 95m; he was wearing heavy equipment on his back and had additional diving gear attached to his front and sides. Although it was not immediately apparent, it was likely that the diving gear impacted into Lex's abdomen during the fall and caused significant internal injuries. Having been helped back to his feet by the boat's crew, Lex made a positive indication that he wished to continue with the dive and he entered the water unaided. At a depth of 88m, Lex started an unplanned return to the surface. He lost control of his breathing and buoyancy shortly afterwards. Three of his fellow divers attempted to increase his buoyancy and administer breathing gases; however, Lex did not start breathing again. He was attached to a lifting bag and ascended to the surface from a depth of 65m. Despite further medical treatment on board *Jean Elaine* and by the emergency services, he could not be revived and was pronounced dead later that evening.

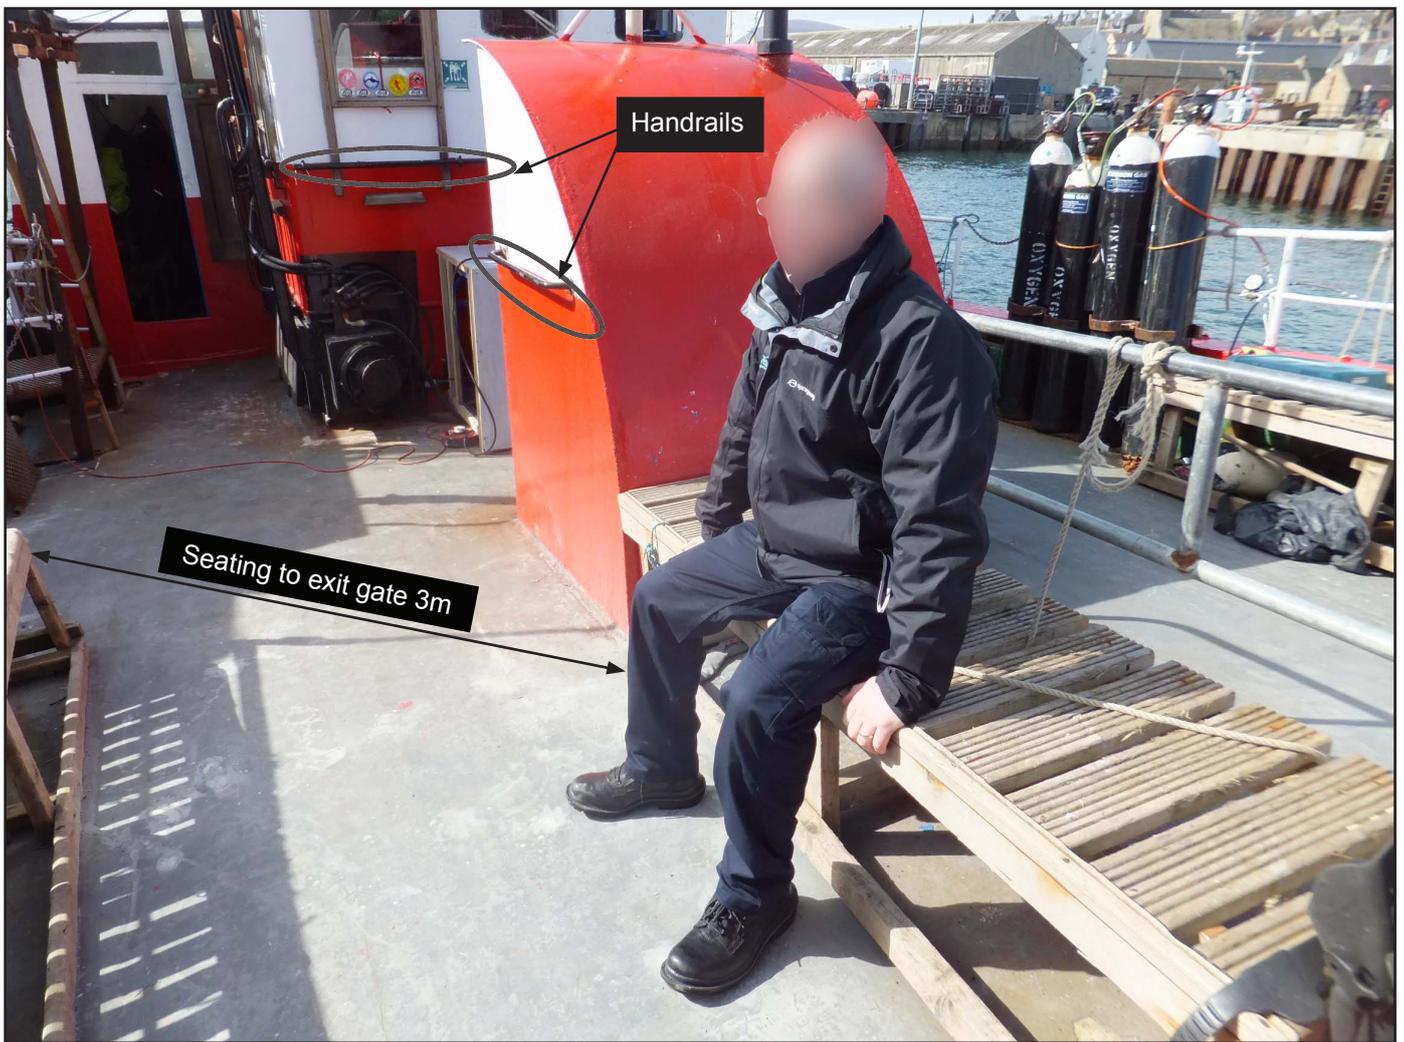
Figure 3: Lex's dressing position

The weather conditions had further improved and were now considered to be very satisfactory for diving; it was warm and sunny with a slight swell. Lex sat on the central bench on *Jean Elaine's* foredeck, facing to starboard (**Figure 3**) to prepare for the dive; this included a successful pre-dive check of his rebreather equipment. All the divers prepared their equipment in isolation; they did not check or assess each other's kit.

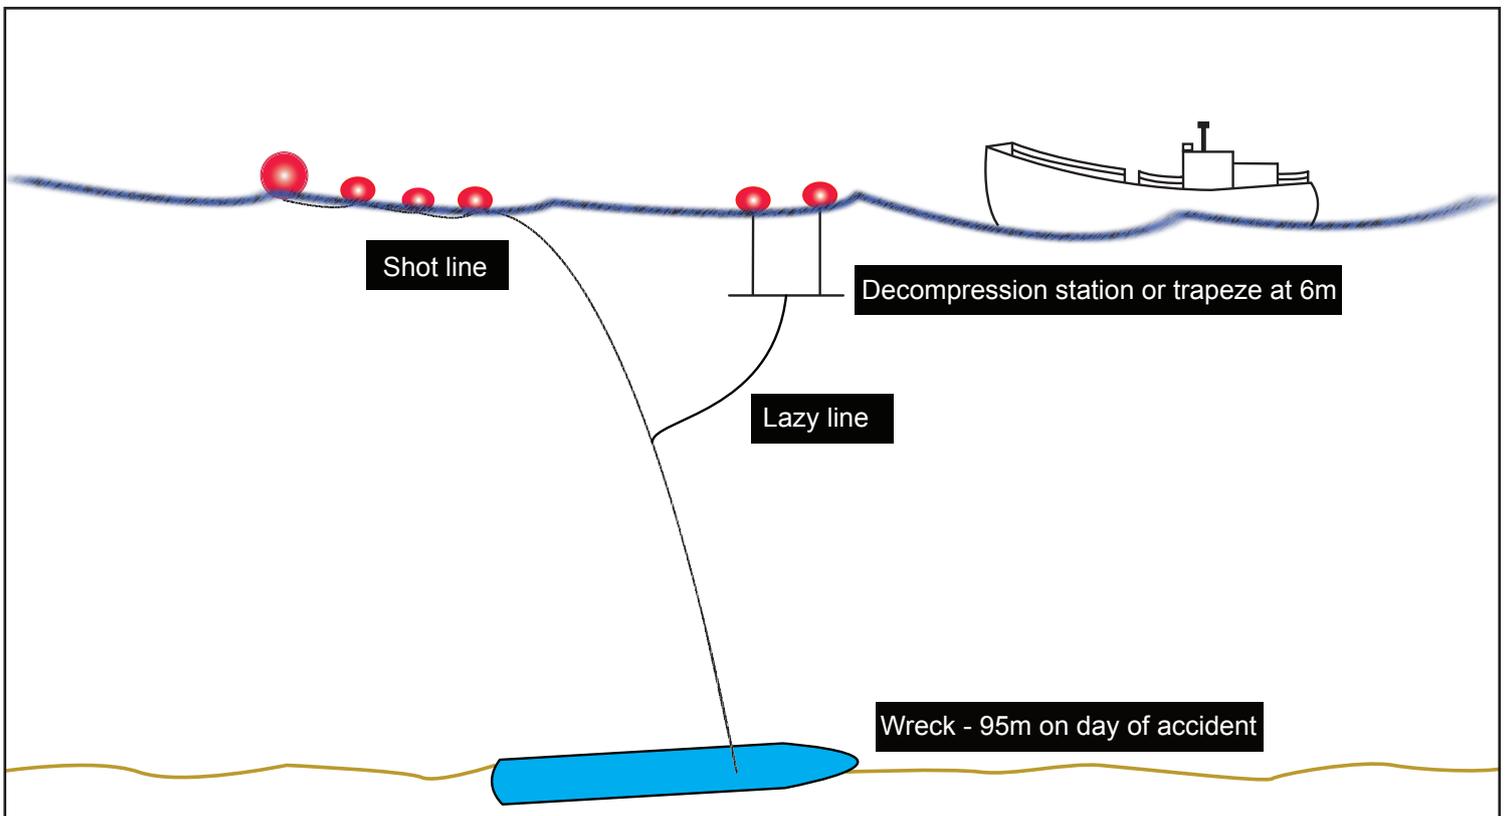
Figure 4: Diving rig

At 1558, in suitable tidal conditions and with all personal preparations complete, the skipper gave a signal for divers A and B to enter the water. They did so and then swam down the shot line to connect its lower end to the wreck. They were soon followed into the water by divers C and D who set up the 'lazy' shot line³ and trapeze decompression station at a depth of 6m (**Figure 4**).

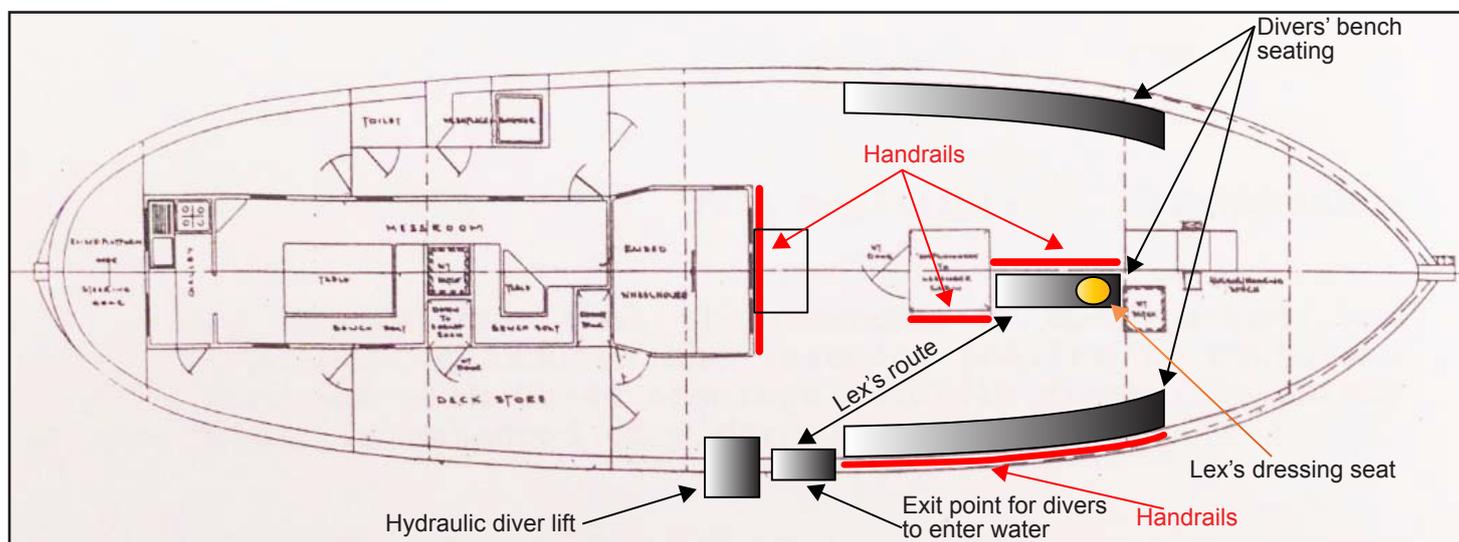
Figure 5: Deck layout

At 1607, diver E entered the water and, at the same time, Lex stood up from the bench and started to walk towards the exit gate on *Jean Elaine's* starboard side (**Figure 5**). Lex was fully prepared for the dive carrying his rebreather equipment on his back, three bail-out bottles⁴ on his sides and additional personal diving kit including a torch, surface marker buoys and dive computers. Lex was breathing through his rebreather and wearing his facemask, gloves and fins.

As he approached the exit gate, Lex fell forwards, landing very heavily onto the deck. The initial impact was to his knees, immediately then onto his hands. His fins became trapped towards his shins, which caused him to roll onto his side and finally over onto his back; a position from which he could not recover himself. There were no obstructions in Lex's path which could have tripped him and he was reported to have expressed frustration and annoyance at himself for falling.

Lex Warner fell, either as a result of losing his balance or tripping, as he tried to walk unaided from the central bench seating on *Jean Elaine*'s foredeck to the exit gate on the boat's starboard side. When he fell, Lex was walking forwards, wearing diving fins. This would have created a very significant tripping hazard. He was also carrying his heavy diving equipment, which raised his centre of gravity and reduced his stability. His visual situational awareness, which could have aided his balance, would almost certainly have been degraded as he was also wearing his diving facemask.

There was no evidence to suggest that the deck was unduly slippery or that there were any tripping hazards in his path. Although the weather and sea conditions were considered to be very satisfactory for diving, the boat was experiencing a gentle rolling action in the slight swell of the open sea. This would probably have contributed to any loss of balance.

The handrails on *Jean Elaine*'s foredeck provided good support in the areas where divers prepared their kit, on either side of the accommodation hatch area and across the front of the wheelhouse. However, there was no physical support immediately available to divers if they crossed in a straight line from the central dressing bench directly to the exit gate.

- 2013/245** Conduct a thorough review of the safety arrangements on this and any other vessels he may operate, to ensure that:
- The risks involved in supporting recreational diving operations are formally and methodically assessed.
 - The employment of crew and positioning of physical supports are considered in order to minimise the risks to divers as they prepare to enter the water.
