Capsize while beam trawling **BETTY G** Lyme Bay 23 July 2012

SUMMARY

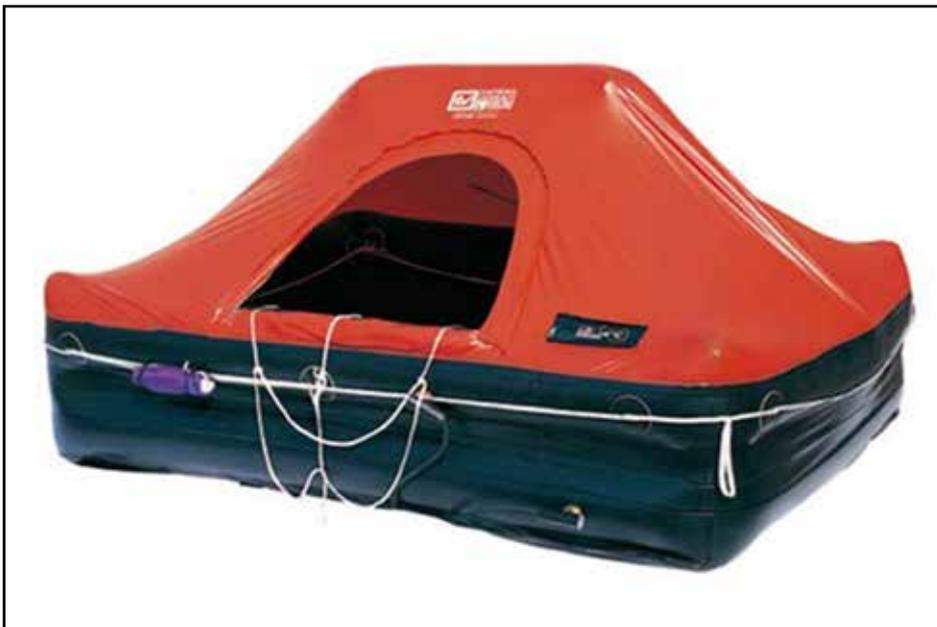
Figure 2: Four-man Eurovinil liferaft

The 4-man Eurovinil liferaft (**Figure 2**), that had been manufactured in May 2007, was included in the sale of *Betty G*. It had been serviced in June 2011 and its next service was not due for a further 3 years. The service record noted the raft was in very good condition. The liferaft was supplied with an Offshore Racing Congress (ORC) emergency pack. This standard pack did not include food, water, thermal protection aids, parachute flares or a heliograph (for attracting attention by reflecting the sun).

The quality of liferafts and the equipment supplied with them varies widely. The Eurovinil liferaft was aimed at recreational users and the ORC pack supplied with the liferaft reflected a minimum level of kit necessary to survive a few hours before being rescued. If the liferaft had been equipped with parachute flares, as required for a liferaft meeting ISO³ 9650 Part 1 or SOLAS⁴, there would have been an improved chance of earlier

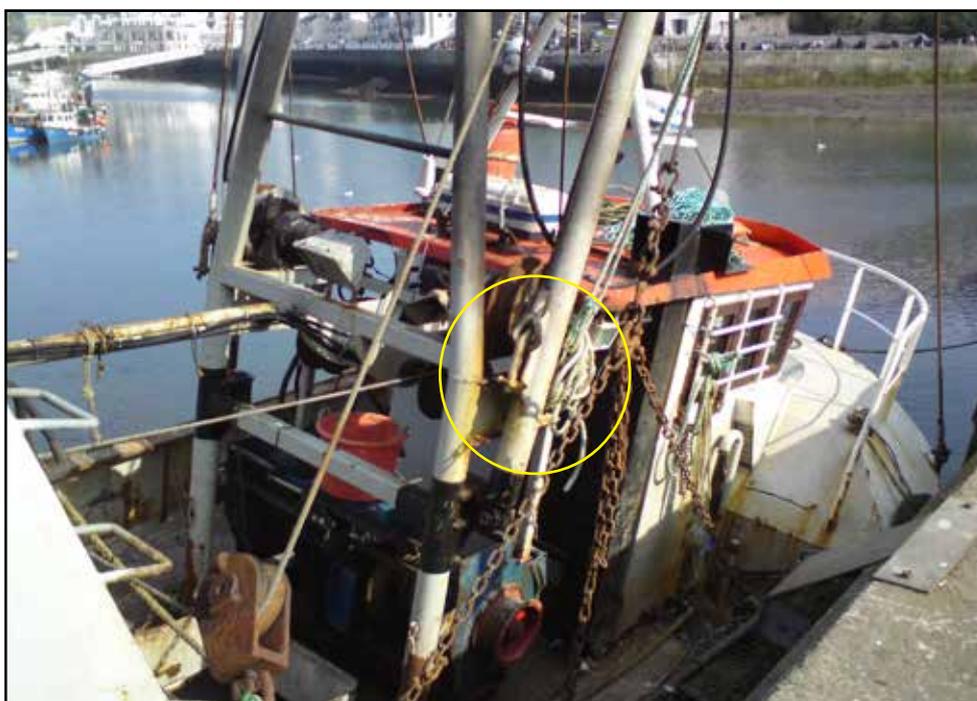
Figure 3: *Betty G* derrick head block release

Another measure, aimed at reducing the resulting heeling lever, would have been to activate the port

derrick head block emergency release (**Figure 3**). At the time of the capsize, the derricks were raised to 45°, meaning not only was the load acting 5m off the vessel's centreline but also over 5m above deck level, so raising the vessel's vertical centre of gravity (VCG). If the securing link had been released, the derrick head block would have been free to fall away, and the trawl wire would have then come to rest on the bulwark rail, dramatically reducing the heeling lever and lowering the VCG. There was no guarantee that this would have prevented the eventual foundering of *Betty G*, but it might have provided the crew more time in which to try to recover the situation.

- There was no effective means of releasing the port trawl wire quickly with the winch dog clutch engaged.
- Activation of the port derrick head block emergency release would have reduced the heeling lever and lowered the vessel's VCG, which might have provided the crew with more time in which to try to recover the situation.

To ensure the emergency derrick head block

release is effective, the system must be properly maintained and a crewman, fully conversant with its operation, must be ready to activate the release when instructed to do so by the skipper. Such steps must be considered during risk assessments and regularly practised to ensure the crew is prepared for such an emergency.

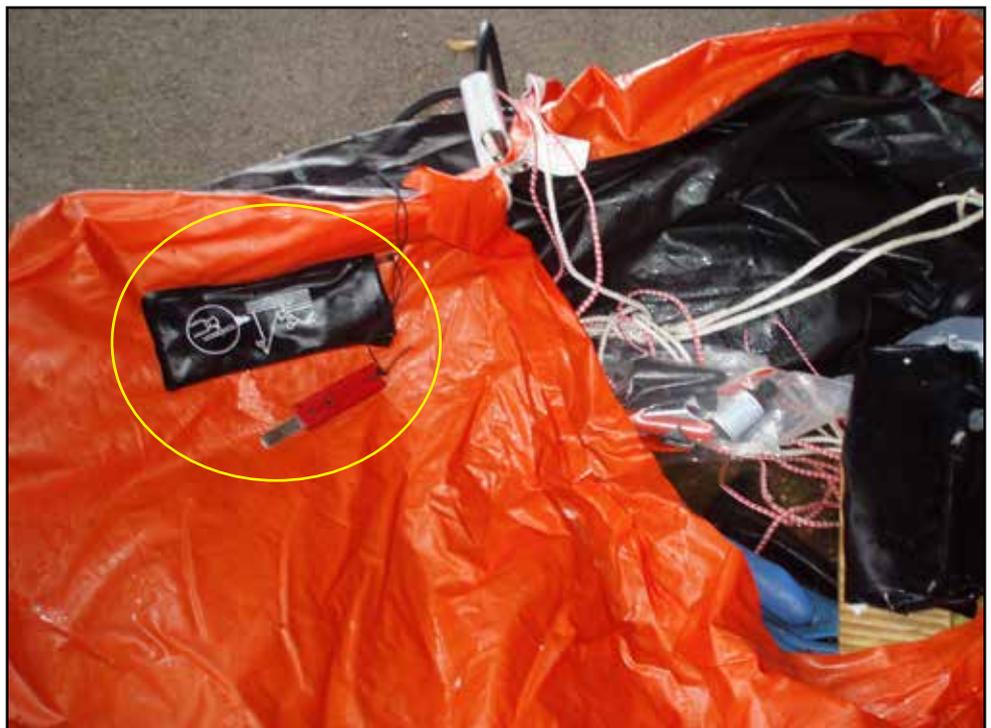
Figure 4: *Betty G* liferaft painter-knife

However, the crew experienced some difficulties with the liferaft, the most significant of which was their inability to locate the painter-knife in the dark. This was due to the knife being stowed in a black pocket on the liferaft canopy (**Figure 4**) and not, as they had expected, on the inflation tubes near the entrance.
