Fire and abandonment of **DENARIUS** 83 miles NNE of Kinnaird Head 9 July 2012

SUMMARY

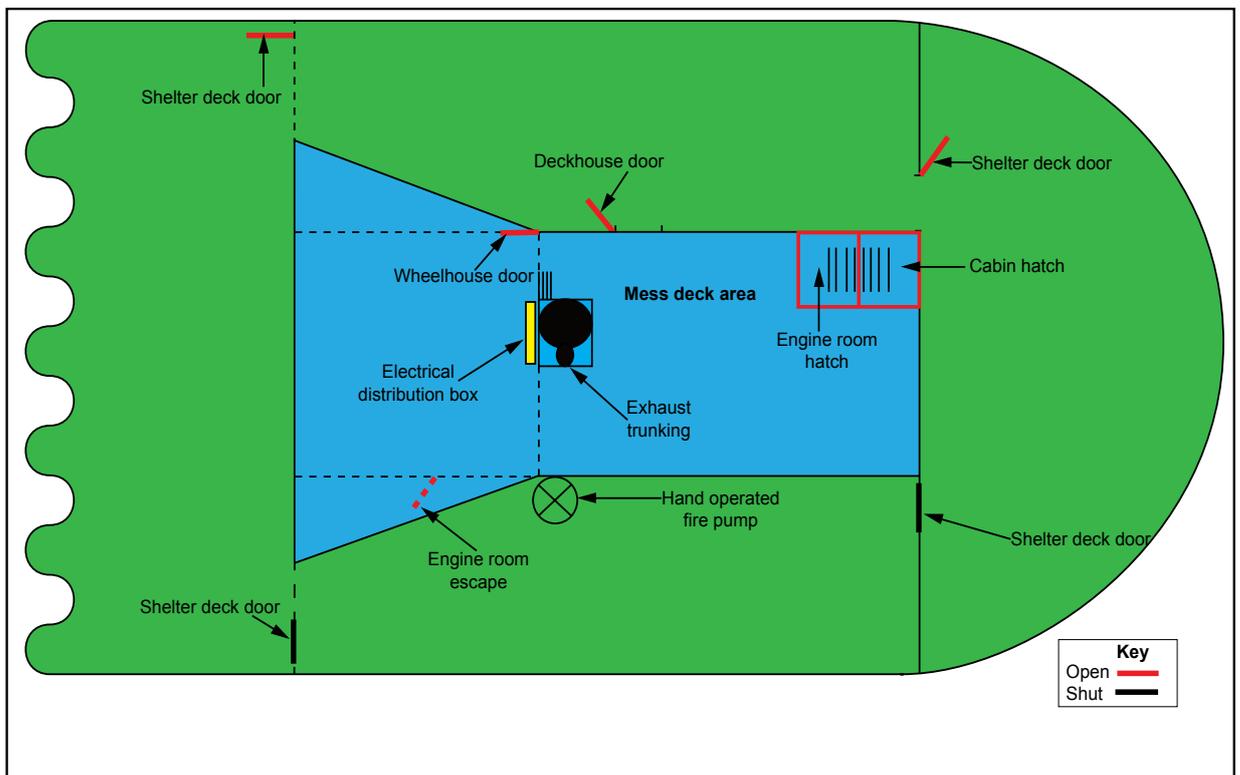
Figure 1: Diagrammatic representation of *Denarius's* accommodation arrangements at time of its evacuation

The crew set about washing the vessel down from stem to stern and, as was normal practice in good weather, they left the weathertight doors on the starboard side and the engine room emergency escape hatch open (**Figure 1**) to improve drying and ventilation.

the fire-fighting training and emergency drills that the crew had taken part in, several doors and hatches in the accommodation were left open (**Figure 1**). Additionally, the starboard shelter deck weathertight doors had been left open following cleaning of the vessel earlier that day, and as was common practice in good weather, with the engine room emergency escape on the port side deck also left open to provide additional ventilation. Not only does the practice of leaving doors and hatches open at sea endanger a vessel through the more common risk of flooding, but it also significantly increases the speed of fire spread. Although closing the doors might not have starved the fire of oxygen sufficiently to put it out, it would certainly have increased the time before flashover and delayed the spread to other spaces, thereby providing a safer environment for longer.

- Weathertight doors were regularly left open, and in their haste to evacuate the deckhouse area, the crew left other doors and hatches open, allowing the smoke and fire to spread quickly through the vessel.

- That engine manufacturers' maintenance instructions are understood and complied with.
 - That fire drills include the methods and benefits of smoke and fire containment.

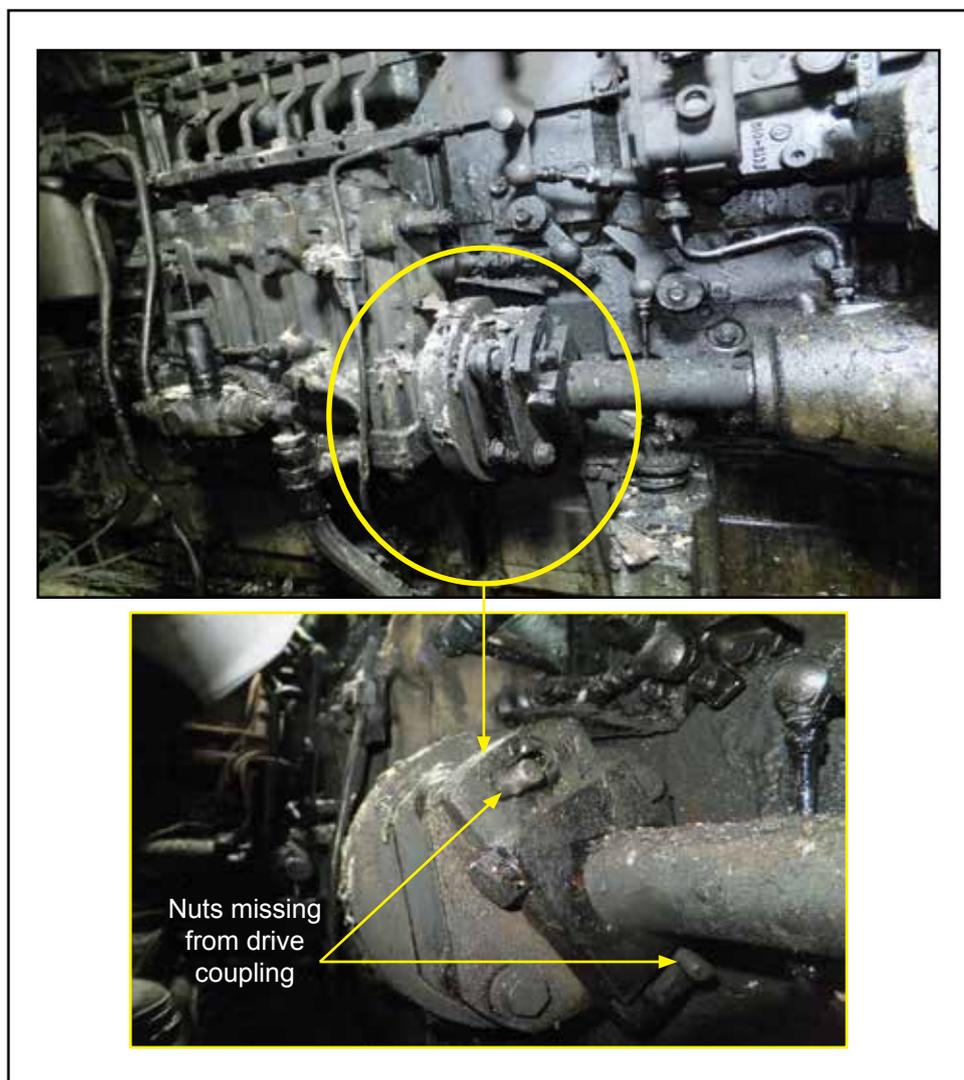
Figure 2: Fuel injection pump coupling

The engine was stopped, the fuel injection pump timing gear was inspected and the fuel injection pump drive coupling, which set the fuel injection pump timing, was found to be loose. This coupling was normally secured by two bolts. However, the securing nuts on both bolts had slacked off and were now missing (**Figure 2**).

The bolts (**Figure 2**) securing the fuel injection pump timing coupling had slackened off over a period of time, causing the fuel injection timing to be retarded by approximately 20°. This led to incomplete combustion, enabling unburnt fuel from the cylinders to enter and accumulate within the exhaust system. The symptoms of this were: loss of power, increased exhaust temperature, smoke from the exhaust, vibration and misfiring.

This would have enabled them to quickly identify the source of the problem. The decision to continue running the engine after the timing had slipped caused the nuts to slacken further, until the point they

- The main engine's fuel injection pump timing had not been inspected and maintained as per the manufacturer's operation and maintenance manual. Had the manufacturer's guidance regarding the injection pump timing been followed, the coupling bolts would have been regularly examined and it is less unlikely that they would have been able to slacken off unnoticed.

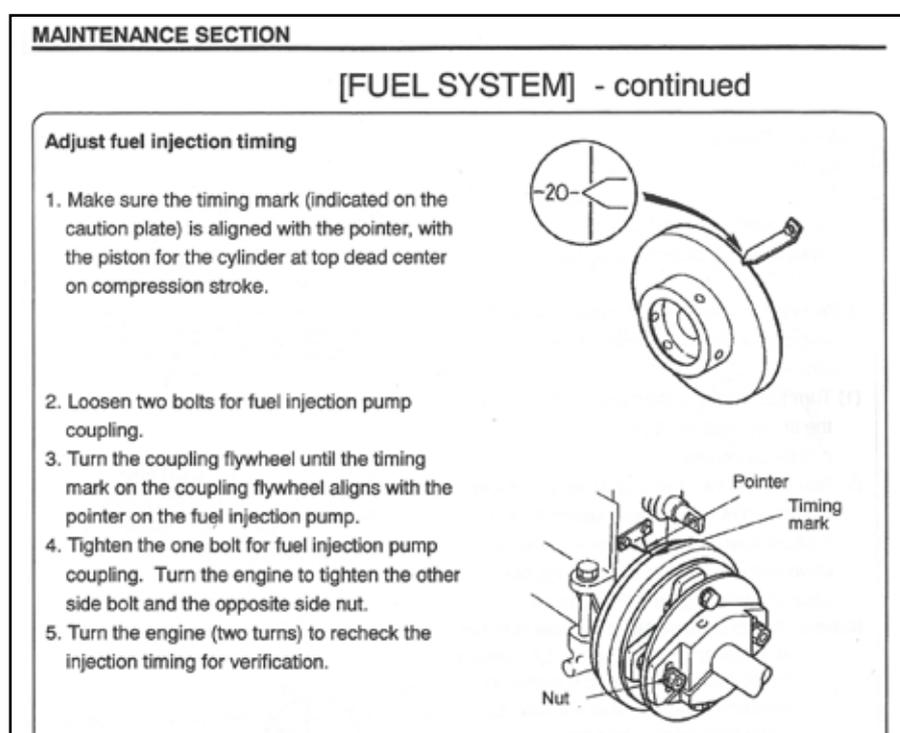
Figure 3: Engine Operations Manual section regarding fuel injection pump timing adjustment

The Mitsubishi S6R2 Operation and Maintenance Manual supplied with the main engine in 2006 made frequent references to the fuel injection pump timing. These included a requirement for the injection timing to be checked and adjusted every 2000 running hours. The manual also explained in relatively simple terms how to complete these and other necessary checks and adjustments (**Figure 3**).

In July 2010 the fuel injection pump had been replaced; this was the last known occasion that the timing had been checked and set. Since

that time the engine had run a further 9000 hours, approximately 7000 hours beyond the recommended period between checks of the injection timing.

Had the manufacturer's guidance regarding the injection pump timing been followed, the coupling bolts would have been examined regularly. This would have reduced the likelihood of the bolts slackening off unnoticed and would have familiarised the driver with the coupling arrangement.

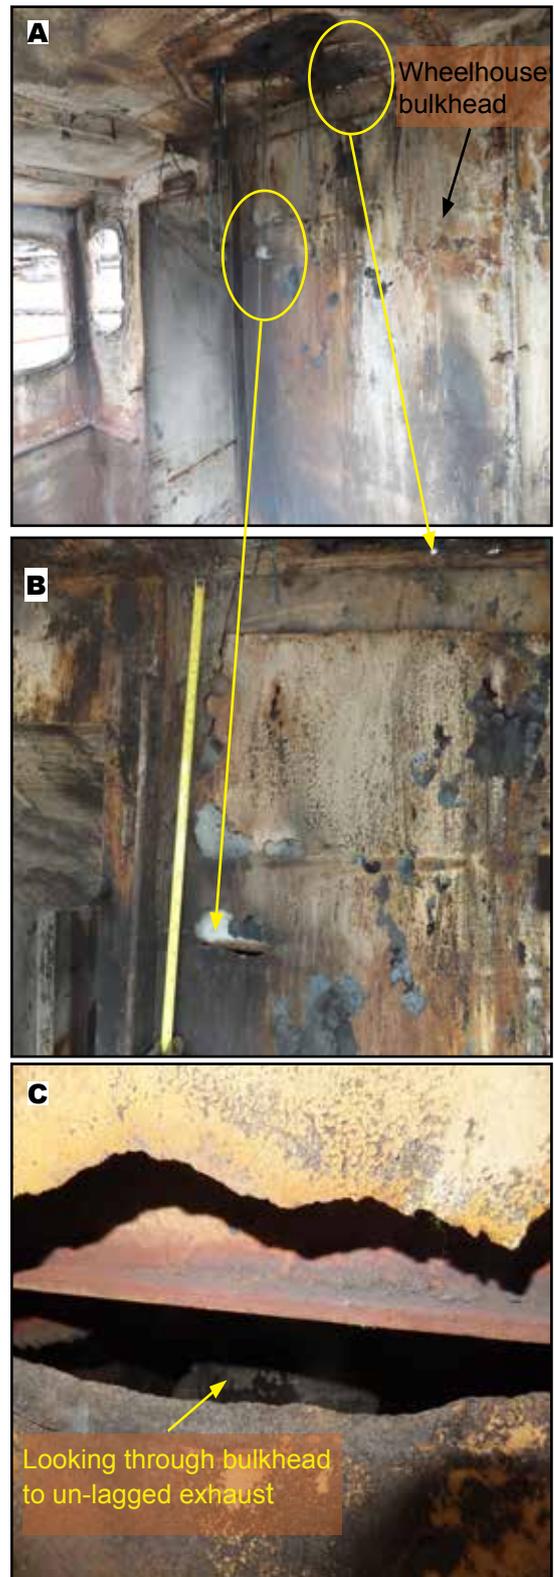
Figures 4a, 4b and 4c: Showing corroded bulkhead damage

The wheelhouse bulkhead was corroded through in places close to the deckhead, probably as a consequence of sea water acting on the steel deckhead, aggravated by heat from the exhaust. Once the deckhead was perforated in this area, water was able to seep into the exhaust lagging, where it would be boiled off as steam that subsequently condensed onto and corroded other internal steel surfaces. This would have been difficult to detect since typically the only obvious symptom is a brief smell of damp lagging drying when starting the engine from cold. When deckhead repairs were carried out on *Denarius*, they did not include the corroded areas inside the exhaust trunking and the bulkhead, which had probably been deteriorating undetected since the vessel's last major modification 22 years earlier. In this case, water and steam had also probably led to degradation of the mineral board insulation forward of the bulkhead, which then provided a direct path for excessive heat from the exhaust to act upon the electrical insulation.

- Excessive temperatures within the exhaust were transmitted to electrical wiring insulation as a result of an un-lagged area on the exhaust and perforated bulkheads resulting from corrosive degradation over a period of almost 22 years.

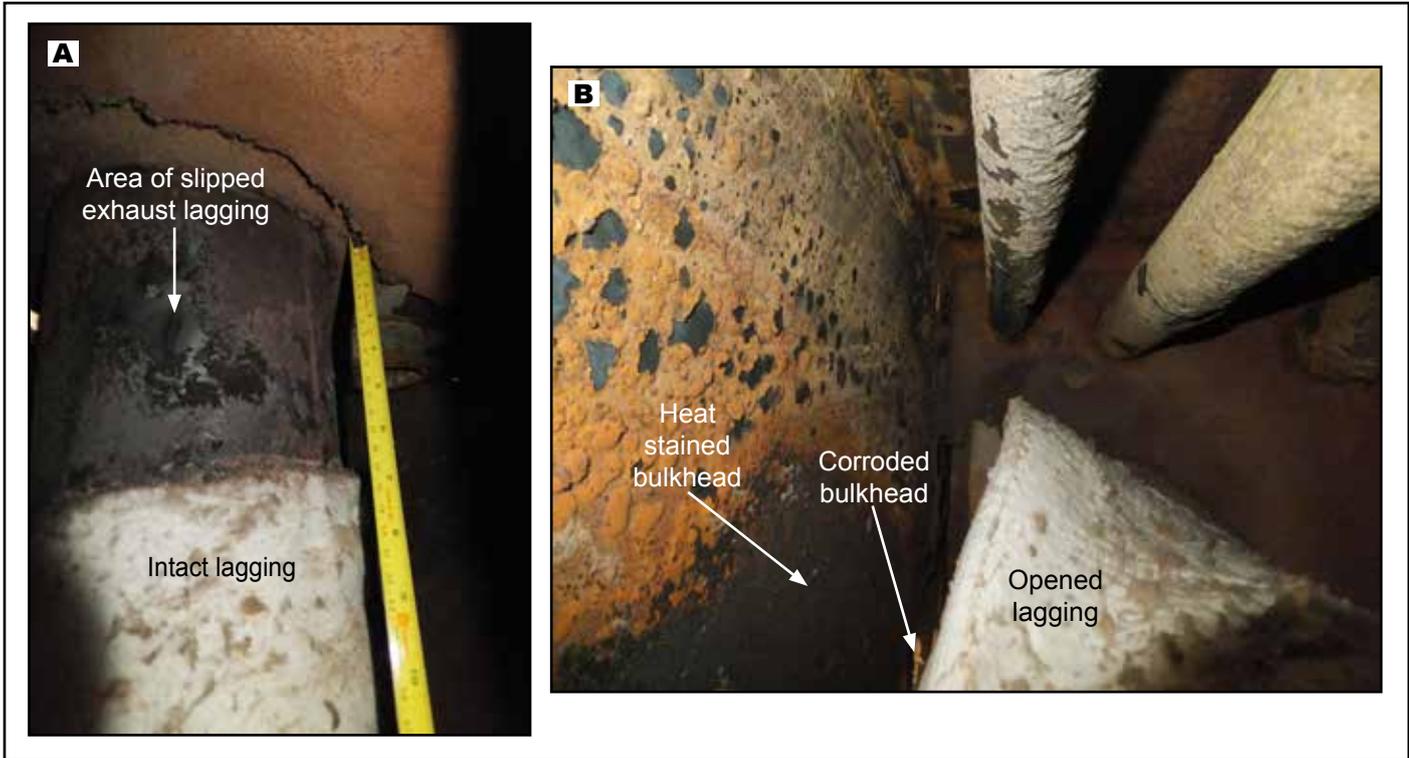
Figures 5a and 5b: Inside exhaust trunking looking towards deckhead; lagging opened up, heat stained bulkhead and corrosion damage

The prolonged running of the engine with retarded timing caused fuel to accumulate in the exhaust system. Some of this fuel burnt explosively, and as these explosions within the exhaust system increased in frequency and violence, the temperature within the exhaust system also increased, leading to the turbocharger casing glowing cherry red⁴. Heat higher up in the exhaust could have been exacerbated by accumulated carbon deposits also igniting. This heat was transferred through the bulkhead into the wheelhouse by both: convection, through a corroded bulkhead (**Figure 4**); and radiation, from the upper exhaust trunking where the lagging had slipped over time to leave a 170mm gap (**Figure**

5) that coincided with an area where the mineral board insulation forward of the bulkhead had degraded.

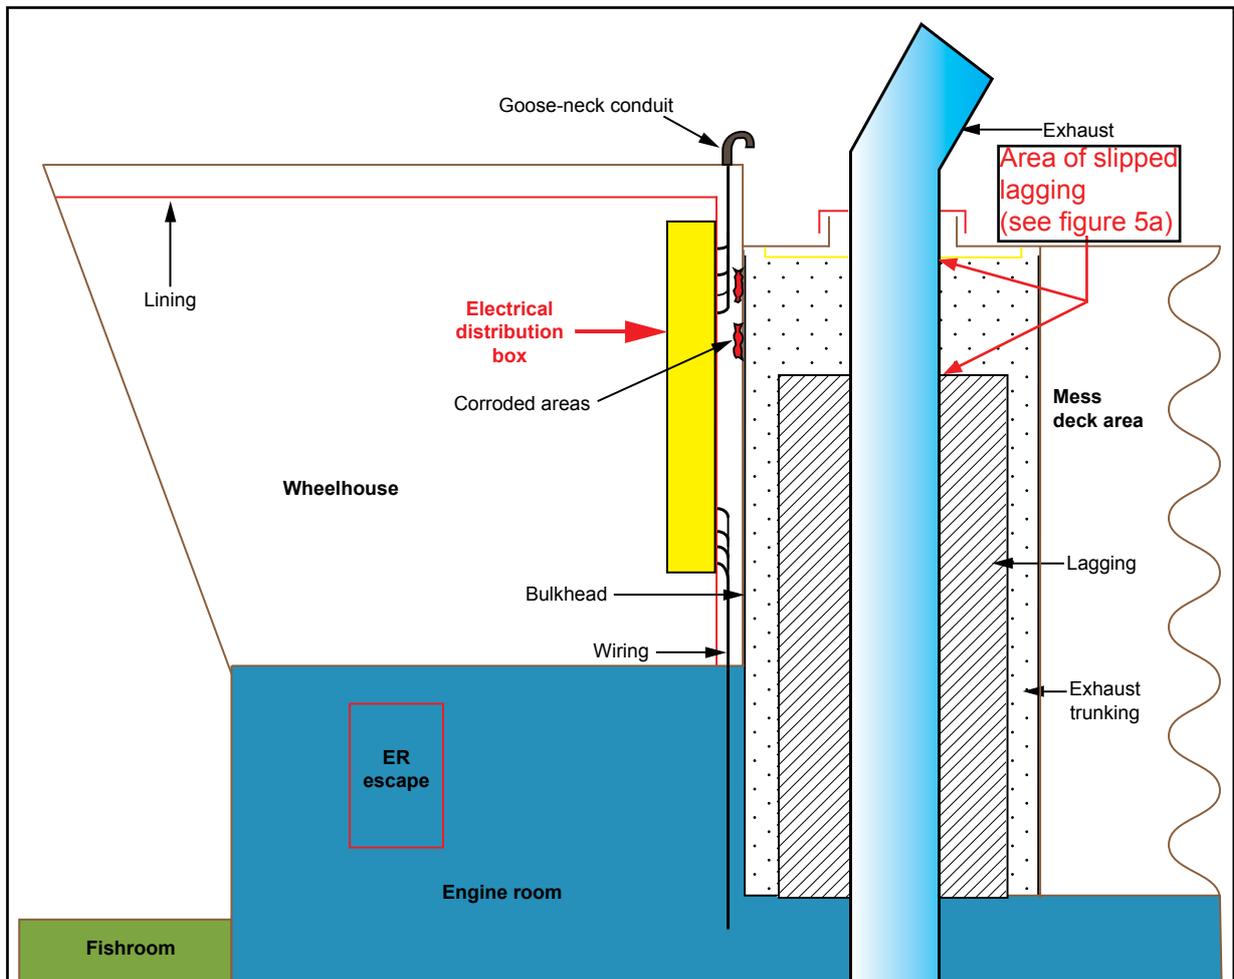
Figure 6: Diagrammatic profile of wheelhouse and exhaust trunking areas

Directly forward of the exhaust trunking in the wheelhouse was a main electrical distribution box (**Figure 6**). The insulation covering electrical cables to and from this is most likely to have been the starting point of the subsequent fire, with the

carbonaceous material in the wheelhouse linings providing further fuel. When the engine was finally shut down, the exhaust temperature remained high, indicating there was still sufficient fuel within the exhaust system to keep a fire burning, maintaining a heat source to the fire at the back of the electrical distribution box.

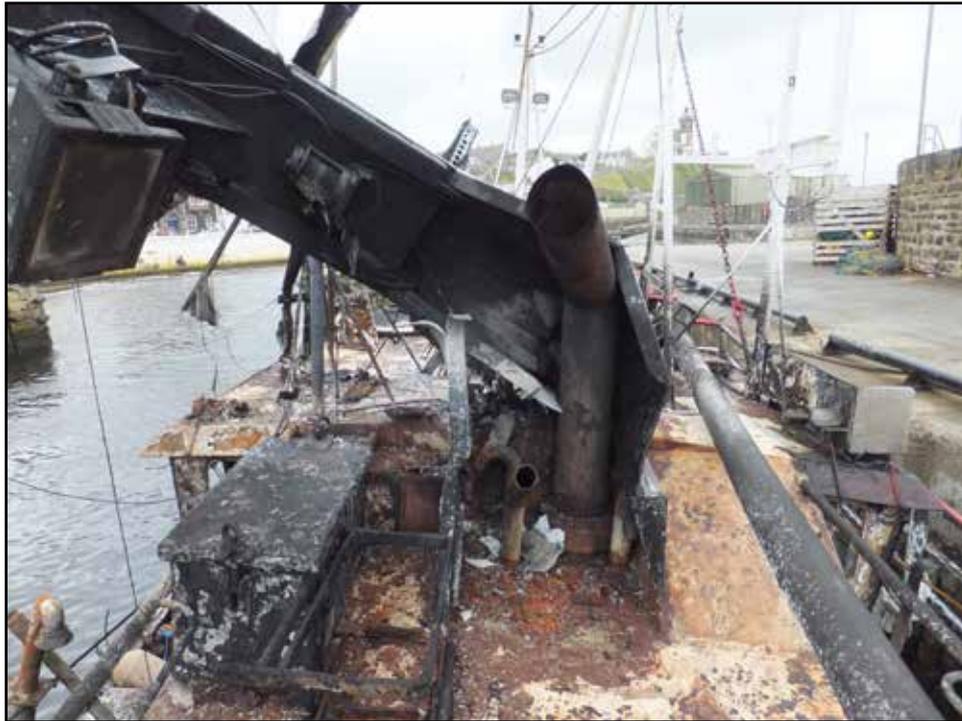
Figures 7: Exhaust exit from deckhouse deckhead

Vessels of less than 24m are not required to carry breathing apparatus, and any attempt at fighting the fire effectively on board *Denarius* would have required such equipment. In the absence of breathing apparatus, the only viable action available was external boundary cooling, which would also have required a good supply of water. However, *Denarius*'s engine-driven water pumps were disabled due to the engines being stopped, eliminating the opportunity for boundary cooling in the area where the engine exhaust exited the deckhouse, immediately above the source of the fire (**Figure 7**).
