## Fatal injury to a crew member on board **E.R.ATHINA** at anchor off Aberdeen 10 June 2012

### SUMMARY

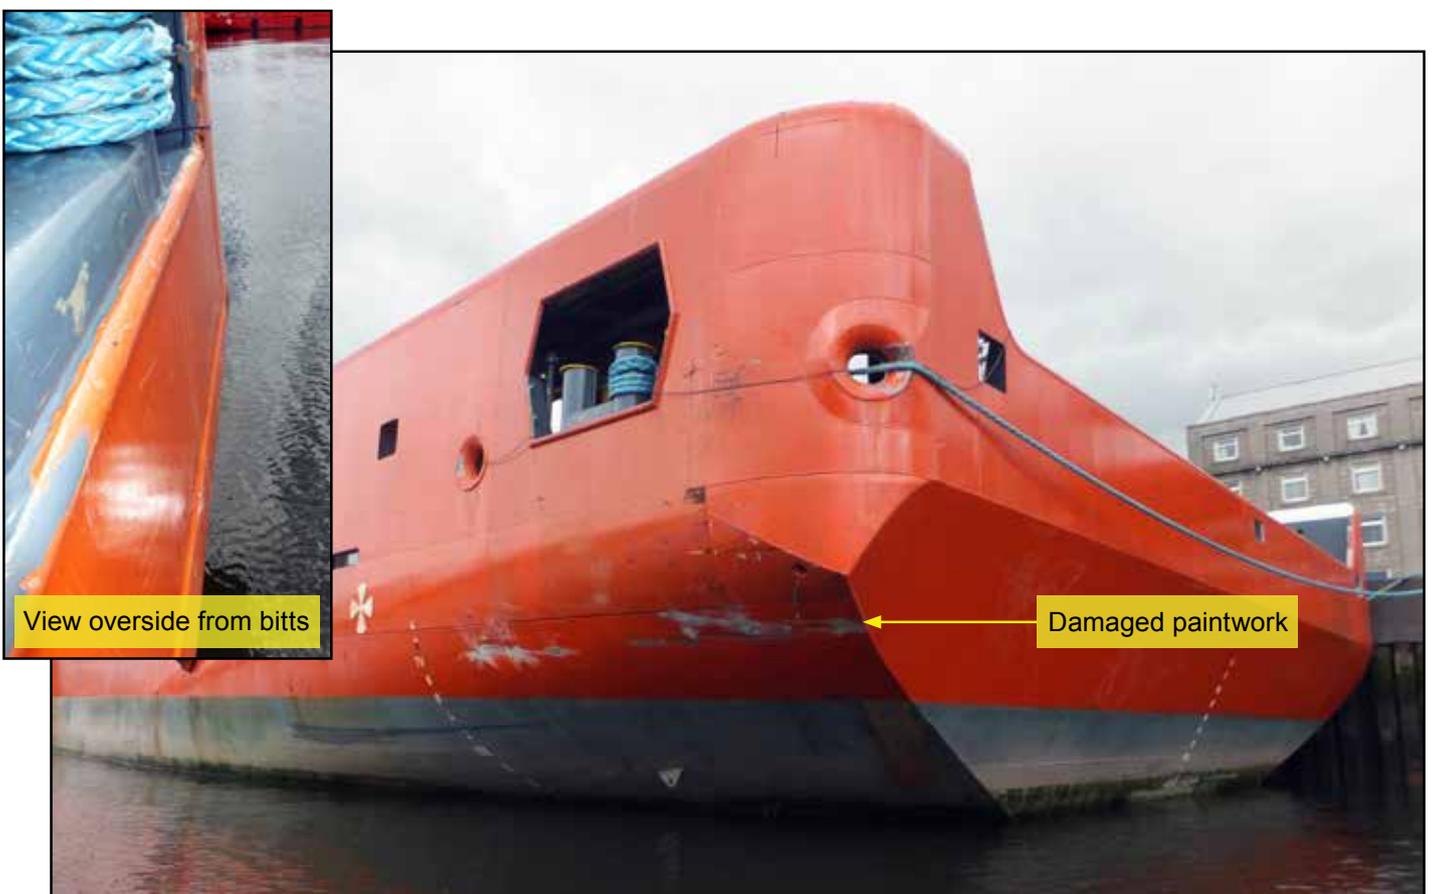
Figure 1: *E.R. Athina* port quarter

During the afternoon of 9 June 2012, *E.R. Athina* sailed from Aberdeen and anchored approximately 2 miles off the harbour entrance, outside the harbour limit. After anchoring, the master and chief officer agreed to carry out drills with the vessel's two FRCs the following day, weather permitting. They also discussed the possibility of using an FRC as a platform from which to paint an area of damaged paintwork on the port quarter (**Figure 1**) which had been scratched during the vessel's arrival at Aberdeen 2 days earlier.

The FRC was moving up and down on the swell, which was also setting the boat under the cutaway or counter section of *E.R. Athina's* hull (**Figures 1 and 3**). Pjero and the OS had to crouch due to the reduced headroom under the counter, and they also had to push against *E.R. Athina's* side to prevent the FRC from being damaged. The FRC's crew were concerned with the situation, so Pjero asked the chief officer to take in the slack in the bow and stern lines to try and reduce the FRC's movement. At about the same time, the chief officer and the master realised that Pjero was experiencing difficulties and asked him if the painting task was feasible. Pjero replied that it was.

Pjero sustained fatal injuries when he was crushed between the side plating on *E.R Athina's* port quarter and the lifting frame fitted to the FRC. At the time, the FRC was secured to the supply ship by bow and stern lines, and the boat was being repeatedly set against the supply ship by the combined effects of the swell and the tidal stream. Pjero had been standing behind the FRC's control console and it is likely that he moved onto the FRC's port side in order to push the FRC clear of *E.R. Athina*, as he and the OS had managed to achieve several times previously.

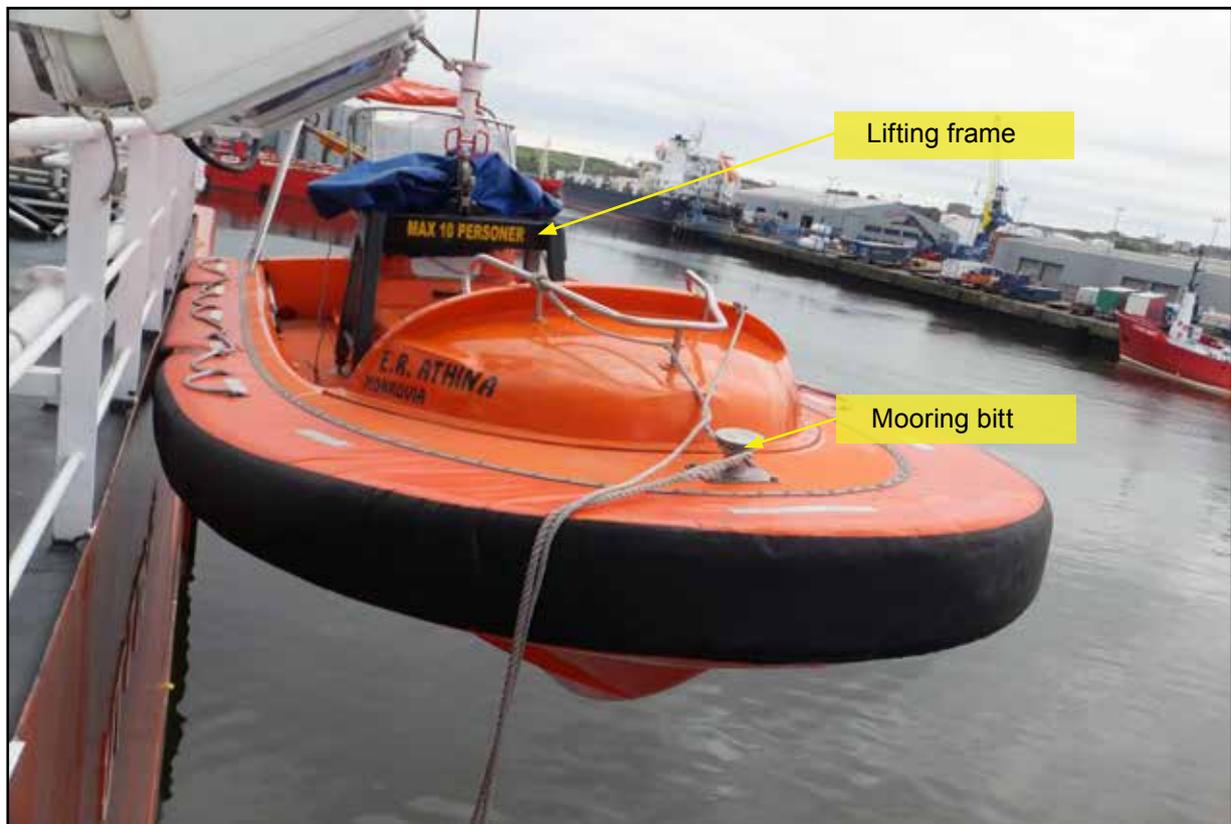
**Figure 2:** Port Fast Rescue Craft

After some initial difficulty, the OS caught the line from the centreline fairlead. However, he was unable to secure it to the single bitt fitted to the FRC's bow (**Figure 2**) so Pjero left the FRC's control console to assist him. When the bow line was eventually secured, Pjero returned to the control console and manoeuvred the FRC astern towards the line from the fairlead on *E.R. Athina's*

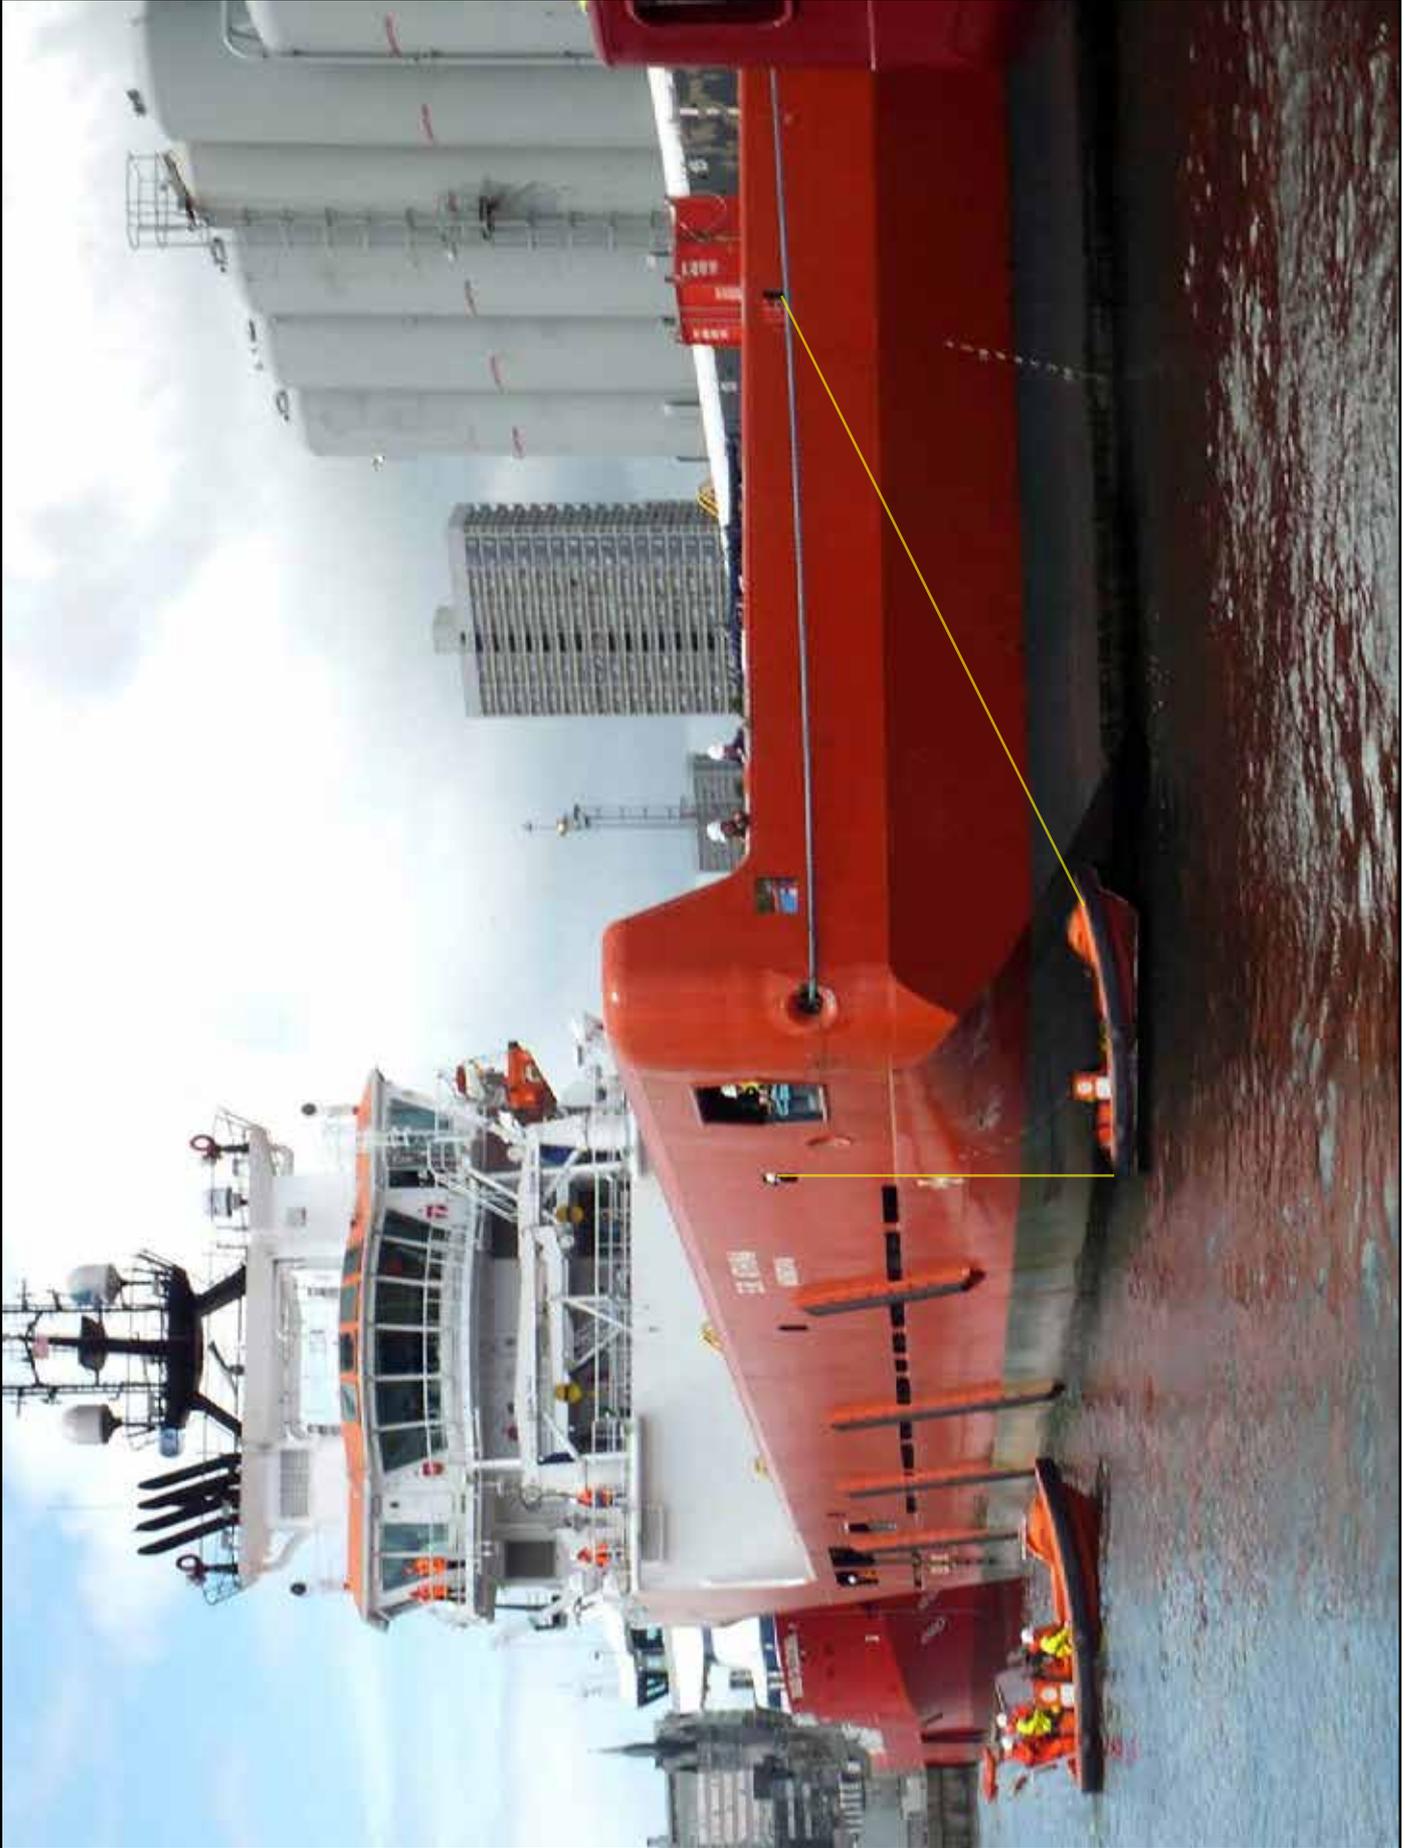
Figure 3: Illustration showing securing arrangement

At 0940, the port FRC was lowered to deck level and its engine was started. The boat was then lowered to the waterline. At 0945, the fall wire hook and painter were released and Pjero tested the FRC's engine by manoeuvring ahead and astern. He then drove the boat around for several minutes before approaching the supply ship's port quarter. The line from the centreline fairlead at the stern had already been lowered and the deck cadet was ready to tend the line from the port quarter. The master and the chief officer were watching from the main deck. Pjero intended to secure the FRC alongside *E.R. Athina's* port quarter, with its bow pointing towards *E.R. Athina's* stern (**Figure 3**).

The chief officer took in the slack in the bow line, but he could not see that the bow line had started to slip from the bitt on the FRC. The OS grabbed hold of the line just before it completely detached and, as he did so, he heard Pjero cry out in pain. The OS turned and saw that Pjero was trapped between the ship's hull and the FRC lifting hook frame (**Figure 2**), facing the frame. Pjero remained trapped for several seconds until he collapsed on to the deck of the FRC.

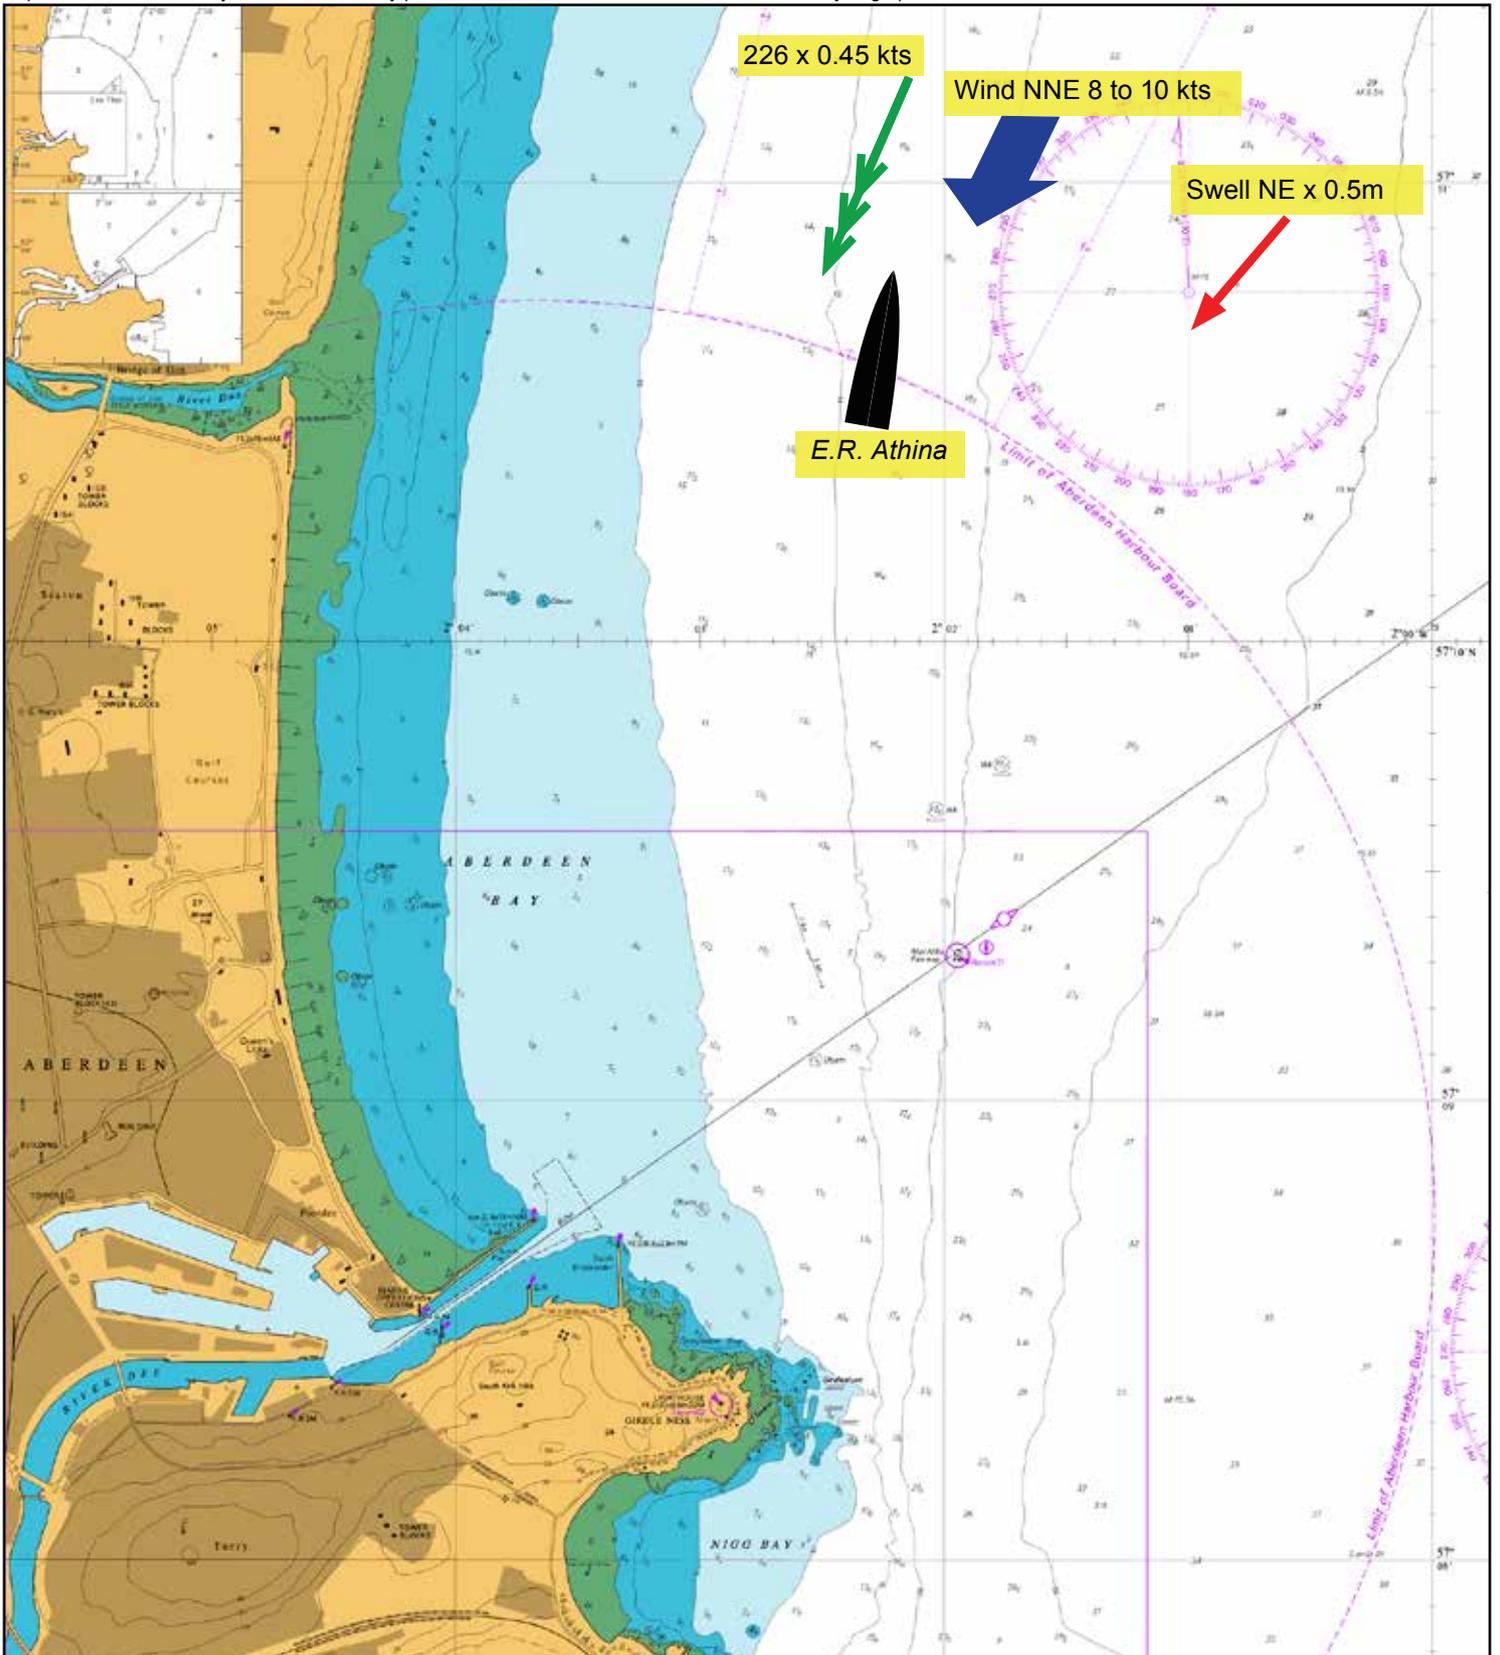
Figure 4: Environmental conditions at 0800 10 June 2012

Between 0800, when the master decided to proceed with the FRC drills and the paintwork repair, and 0955 when Pjero was fatally injured, *E.R. Athina's* heading had altered significantly. At 0800, the vessel's heading was 012° with the prevailing wind, swell and tidal stream setting on to her starboard bow. As a result, the port quarter and stern were relatively sheltered (**Figure 4**).

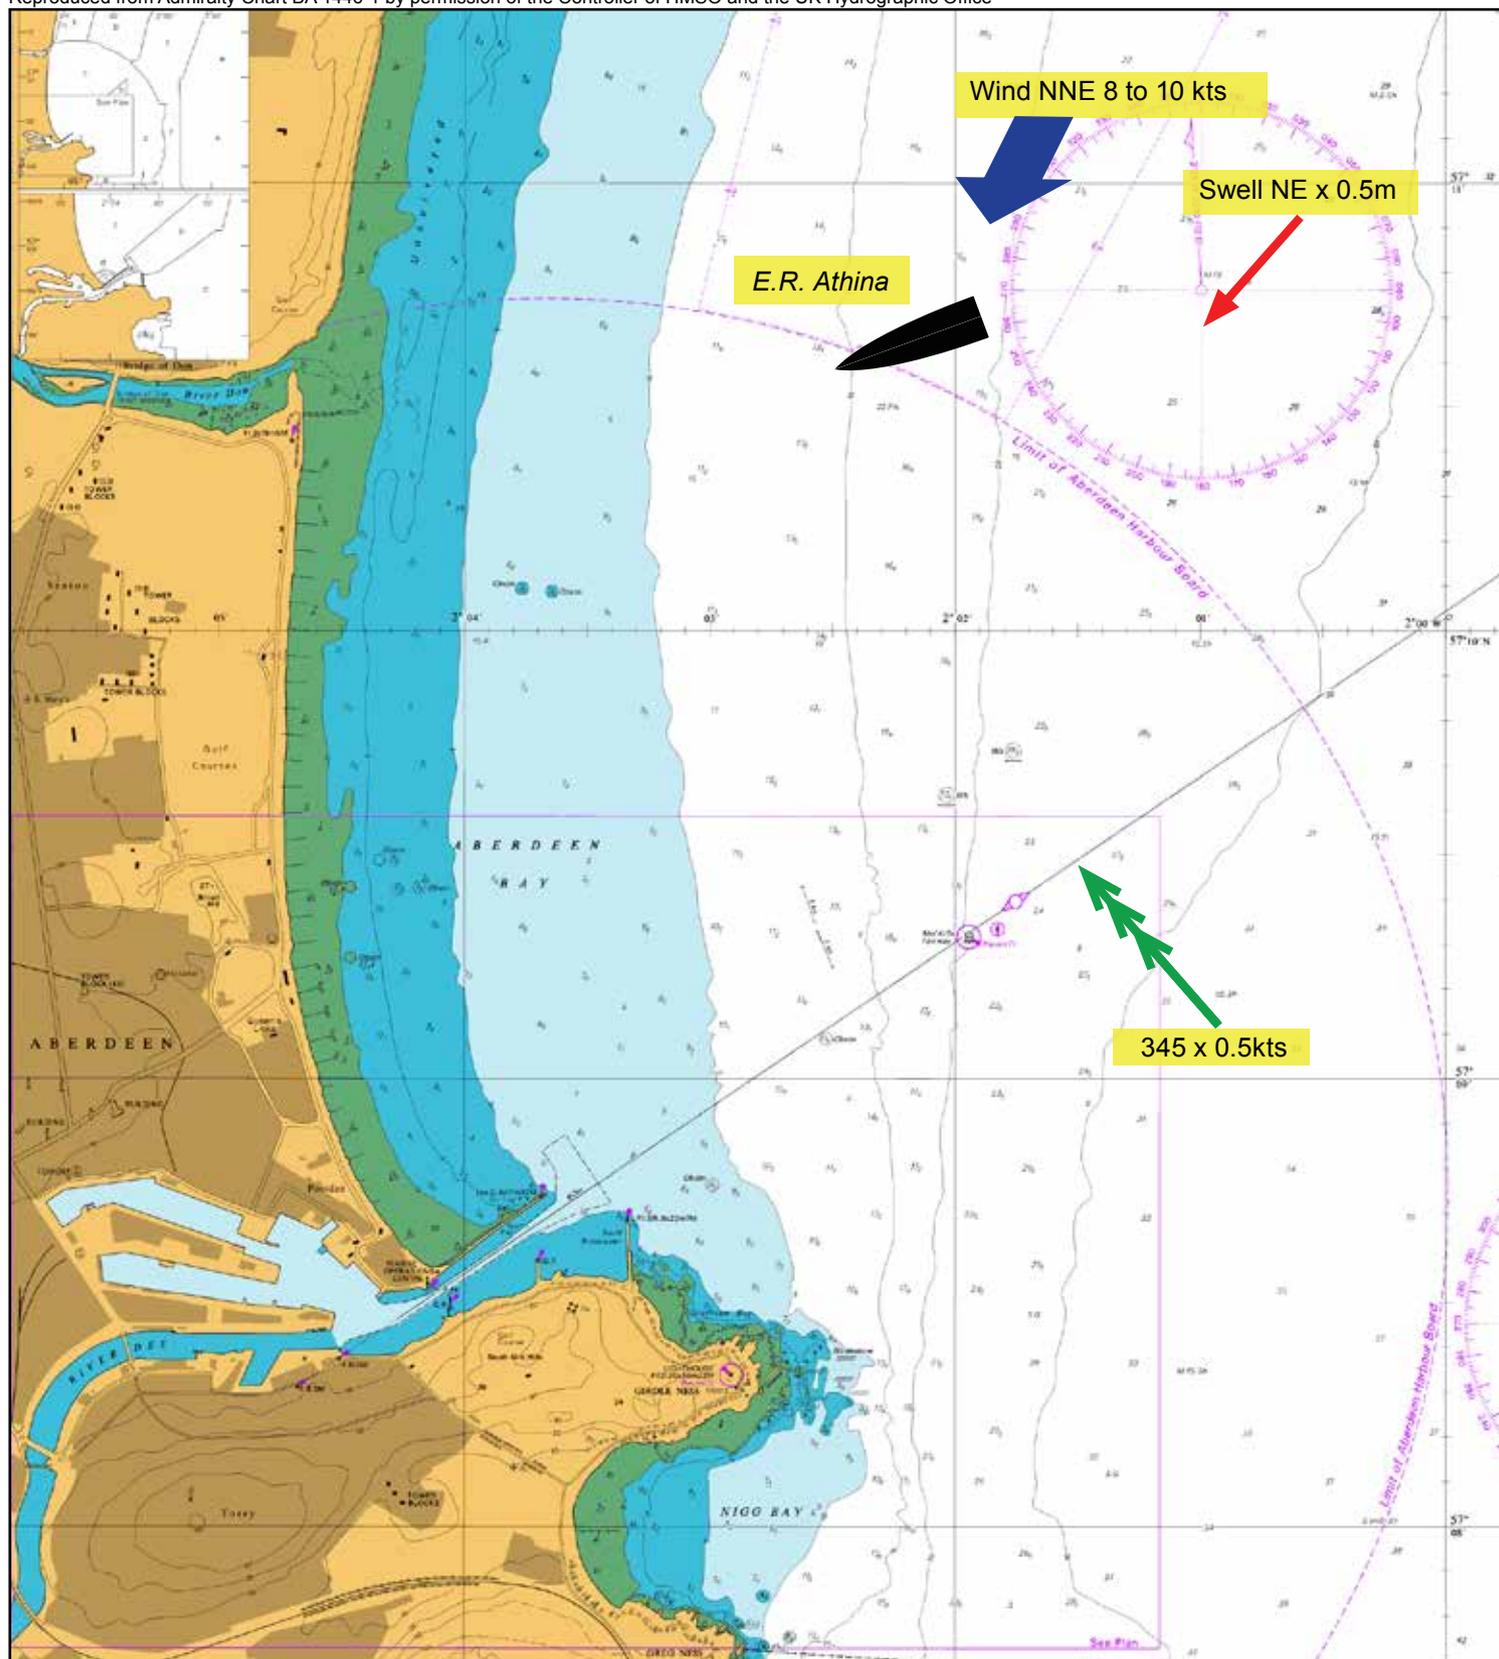
Figure 5: Environmental conditions at 0945 10 June 2012

By the time the FRC had been secured alongside the port quarter at 0955, *E.R. Athina* had swung about her anchor onto a more westerly heading. On this heading, the supply ship was balanced between the effects of the wind and tidal stream, and her stern and port quarter were far more exposed to the north-easterly swell (**Figure 5**). Although the supply ship's alteration of heading was almost certainly due to the change in direction of the tidal stream from 226° to 345°, the tidal stream was not calculated or monitored and was therefore not taken into account. Consequently,

the effects of the exposure of the port quarter to the swell, which were predictable, were not fully appreciated until Pjero and the OS had difficulty in positioning the FRC alongside.
