Boatyard invoices for works carried out to *Purbeck Isle's* hull during 2011 maintenance period and the out of water emergency repairs undertaken in December 2011 and February 2012

Wooden boat surveyor's report

***Purbeck Isle*: Foundering resulting in the loss of three lives**

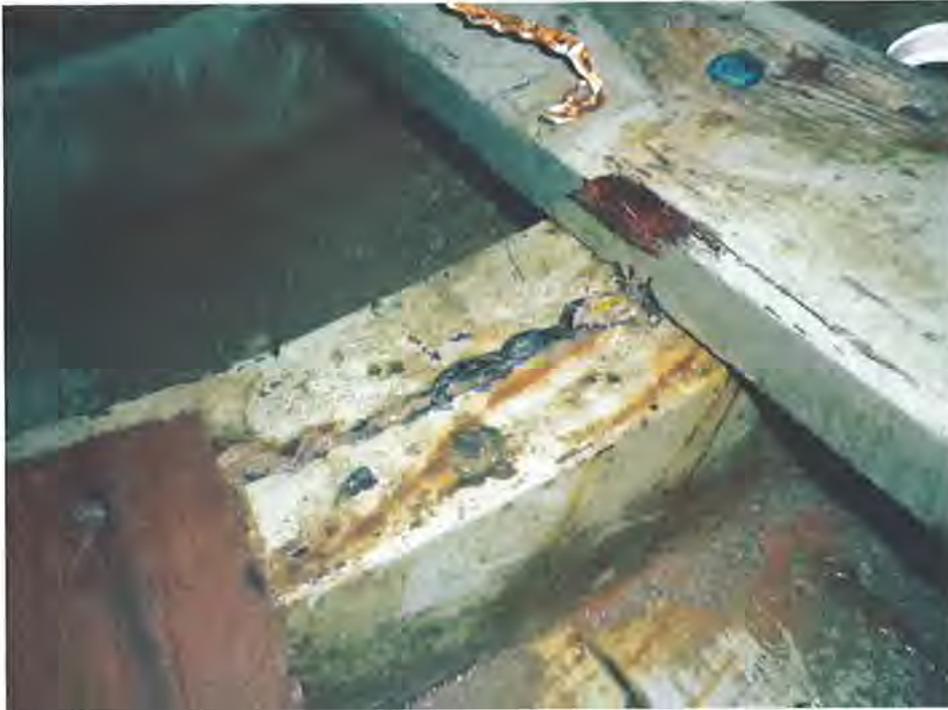
Fig. 1

This shows a connection between sistered frames and a bilge stringer with the hull planking also visible. Clenched-over copper nails and roves are visible on the inside of the stringer and one of the frames. The area around the nail in the stringer is showing the typical signs of softening and de-lignification. Also seen here is caulking cotton between two sections of frames. This is not how the vessel was originally constructed and suggests movement between the frame sections and leakage through plank seams near the frames.

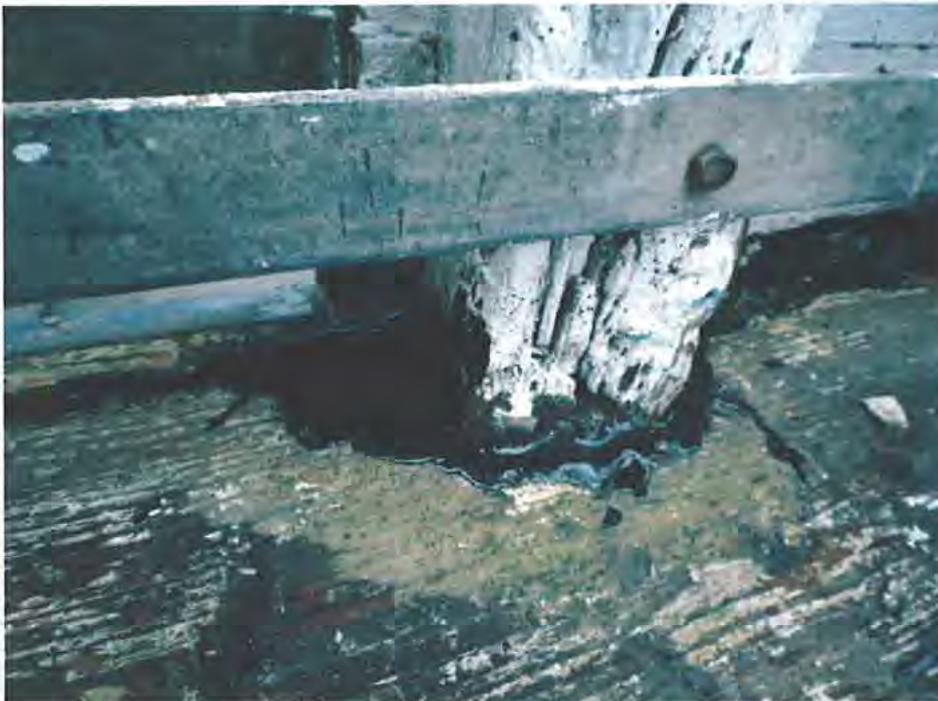
Fig 2. This shows a bulwark stanchion as it passes through the margin plan of the deck. Poured-in melted pitch has been recently applied.

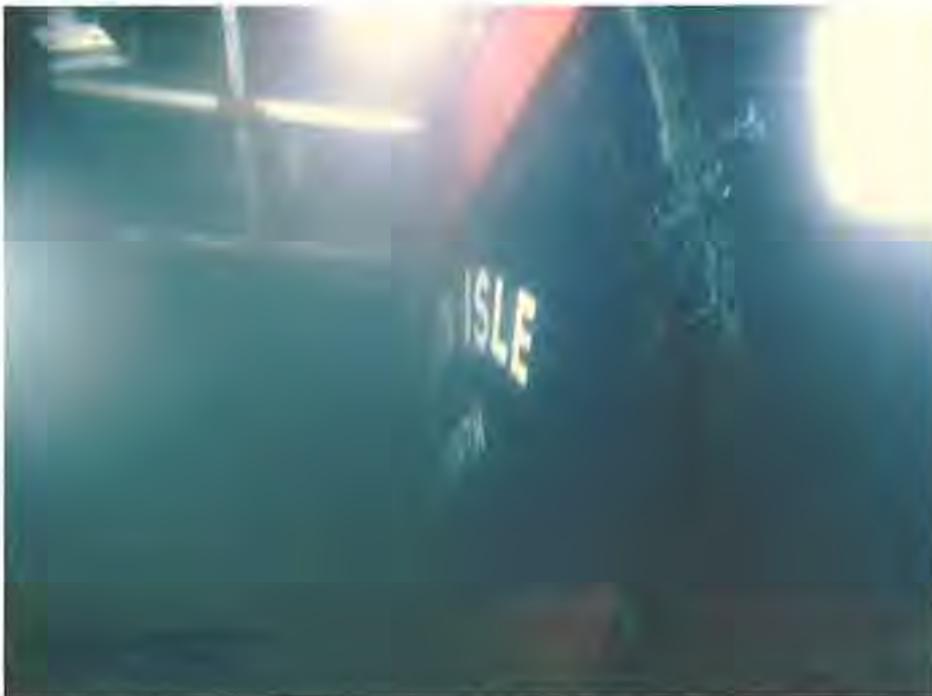
Fig 3 This shows the transom adrift from the hull planking mainly at the lower end. Remains of tingling at the side to transom connection can be seen. The inserted section in the outer edge near the upper part of the transom is visible.

In trying to imagine why the lower part of the transom has come adrift I considered that air pressure during the sinking might have been the cause. This does not seem correct as if the vessel sank very quickly bow first and air was pressed aft this pressure would have been relieved through the steering hatch. A second possibility occurred to me that a significant volume of water had accumulated below and with the vessel pitching a surge of water could have forced the transom off the vessel. Alternatively the transom simply let go in one piece allowing a very rapid inrush. But why did the transom not close under pressure from the outside like a flap? I can see no broken or bent spikes in the photos.

In any event the damage indicates to me that little or no integrity of the fastenings associated with the transom remained and the transom was not properly secured to the vessel.

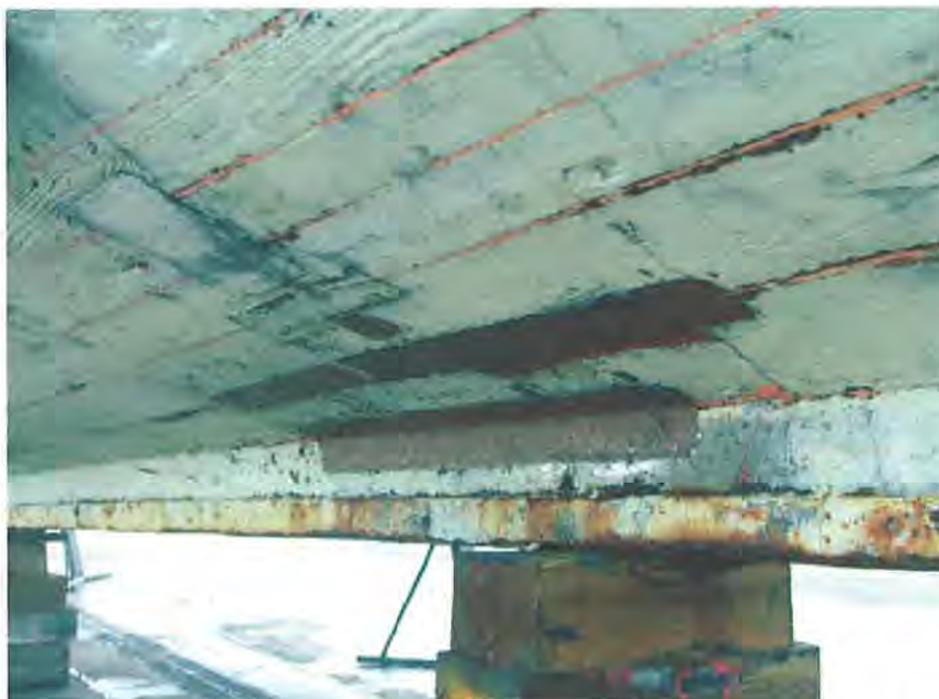
The purpose is normally a temporary solution to a leak. This can be a loose fastening, a split in a plank or a seam. Tingles are not a permanent solution to an underlying problem and must be seen as an expedient “quick fix” to enable a vessel to get back afloat.

Fig 4 This shows new tingles being fitted to the garboard seam and the seam above. A small square tingle is fitted in the middle of plank No 2 another across the seam immediately above. Above this a larger rectangular tingle is fitted spanning plank No. 4 and the adjacent seams. The fact that all these are in a line across the vessel indicates to me that movement and leakage is occurring here.

Surveyors will often (but not always) require tingles to be removed during an inspection. This will enable the underlying problem to be examined and attended to. In reality it is far too common for tingles to become permanent. From the various photos a number of tingles have been fitted to the hull. It is not reliably known how long these remained in place but from the summary of survey reports. Most of the tingles seen are over quite short length of plank seams addressing leaks in these parts. The tingles could be the indicator of planks coming adrift and moving because the fastenings have failed. The picture above (Fig.4) is worrying with the tingles in a line suggesting the possibility of a failure on one frame.

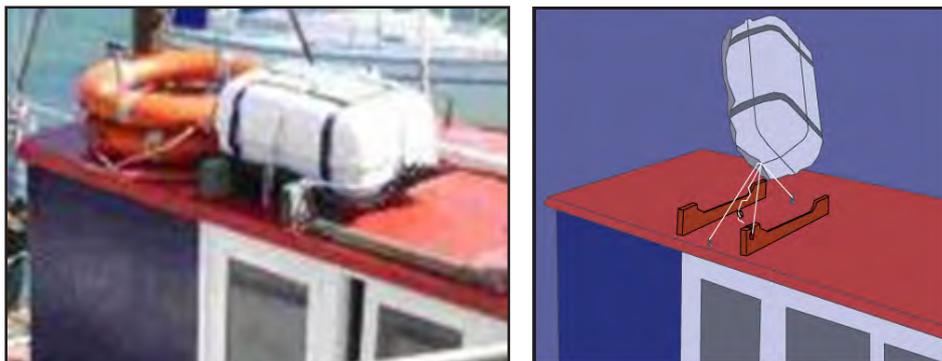
The investigation found that although the liferaft's HRU activated as designed, *Purbeck Isle's* liferaft failed to float free and automatically inflate because it had not been correctly stowed or secured in its cradle on the wheelhouse roof. Because the liferaft canister did not fit snugly into its cradle, the skipper had applied additional lashings to prevent it from falling off the wheelhouse roof in heavy seas. These additional lashings had been intertwined with the liferaft's main lashing rope and they prevented the raft from floating free.

However, had the liferaft floated free, it would not have automatically inflated because its painter had not been attached to the HRU's weak link. The liferaft had also been stowed upside down in its cradle. This would have allowed water to build up inside its canister, reducing its inherent buoyancy and increasing the likelihood of its inflation mechanism suffering from corrosion and failing.

1. Liferafts are stowed and secured in accordance with the guidance provided in MGN 343 (M+F) (www.dft.gov.uk/MCA/).
2. They follow the instructions provided by liferaft and HRU manufacturers.
