Report on the investigation of
the collision between

Stena Feronia and Union Moon

in Belfast Lough
on 7 March 2012

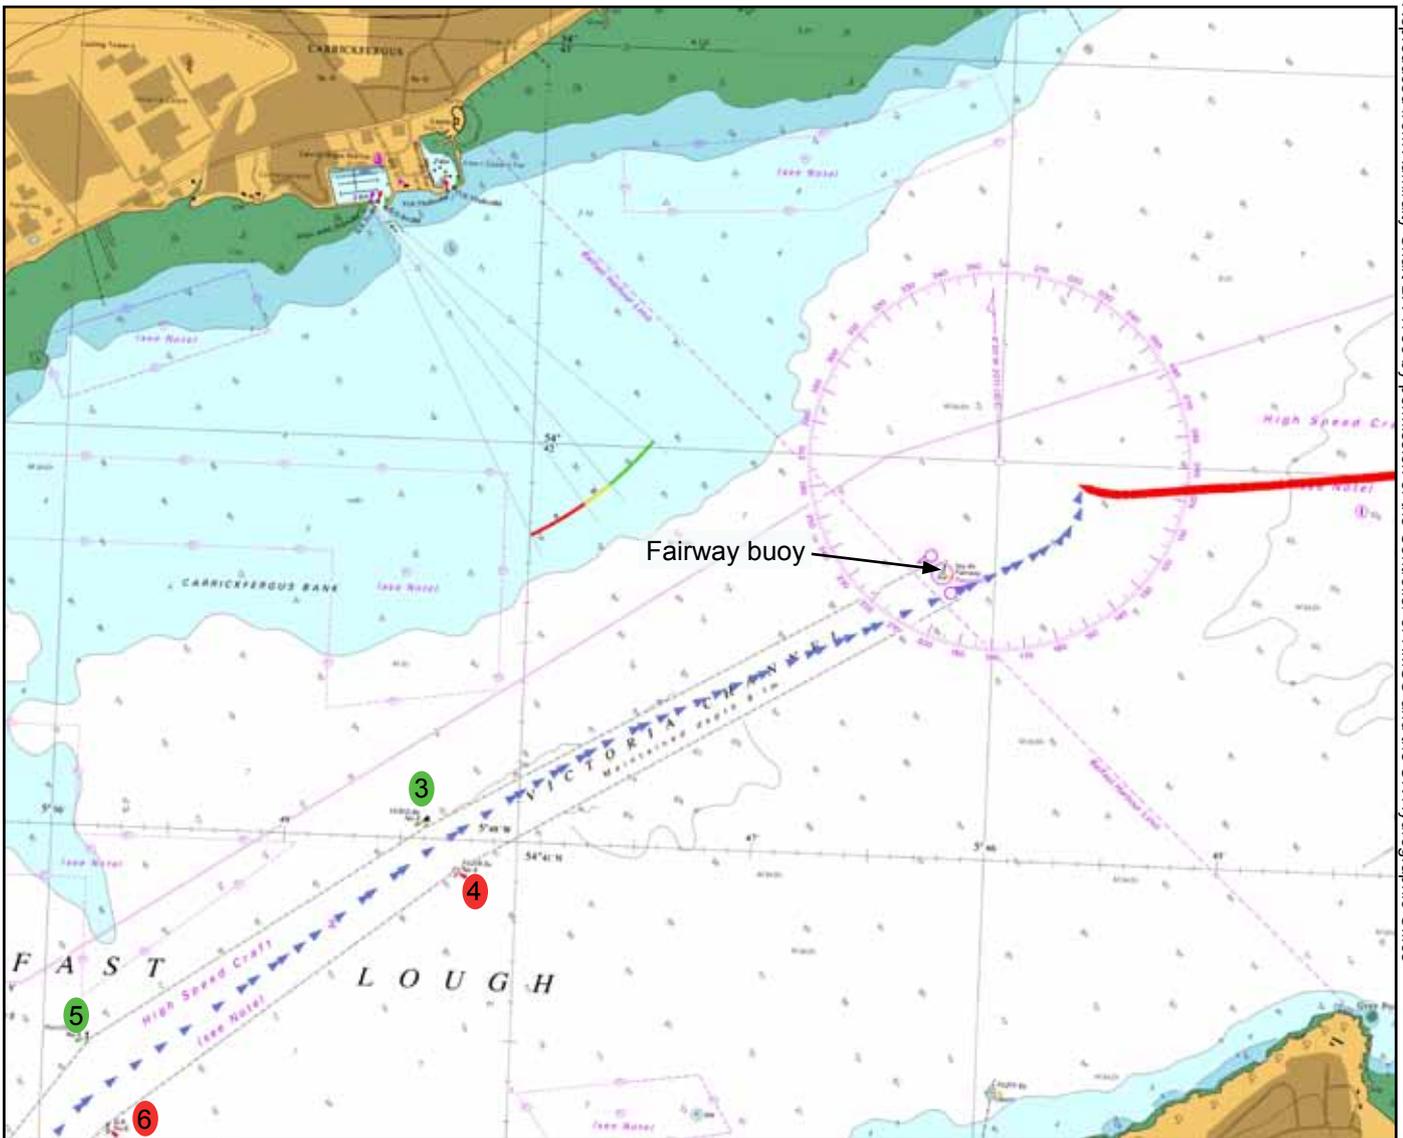
Figure 3: Chart showing the area around the fairway buoy

At 1854, the master of *Union Moon* called Belfast VTS and reported that his vessel was passing the fairway buoy outbound (**Figure 3**).

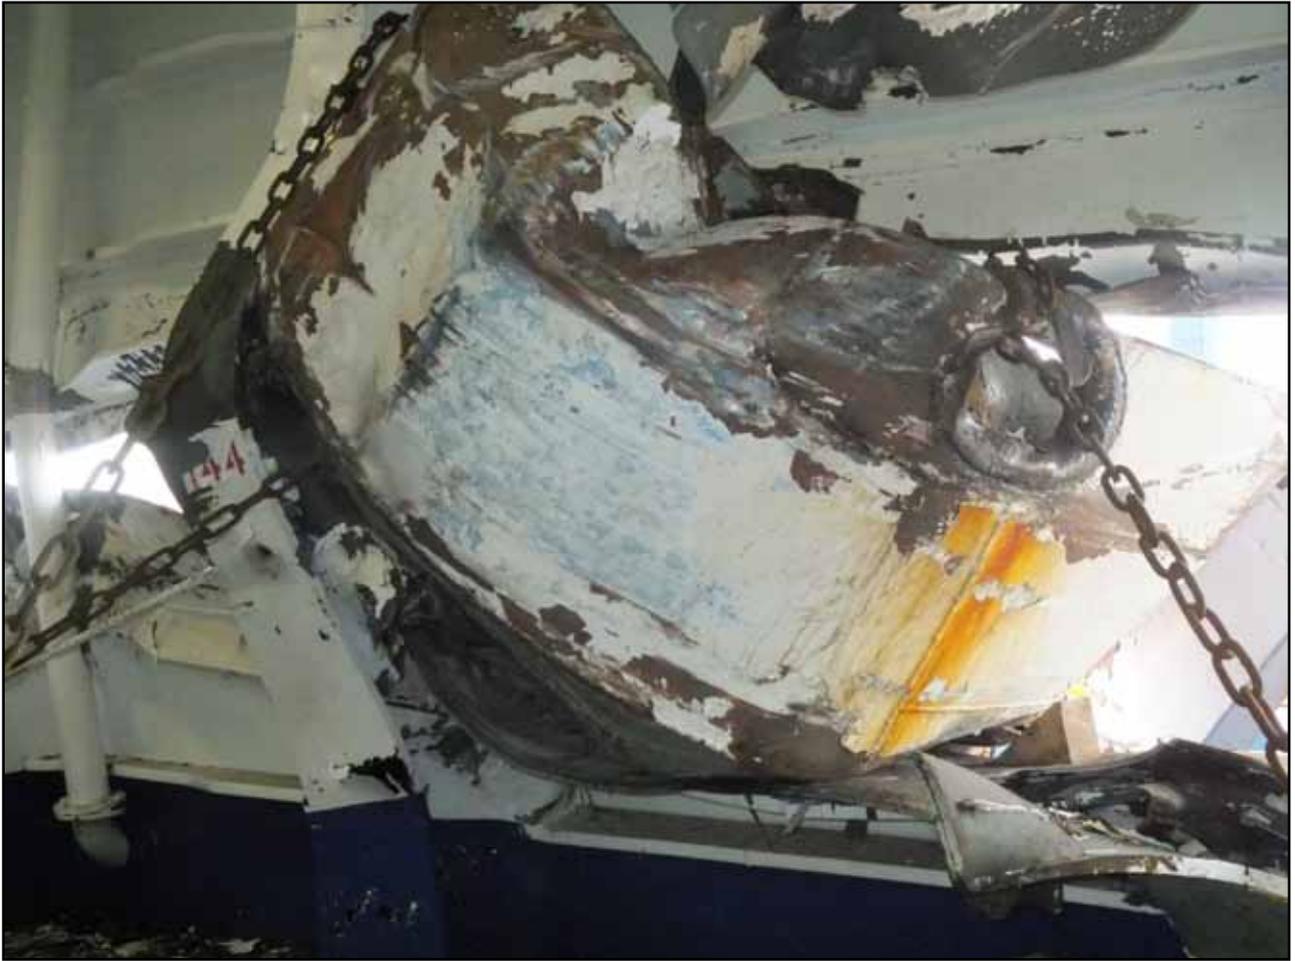
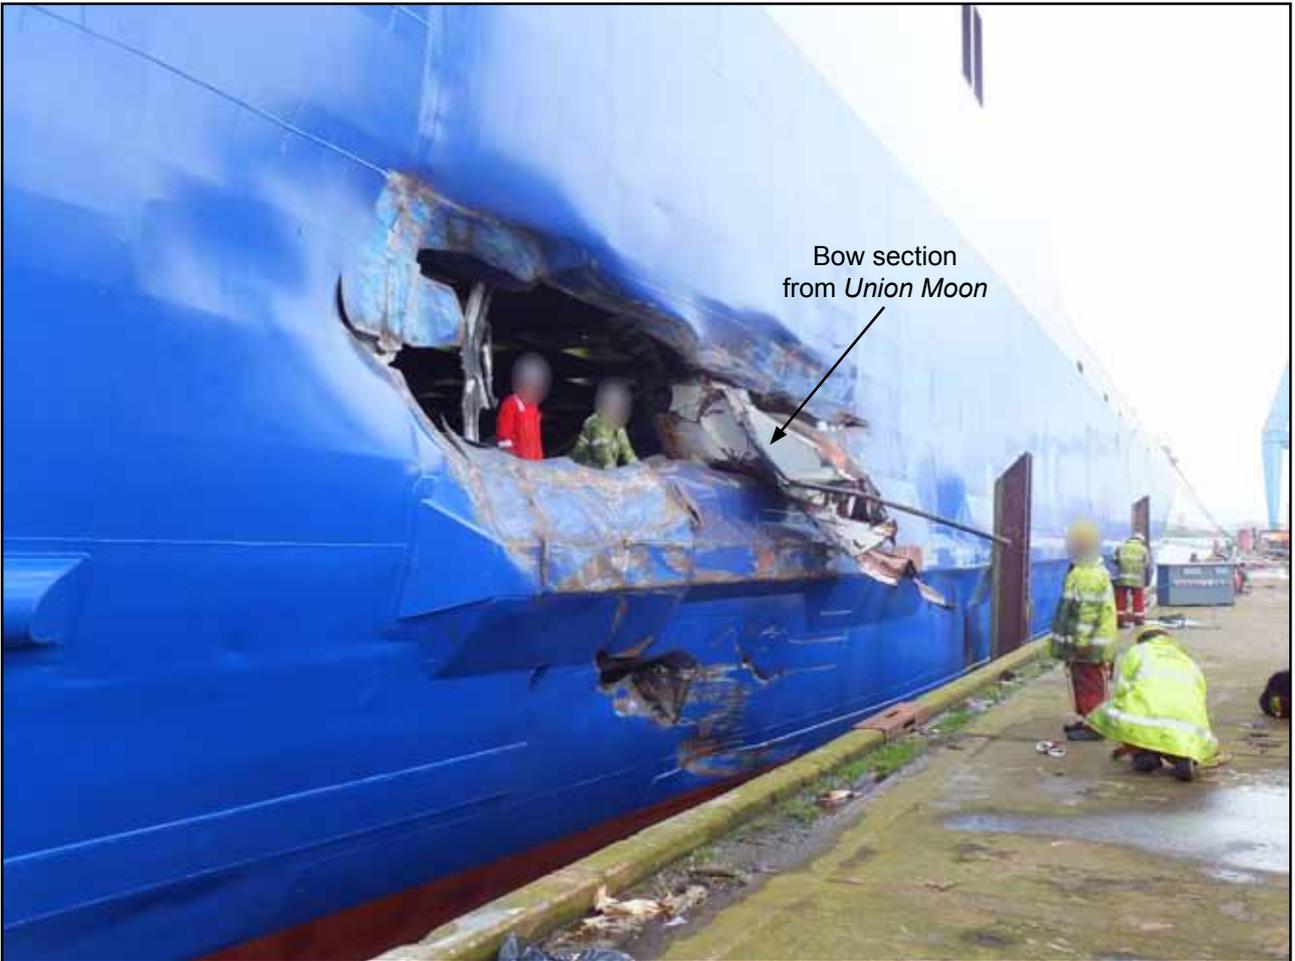
Figure 4: Damage to *Stena Feronia*

Stena Feronia suffered port side shell damage in way of the main deck and water ballast tanks 6 and 7 port (**Figure 4**). The damage extended from frame 138 to frame 156 and from the main deck up to the fifth side shell longitudinal above the main deck.

The transverse bulkhead at frame 147 was buckled below the main deck over an area approximately 2m by 0.75m. Several side longitudinals were found buckled in this area also.

Repairs to the damage were completed to classification society requirements on 24 March 2012 and the ship sailed for the Baltic Sea the following day.

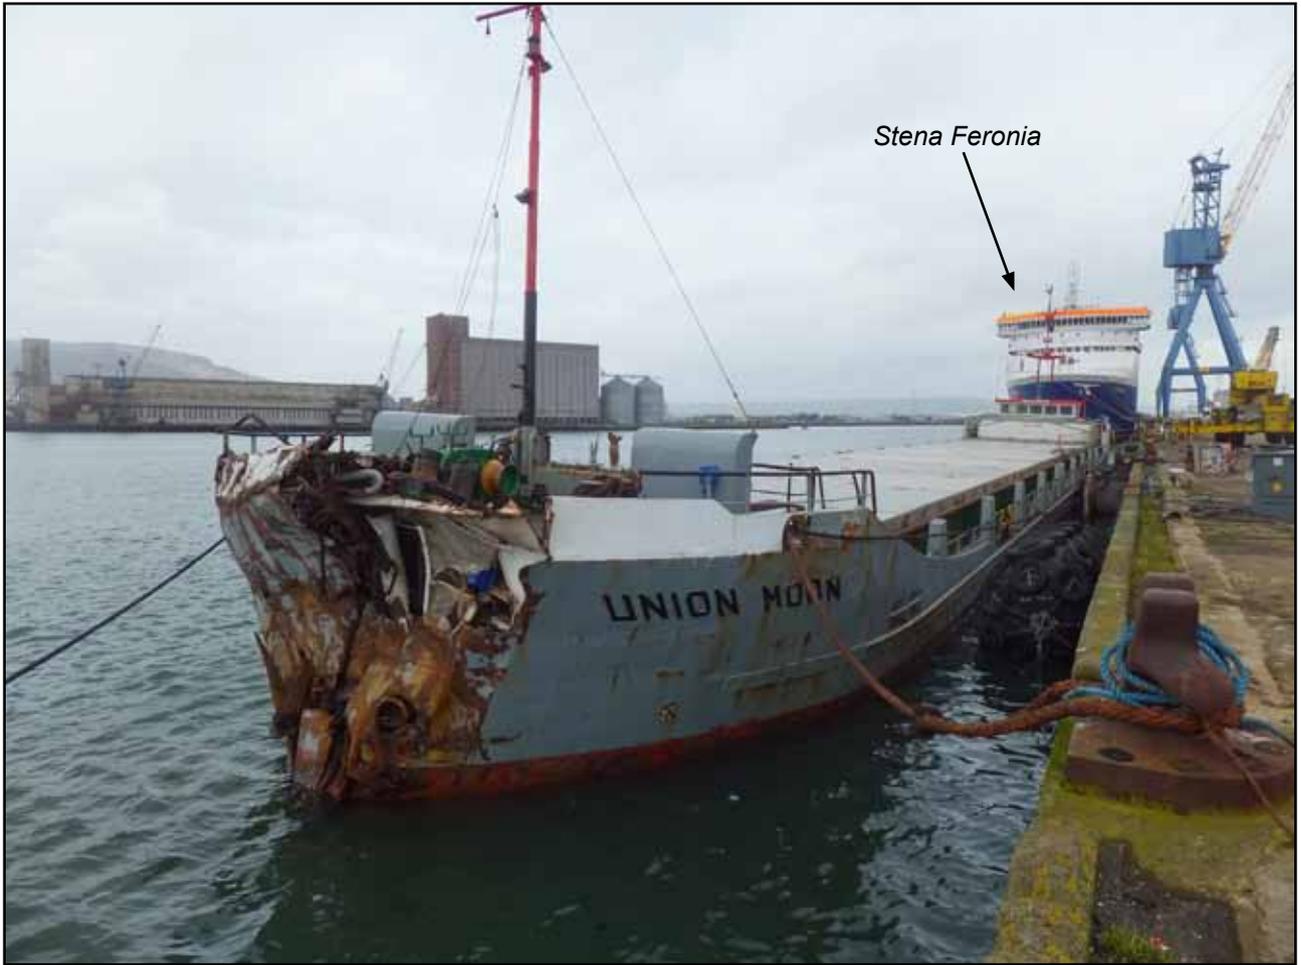
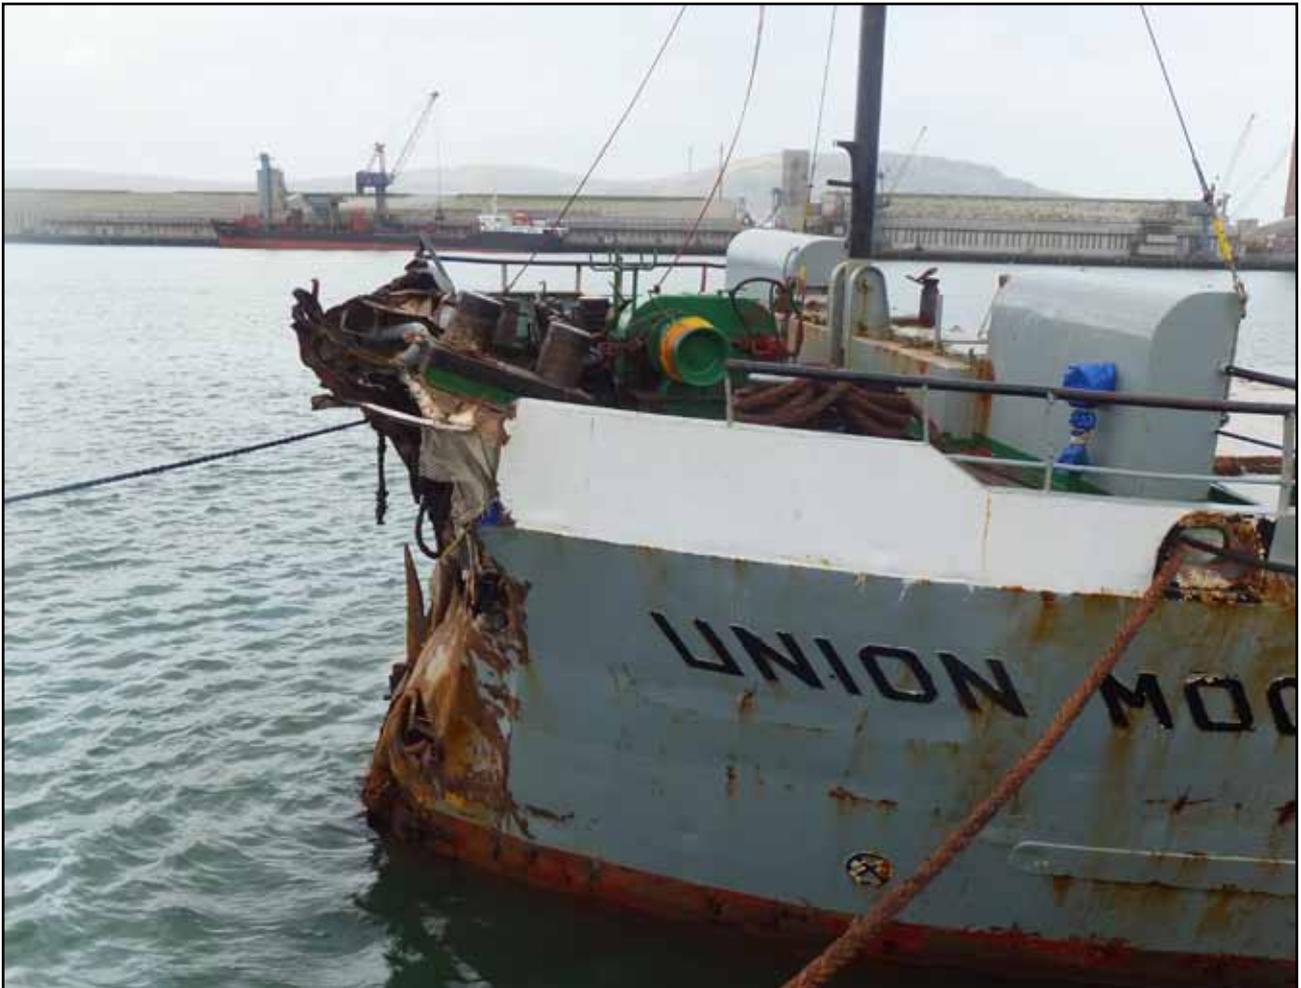
Figure 5: Damage to *Union Moon*

Union Moon's damage was limited to the forward part of the vessel. The port side bow area above the forecastle store deck, from forward to frame 136, including the bulwark, side shell and internals, forecastle deck plating, and the access trunking to the store, were missing. The remaining structure, including the port hawse pipe and the port paint store cage, was crushed and set aft to about frame 135 (**Figure 5**). The missing bow section was found on board *Stena Feronia* (**Figure 4**).

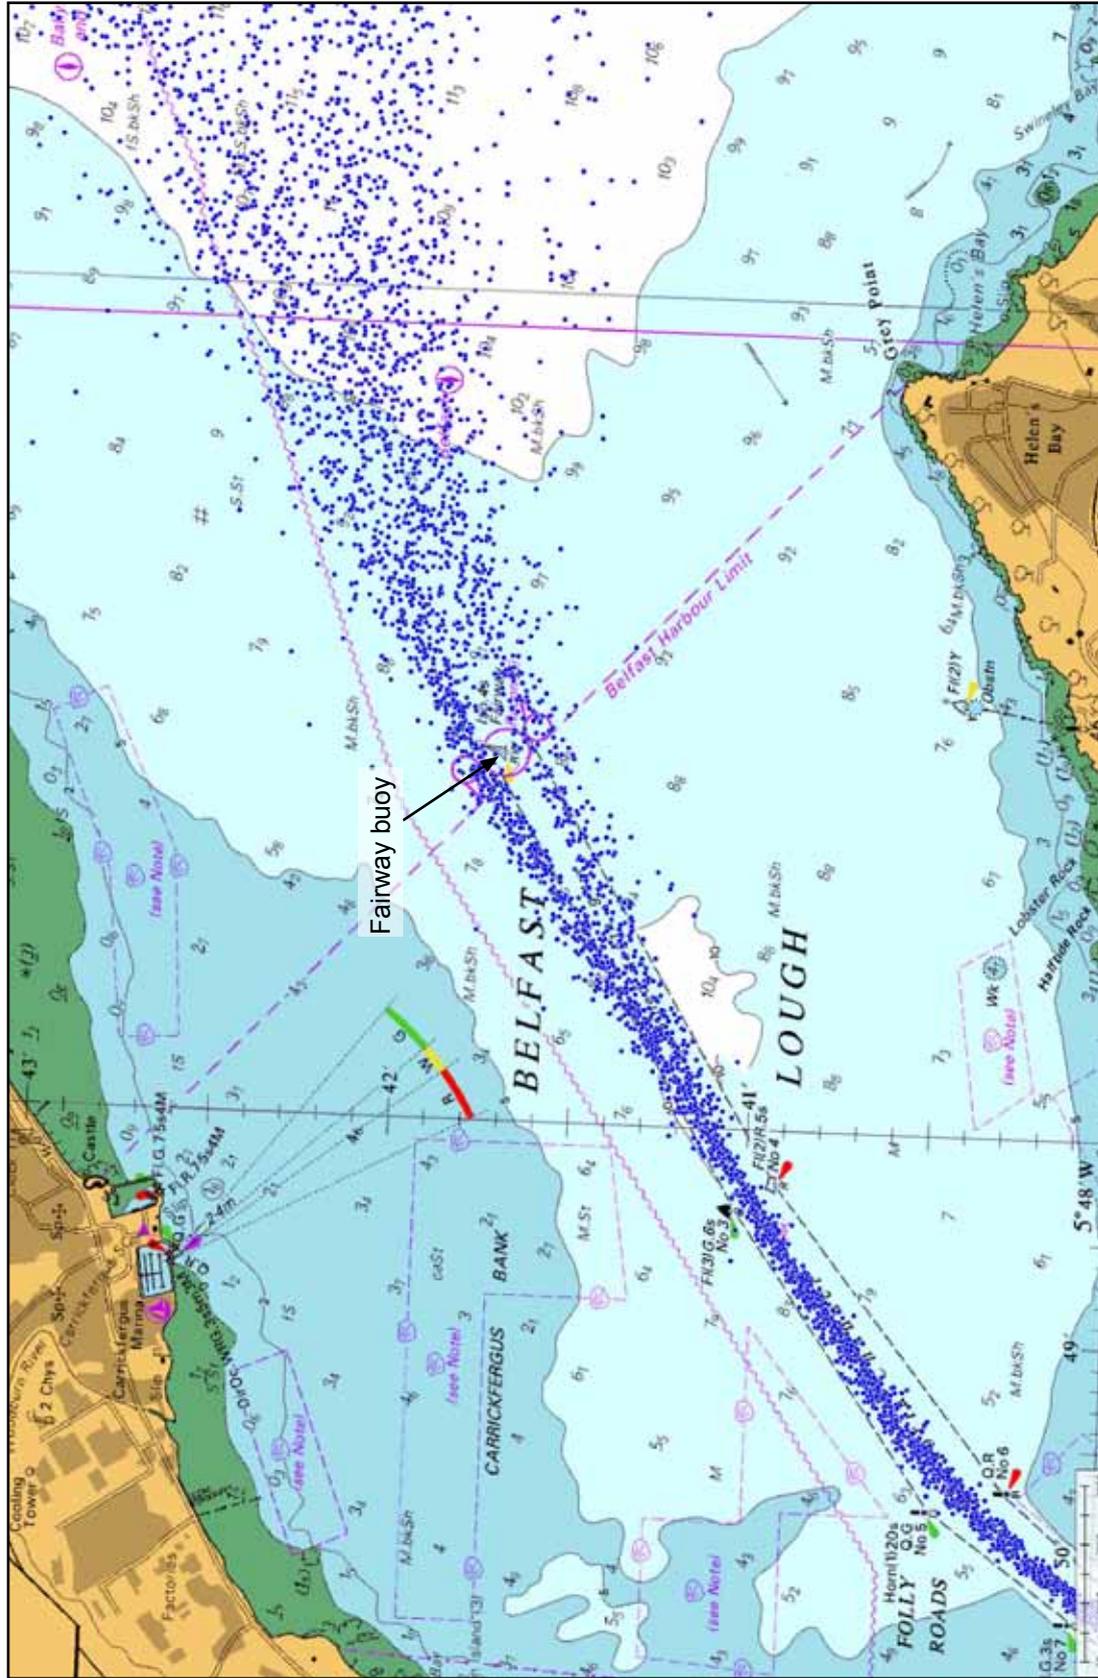
Figure 9: Tracks of ships over 50m LOA entering Belfast

The AIS tracks of vessels over 50m LOA, entering and leaving Belfast over a 5-month period between 1 November 2011 and 31 March 2012, show that the vast majority of ships leaving the port pass to the south of the buoy and leave it on their port side (**Figure 8**). Vessels entering the port pass either side of the buoy with no clear trend either way (**Figure 9**).

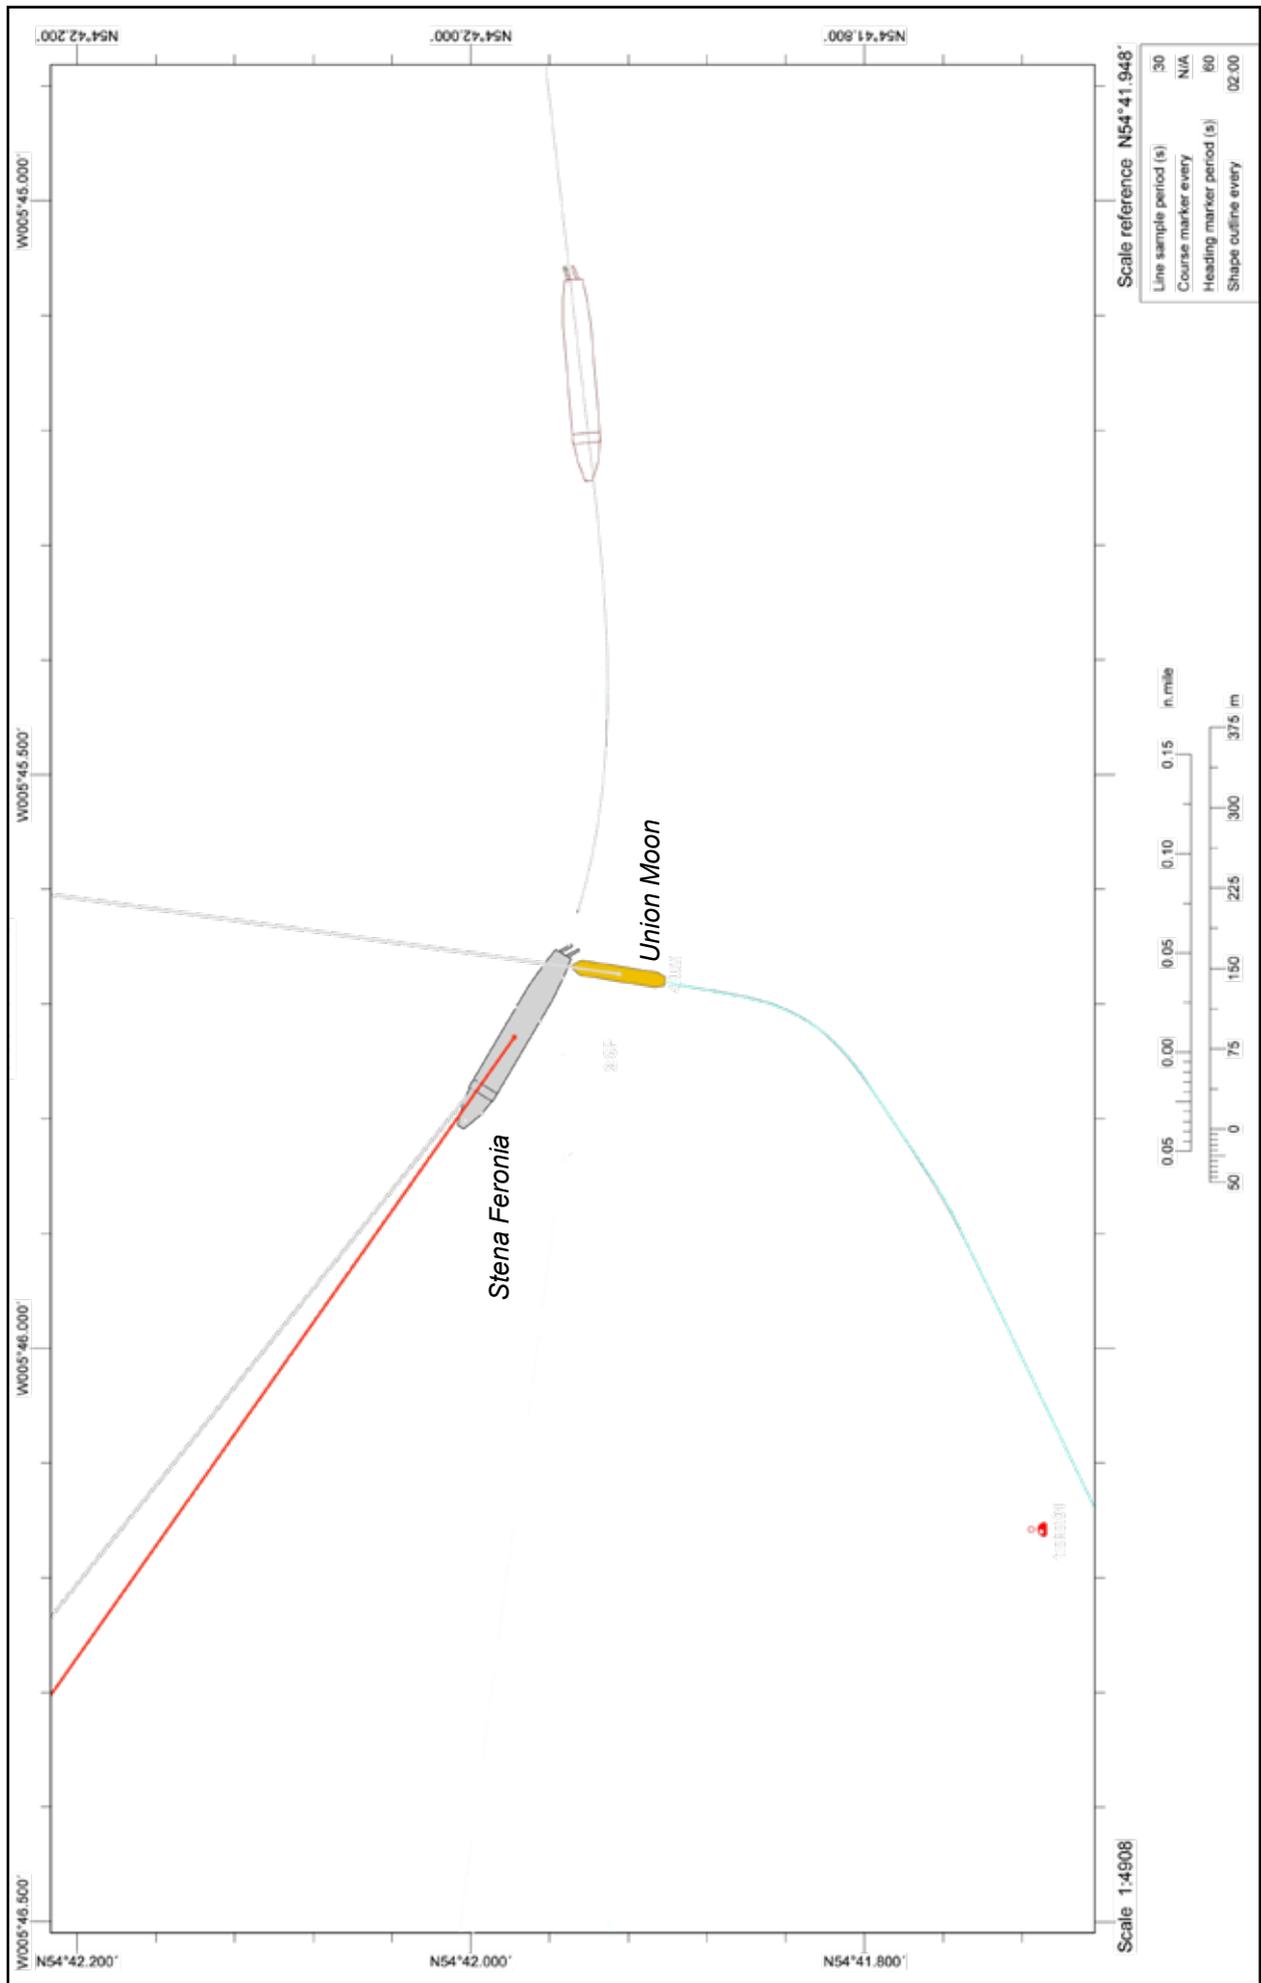
Figure 12: Third trial manoeuvre

A third trial considered *Stena Feronia* going hard to starboard at the point when *Stena Feronia*'s third officer first announced that he could see *Union Moon* was altering course to port. It was at this same time that Belfast VTS was informing *Union Moon*'s master that his actions were standing him into danger with the inbound ferry. This was 8 seconds later than the alteration in the second trial (1856.34s).

Altering course at this point resulted in the ferry passing ahead of *Union Moon* by only a few metres (**Figure 12**).
