Inspection report (with addendum)

“HEATHER ANNE”

of the port of Fowey, FY126, GT 11.67, whilst shored up on the Queens Wharf in Falmouth Docks, Cornwall, for the purpose of assisting with an investigation following the vessels sinking on the 20th December 2011.

Stability Assessment
Investigation into capsizing of FV 'Heather Anne'
Marine Accident Investigation Branch

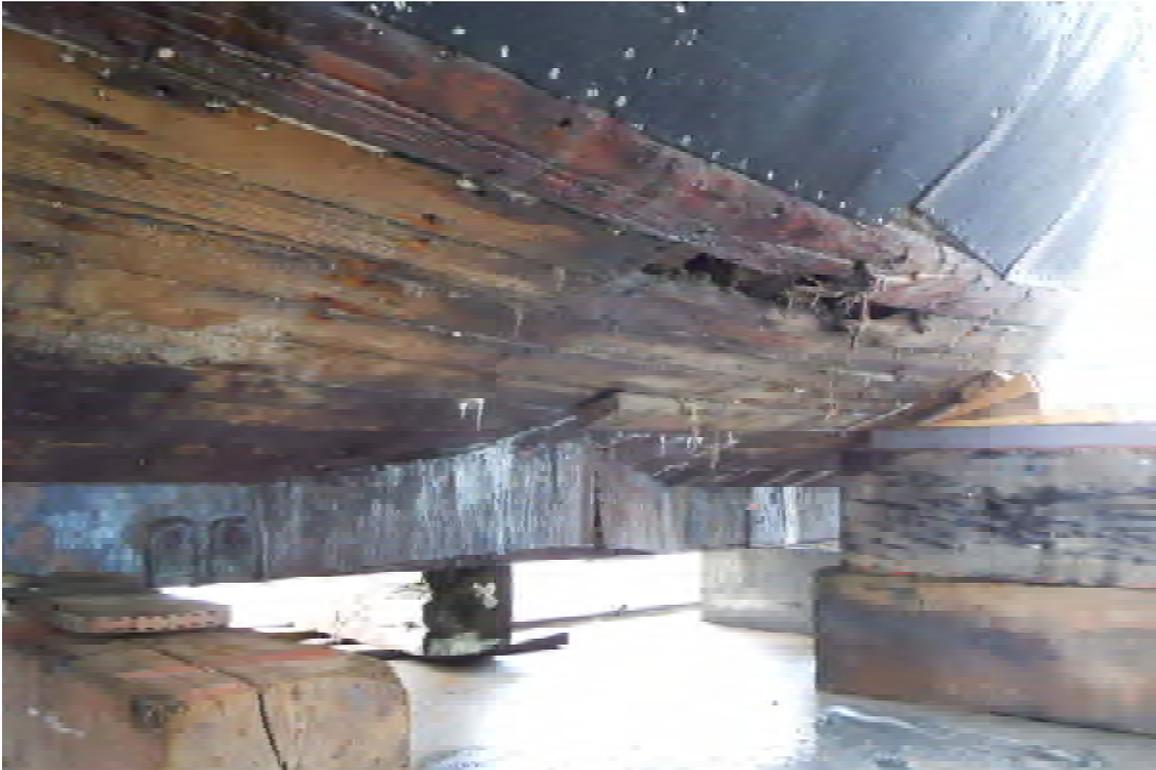
2. The area in way of the starboard damage was examined closely, especially in way of the fastenings and some fastenings were removed. The bottom coating was scuffed off from about frame 8 to frame 17/18 with the area over which the planks were damaged being from the keel extending outboard over a distance of about 1300mm and from the after part of frame 13 forward for about 1900mm.

3 - View looking forward to damage starboard side.JPG

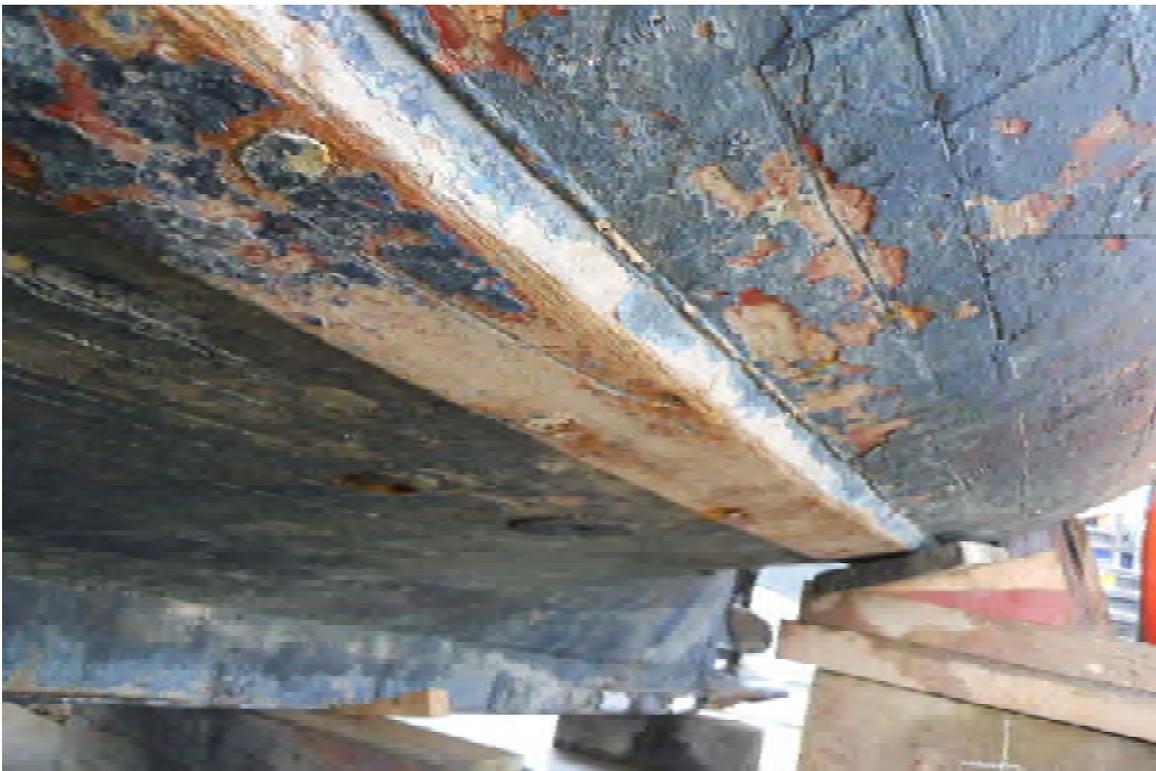
4 - Port side bottom planking looking aft.JPG

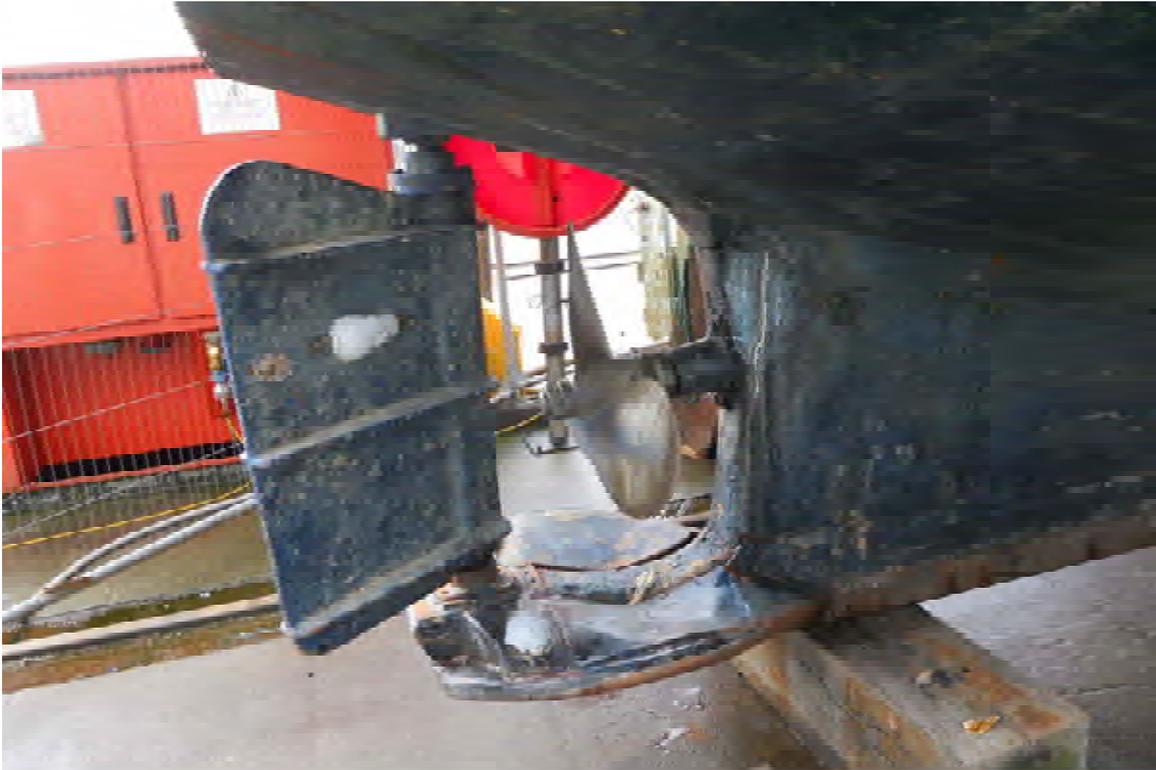
- i) Tailshaft clearance, found in order.
 - ii) Rudder stock and heel pintle clearances, found in order. (Further rudder information later in this report)

- iii) Skeg fastening. The timber skeg of the vessel had been supplemented on the port and starboard sides with a steel plate arrangement and it was noted that this had been moving slightly and that some welding was damaged.

5 - Stern Gear.JPG

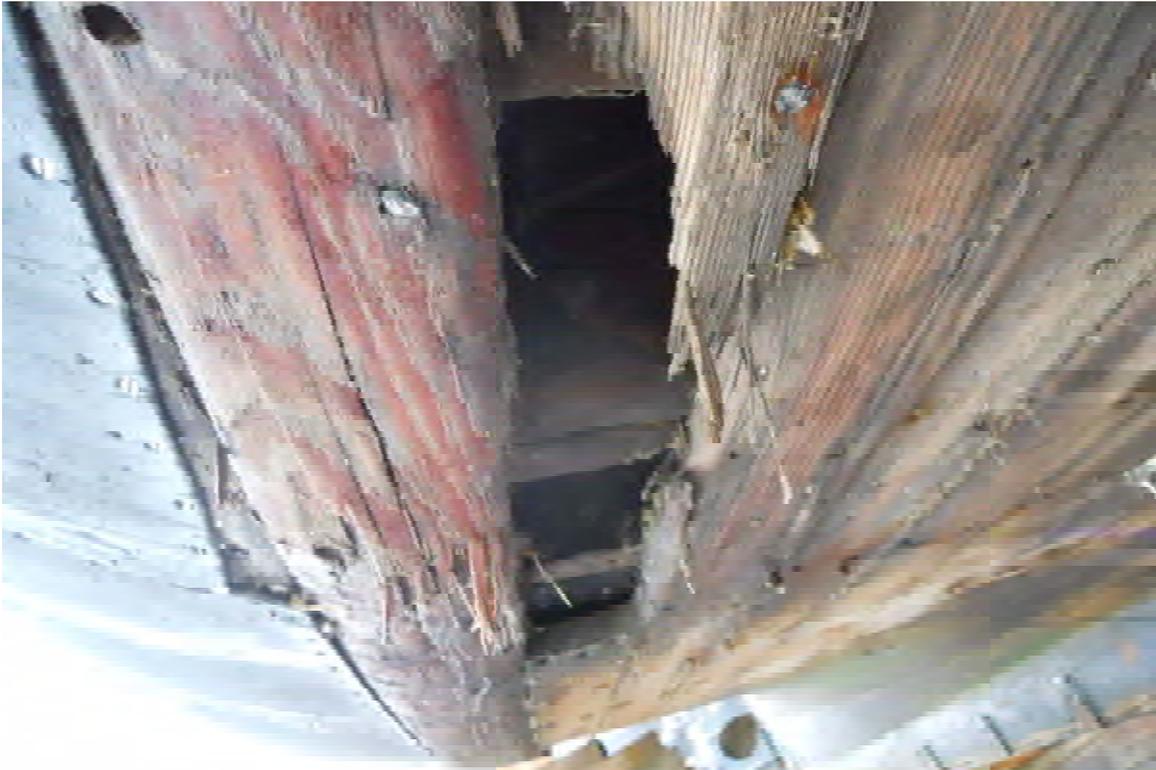
This plank was found with a section about 800mm missing from about frame 11 to frame position 13 which is the hold to engine room bulkhead. The coating was completely scuffed and the following was found:-

One fastening removed in way of the forward plank fracture at frame 11 was found with slight corrosion towards the head. About 300mm forward of this at frame 10 two fastenings were removed, one appeared to be new with no corrosion and one was severely corroded just below the head.

The plank aft of the missing section was found with a gap of about 15 to 20mm between the plank butt and frame 13 and there was no evidence of any fastenings in this gap. At the next frame aft (14) new fastenings were noted.

Some of the missing section of plank 9 was recovered from the seabed and the largest piece was found with one sheared fastening at about mid length. This fastening appeared to have been recently renewed.

9 - 9th plank out from keel starboard side with section missing.JPG

- i) Plank 9 in way of the forward part of fracture squared off and a piece of timber screwed in place of the missing section.
 - ii) Damage to plank 10 in way of the missing section of plank 9 cropped out and a piece of timber screwed in place of the missing section.

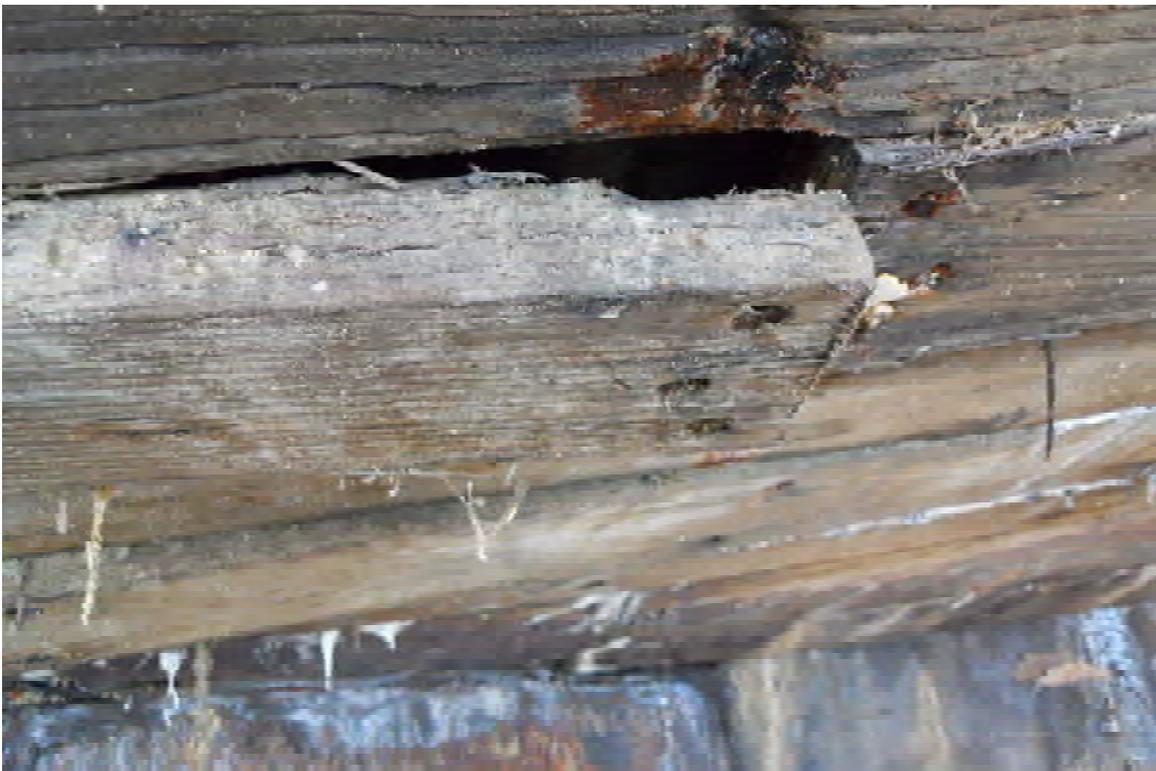
This plank had sprung at frame 12 and there was no evidence of any new fastenings having been recently fitted from the sprung butt for a distance of about 1500mm forward of this. Coating fully scuffed and some fastening heads were visible but some fastenings were found completely missing from the plank.

10 - Plank 7 starboard side sprung at butt.JPG

- iii) Sprung planks jacked back into place and secured with woodscrews
 - iv) Planks where inadequate fastening was noted secured with additional woodscrews.

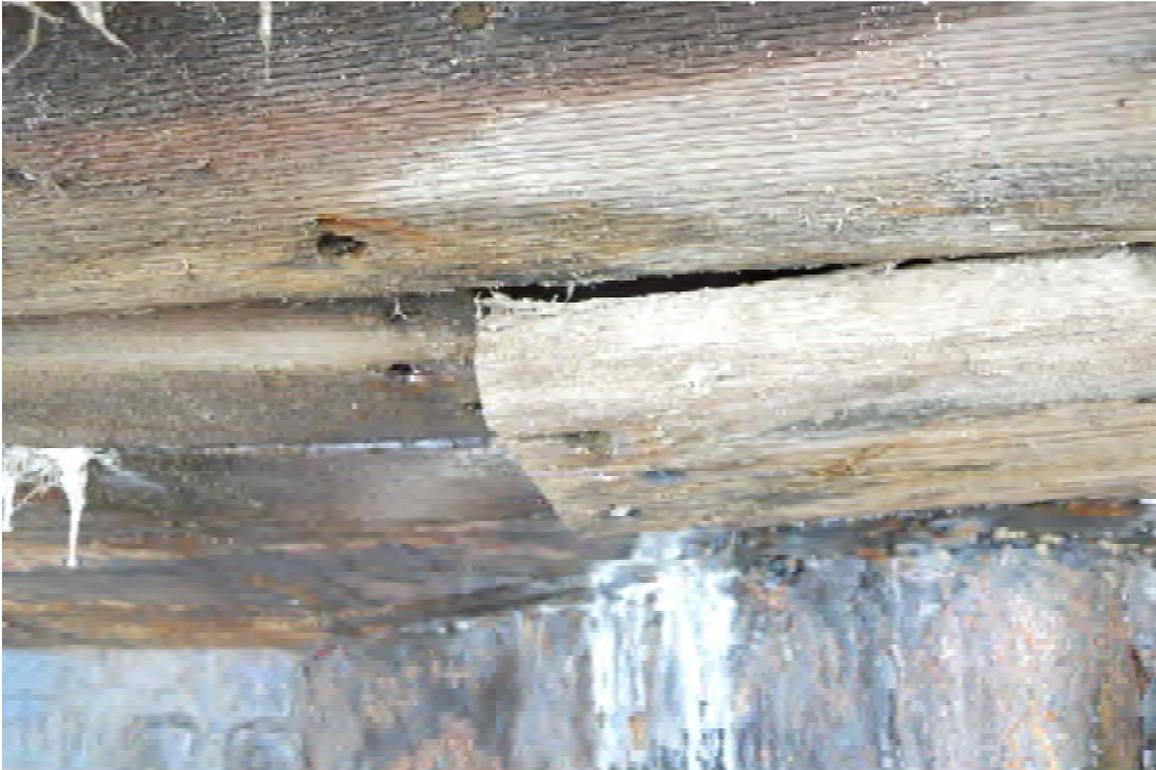
11 - Plank 5 starboard side sprung at butt.JPG

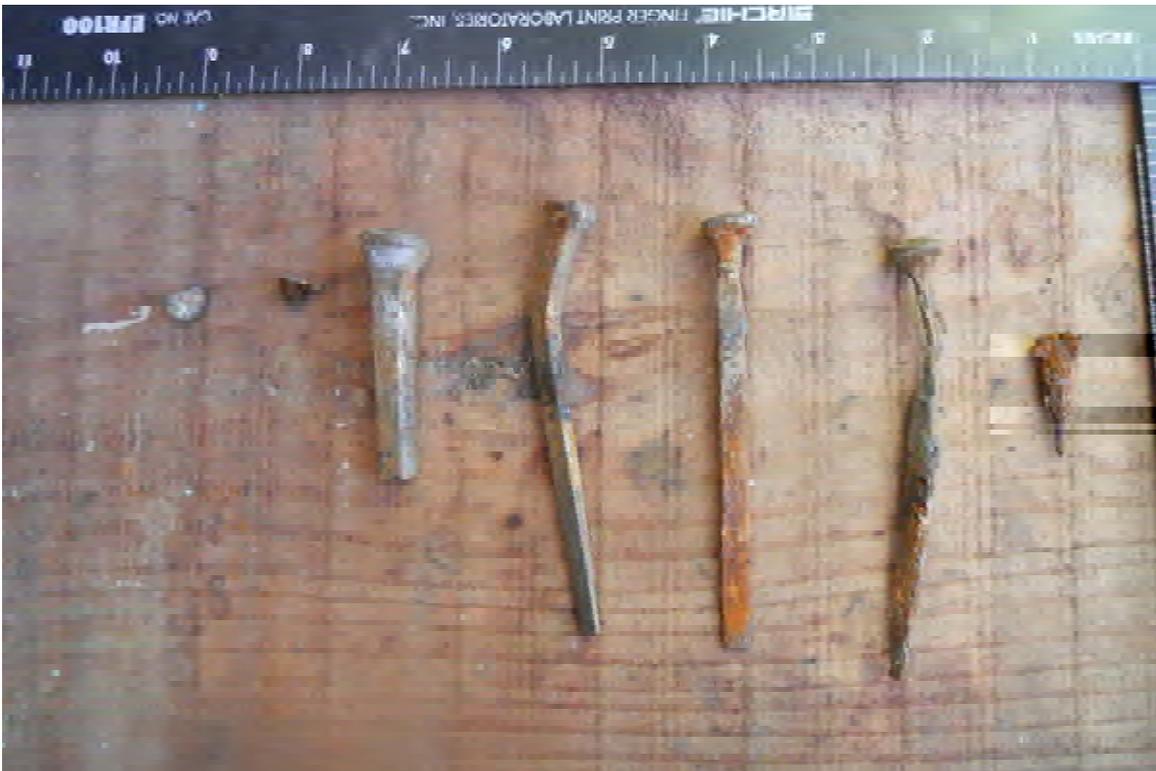
This plank was found in place and some new fastenings had recently been fitted away from the damaged area. Coating fully scuffed and some original fastening heads visible but some missing. Fastenings removed from this plank found severely corroded.

12 - Fastenings removed from starboard side of hull.JPG

We have unofficially been advised that this vessel has suffered with plank fastening problems in the past and this could be why some refastening had been carried out. We assume that when this work was carried out that the certifying authority for the vessel would have been involved and should have insisted on all planks in way of the problem area being refastened.

If the vessel is to be repaired we would recommend that that all fastenings either be renewed or supplemented at each and every frame position.

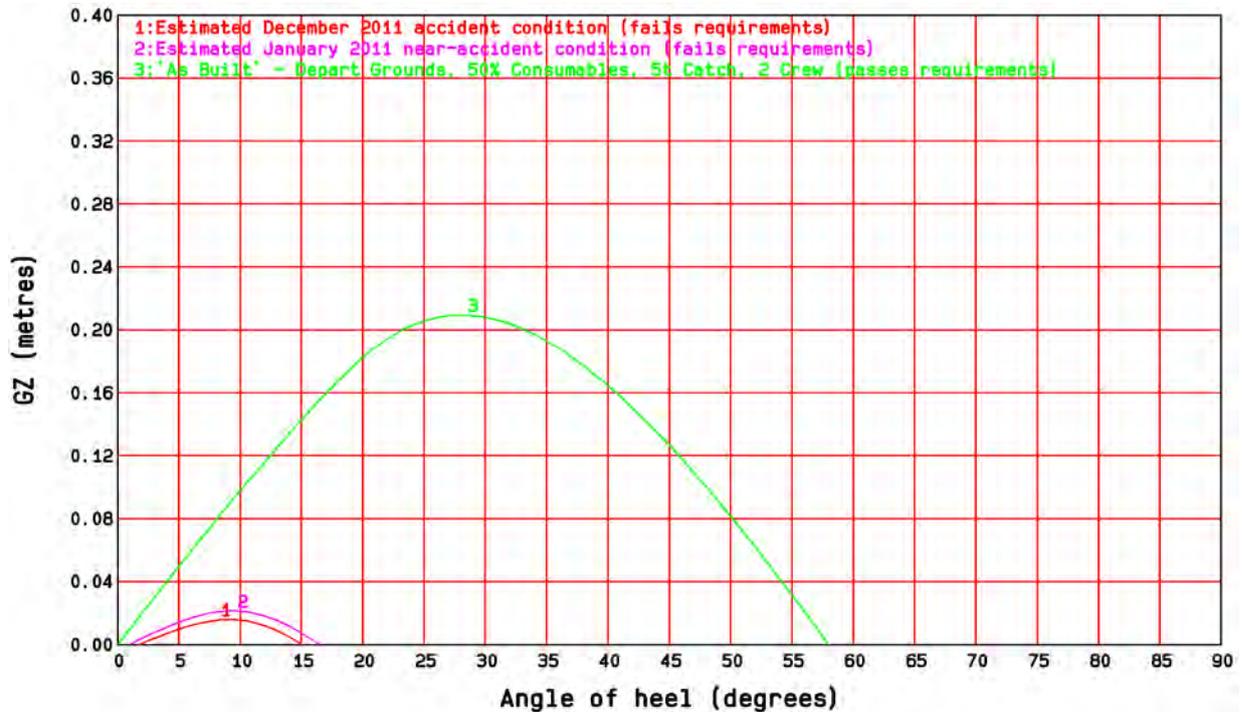
Diagram 6 – Righting lever curves for the 2011 accident, near accident and Depart Grounds ‘As built’ conditions

The righting lever curves for the two conditions are to be found in Appendix 7 and are reproduced in diagram 6 at the head of the next page. For comparison, the righting lever curve from 'As built' Condition No. 4 (see right hand column in table 3) has been superimposed on the plot - this represents marginal compliance with the requirements.

As the diagram above indicates, righting levers in the accident condition were very low indeed and capsize was therefore a very real risk in the deteriorating weather conditions. The obvious question is then ‘why did Heather Anne not capsize sooner?’. The most likely explanation is the temporary increase in righting lever provided by the immersion of the bulwarks. However, when the lower part of the bulwarks were immersed for more than a few moments, the incoming water onto the deck through the freeing ports would have nullified this increase and capsize would then be almost inevitable.
