SUMMARY

MV *TEMPANOS* Fatality from fall into cargo hold Felixstowe 17 December 2011

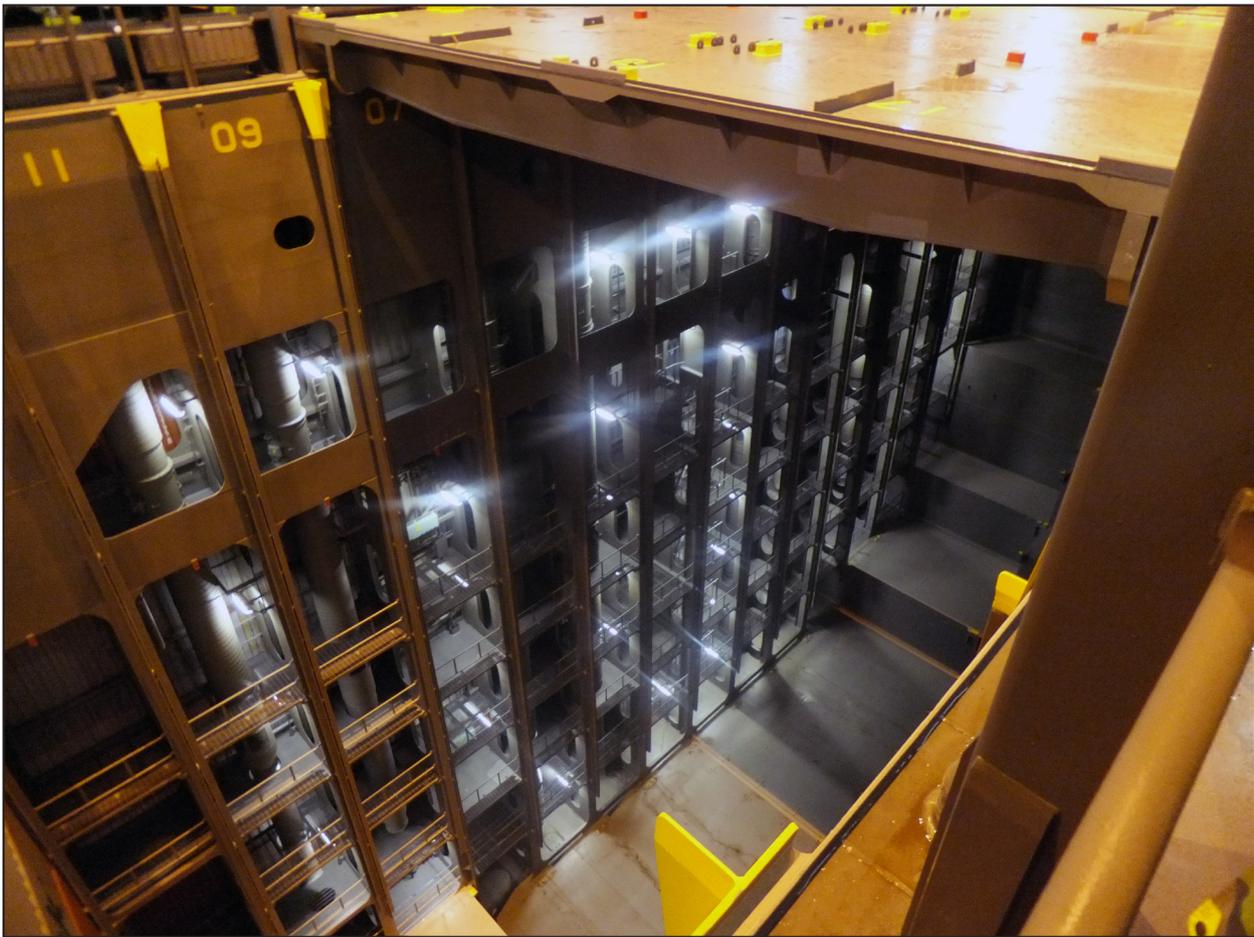
At around 0700, the OS returned from his breakfast and met the third officer at the gangway. The two men asked each other where AB Gonzalez was. Realising that he might be missing, they started to search for him. At 0704, the OS saw AB Gonzalez lying at the bottom of cargo hold 3 in bay 18, row

9, approximately 5m aft of the forward bulkhead of the hold (**Figure 1**). The OS immediately alerted the third officer.

Figure 1: View of cargo hold 3 port side, looking aft

Considering the injuries he sustained and the position in which he was found, there is little doubt that AB Gonzalez died from falling into the cargo hold. The last communication between AB Gonzalez and the third officer was at 0642, when he reported that cargo work had commenced at bay 14. When AB Gonzalez was called on the radio at around 0645, he did not answer. Therefore, it is likely that he fell between 0642 and 0645 even though his body was not discovered until 0704.

AB Gonzalez could have fallen from either the hatch cover adjacent to the open hold or through an opening in the walkway's guardrail where a safety barrier had been left open. As his body was found approximately 5m aft from the bulkhead which was directly beneath the walkway it was thought unlikely, although not impossible, that he could have moved this distance horizontally during the 25m fall. The more likely scenario is that AB Gonzalez was on the hatch cover immediately before the accident. As ice was reported on the forecastle and the shore crane access platform at around the time of the accident, and puddles of water were seen on the hatch lids later on in the day, it is also quite likely that the hatch cover's surface was slippery due to icy patches at that time.

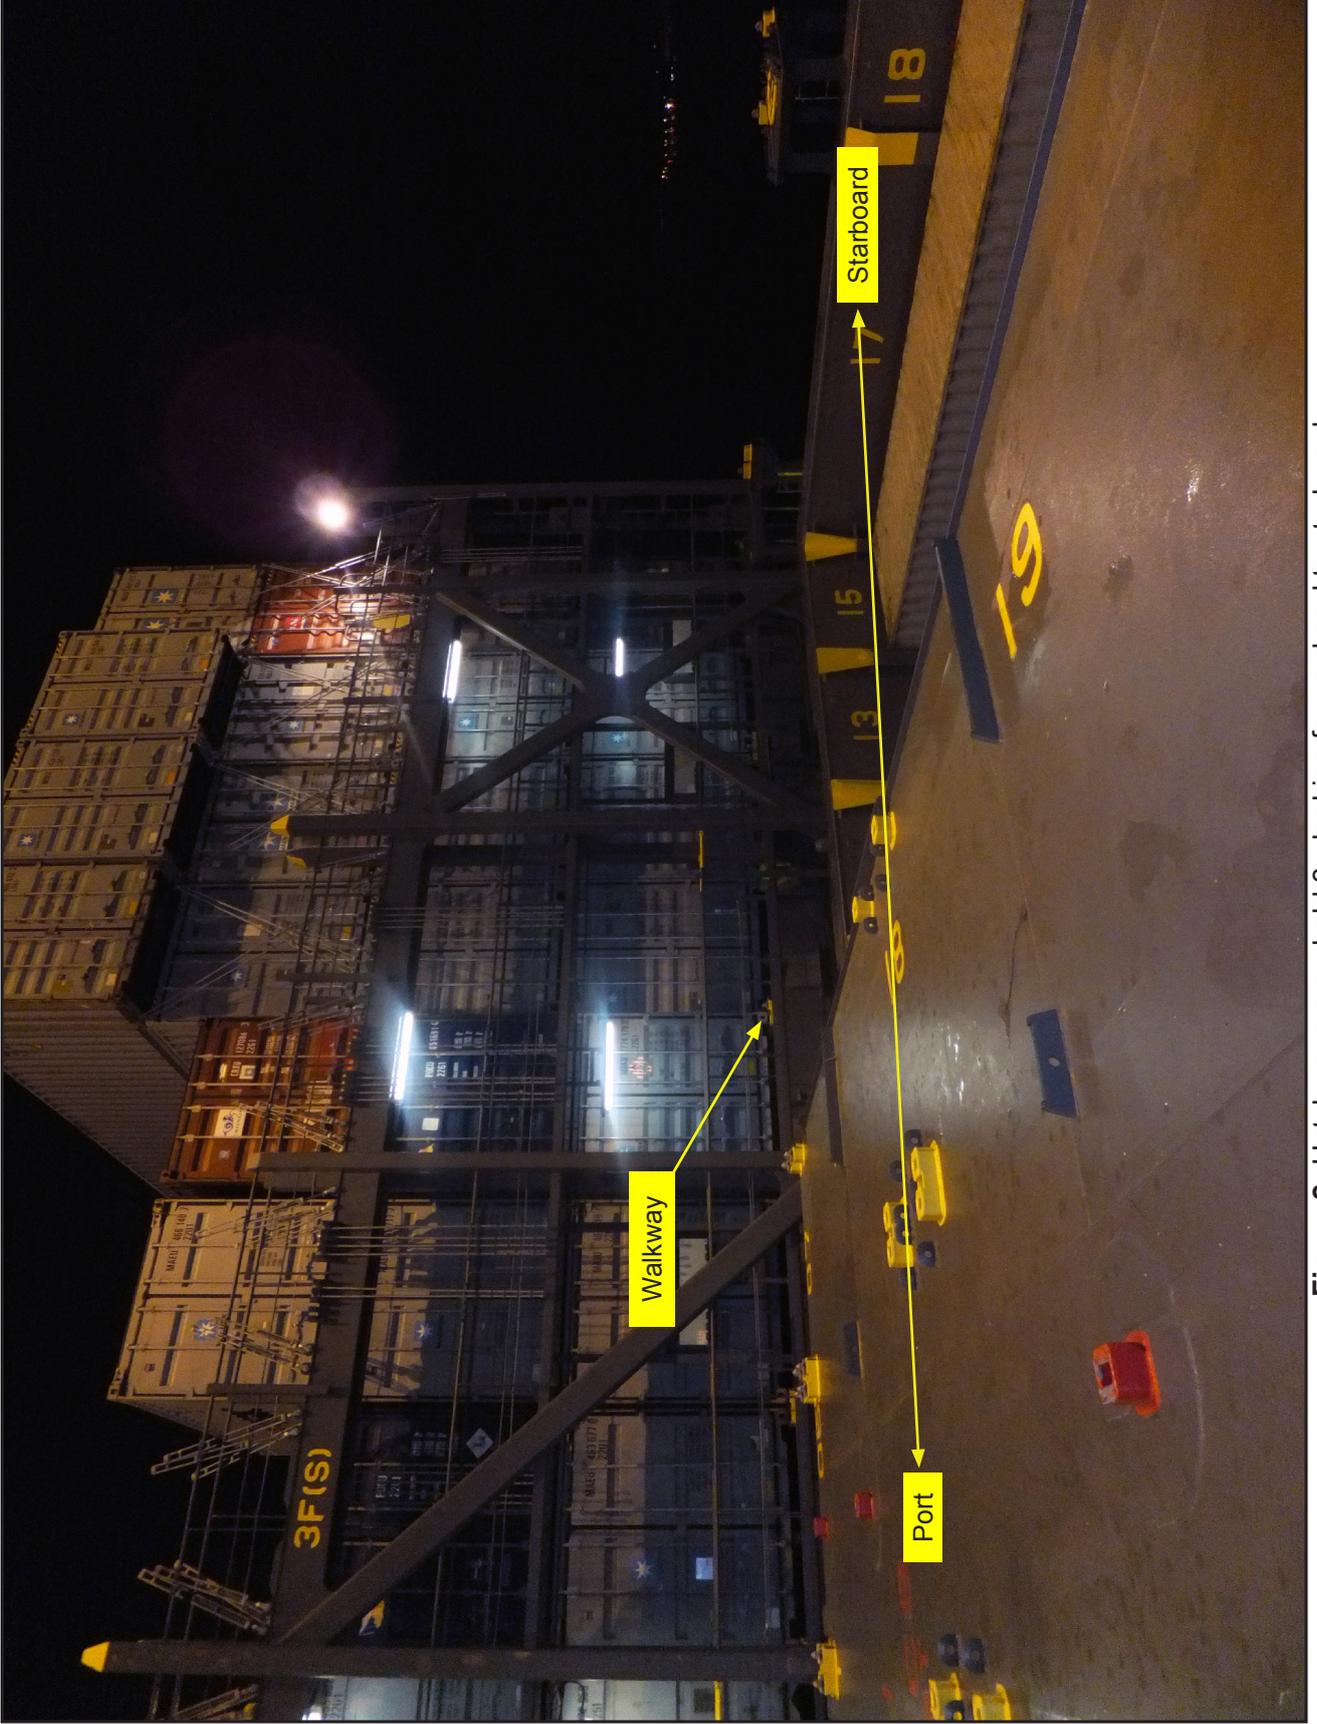
Tempanos had a total of 17 cargo holds and the distance from the top of the hatch coaming to the bottom of the hold was approximately 25m. The hatch covers for cargo hold 3, the location of the accident, were in four sections. The container storage locations were referred to as bays, which ran in the forward and aft direction of the ship. Within each hold, containers were stacked longitudinally and vertically with their locations identified by row, bay and tier. Two Twenty-foot Equivalent Unit (TEU) containers could be loaded in each section of a row, in the case of hold 3, the forward TEU would be in bay 17, and the after TEU in bay 19 (**Figures 2 and 3**). If a 40 foot container

Figure 2: Hatch covers on hold 3 - looking forward and to starboard

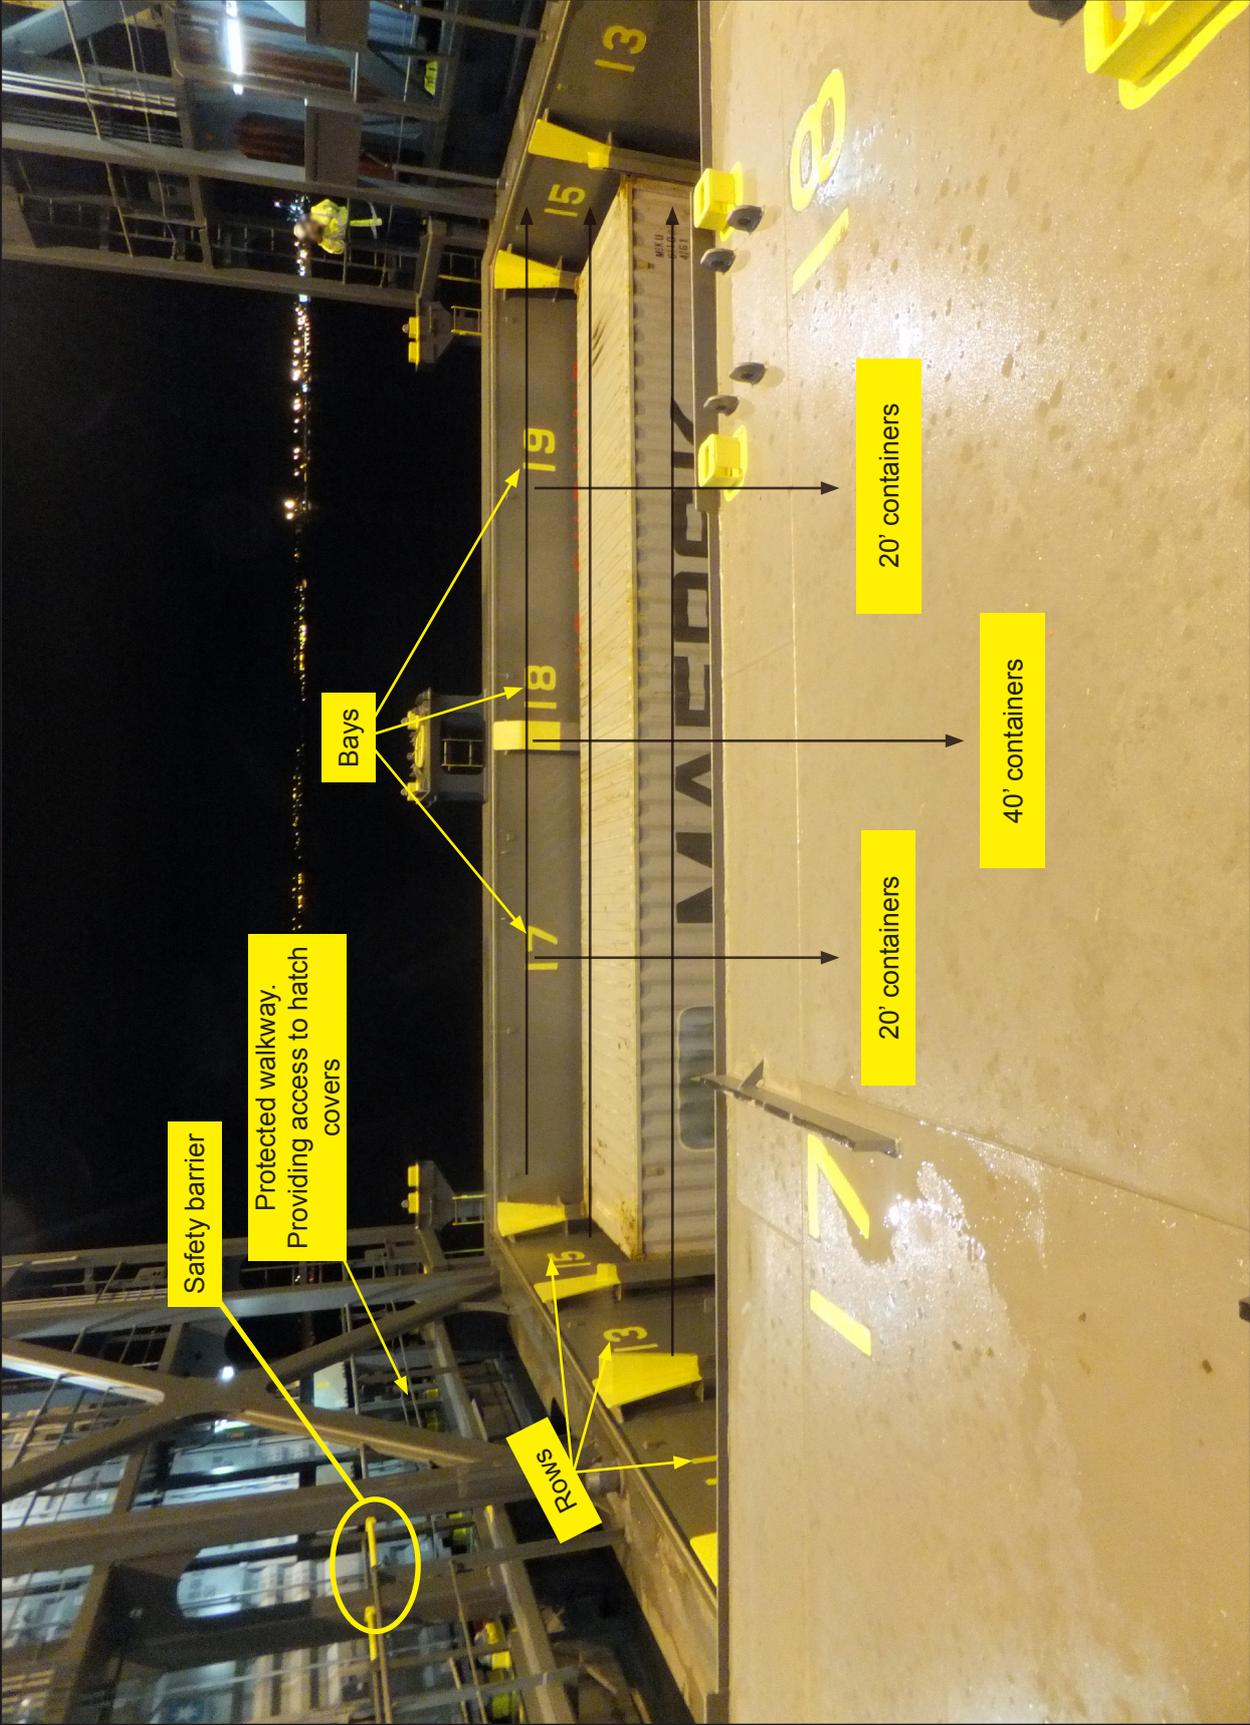
Figure 3: Container location terminology

was loaded instead of two TEUs, this was said to be loaded into bay 18. In hold 2, a 40 foot container could be loaded in bay 14, or TEUs into bays 13 and 15.

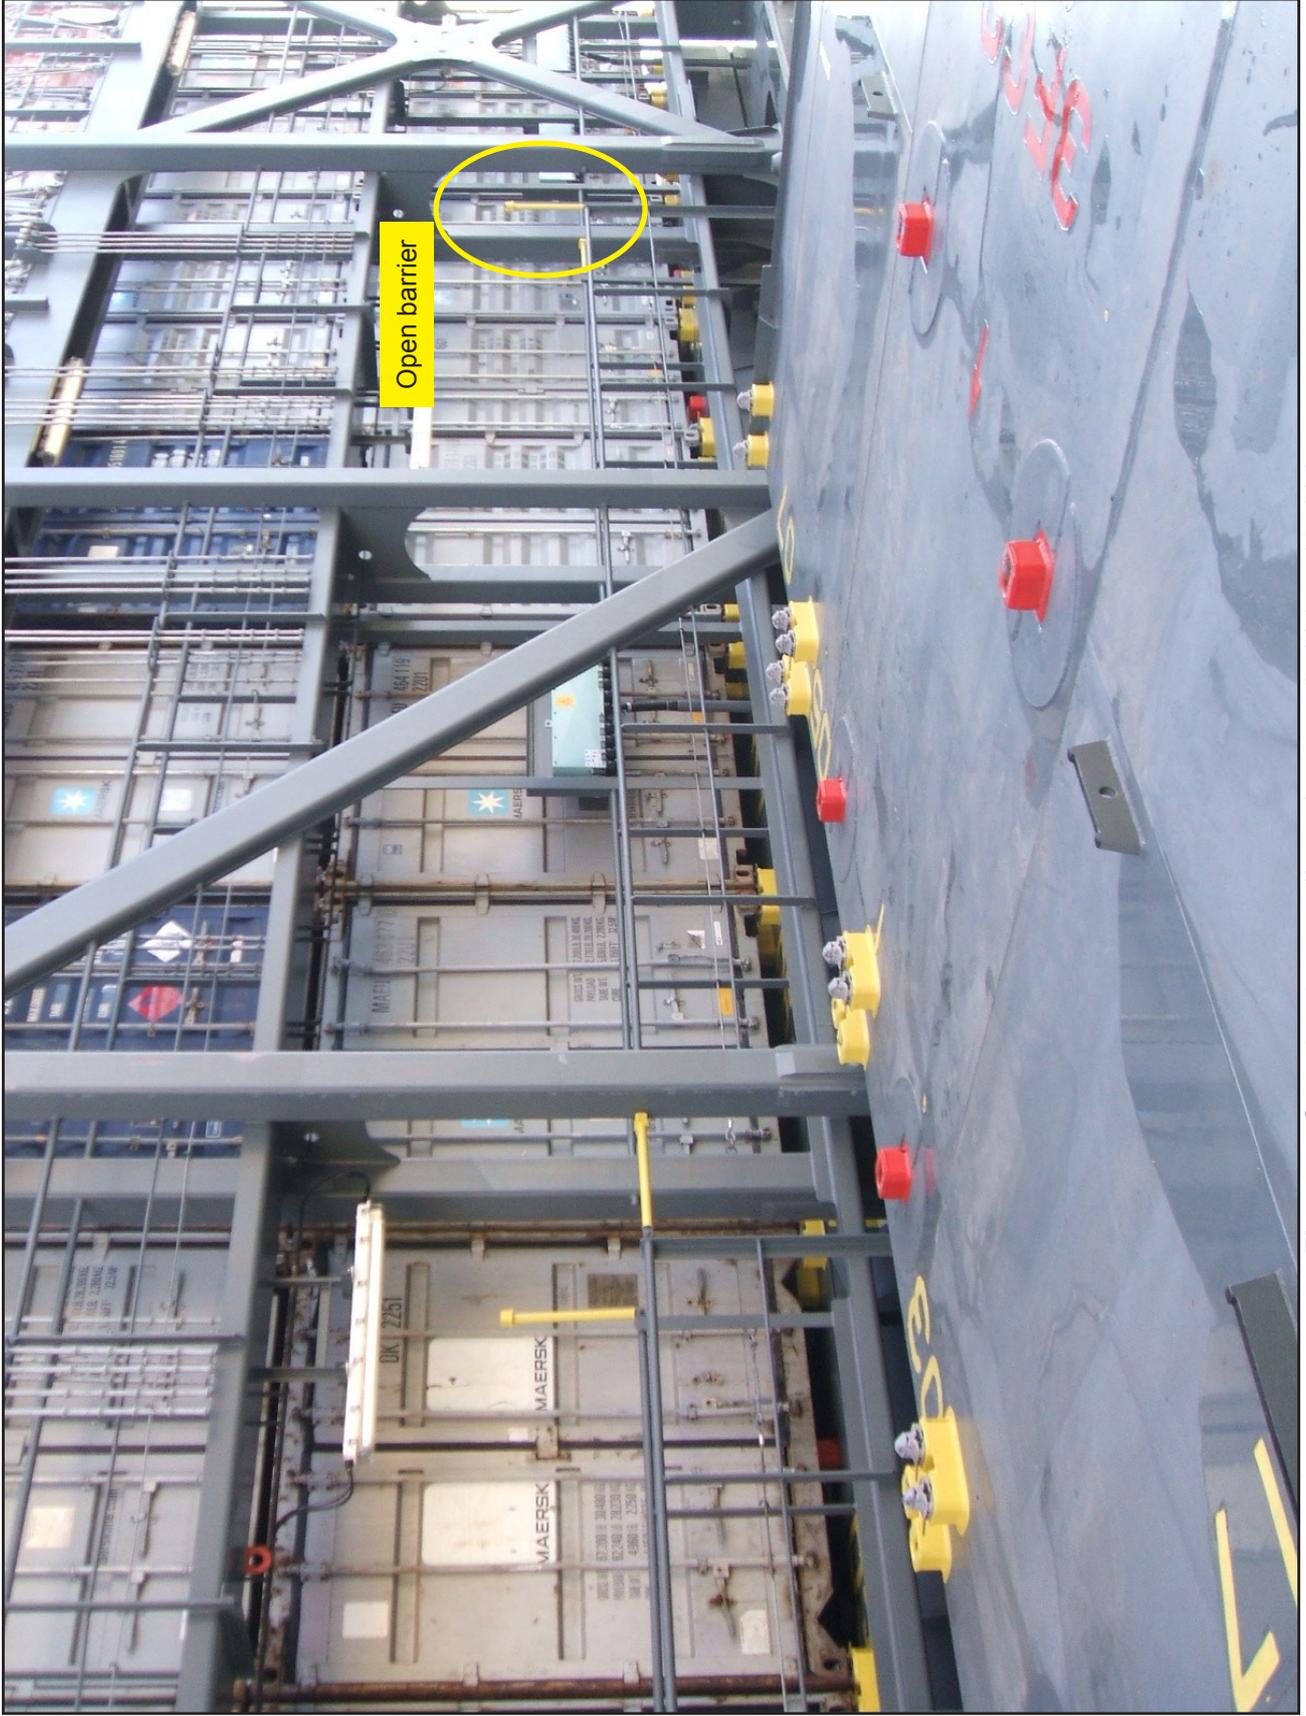
A protected walkway was provided between each cargo hold. This was accessed by climbing up a short ladder from the main deck. The guardrails on either side of the walkway were fitted with safety barriers, which could be lifted to gain access onto the hatch covers. The safety barriers on *Tempanos* were not self-closing, and could be left in the open position (**Figure 4**). Several safety barriers for accessing the hatch covers of hold 3, including one which led to the area where the hatch cover had been removed, were found in the open position immediately after the accident.

Figure 4: Open barrier at walkway between hold 3 and hold 2

Although it is considered less likely that AB Gonzales fell through an open safety barrier in the guardrails protecting the walkways between the holds on *Tempanos*, several barriers (including the one that led to the open section of the hold at bay 18) were found open immediately after the accident. This was a serious breach of the instructions in the vessel's safety management system, which required the barriers to be kept closed whenever the hatches from the adjacent cargo hold were removed.

- Issued instructions to its technical department to modify safety barriers in the guardrails protecting the walkways between the holds so that they close automatically.
- Introduced a requirement for all crew members to wear high visibility clothing and safety helmets if they go on deck during cargo operations.
- Started a safety campaign including additional training on board managed vessels and an increased number of visits, both by safety superintendents to vessels and crew to the company's main office, in order to improve awareness of safe working practices.
- Revised the company's 'Container Vessel Management Manual' to include the requirement for ships' crews to conduct safety meetings with container terminal personnel before starting cargo work.

Hutchison Ports (UK) has advised the master of *Tempanos* to modify the safety barriers in the guardrails on the walkways between the holds, so that they become self-closing.
