Report on the investigation of  
windlass damage, grounding and accident to person  
on the ro-ro ferry

***Norcape***

Firth of Clyde and Troon, Scotland

on 26-27 November 2011

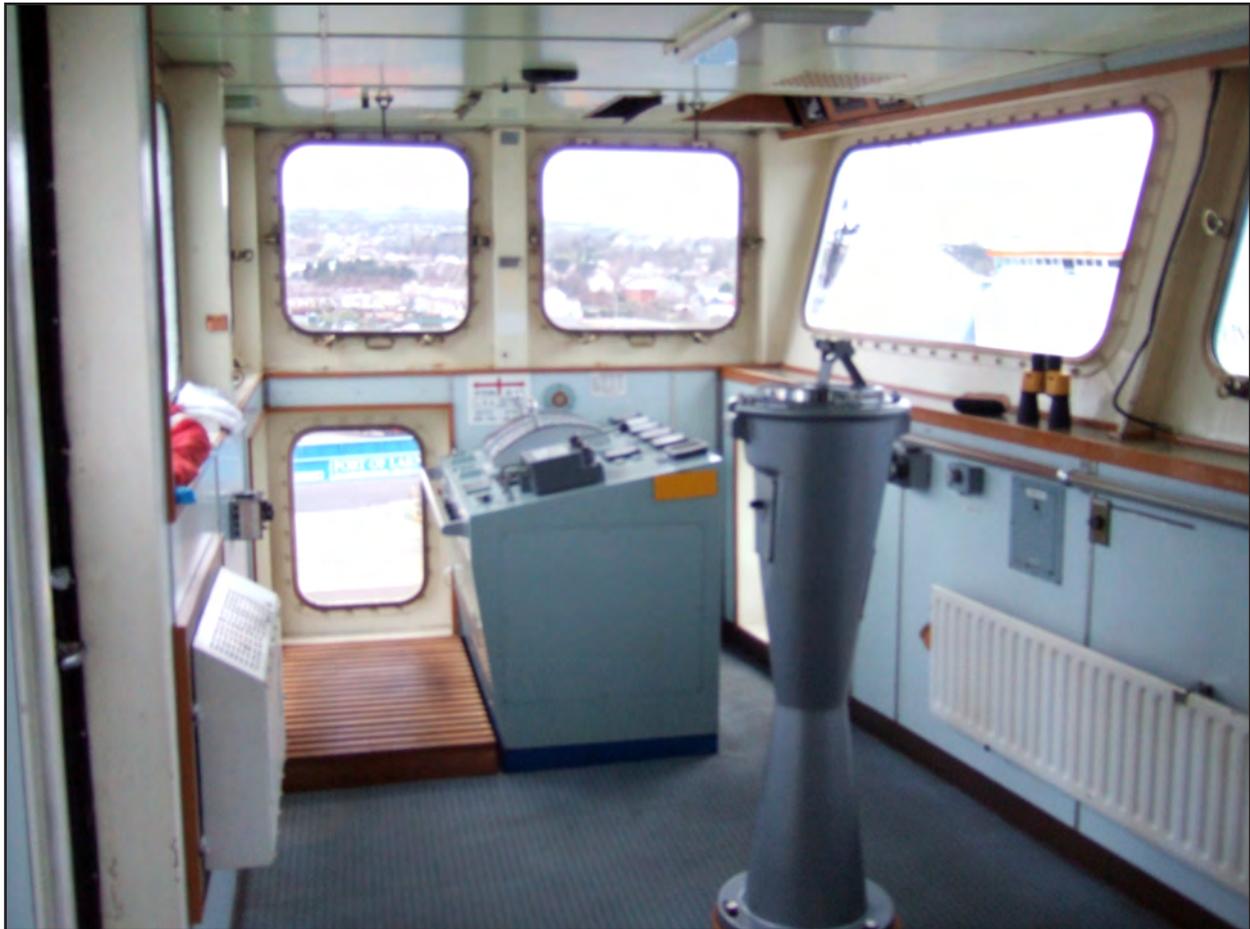
**Figure 2:** Port side control console

At 0008 the vessel's heading had reached 315°, almost parallel to the berth, and the first of the headlines was being passed to the shore when one of the bow thrusters cut out. *Norcape's* bow immediately began to move downwind, to starboard, and it was not possible for the headline to be secured ashore.

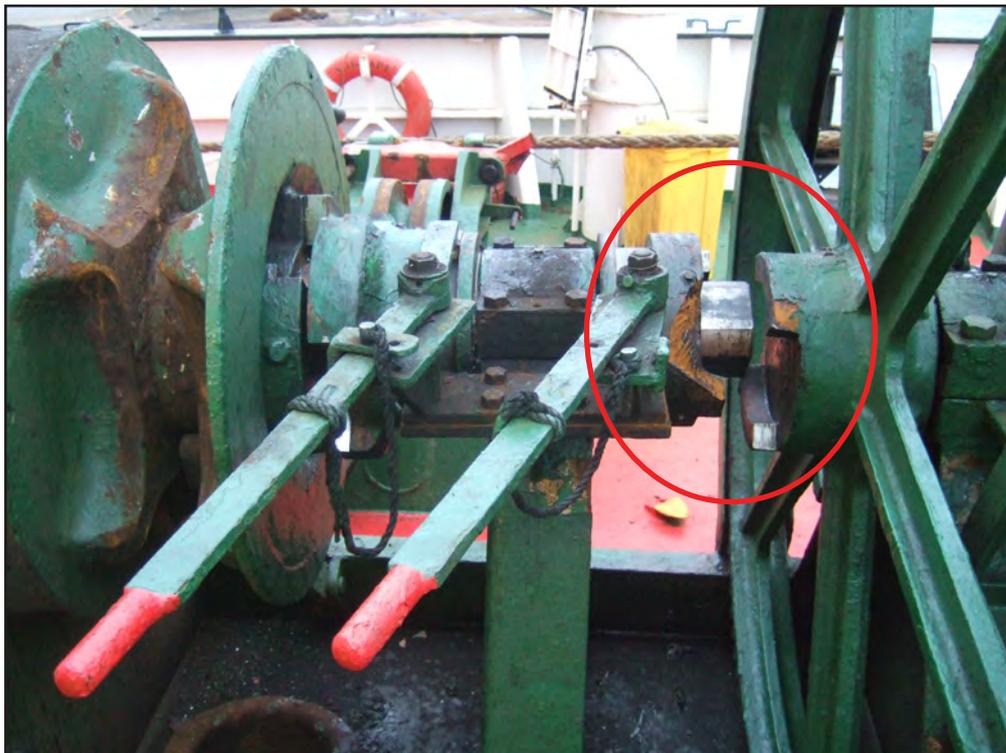
**Figure 4:** *Norcape*'s windlass showing damage to dog clutch mechanism and bent shaft

At 0615 the OOW reported that the port anchor cable had rendered while being recovered, and that the windlass had been damaged as a result. It was later confirmed that the windlass’s dog clutch had been destroyed and the drive shaft had bent (**Figure 4**). The vessel was then lying to the bitter end<sup>4</sup> of the port anchor cable.

*The excessive load on the drive can create a sideways force on the clutch if the dog clutches are slightly worn. The force is born by the fork guides that follow the circular groove which then fracture and so release the clutch, which allows the cable to run freely out of control.*

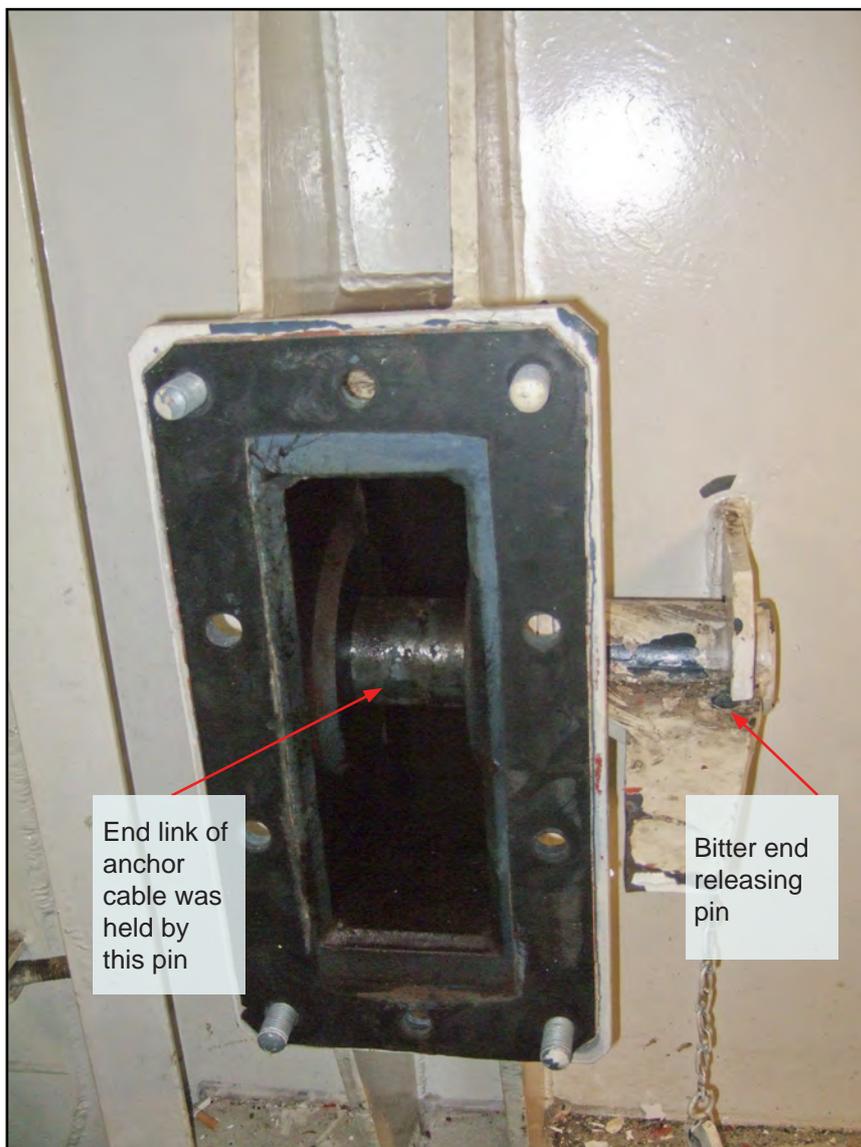
**Figure 5:** Releasing pin for bitter end of port anchor cable.  
(Located on external bulkhead of chain locker).

The bridge team consulted the available company guidance and considered the options for slipping the anchor cable. A marker buoy and line were attached to the cable before an unsuccessful attempt was made to slip the cable by knocking out the pin which secured the bitter end to the chain locker (**Figure 5**).

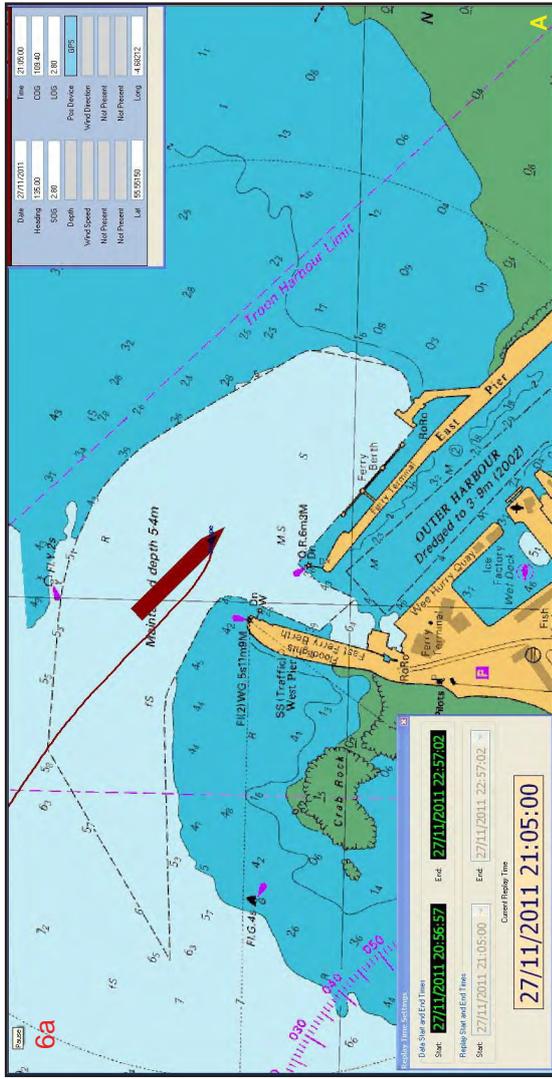
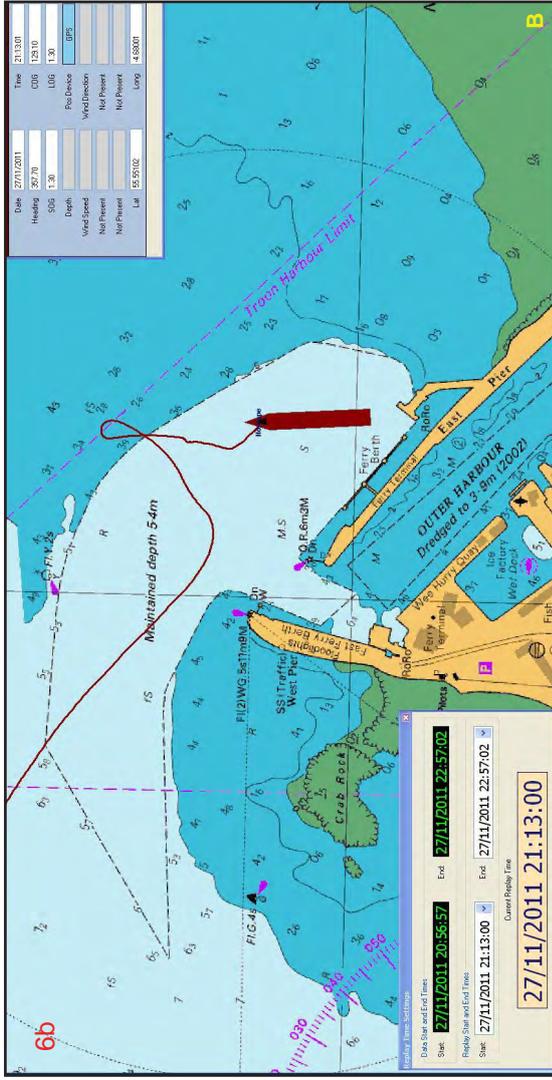
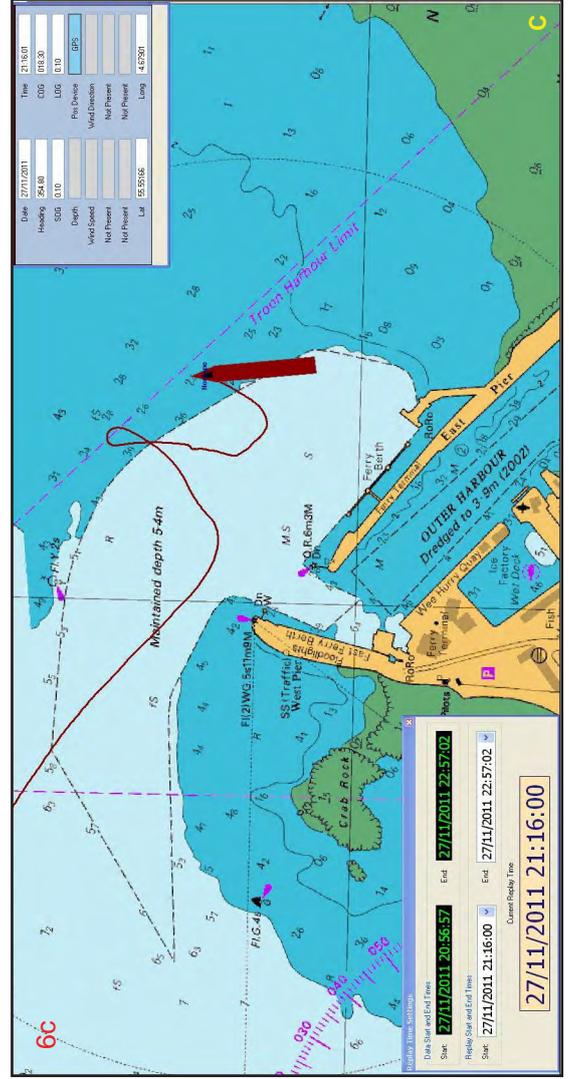
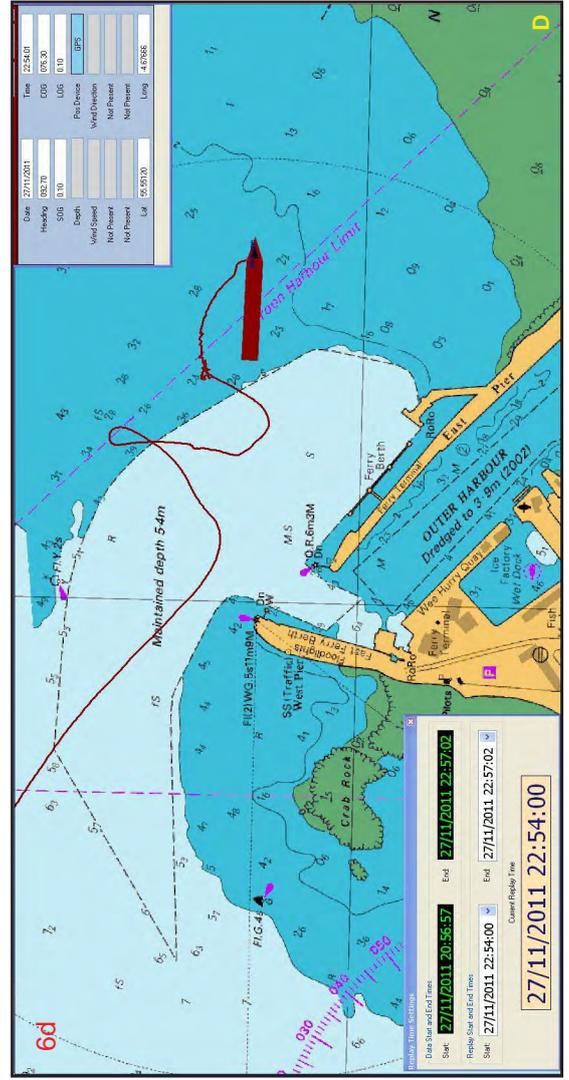
Figure 6: Norcape's GPS track of entry to Troon and grounding, 27 November 2011

At 2116 (**Figure 6c**) the vessel grounded and the propeller controls were placed to zero pitch. The tug skipper then advised that it was not possible for *Red Finess* to continue to operate on *Norcape's* starboard side as the water was too shallow.

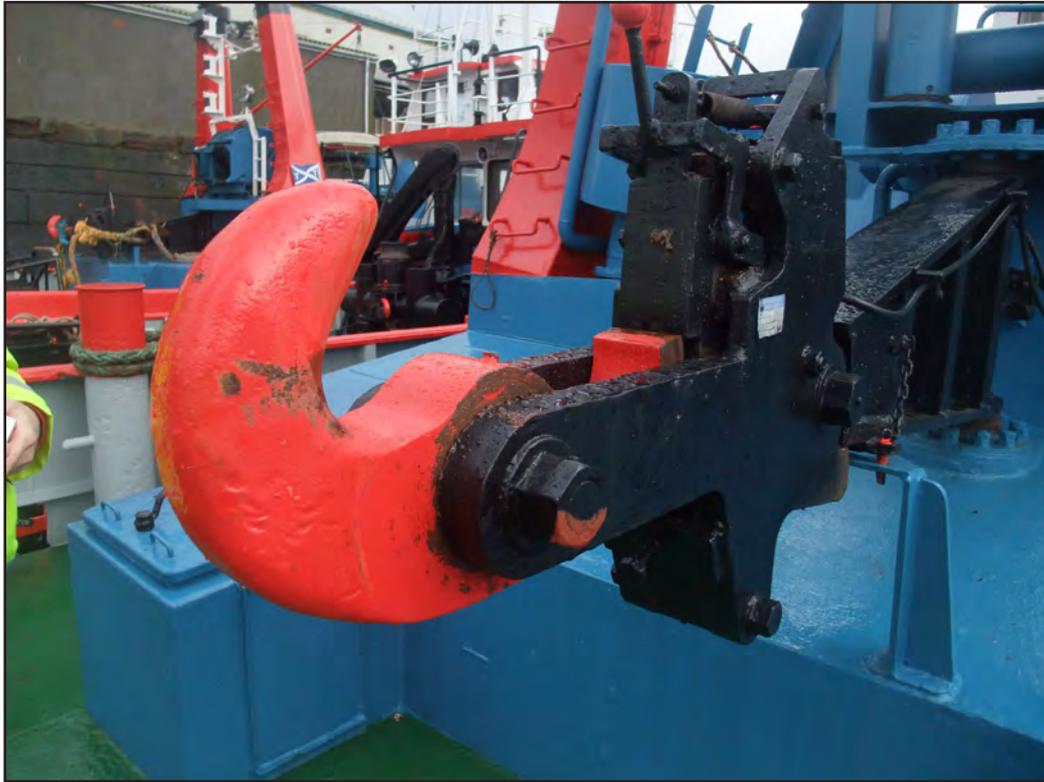
**Figure 7:** *Red Fitness* - towing hook

A mooring line was passed to the tug from *Norcape's* port aft quarter at 2126 and the eye of the line was placed over the tug's towing hook (**Figure 7**). The tug pulled the line out from the vessel and then stopped to check the length of line, at which point it was made fast by *Norcape's* crew onto a set of bitts close to the port rail (**Figure 8**).

At 2145 *Norcape's* master saw the towline detach from *Red Finess's* towing hook and recoil back towards his vessel's side (**Figure 10**).

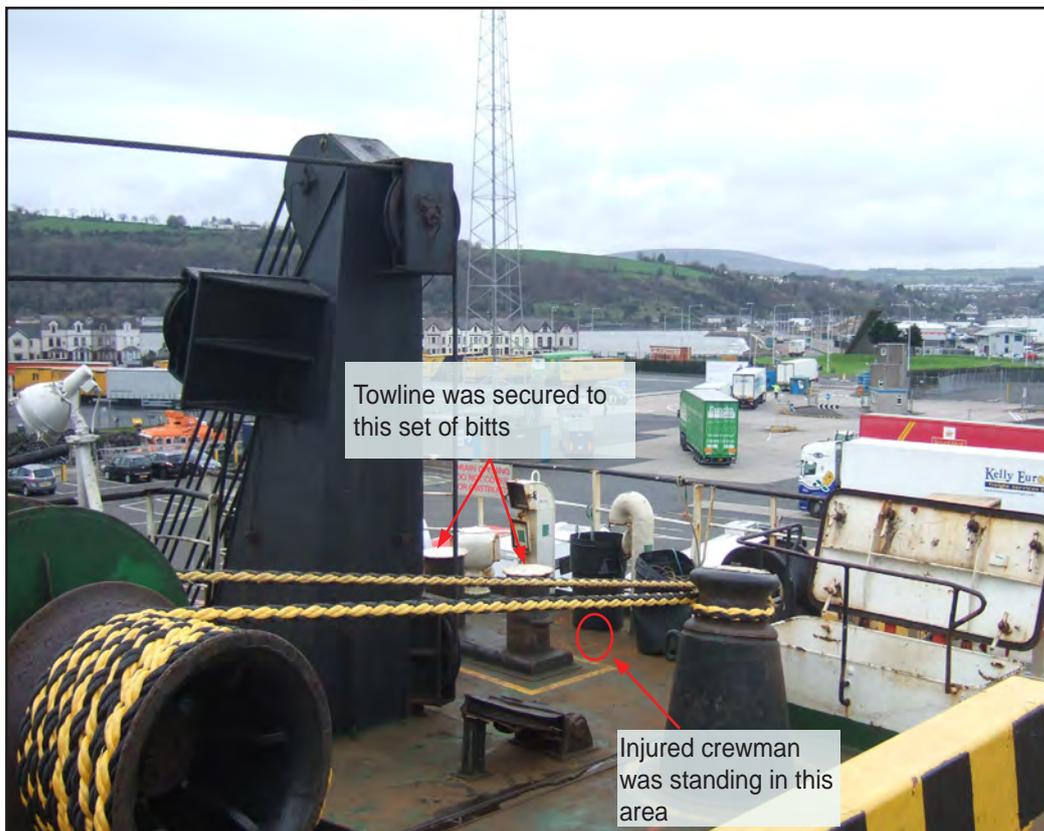
Towline was secured to this set of bitts

Injured crewman was standing in this area

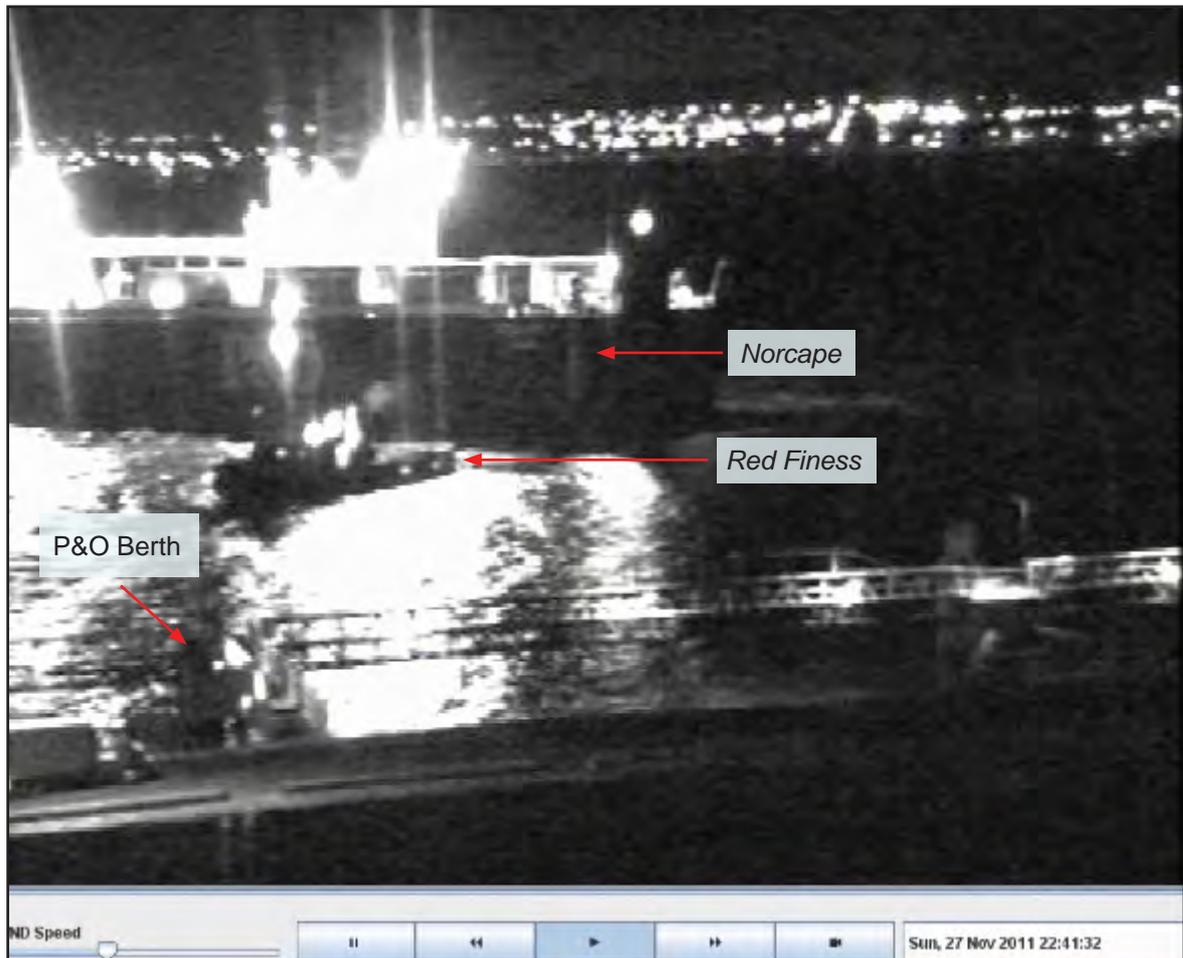
**Figure 10:** 'Still' from CCTV image taken as the towline slipped from the towing hook of *Red Finess* (P&O berth visible in the foreground)

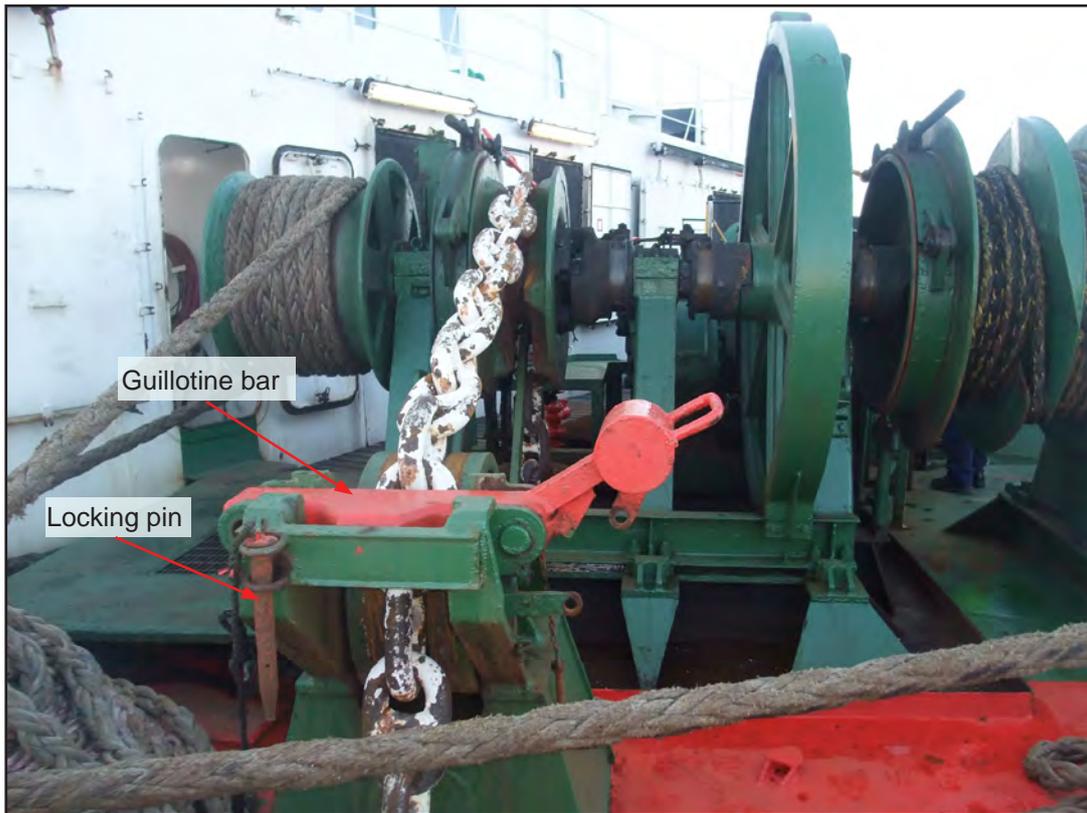
**Figure 15:** *Norcape* - starboard windlass showing guillotine bar across cable with locking pin in its stowage position

The guillotine bar and pin arrangements were designed to ensure that, with the pin engaged, the anchor cable could not pay out and the structure would take the weight of the anchor cable.

Measurements were taken to verify that the cable could not have passed under the bar with the pin engaged.

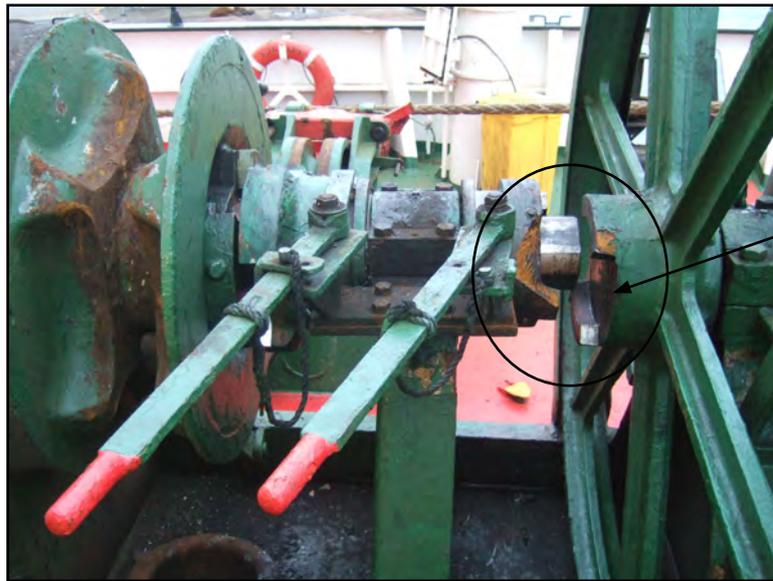
Broken dog clutch  
and bent shaft on  
port windlass
