MV PRIDE OF CALAIS

Machinery failure leading to contact with berth Calais, France 22 October 2011

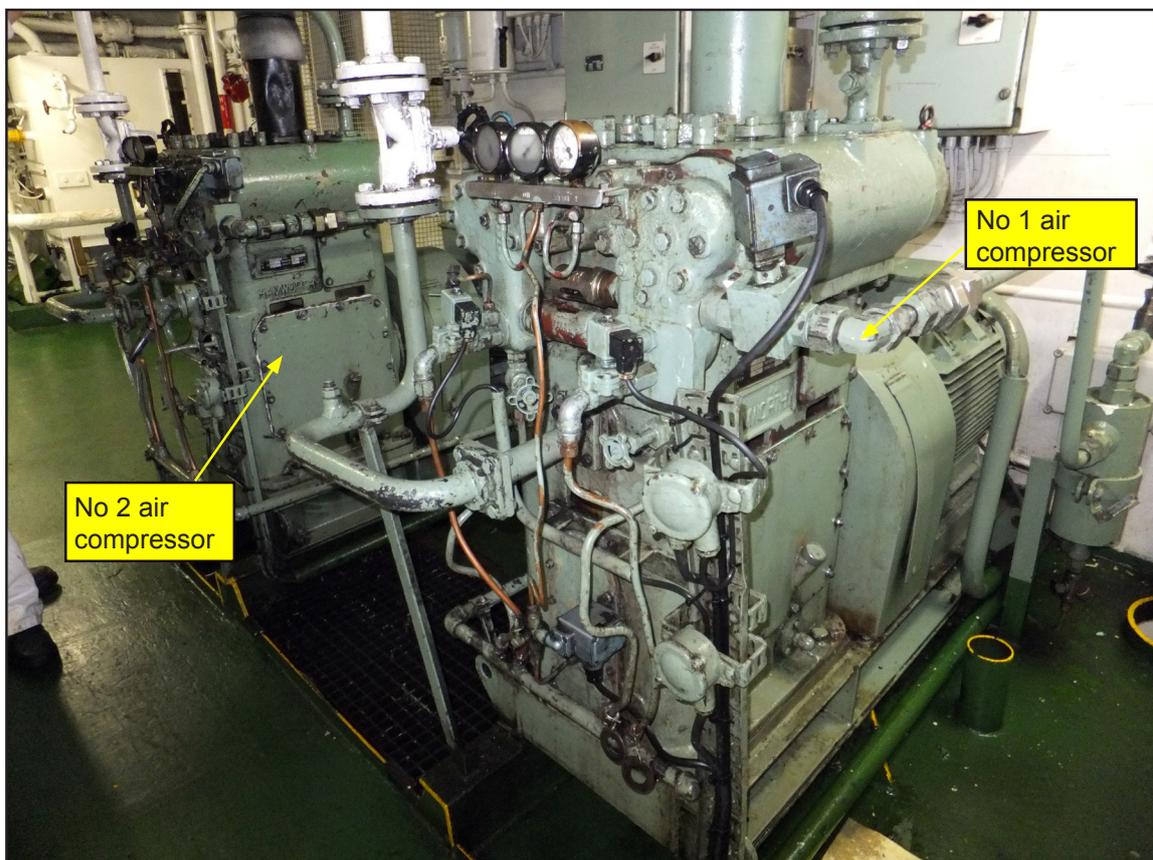
Figure 1: No 1 and No 2 air compressors

At approximately 2250, the fourth engineer officer (4EO) noticed an oily mist surrounding number 2 air compressor (AC2) during his routine rounds of the engine room. After a visual inspection, he selected the number 1 air compressor (AC1) as the running or 'lead' compressor, leaving AC2 as the standby or 'lag' compressor (**Figure 1**). He then returned to the engine control room (ECR) to report his actions.

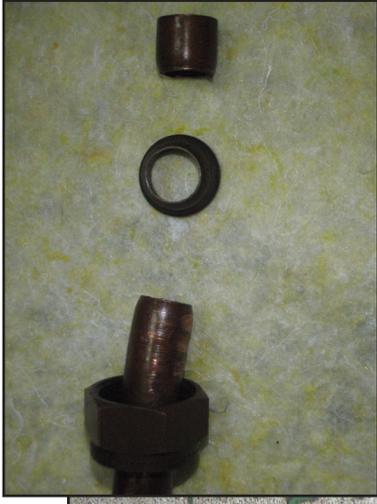
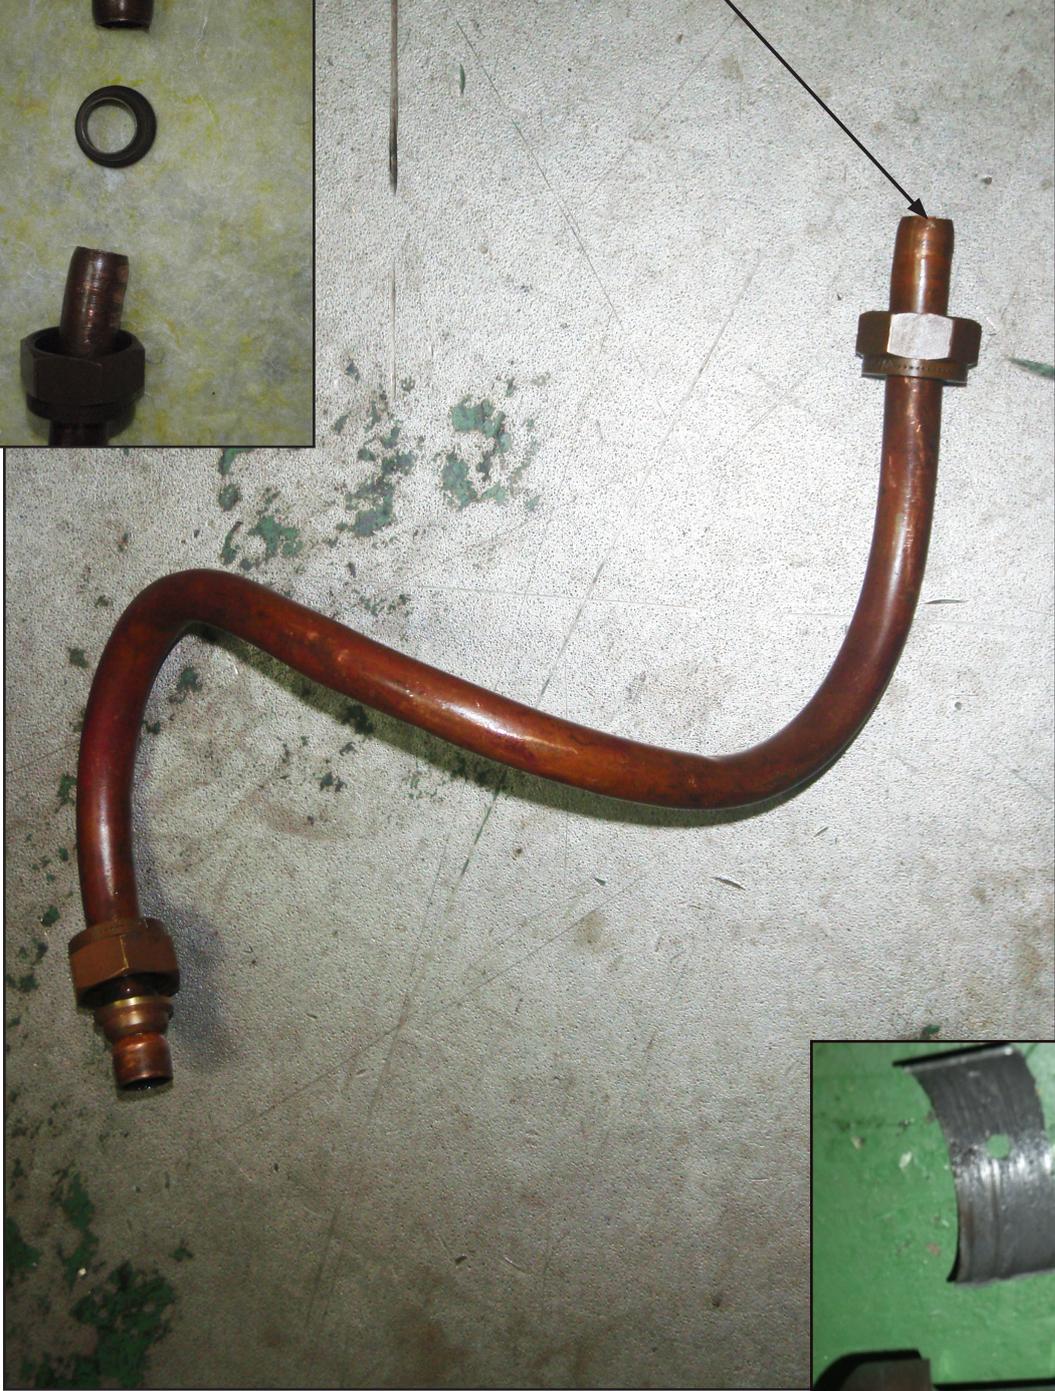
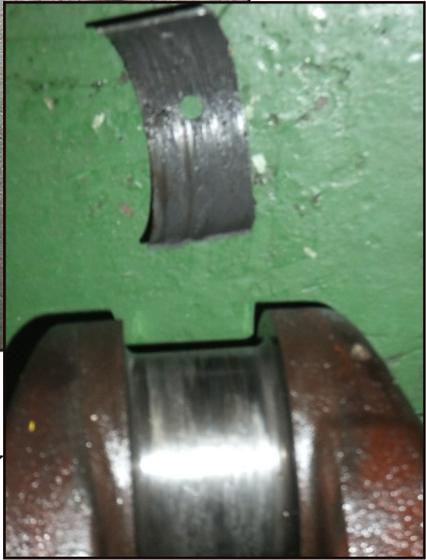
Figure 2: Damage to lubrication oil pipe and bottom end bearing

The 3EO checked that the oil level in AC2 was correct and then tried to start it. AC2 immediately tripped, so the 3EO removed the compressor's crankcase door and saw that the main lubricating oil discharge pipe assembly had detached and that the bottom end bearing had overheated and failed (**Figure 2**). The 3EO, in consultation with the relief chief engineer officer (RCEO), who by then, had joined the 3EO, assessed that AC2 was unusable. The compressor was isolated and the RCEO and 3EO returned to the ECR. Once in the ECR, the engineers noticed that the air pressure in the main air receiver¹ was dropping.

Failed lubricant oil pipe end fitting

Bottom end bearing

In November 1996, the lubricating oil discharge pipe in AC2 was replaced after it had sheared. It was replaced again in July 2004, when it was found to be loose and its olive worn. The 12mm copper lubricating oil discharge pipes had also been replaced for similar reasons on identical compressors fitted to other P&O vessels. The pipe was connected at each end by a compression fitting, sealed by a brass olive. It was recognised that the compression fitting occasionally vibrated loose, and it was tightened as a matter of course during routine maintenance.

- The main engines' clutches disengaged due to the reduction in the pressure of the control air.
- The reduction in the pressure of the control air was caused by AC1 operating at a reduced output due to a material failure of a discharge valve, and by AC2 being unserviceable due to the recent fracture of a lubricating oil pipe.

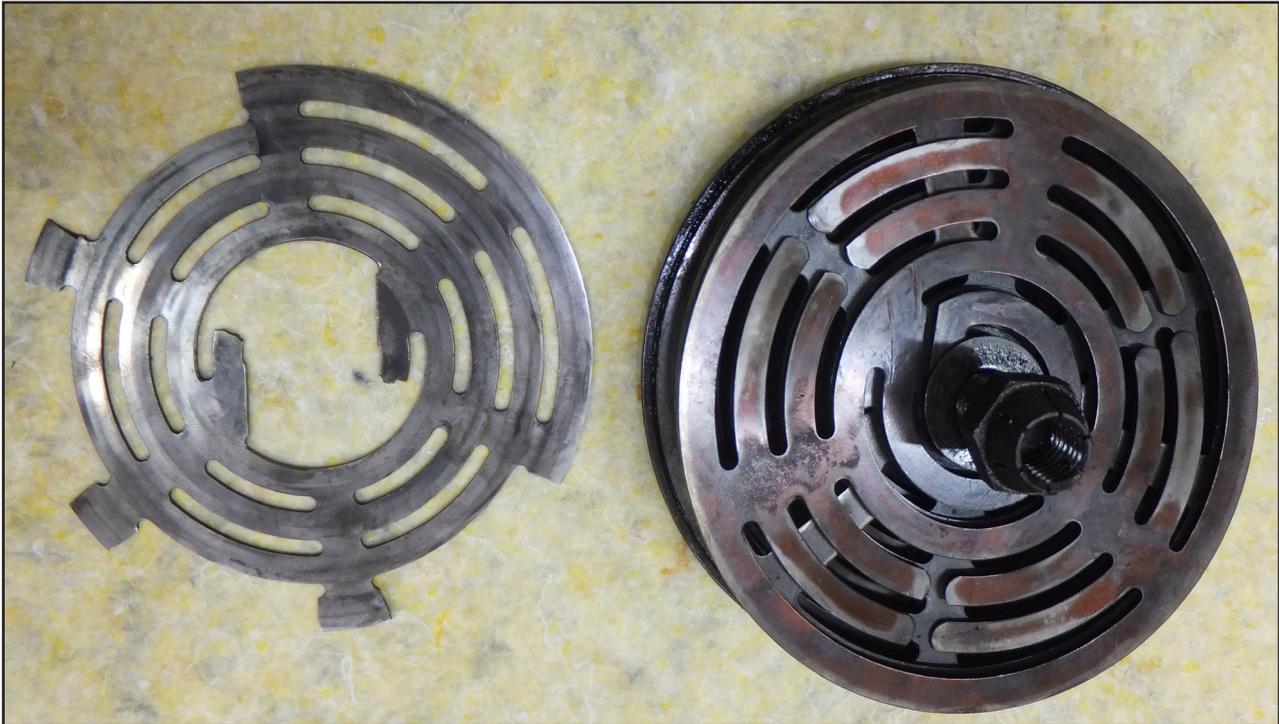
Figure 5: Damage to No 1 compressor, low pressure discharge valve

Subsequent examination of the air compressors highlighted that the locking nut on the bolt holding the plates in the low pressure discharge valve on AC1 had worked loose. This had resulted in partial disintegration of one plate (**Figure 5**) and debris entering the low pressure cylinder, causing damage to the cylinder head and piston. The failure of the lubricating oil pipe on AC2 (**Figure 2**) was attributed to the repeated tightening of the securing nut against the olive which had resulted in 'work hardening' and weakening of the copper pipe.

The vessel's air compressors were not supplying the main air receiver as intended. The output from AC1 had been reduced by the mechanical failure of the low pressure discharge valve components (**Figure 5**), and subsequent damage to the cylinder head and piston. AC2 was unusable due to the recent failure of the lubricating oil pipe (**Figure 2**) and the resulting damage to the bottom end bearings. From around 2250, when AC1 became the only compressor that was running, the pressure in the main air receiver started to fall.
