Report on the investigation of the steering  
control failure and subsequent contact  
on board the high-speed catamaran

***Moon Clipper***

on the River Thames, London

5 October 2011

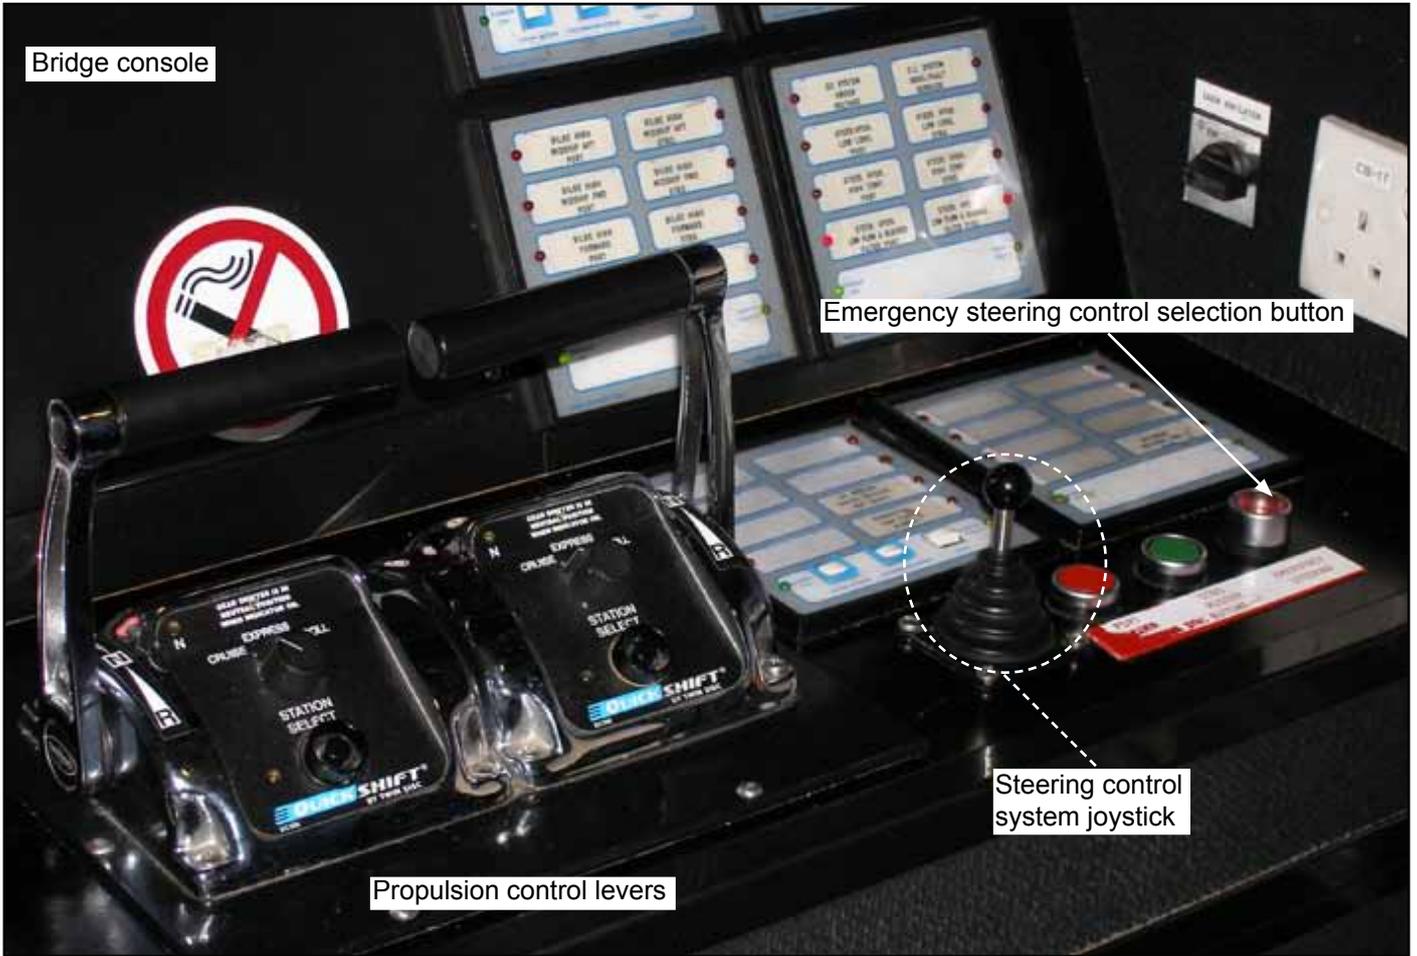
**Figure 2:** Steering control system joystick

*Moon Clipper* departed North Greenwich Pier at 1115, and headed upriver on the westbound leg of the commuter circuit. Shortly after entering service, the master noticed that the bridge console's steering control joystick (**Figure 2**) had become loose and was sometimes sticking over to port or to starboard when released, instead of springing back to its normal central position. The master reported the fault to his fleet controller and requested the attendance of an engineer on his return to North Greenwich Pier at the end of the run.

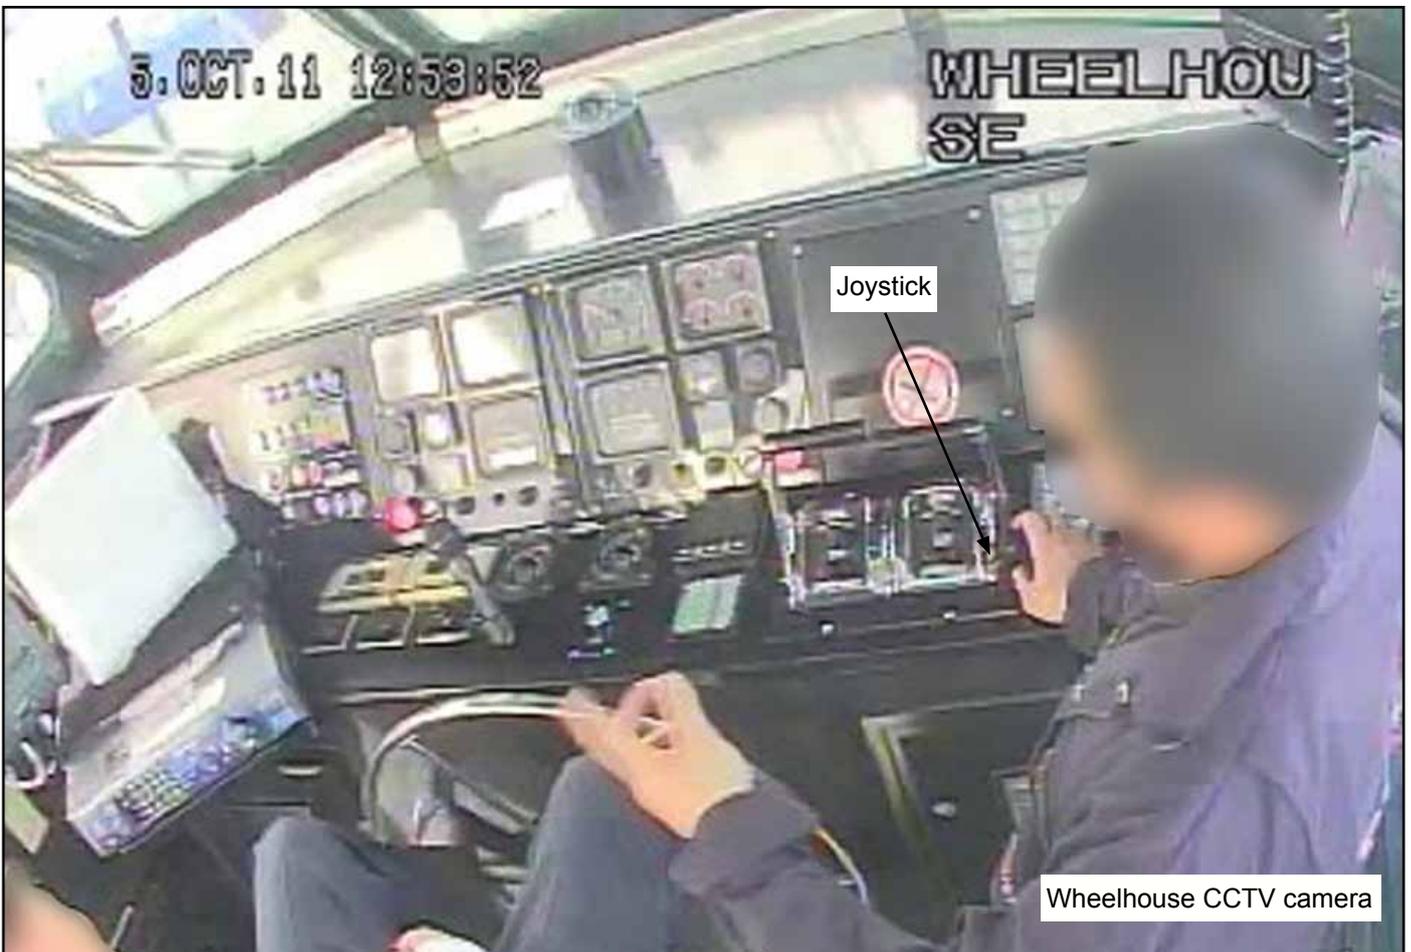
**Figure 3:** Service engineer investigating the reported steering joystick fault (CCTV time local + 3 minutes)

At about 1255, *Moon Clipper* berthed at North Greenwich Pier where one of the company's duty service engineers was waiting. The engineer boarded the vessel and made his way to the bridge. The master explained the defect to him and demonstrated the problem by moving the joystick to port and to starboard several times (**Figure 3**). The engineer told the master that he did not have a spare joystick with him, but said there might be one in the store ashore. The master decided to keep his vessel in service and use the wheel to control the ship's rudders. The engineer pointed out that the joystick was still working and could be used as a back-up. The master explained that the vessel would be temporarily out of service for a crew break at about 1700, and the engineer said that he would return then if they had a spare joystick in the engineers' store. At 1315, the master manoeuvred *Moon Clipper* off the berth and began his second trip of the day.

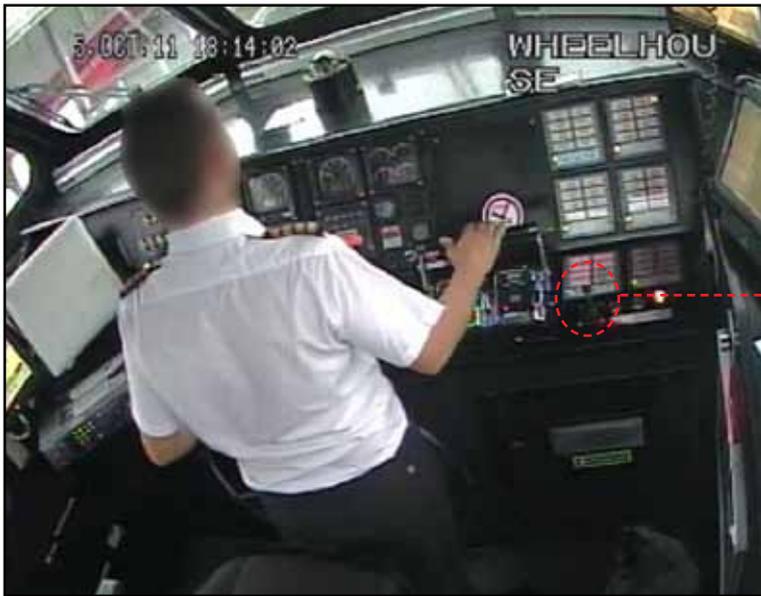
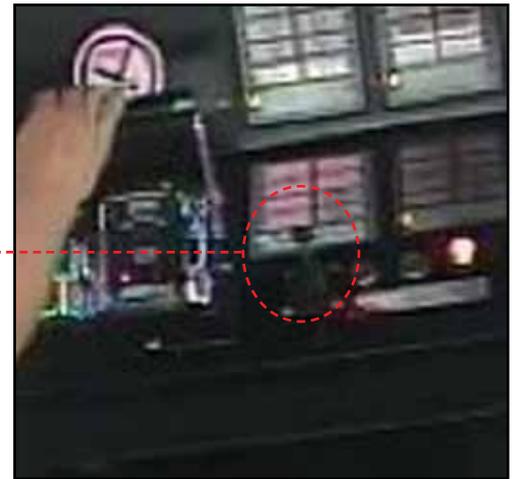
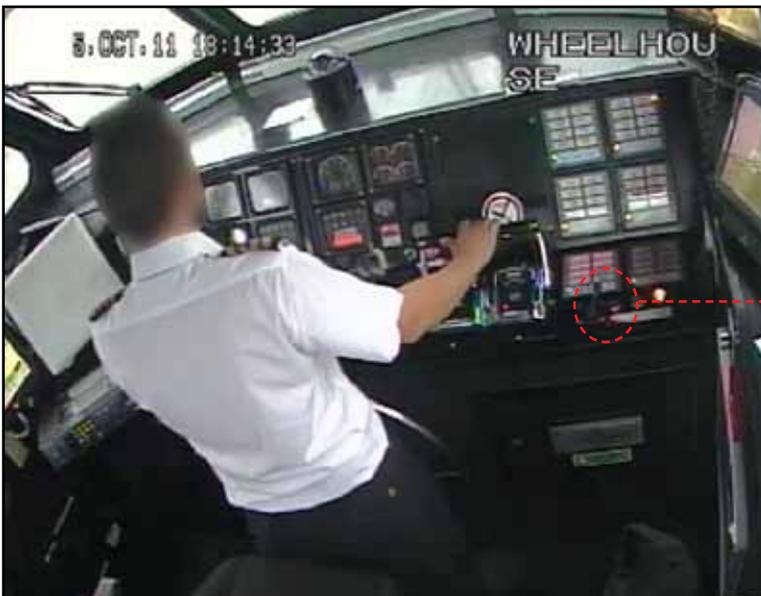
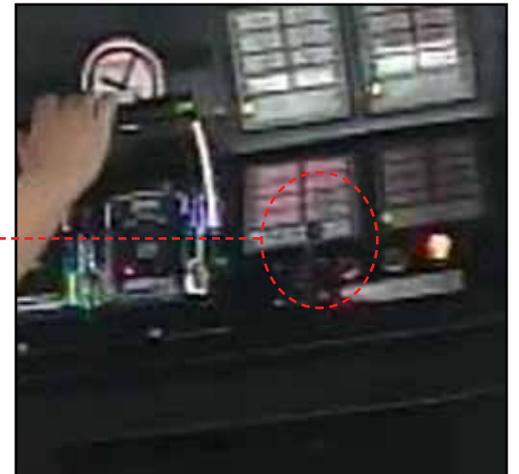
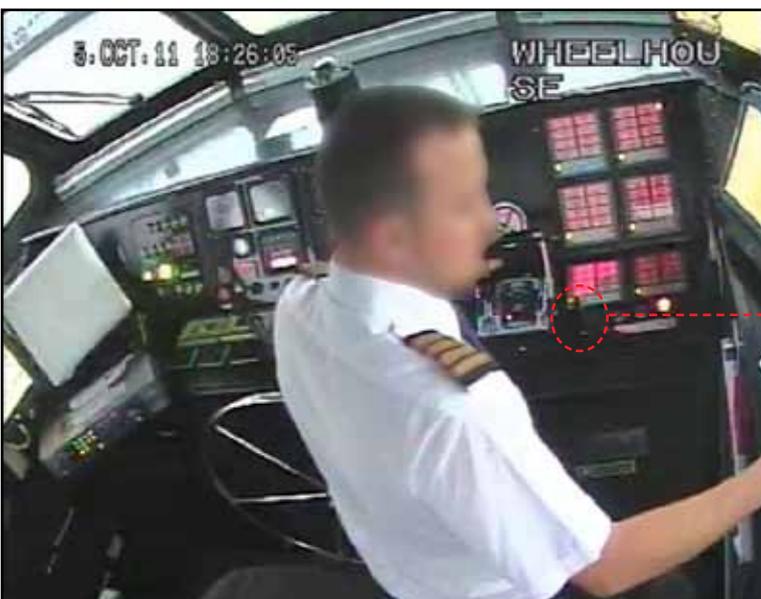
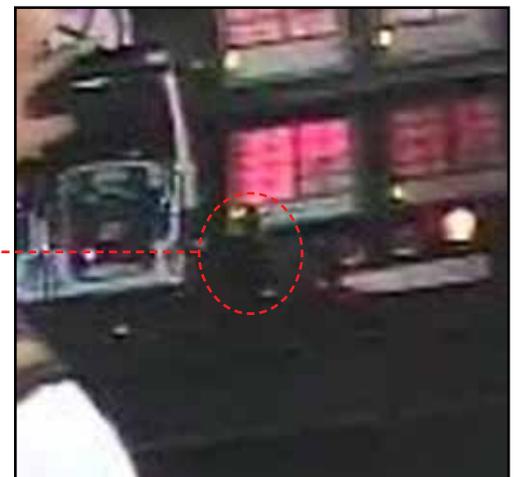
**Figure 4:** Examples of the steering joystick sticking prior to the accident  
(CCTV time local + 3 minutes)

1817 - Joystick in its central position

1817:30 - Joystick stuck to starboard

1829 - Joystick stuck to port

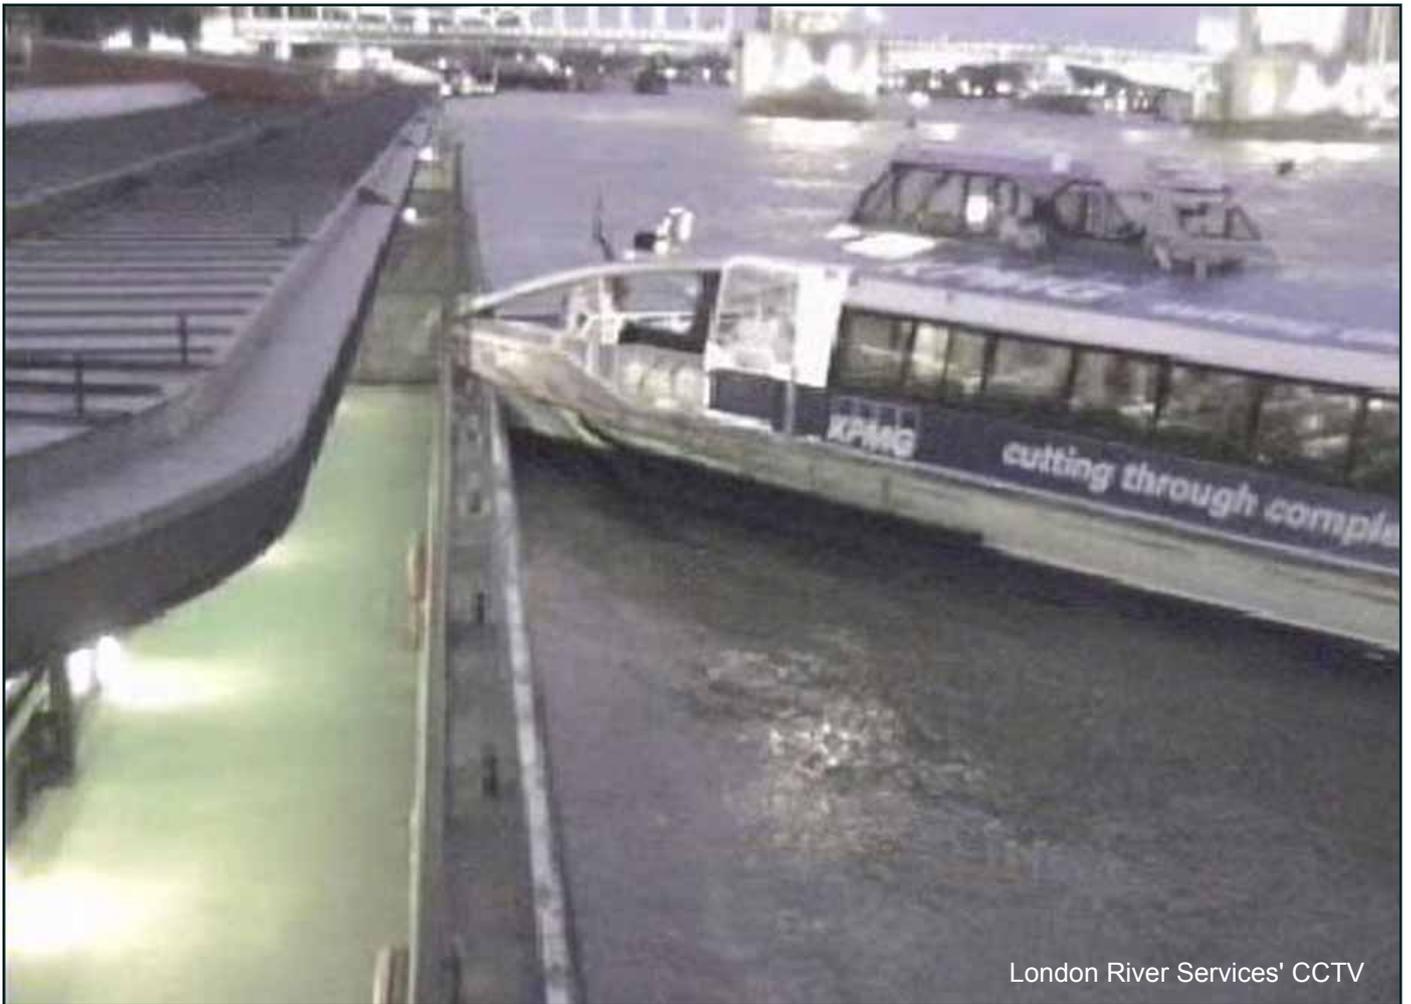
**Figure 8:** *Moon Clipper's* impact with Tower Millennium Pier  
(CCTV time local + 3 minutes)

*Moon Clipper* struck the pier at 8.5 knots, at an angle of about 60°, and then rebounded astern. The force of the impact caused everybody on board to be thrown violently forward (**Figure 9**). Most of the passengers seated in the cabin hit the back of the seats in front of them. Those passengers seated on the open deck aft and in the front row of seats in the cabin, including a passenger seated in a wheelchair, were thrown on to the deck. At least 14 passengers and the CFR were injured. The vessel drifted momentarily with the port gearbox in neutral while the master attempted unsuccessfully to restart the starboard engine. However, he soon regained control and manoeuvred alongside using the port engine and wheel steering.

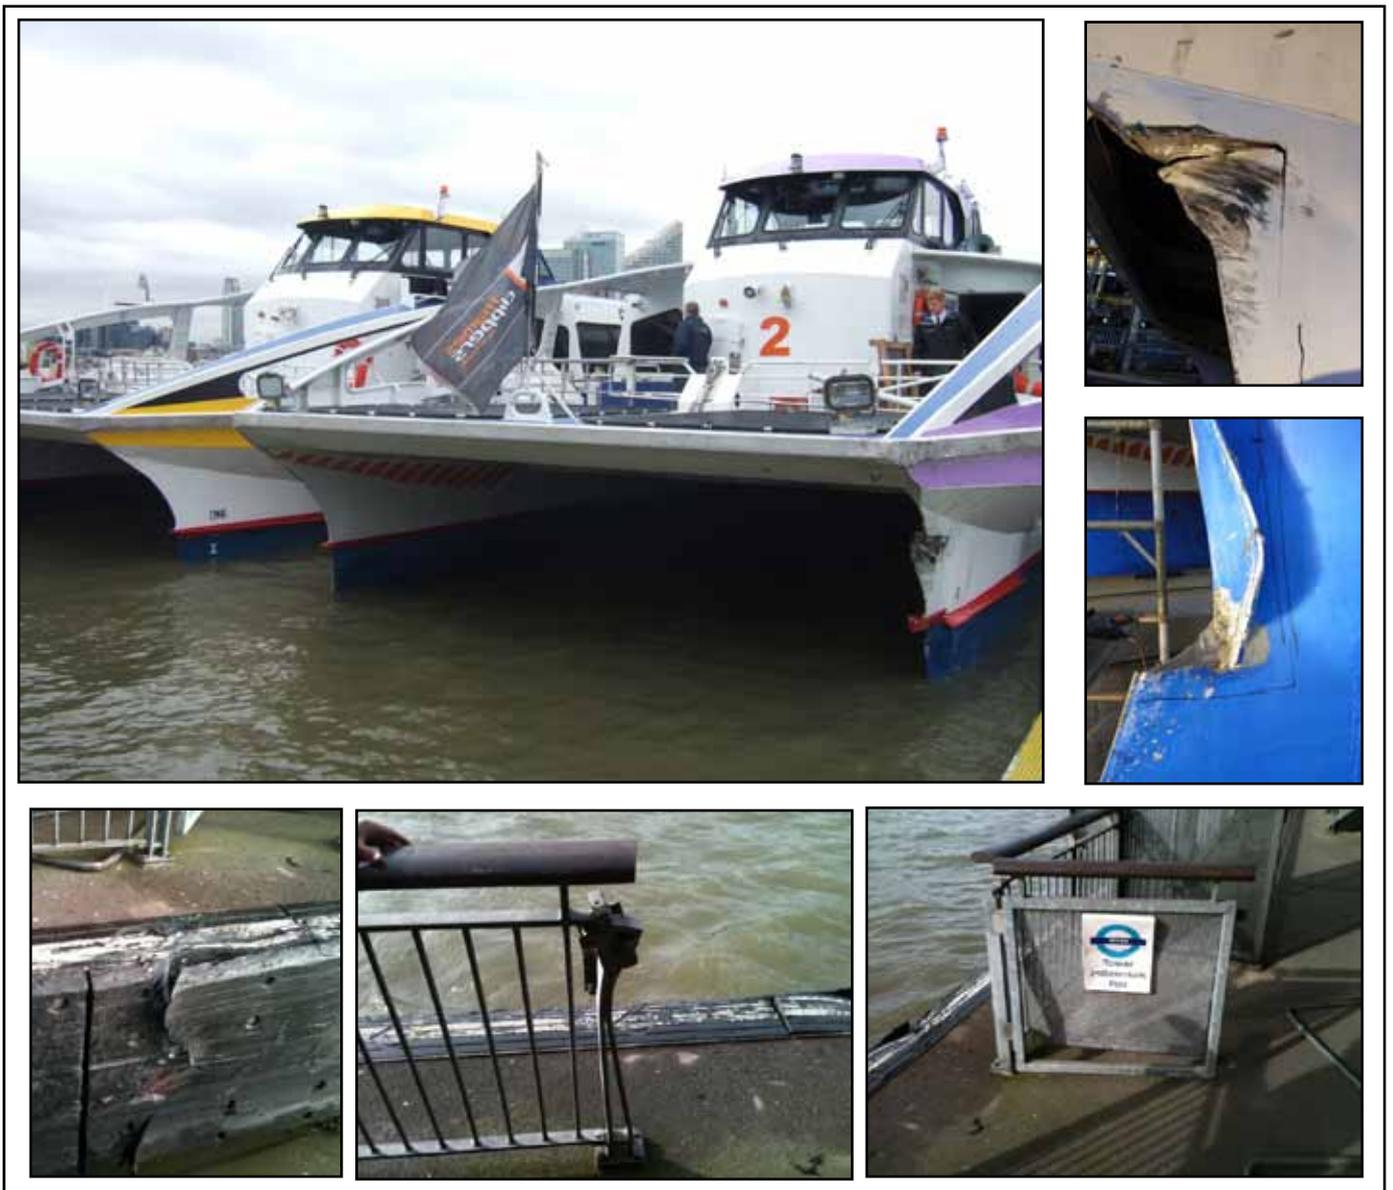
**Figure 12:** Damage caused by the contact

*Moon Clipper's* contact with Tower Millennium Pier caused damage to both the craft and the pier's pontoon (Figure 12). The damage to the high-speed catamaran was limited to the stem of her port hull. The force of the impact caused the aluminium stem to crease and tear above and below the waterline (Figure 12). The tear just below the waterline was about 10cm long, and the second tear approximately 1m above the waterline was about 20cm long. The water ingress was limited to the port forepeak tank and had little effect on the craft's stability.

The stem of *Moon Clipper's* port hull damaged a section of the pier structure's solid rubber fender. The tip of *Moon Clipper's* port bow also struck a section of handrails and an access gate, causing minor damage to both. The pier was not holed.

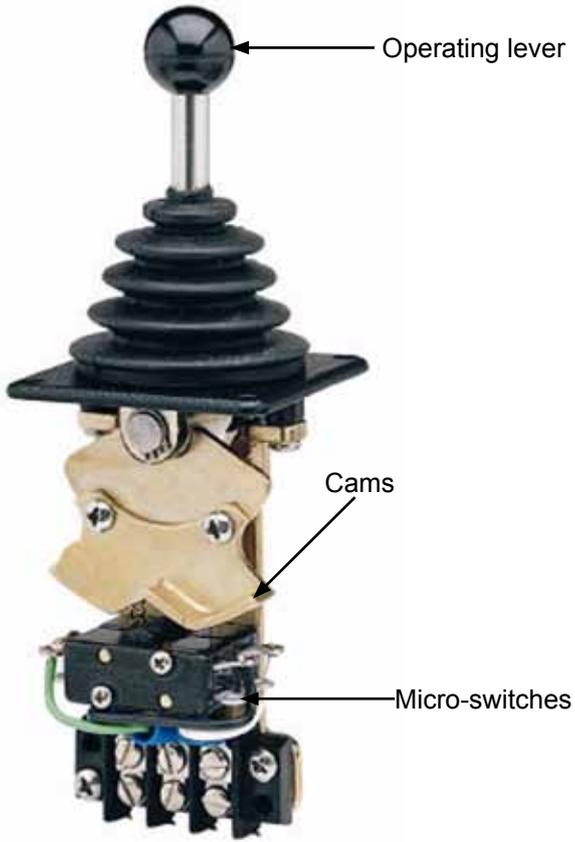
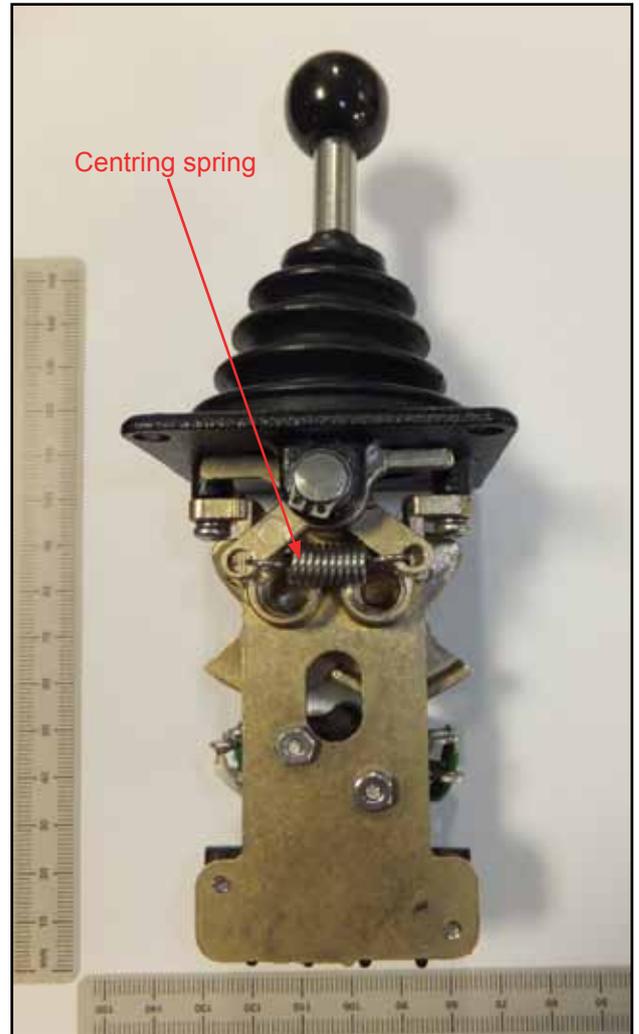
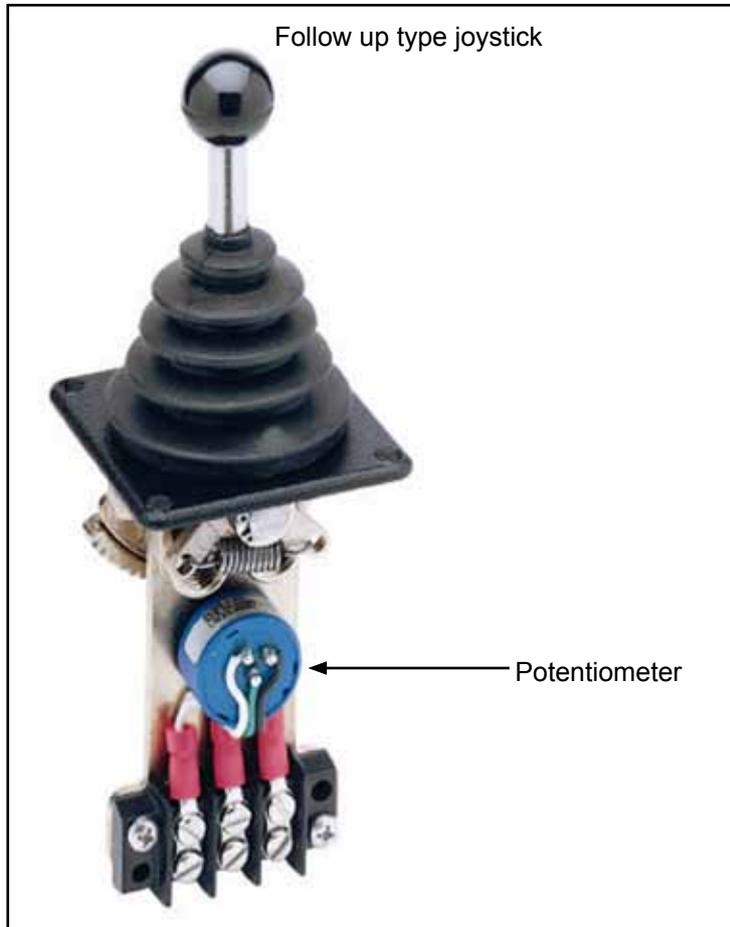
Figure 16: Kobelt model 7165 compact single axis joystick

The non-follow up joystick was fitted with a spring (**Figure 16**) that was designed to return the operating lever back to its central position when released. The centring spring fitted to the 7165 joystick was a closely wound helical coil type spring. It had crossover type hooks and was manufactured from grade 302, spring temper, stainless steel. The spring's theoretical cycle life was over 10,000,000 cycles for torsional stress and 159,331 cycles for bending stress.

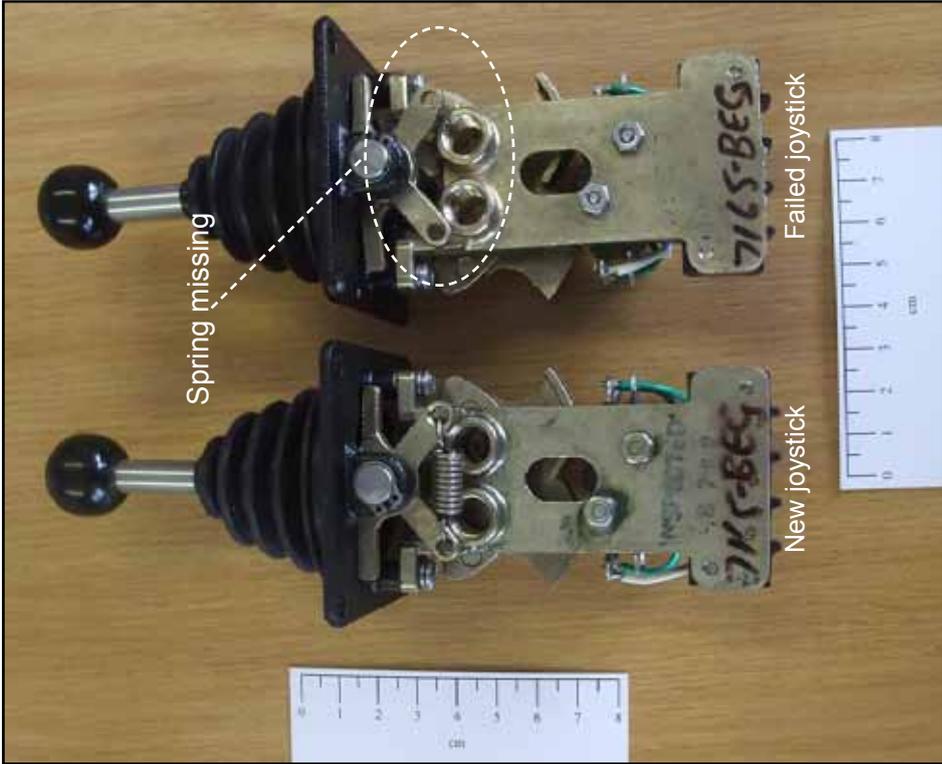
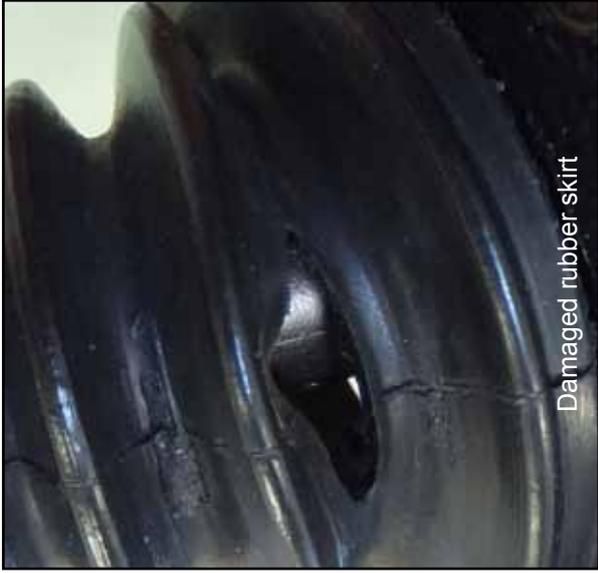
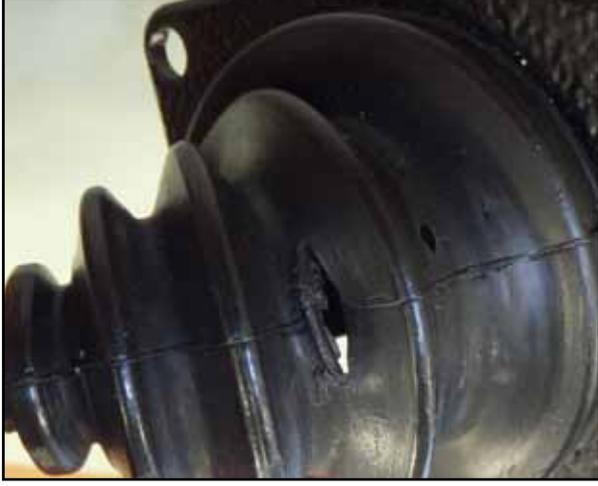
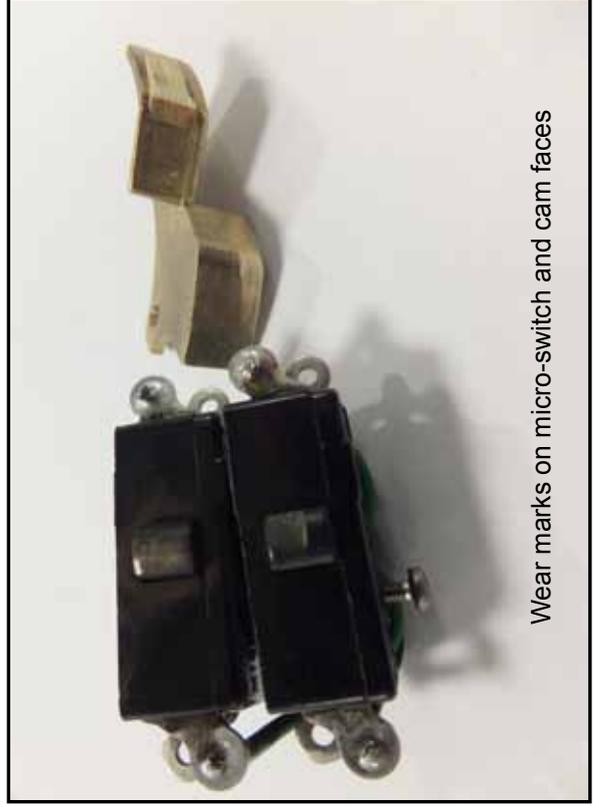
Figure 19: Failed joystick

On 12 January 2012, Thames Clippers advised the Marine Accident Investigation Branch (MAIB) that a similar Kobelt joystick fitted on board *Storm Clipper* to control her water jet buckets had failed. On this occasion, the company's service engineers recovered the centring spring (**Figure 20**). The spring had failed close to the root of one of its crossover hooks. The joystick had been fitted in October 2011 and was new at that time. Five days later, the centring spring of the new Kobelt joystick fitted to *Moon Clipper* after the accident in October, also failed (**Figure 20**). Again, the spring was recovered and was found to have suffered a similar fracture at the root of the spring hook.

This information was passed to Kobelt's head office in Canada, and was the first report the company had received of such a failure. Kobelt had sold 294 of its type 7165 non-follow up joysticks in the 2 year period prior to the accident, and all the springs fitted were of the same type and had been supplied by the same spring manufacturer. The spring manufacturer was instructed to investigate the cause of the failures and establish what improvements could be made. Its investigation concluded that the springs failed because they had suffered fatigue fractures at the small radius of the crossover hook. It recommended that the design of the hook be changed (**Figure 20**) to eliminate the small radius, and the grade of the stainless steel improved to increase the ultimate tensile strength of the spring. The recommended changes, adopted by Kobelt, increased the spring's theoretical cycle life for bending stress from 159,331 cycles to over 10,000,000 cycles.

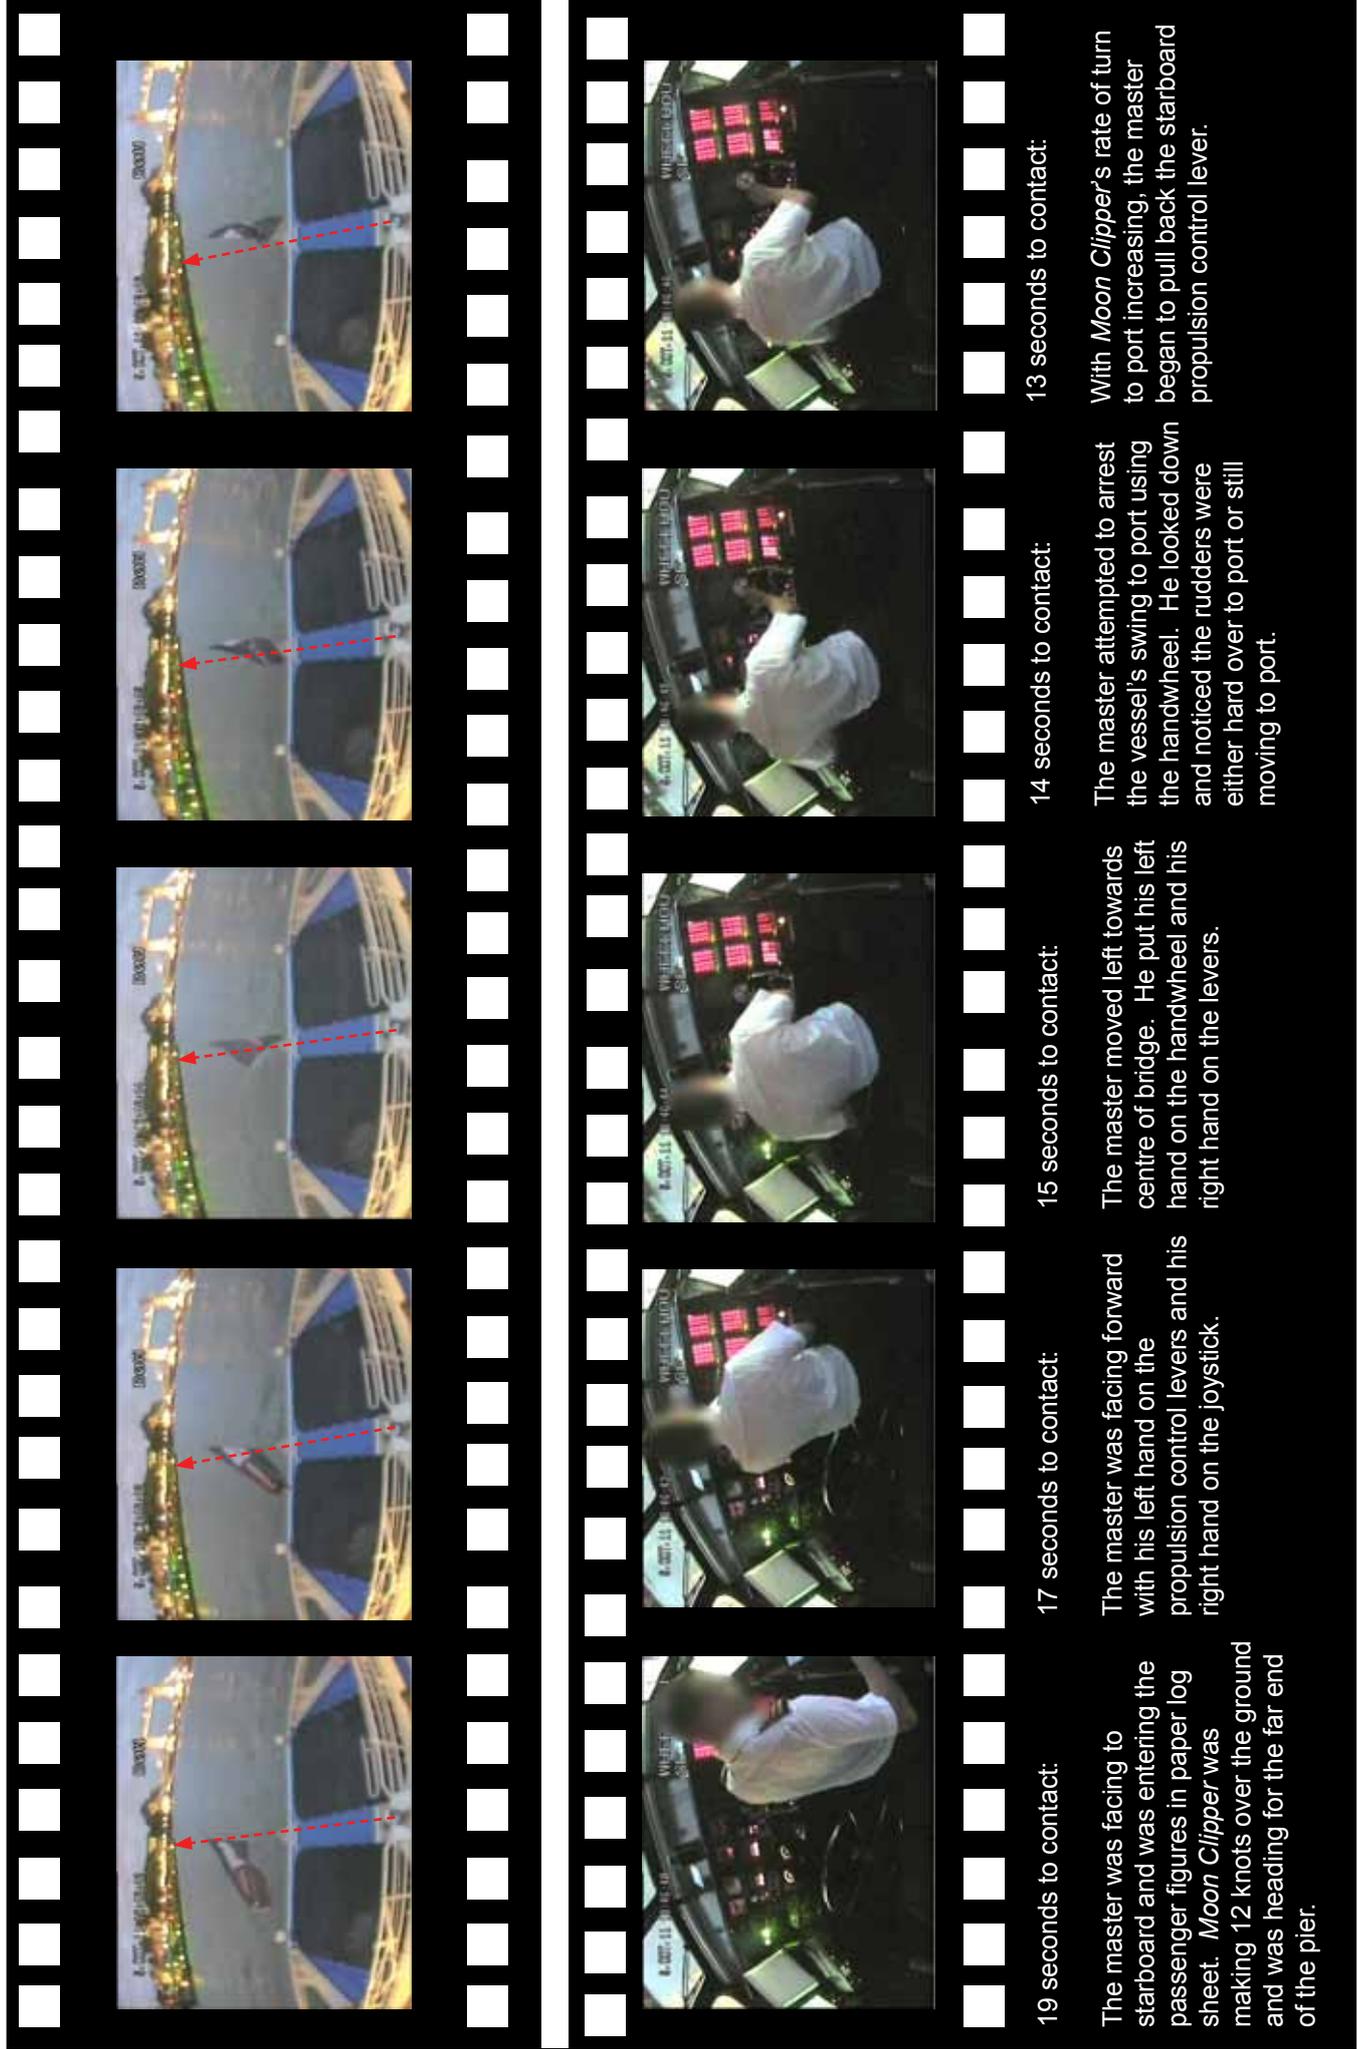
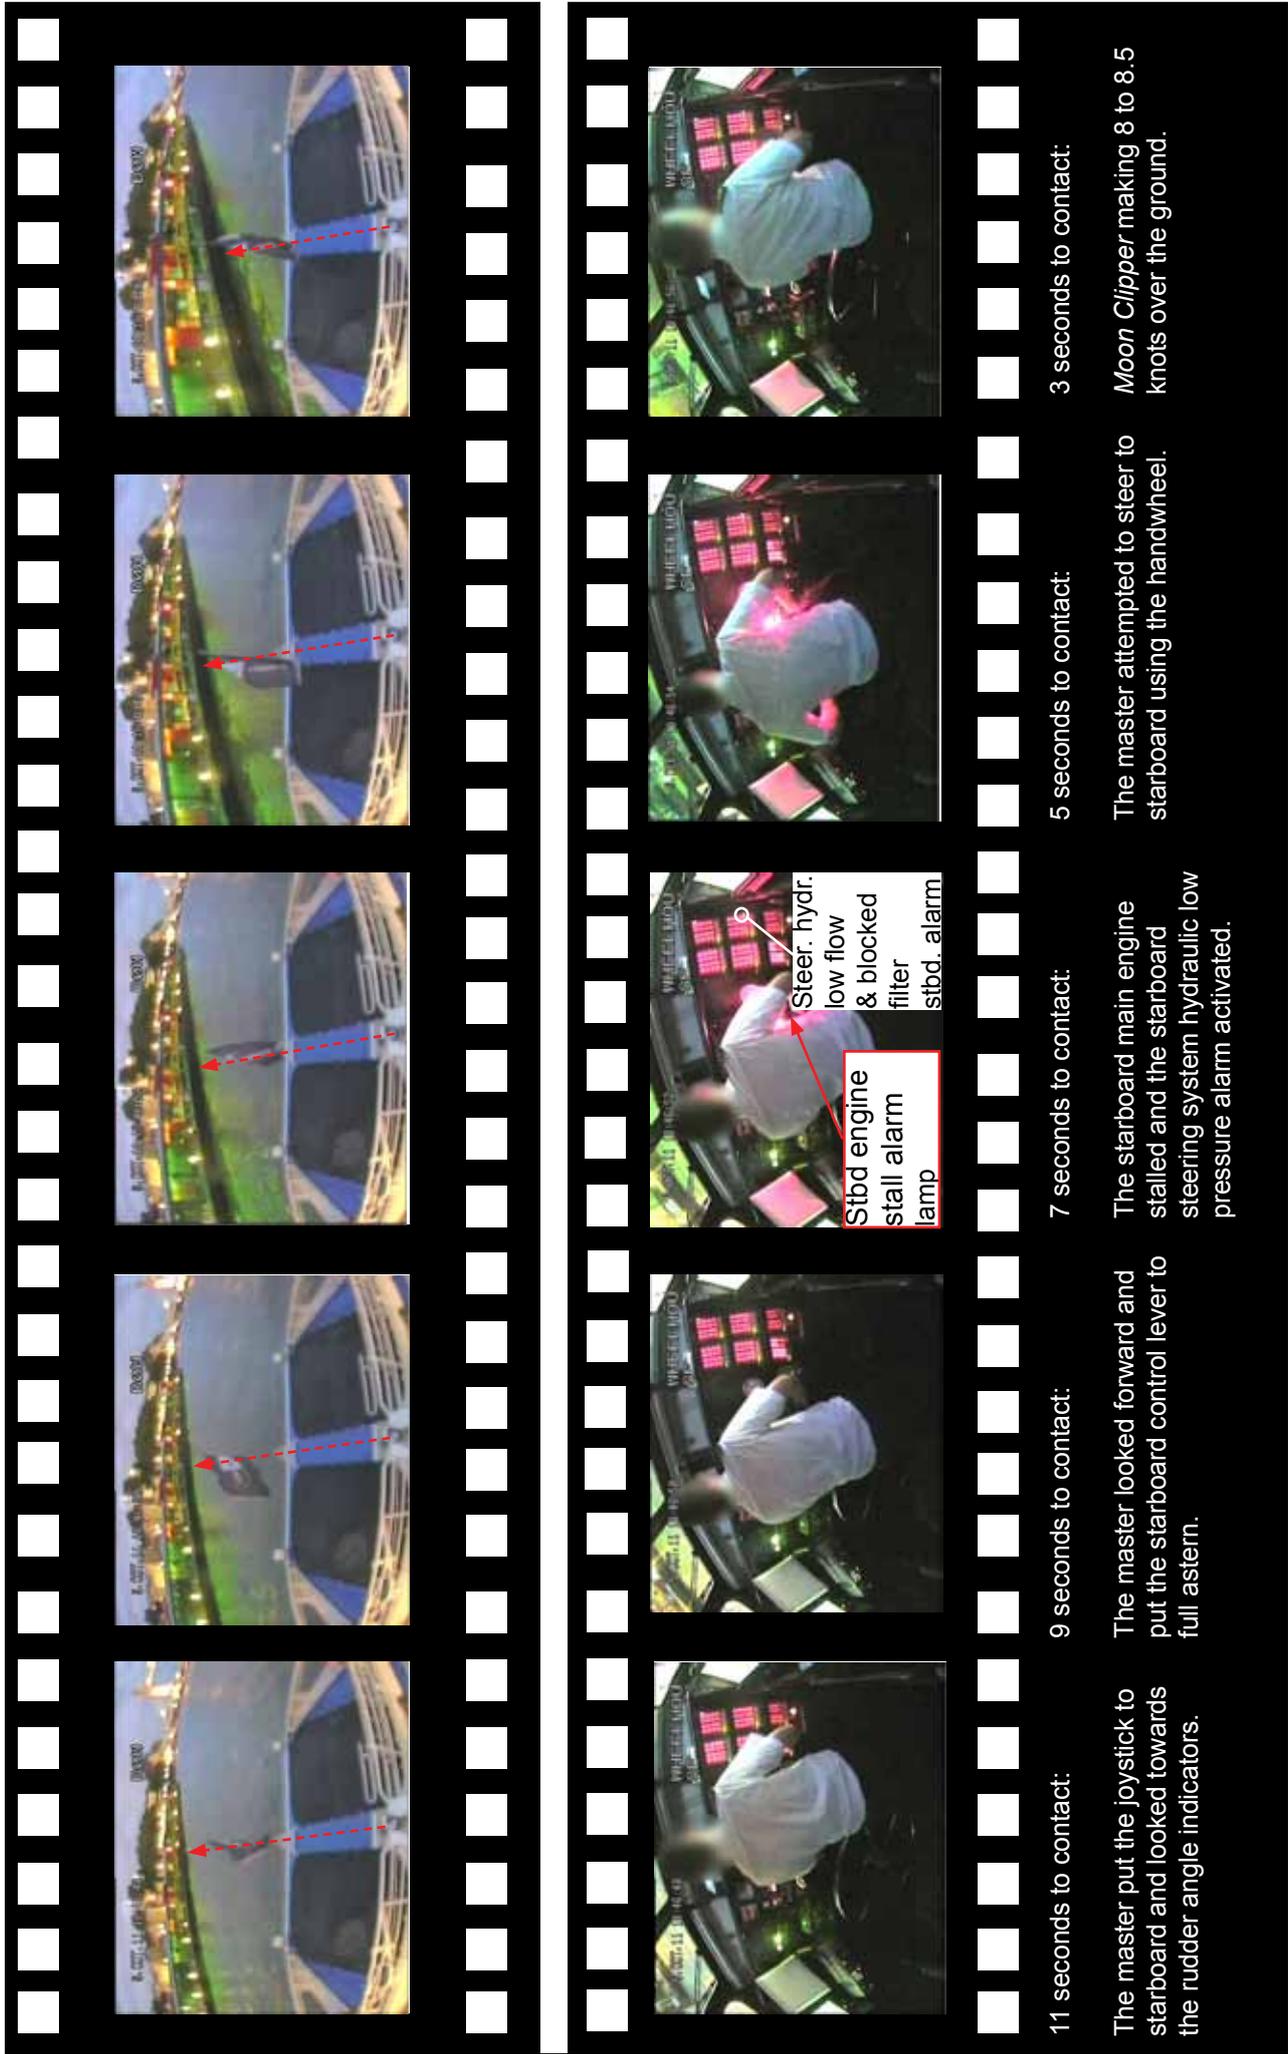
**Figure 22:** *Moon Clipper's* approach to Tower Millennium Pier (CCTV time local + 3 minutes)

The master was probably unaware of the developing situation at this point as he began to turn the wheel to starboard. It is likely, taking into consideration the results of the trials conducted after the accident (paragraph 1.15.3), that the master would have felt an unusually small amount of resistance when he moved the wheel. When the master looked down towards the rudder angle indicators, he probably saw the rudders were either still moving to port or were stuck hard over. As *Moon Clipper's* rate of turn was increasing, the master appeared not to be concerned by the situation, and he began to ease back on the starboard propulsion control lever.

With 11 seconds to contact, the master put the steering joystick over to starboard and appeared to be looking towards the rudder angle indicators again. Two seconds later he pulled the starboard lever to full astern. At that time, the joystick was stuck over to starboard and the rudders were likely to have reached an angle of about 15° to port. Almost immediately after putting the starboard lever to full astern, the

starboard engine stalled and its alarm lamp illuminated. In addition, the starboard steering system's hydraulic failure alarm sounded on the bridge console's machinery alarm panel.
