Report on the investigation of the
fatal accident to a crewman
on board
the fishing vessel

Starlight Rays PD230

126nm NNE of Aberdeen
on 25 August 2011

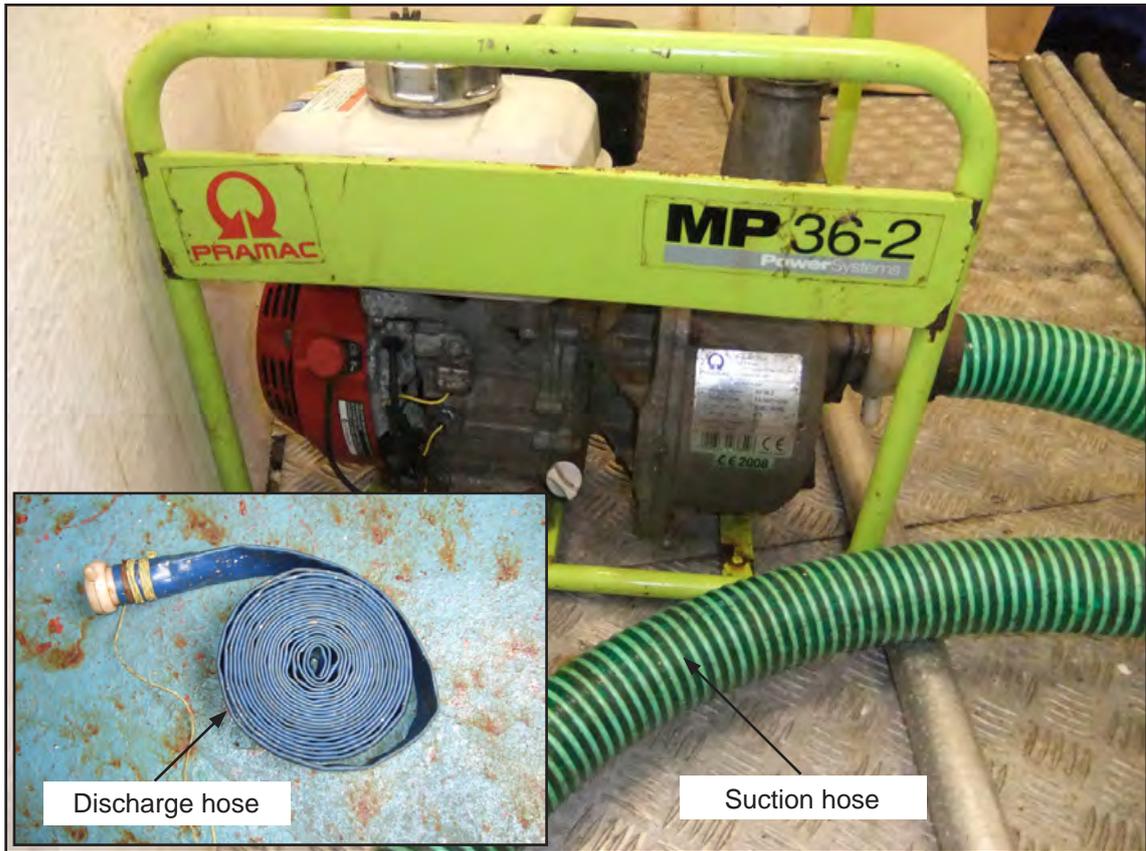
Figure 1: *Starlight Rays'* petrol engine-driven pump and hoses

The pump was purchased new and placed on board, along with a 5m length of semi rigid suction hose and a 15m length of flexible discharge hose (**Figure 1**), in June 2009. The crew last operated the pump to remove sea water from the fish hold around 4 days before the accident.

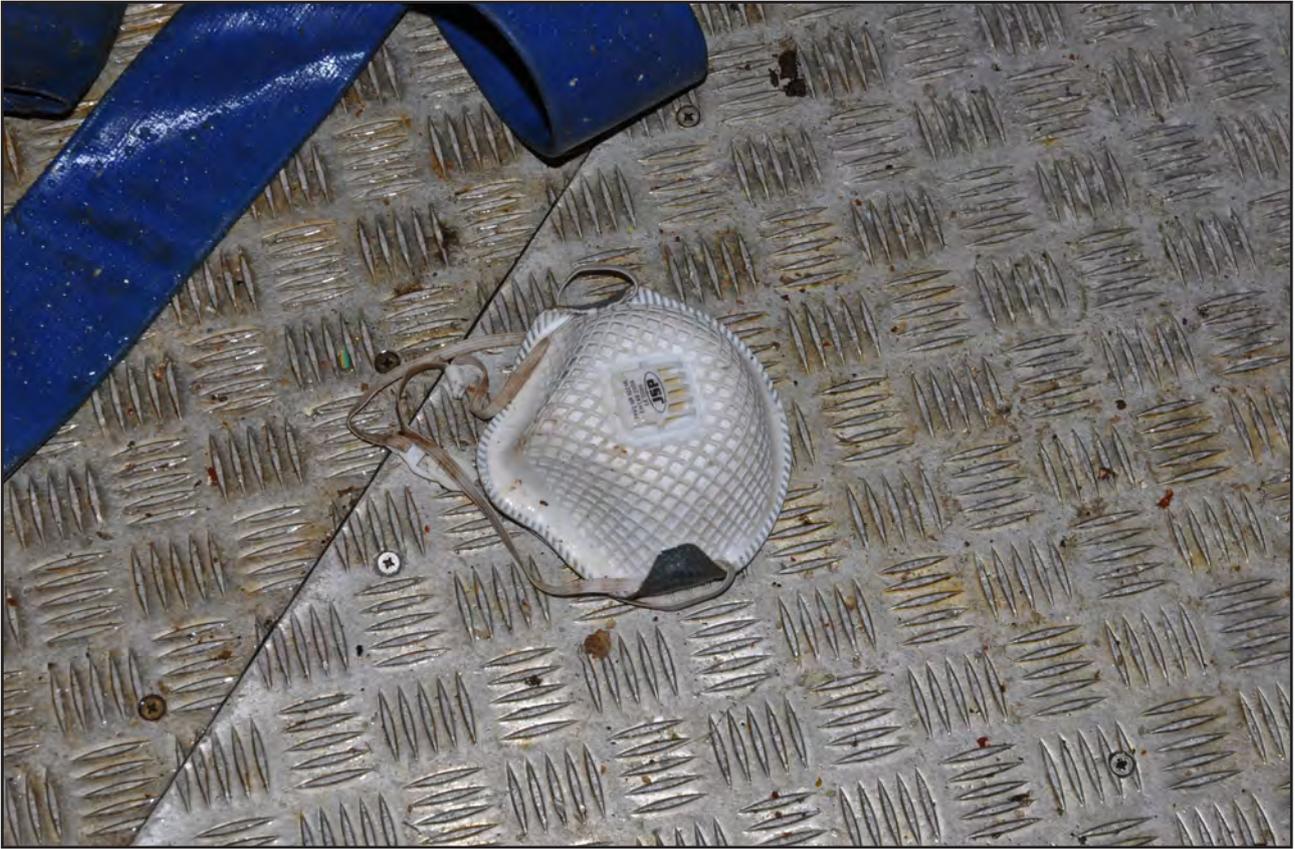
Figure 4: Dust mask used during rescue

The unconscious engineer was exposed to toxic CO gas throughout the rescue, and his condition would have continued to deteriorate. In an attempt to assist the engineer, the crew used a dust mask to cover his mouth. However, this mask provided no protection from the toxic gas as it was not designed for this purpose. Without oxygen or a supply of fresh air from a BA set there was no means of treating the engineer until external assistance arrived.

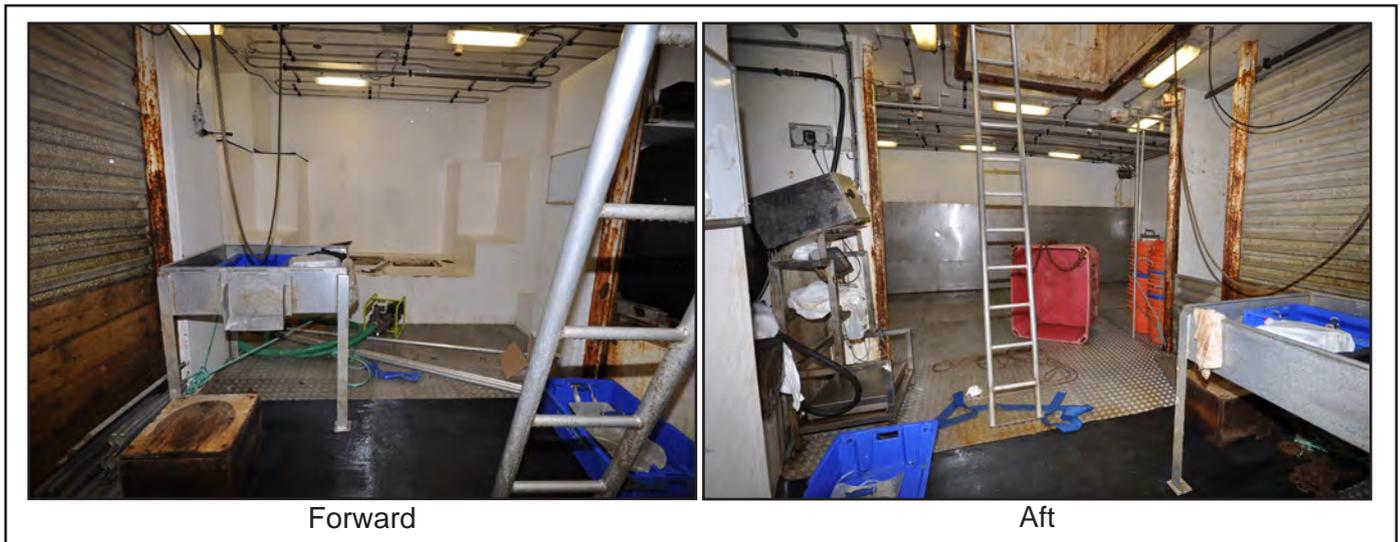
Figure 11: Fish hold forward and aft view

The refrigerated fish hold had an internal volume of 167m³. The hold had no forced ventilation system and its only natural ventilation was via the hatch opening(s). The main hatch cover contained two smaller hatches: one for loading fish and the other for crew access (**Figure 2**). At the time of the accident, the hold contained refrigeration pipework, a seawater slush ice tank, an ice storage bay and empty fish boxes (**Figure 11**). The fish hold had a bilge well at the aft end that connected to the fixed bilge pumping system. The bow thruster space was accessed via a hatch at the forward end of the hold.

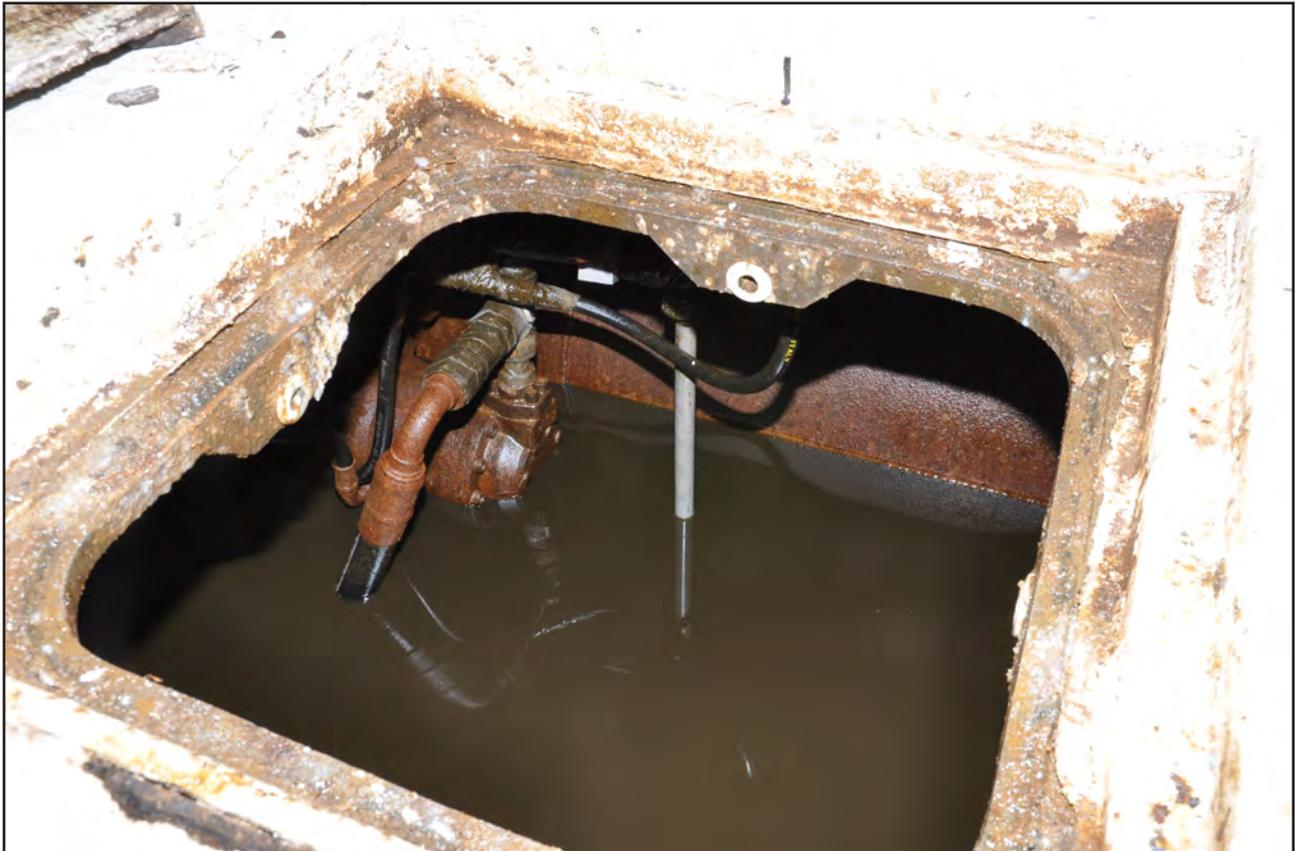
Figure 12: Bow thruster space and contents

The bow thruster's hydraulic motor was located in an otherwise void space at the forward end of the fish hold. The space had an internal volume of around 3m³. At the time of the accident it contained 1.8m³ of water mixed with about 0.25m³ of hydraulic oil (**Figure 12**). The space had been fitted with suction pipework at build that enabled the space to be pumped out using *Starlight Rays*' main bilge pumping system. However, the crew on board at the time of the accident did not know this. The oil had leaked from the bow thruster's hydraulic system and accumulated from several separate hydraulic system failures. Water, from the melting ice from the stowed fish boxes and the water used to wash down the hold once the fish had been landed, had entered the space through leaks around the hatch cover.

If the oily water overflowed into the fish hold it would spoil any fish stored on the deck. Consequently, the crew pumped out the bow thruster space about once or twice a year. This had been done by a variety of different methods in the past, including at least one attempt using a petrol engine-driven pump positioned in the fish hold. This had been done while the vessel was in port, with all the hatches open. The oily water was discharged into drums on the quayside and it was reported that it only took around 20 minutes for the pump to empty the space.

It is particularly tragic that the use of the petrol-driven pump could have been avoided completely. Proper inspection and maintenance of the bow thruster space hatch lid would have shown that the seal was not effective; if this had been replaced, water would not have accumulated in the space. There was also a fixed bilge suction line in the bow thruster space. If the crew had understood the system properly and been able to arrange the discharge into a storage tank, the oily water could have been disposed of safely and in accordance with MARPOL.

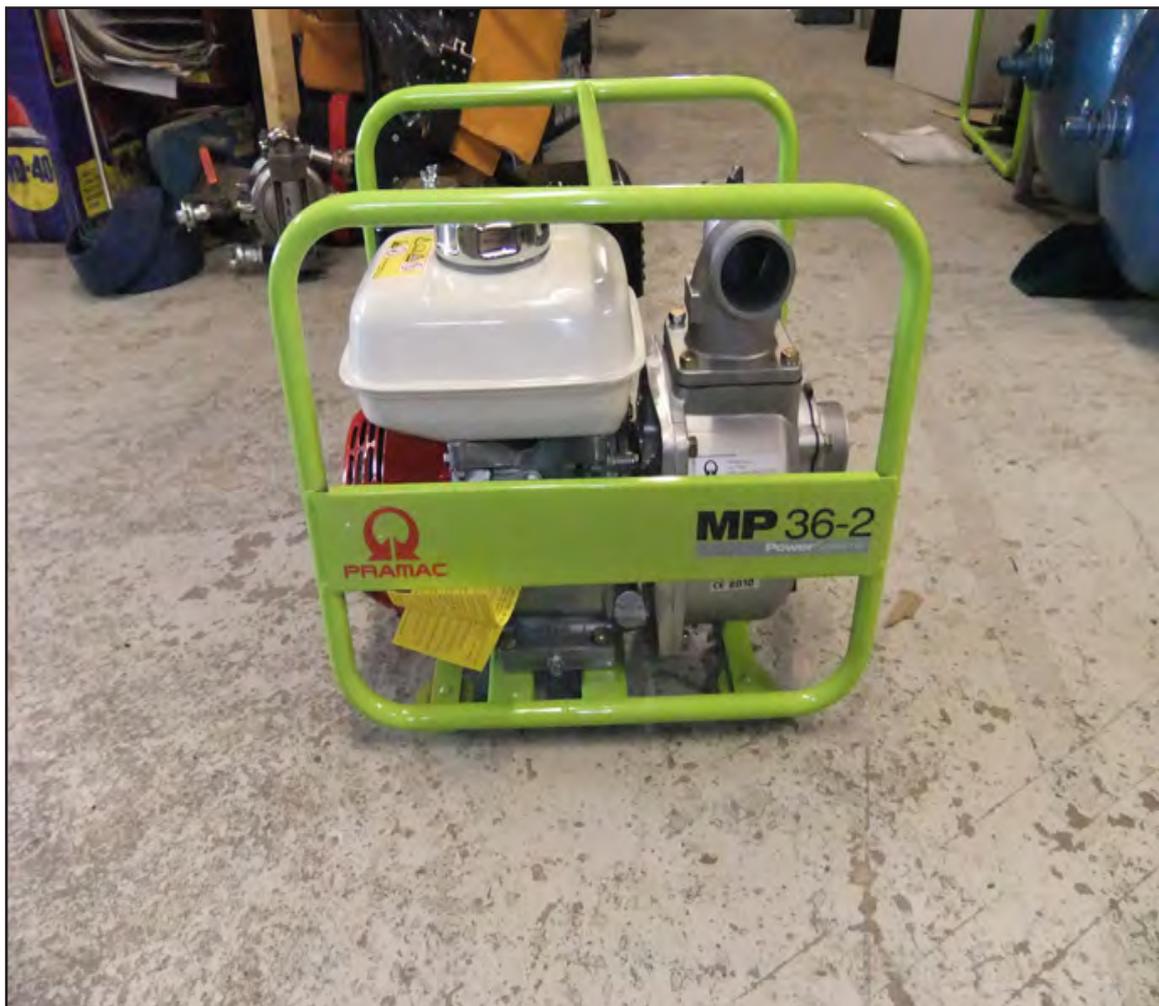
Figure 13a: Pramac MP 36-2 petrol engine-powered pump

Starlight Rays' petrol engine-driven salvage pump was a Pramac model MP 36-2 (**Figure 13a**); the petrol engine was a Honda model GX120 that produced 2.6kW of power. The pump was capable of producing a maximum flow of 600 litres per minute when not pumping against a pressure head. It was theoretically capable of pumping against a total head of 30m through a 50.8mm (2") outlet hose.

To test the pump under realistic load conditions, the analysts attempted to make the unit pump water, however the pump could not be made to prime. The analysis found that:

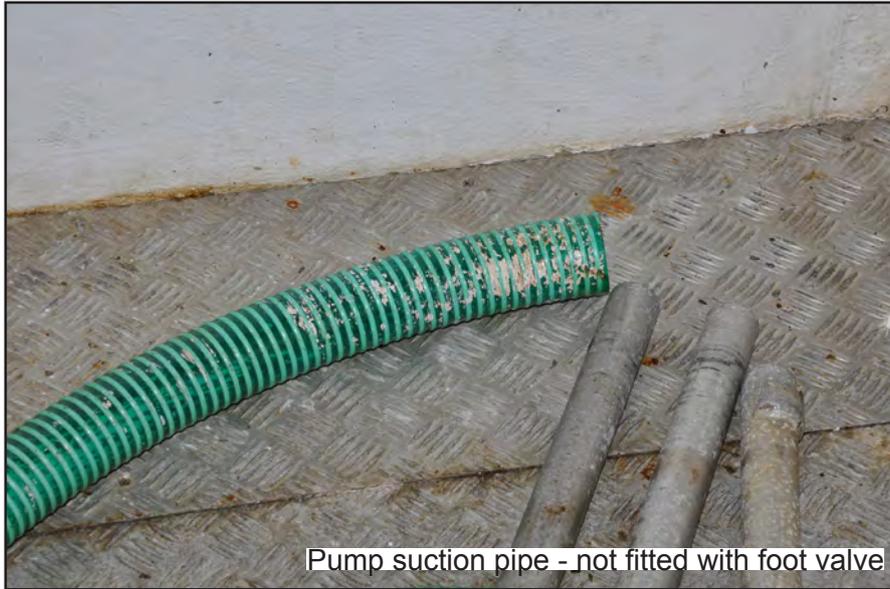
Pump suction pipe - not fitted with foot valve

Starlight Rays' salvage pump's suction hose was not fitted with a foot valve; there is no requirement or recommendation for one to be used. Fitting a foot valve to the suction hose enables a salvage pump to be primed higher above the water level, therefore reducing the need for crewmen to take the pump into internal spaces.

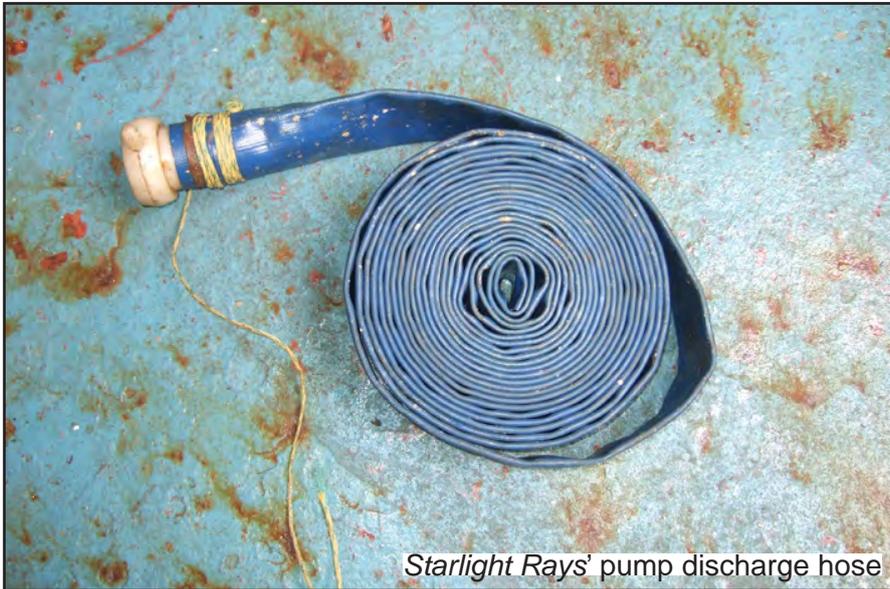
Starlight Rays' pump discharge hose

The flexible discharge hose on *Starlight Rays*' pump was not suitable for fitting to a fire nozzle and, with its open flexible end, it would have been difficult to make it form a jet of water that could be directed onto a fire. It was not possible to connect the portable pump's discharge hose to the fire main on *Starlight Rays* so that existing fire hoses and nozzles could be used if the main pump or the power supply failed. There is no requirement or recommendation for this simple capability to be provided on 15-24m fishing vessels.

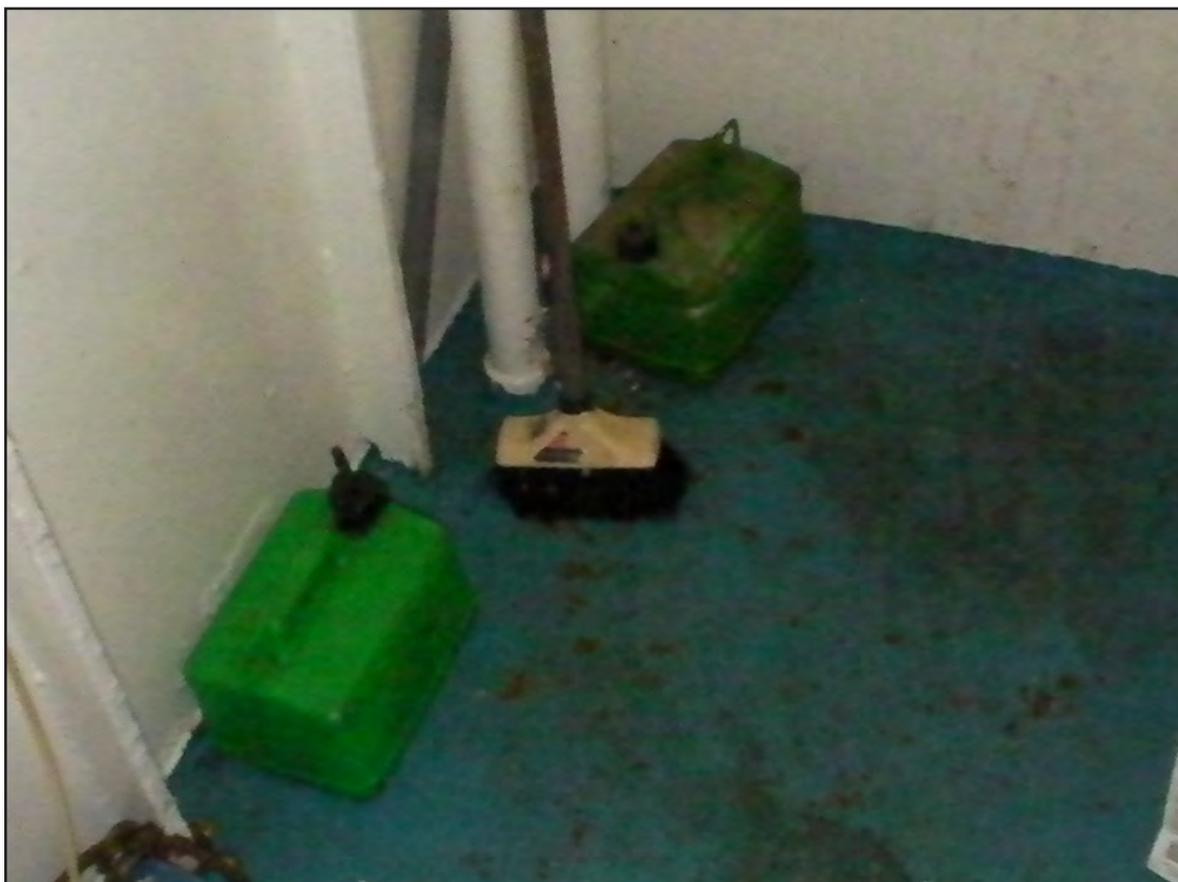
Figure 16: Petrol cans located inside the accommodation

Following the accident, two empty plastic petrol containers were found outside *Starlight Rays*' mess room, at the entrance to the weather deck (**Figure 16**). Prior to the accident the petrol was stored in a locker close to the crew accommodation. Storing petrol on board in this way introduces several possible hazards. The vapours from a leaking canister are flammable and can be ignited when exposed to an ignition source, the fire is then provided with the readily available fuel source from the petrol stored inside the containers. If a fire has already started for some other reason in a compartment where petrol is stored, it adds a considerable amount of fuel and creates a significant risk of an explosion. When the petrol is contained in a plastic, rather than a metal, container this risk is exacerbated. In larger, SOLAS⁷ sized vessels there is a requirement to store petrol in containers in a location where they can be easily jettisoned over the side in an emergency.

There is no regulation or guidance for the storage of petrol on board fishing vessels. The MCA advises its fishing vessel surveyors and inspectors to provide skippers with guidance on suitable places to store petrol during their visits on board if this is required.
