Report on the investigation of the accidental  
discharge of carbon dioxide on board

***SD Nimble***

resulting in serious injury to a  
shore-based service engineer  
at Her Majesty's Naval Base

23 August 2011

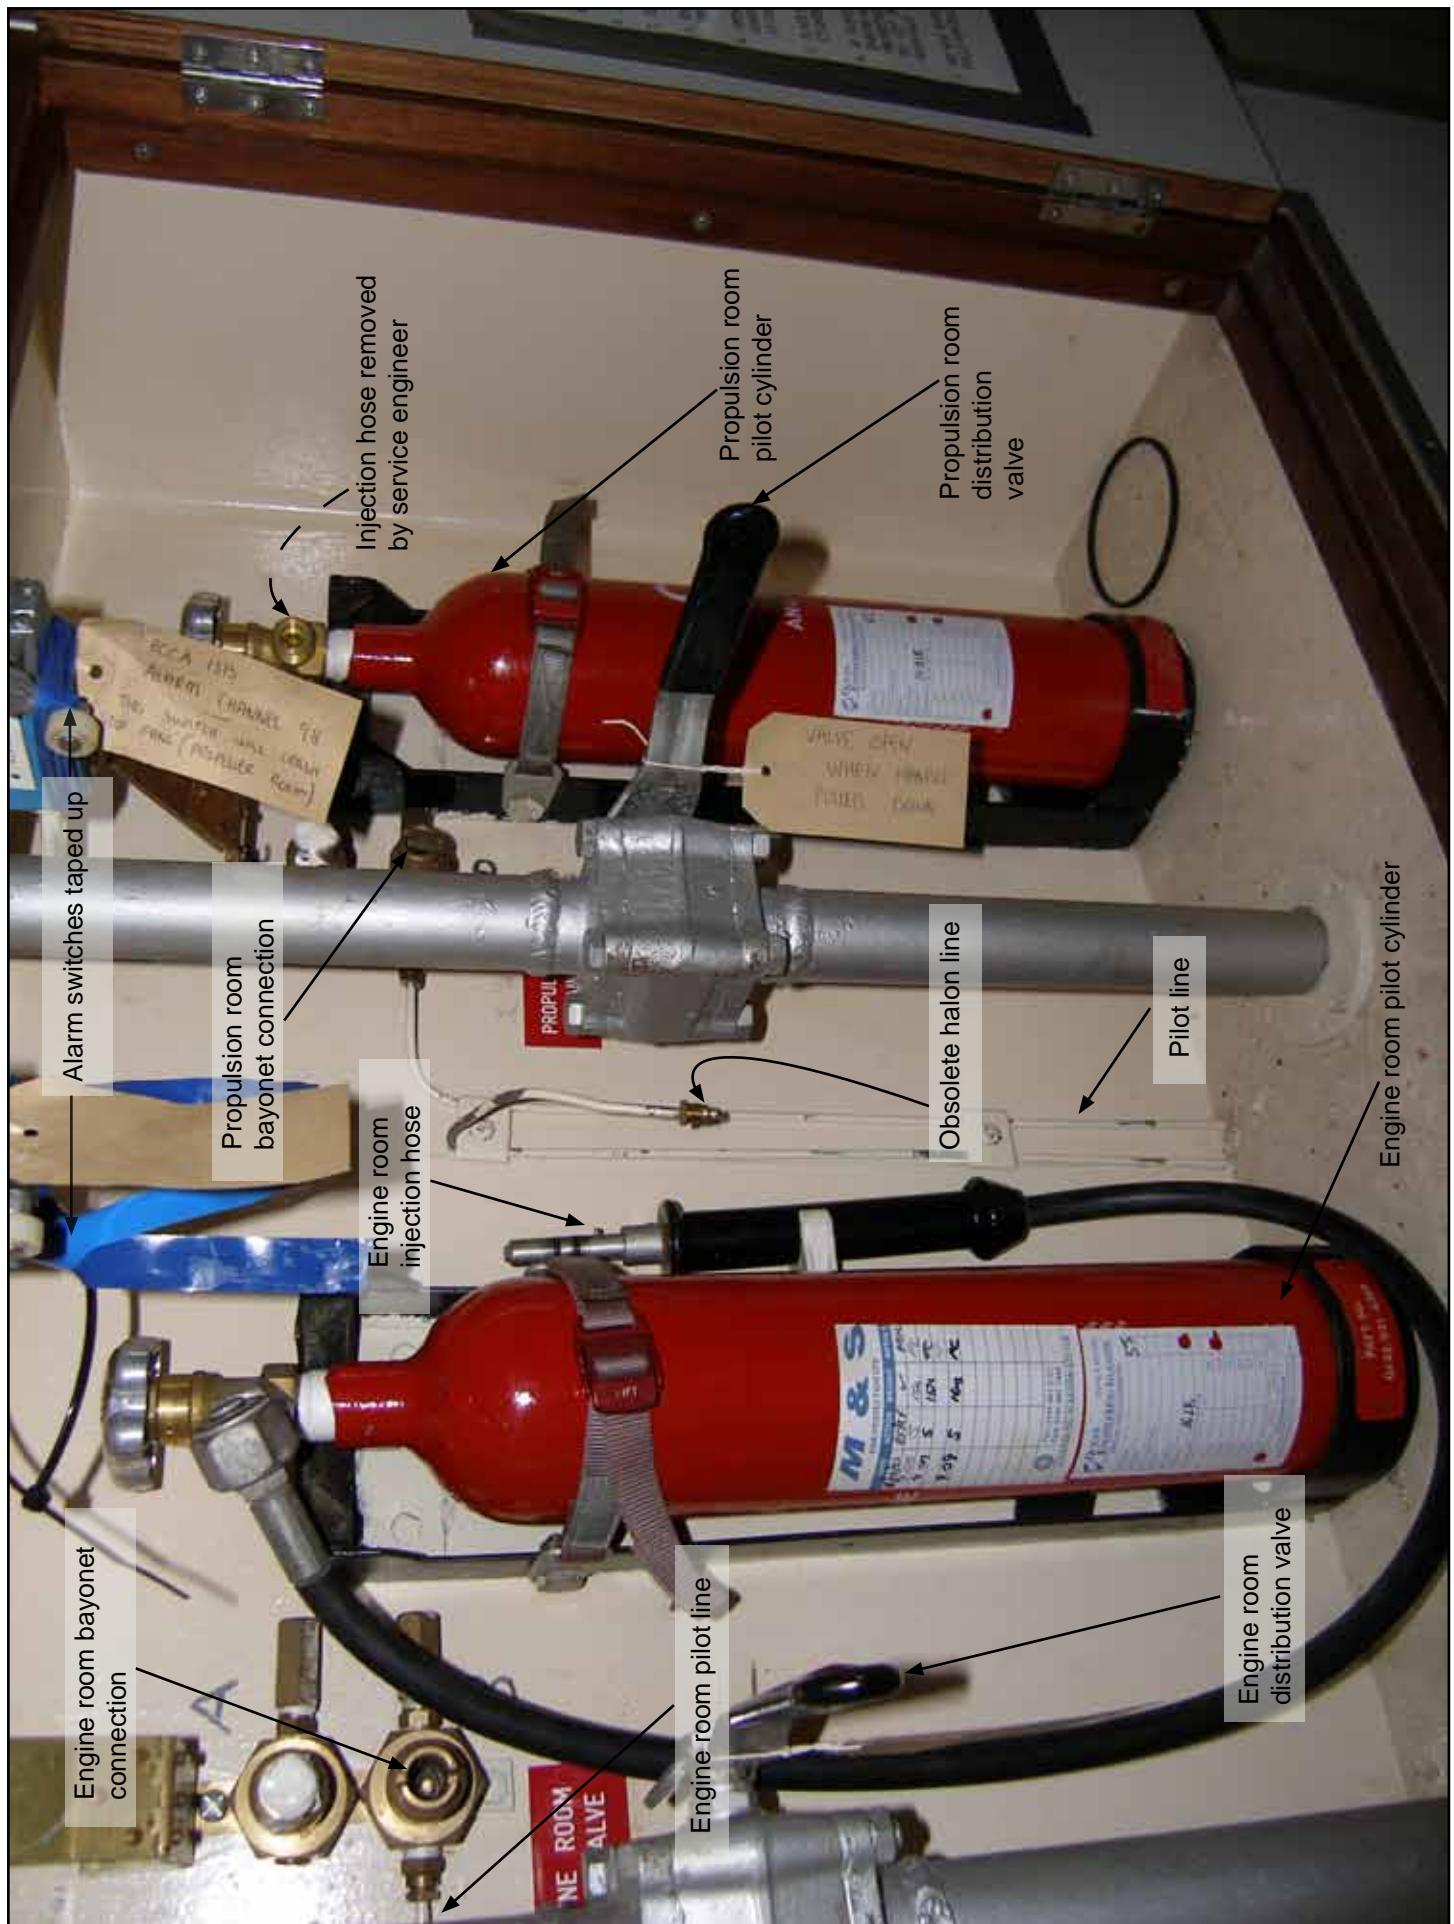
Figure 3: CO<sub>2</sub> control station

Meanwhile, the trainee engineer opened the doors of the CO<sub>2</sub> control station cabinet, which were not locked, and an alarm sounded. To silence the alarm, the trainee engineer started to secure the spring-loaded switches behind each of the cabinet's doors with tape. The chief officer was standing nearby, and shouted down to the chief engineer to let him know that the alarm was due to the service engineer opening the doors of the CO<sub>2</sub> control station. The chief officer then joined the master on the bridge.

Once the trainee returned on board, he weighed the two CO<sub>2</sub> pilot cylinders located inside the control station (**Figure 3**). He then disconnected the discharge hose from the propulsion room<sup>4</sup> pilot cylinder and fitted it to a portable test cylinder.

- The control station doors were open with an open padlock on the hasp.
- The ‘break glass’ key holder was intact with a key inside.
- The pilot cylinder hose serving the propulsion room was disconnected.
- The pilot cylinder hose for the engine room was connected to the cylinder; its bayonet end was secured in a bracket.
- The engine and propulsion room distribution valves were open.
- The spring switches on the cabinet doors were taped back.
- A CO<sub>2</sub> test cylinder with hose, with a bayonet connection attached, and other equipment, were found adjacent to the control station cabinet. The equipment included a clipboard with a blank service report attached (**Annex A**), a tool bag, scales, an adjustable spanner and one anti-recoil cap (from test cylinder).

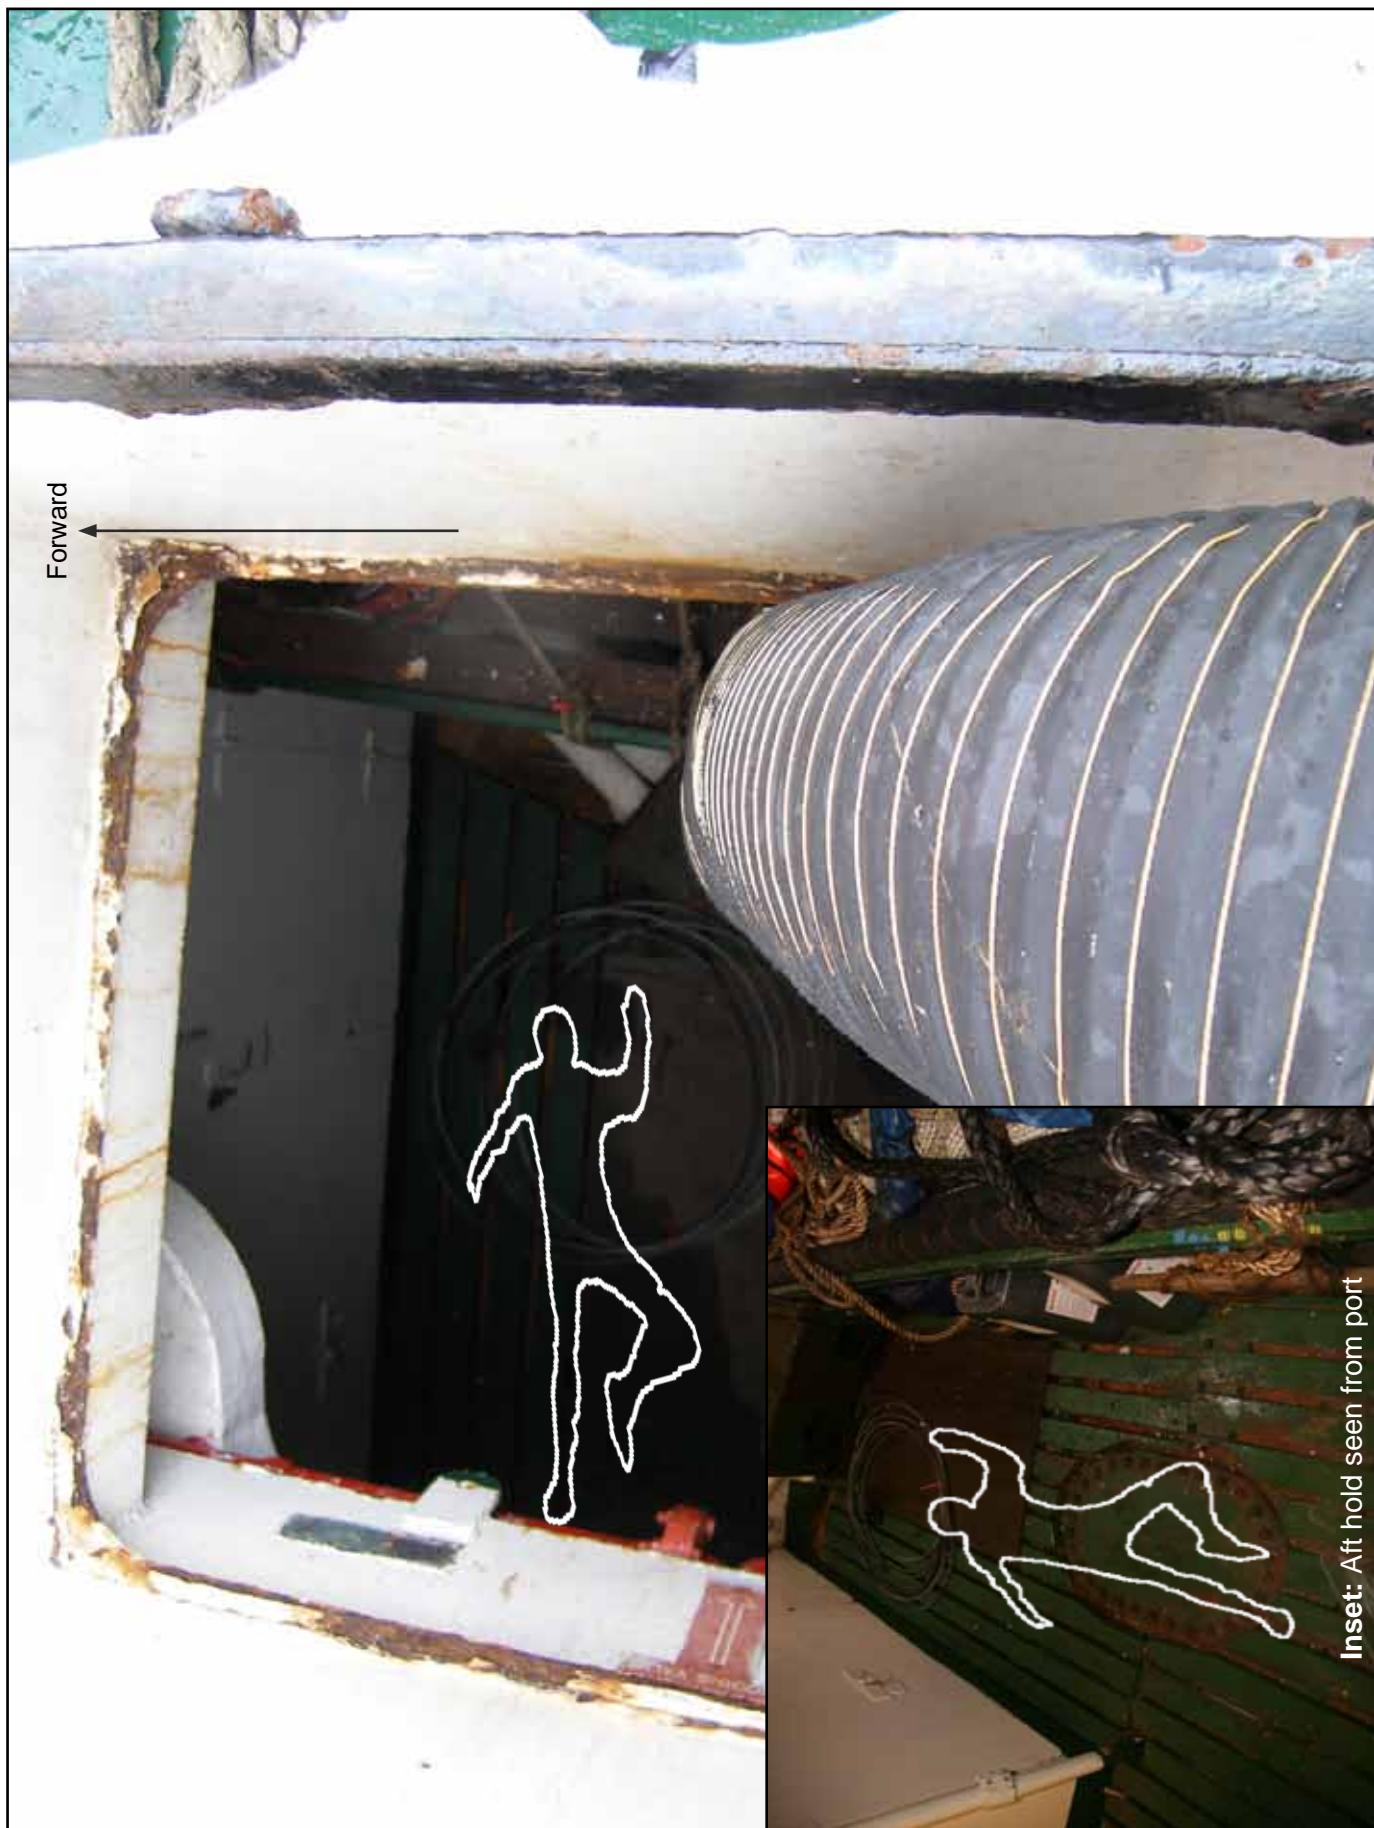
**Figure 6:** Position of the service engineer from the top of the access hatch

It is evident from the escape of the CO<sub>2</sub> through the deck hatch, that the CO<sub>2</sub> rapidly filled the cylinder room and the aft hold. The location in which the senior engineer was found (**Figure 6**) indicates that he tried to escape. However, he would have quickly been overcome by his inhalation of CO<sub>2</sub> which would have been rapidly increasing in concentration.

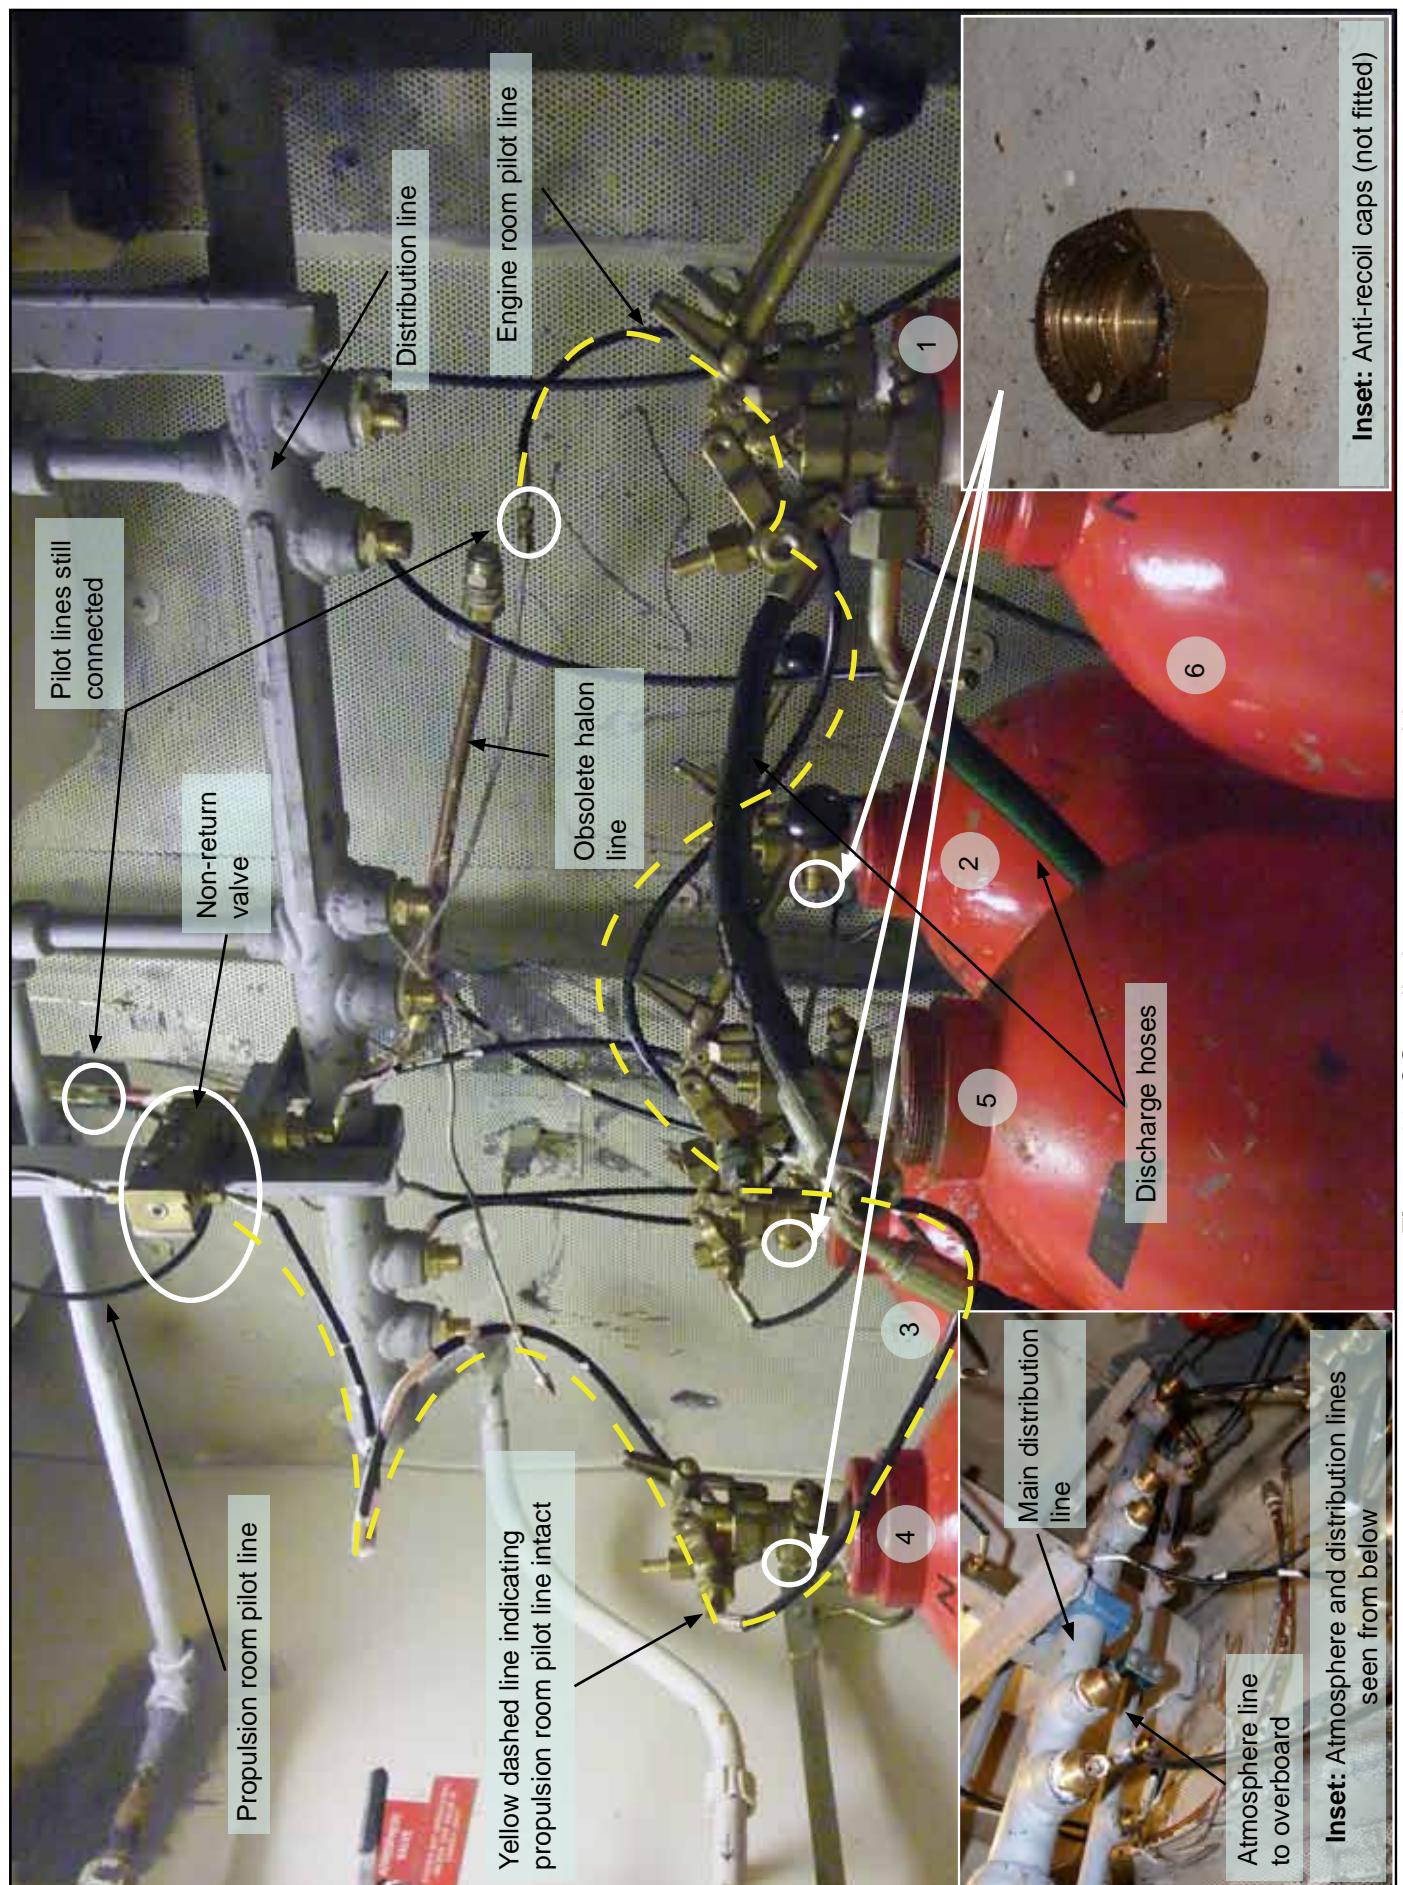
Figure 10: CO<sub>2</sub> cylinder room post accident

#### CO<sub>2</sub> cylinder room (**Figure 10**)

- The flexible discharge hoses were loosely connected to cylinders 1, 5, and 6 but they were disconnected from the distribution line. The fittings on the disconnected ends of the hoses were damaged.

- There was minor damage to pipework and paint.
- A screwdriver was on the deck.

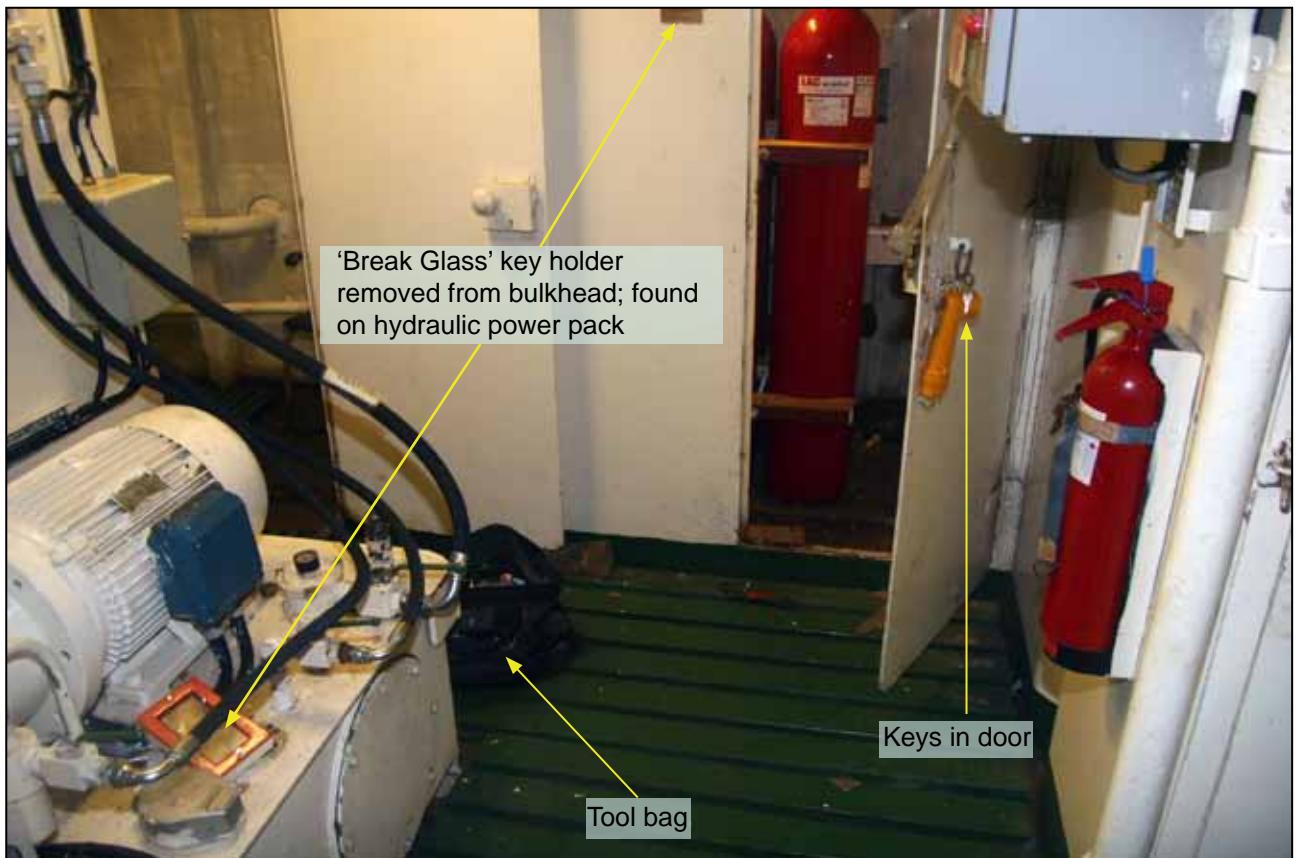
**Figure 11:** Aft hold post-accident

### Aft hold (**Figure 11**)

- Blood was found on the deck in the vicinity of the access hatch.
- One anti-recoil cap was found on the deck.
- The ‘break glass’ key holder was lying on top of a hydraulic power pack.
- An adjustable spanner and tool bag were lying on the deck by the CO<sub>2</sub> cylinder compartment door. Among other items, the tool bag contained two anti-recoil caps.
