Flooding and foundering of **VELLEE** in the Little Minch 6 August 2011

SUMMARY

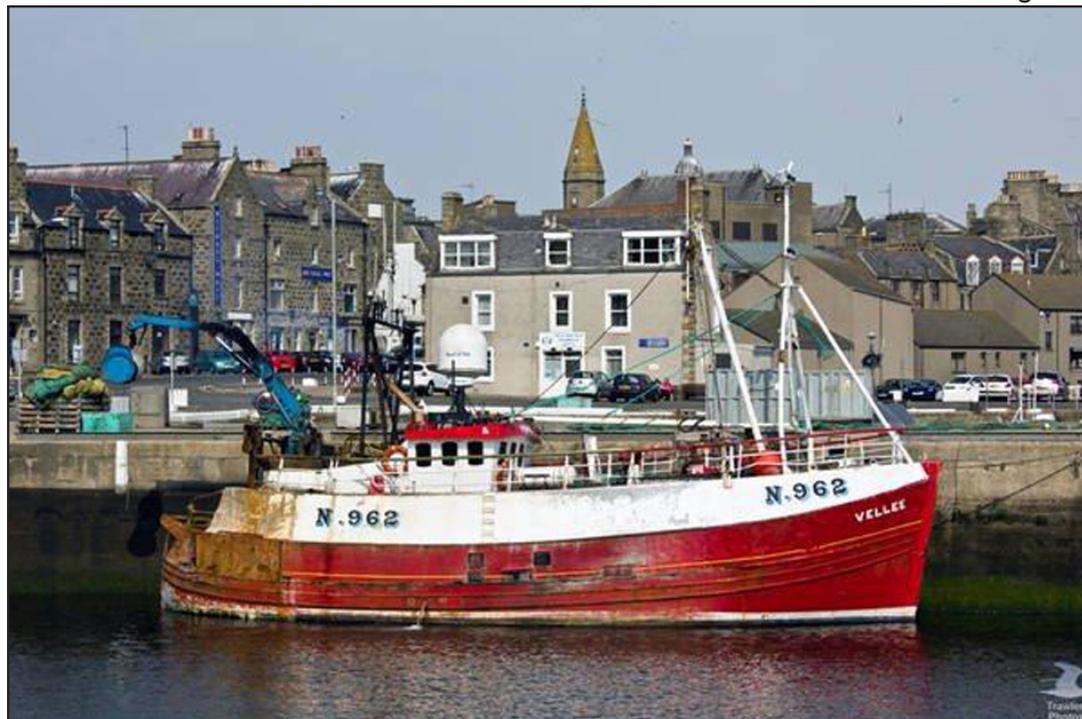
Figure 1

fv *Vellee*

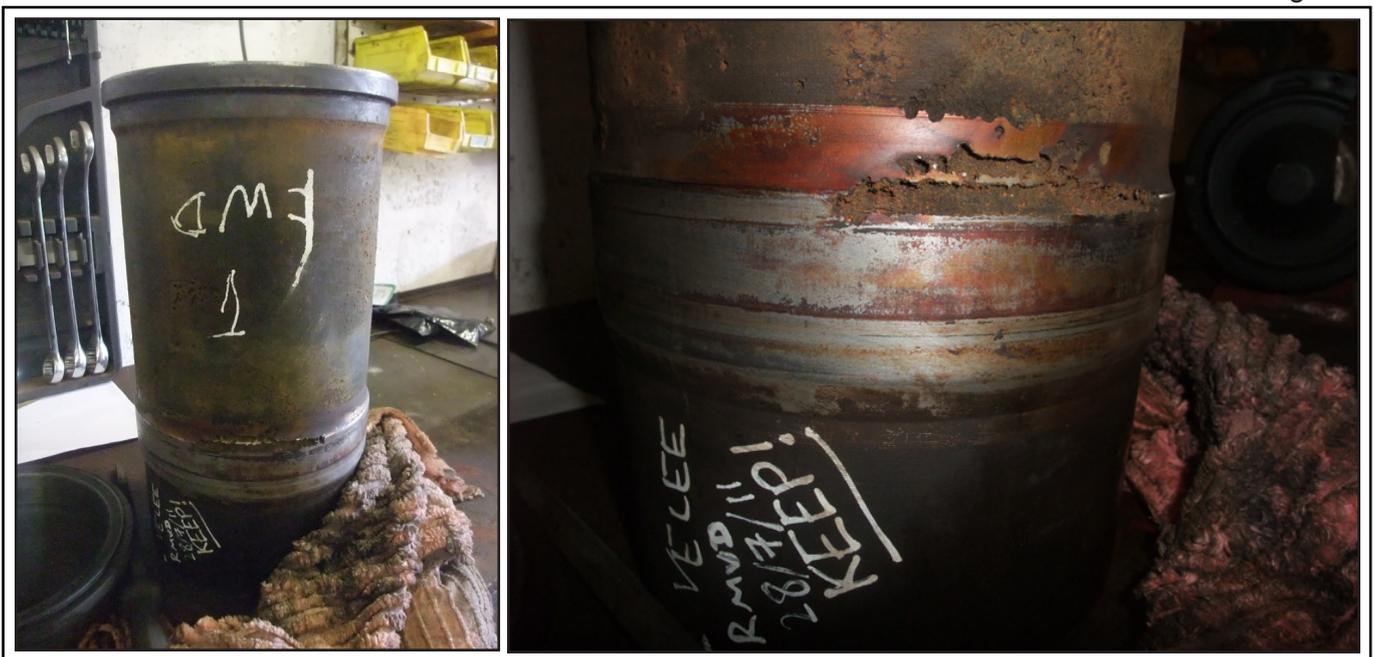
Figure 2

During main engine repairs a few days before *Vellee*'s final voyage, it was discovered that two of her eight main engine cylinder liners had suffered extreme electrolytic corrosion, reducing their thickness by 85% in places (**Figure 2**). The engineering company carrying out the work advised the owners to have an electrician investigate the cause of the electrolytic action. The subsequent investigation found that the main engine earth bonding strap was missing and that there was an earth fault on one of the vessel's radio installations. The electrician's opinion was that these faults could have caused the electrolytic corrosion of the cylinder liners. No further inspections were instructed or carried out to establish if electrolytic action had affected any other areas in the vessel.

Electrolytic corrosion on *Vellee*'s cylinder liner

Two of the vessel's main engine cylinder liners needed to be replaced as a consequence of severe electrolytic corrosion only days before her final voyage. It is highly probable that electrolytic corrosion had also affected the vessel's sea water piping and associated fittings, weakening their integrity and ultimately causing a failure.

- Improve the planned maintenance and inspection regimes on all vessels in which they hold an interest, with particular focus on the integrity of sea water systems, hull fittings and identification and prevention of electrolytic corrosion.
