Report on the investigation of the
fatal accident of a crew member
on the Woolwich ferry

Ernest Bevin

on the River Thames, London

3 August 2011

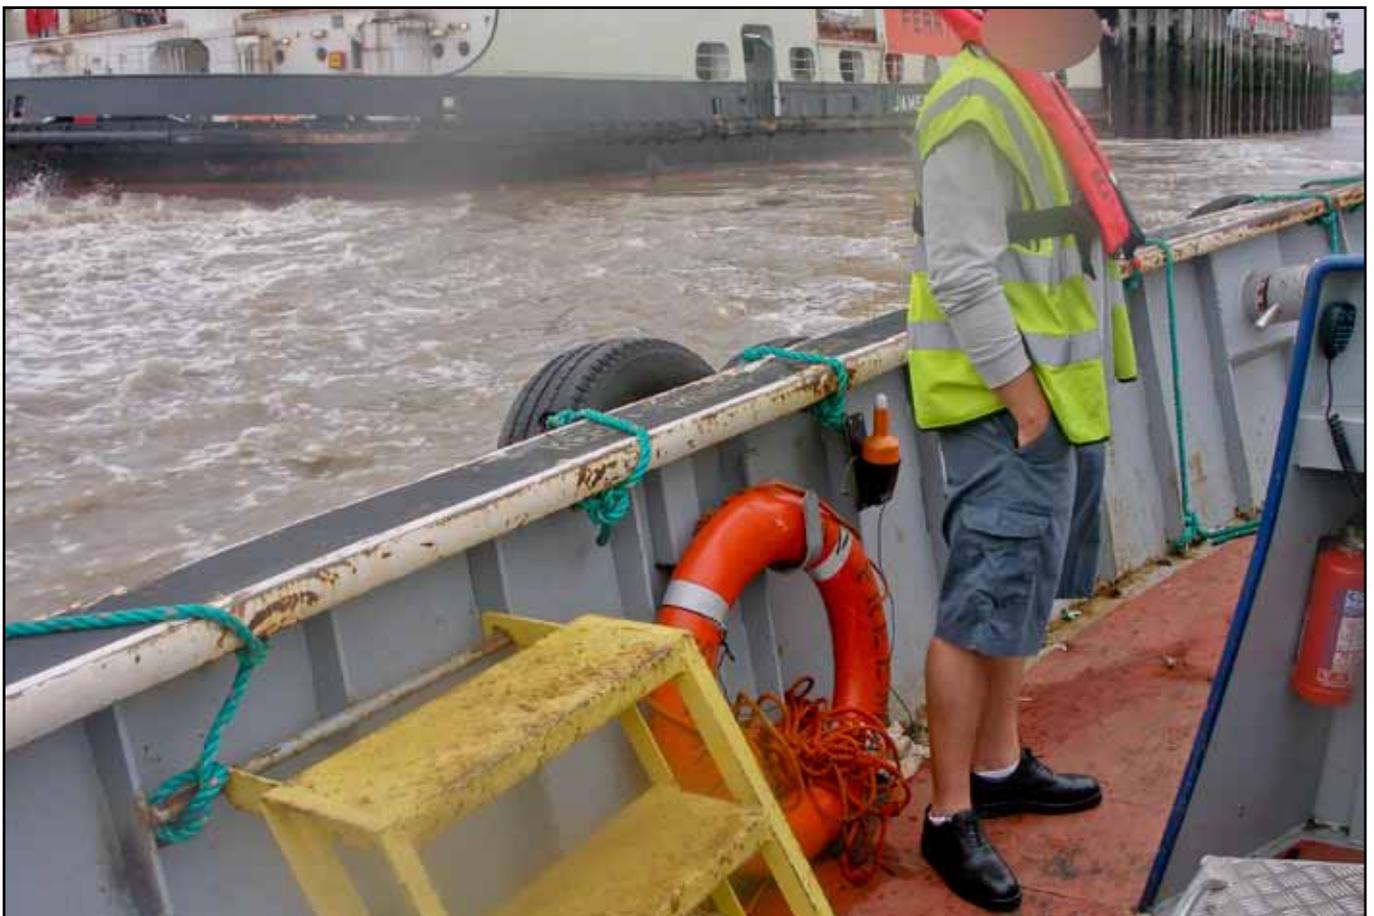
Figure 6b: Workboat deck and relative height of bulwark for manoverboard recovery

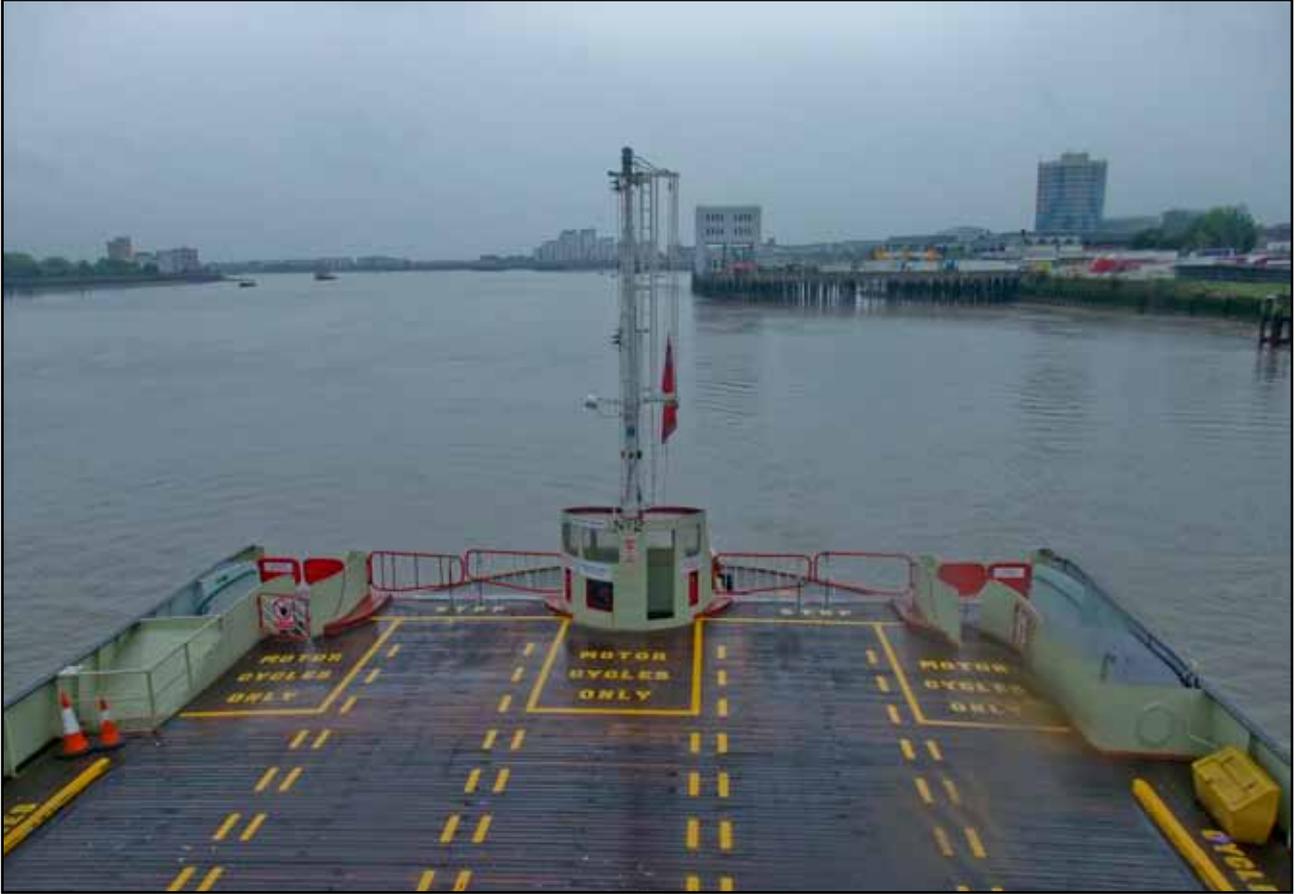
Figure 9: Master's view from control platform towards the mooring deck while moored to buoys
(Note: The obstruction posed by the traffic control hut and the lack of visibility of the mooring buoy)

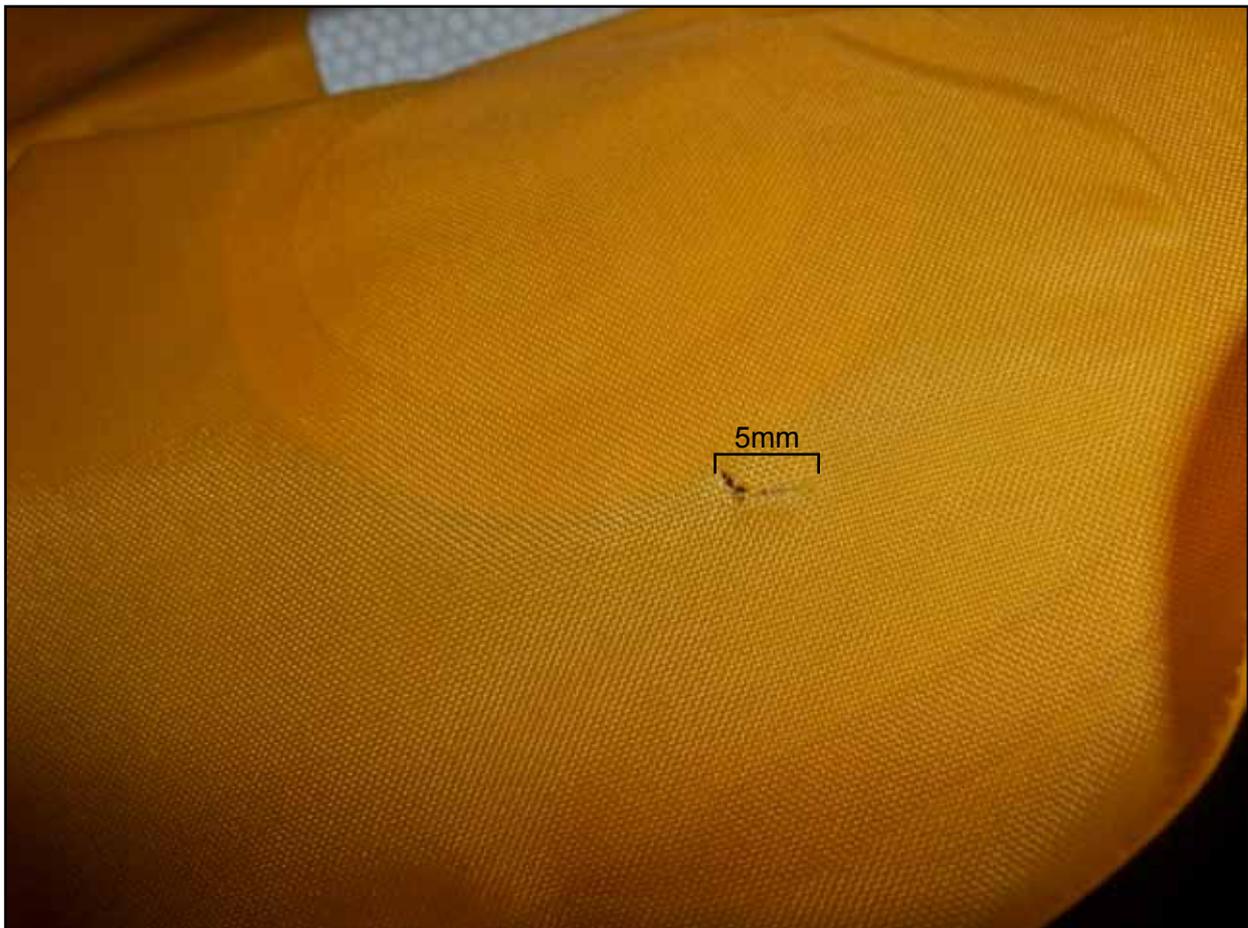
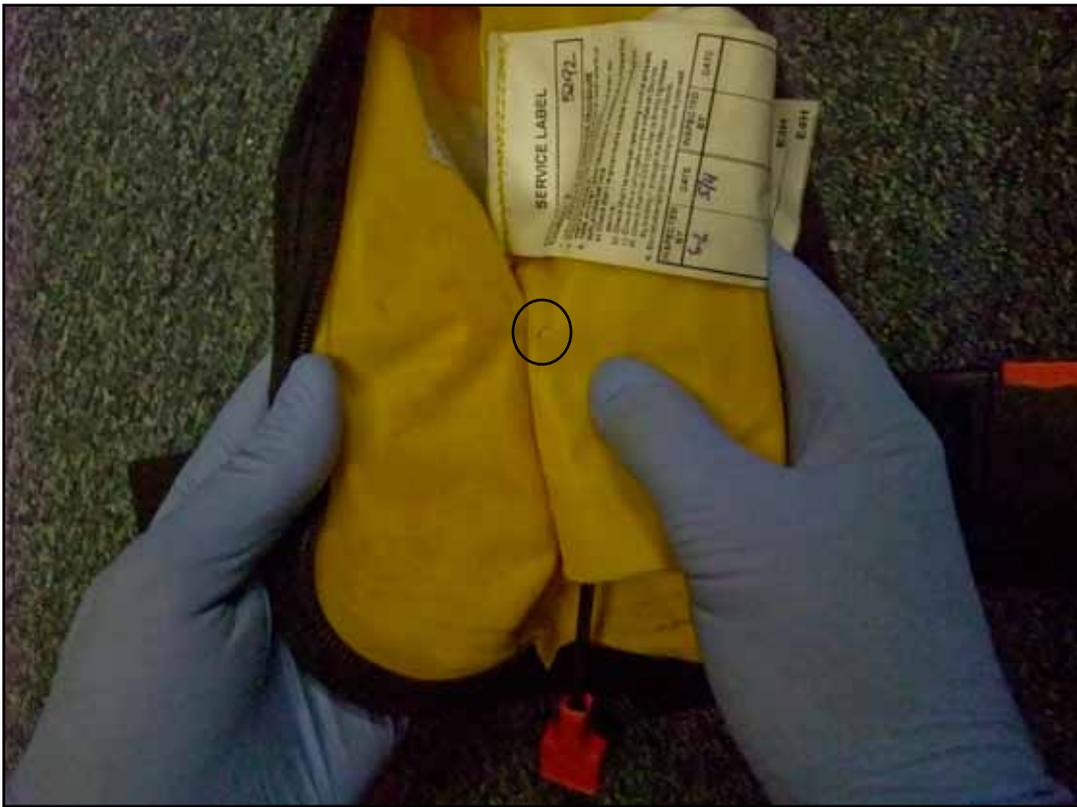
In the accident, the lifejacket suffered an impact in way of the operating head sufficient to cause a 5mm hole in the lifejacket's chamber (**Figures 11a and 11b**), and there was paint residue on the outer cover and buckle (**Figure 12**), consistent with the paint on the bulwark top rail. A zip toggle from Benjamin's lifejacket, and a set of nail clippers from his pocket, were found on the rubbing strake⁵ outboard of the bulwark that Benjamin crossed when he went overboard (**Figures 13a and 13b**).

Figure 11a: Lifejacket puncture

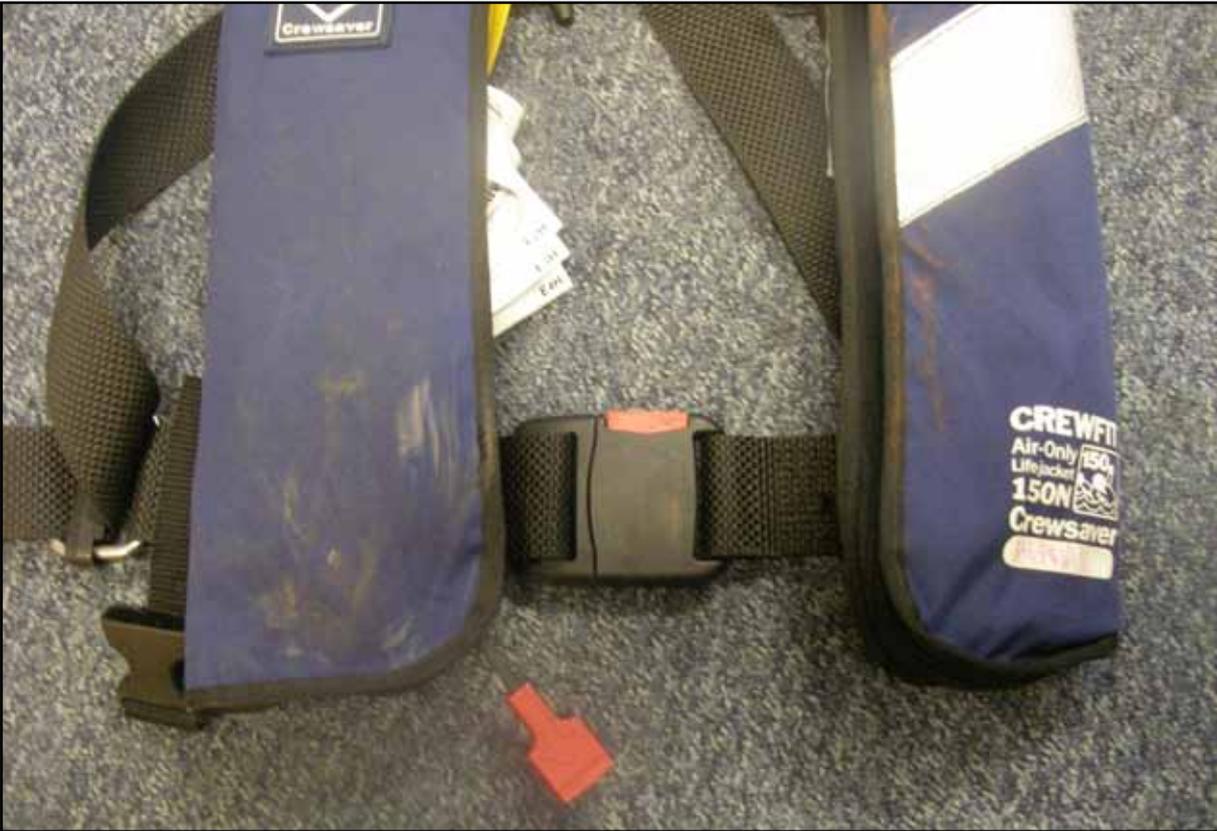
Figure 12: Bulwark rail paint residue on lifejacket

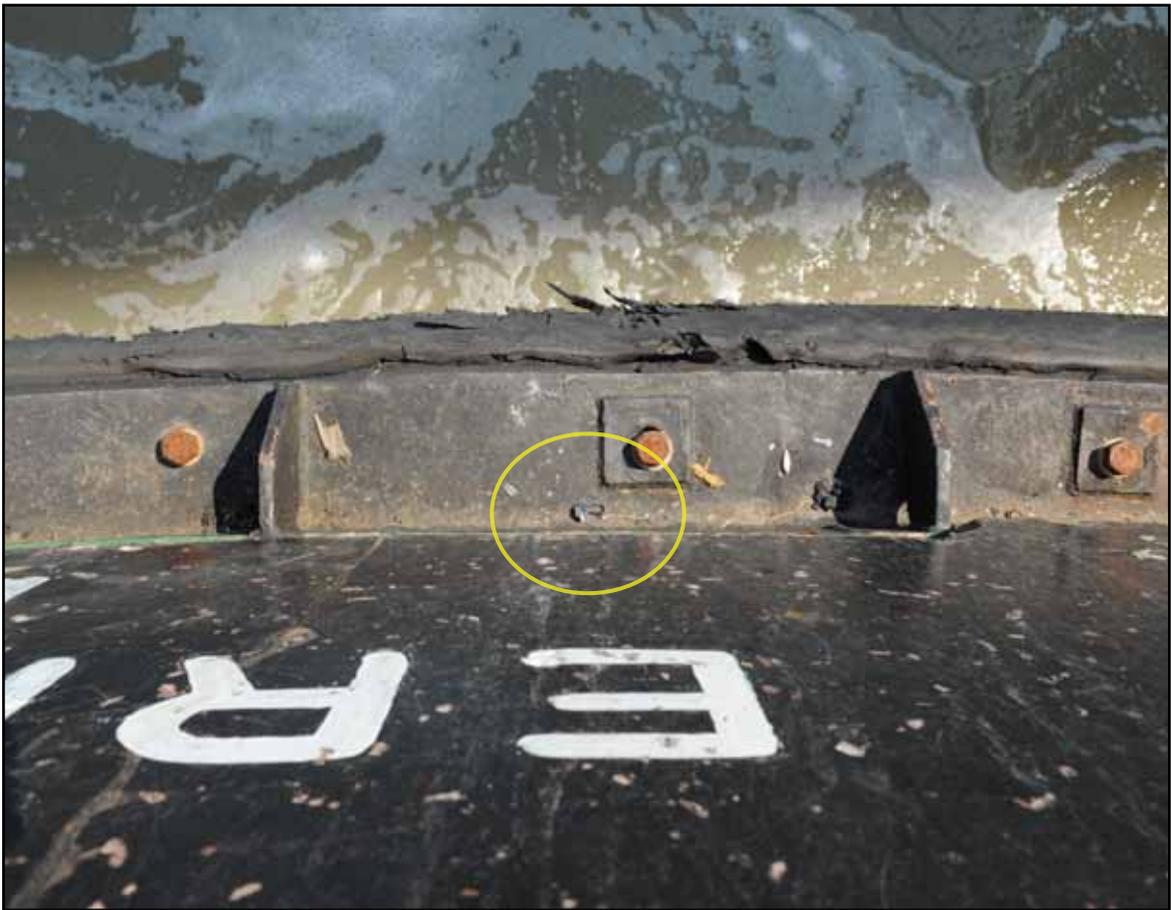
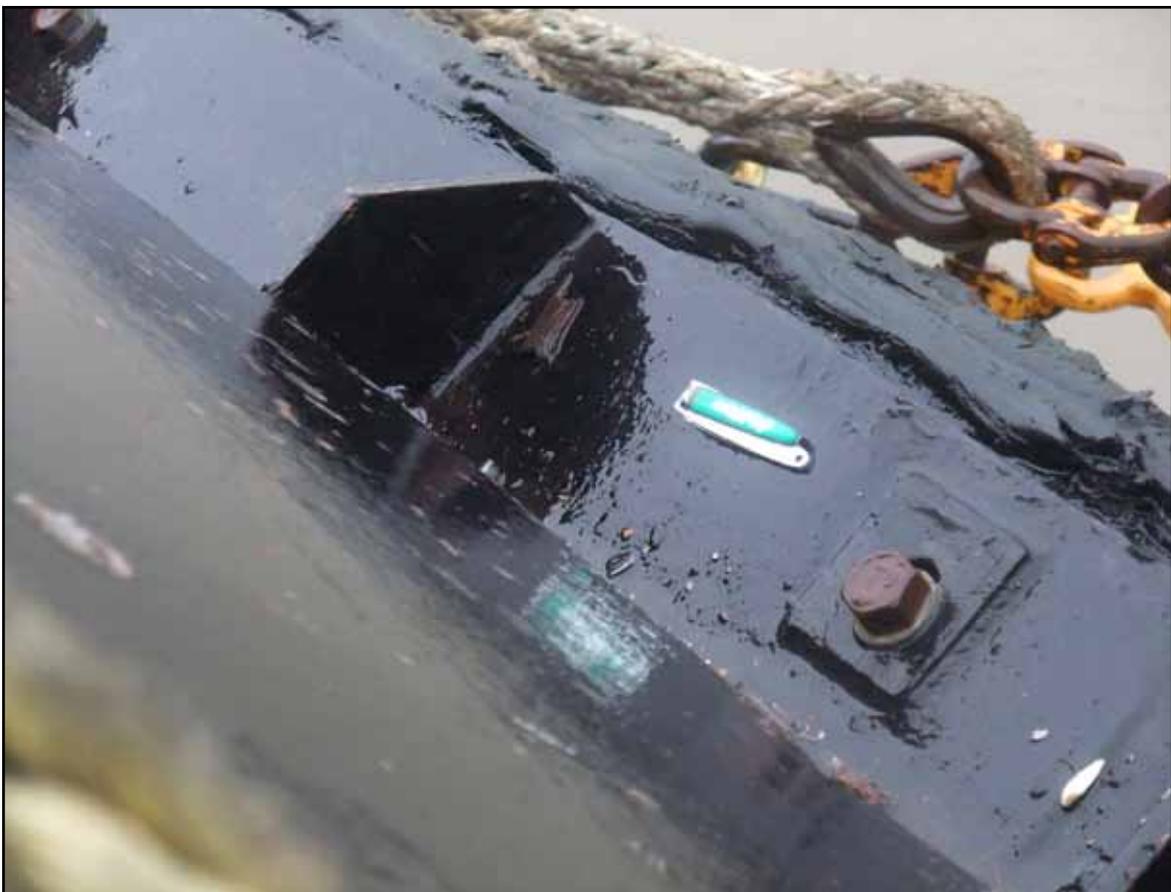
Figure 13a: Zip toggle from Benjamin's lifejacket

Figure 13b: Nail clippers repositioned where it was found after the accident

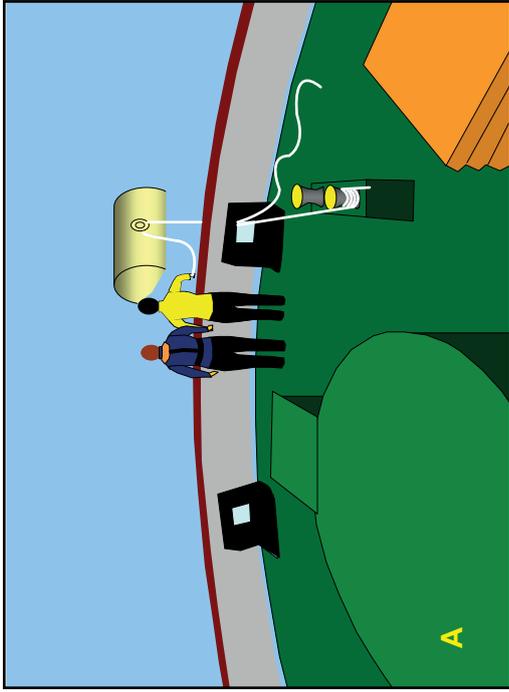
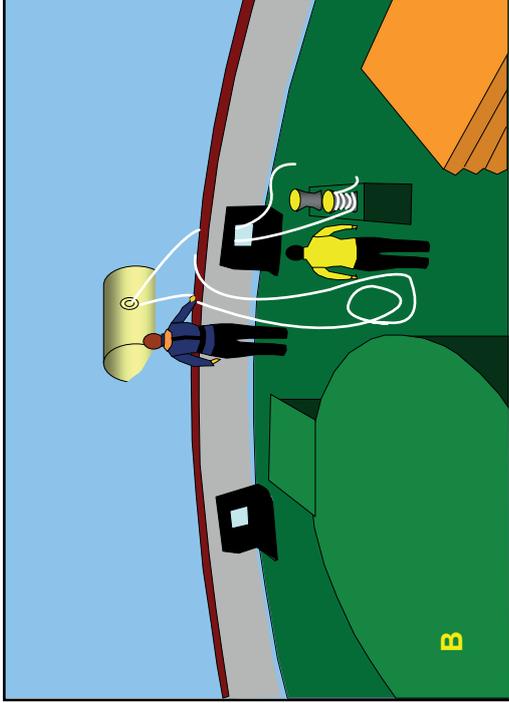
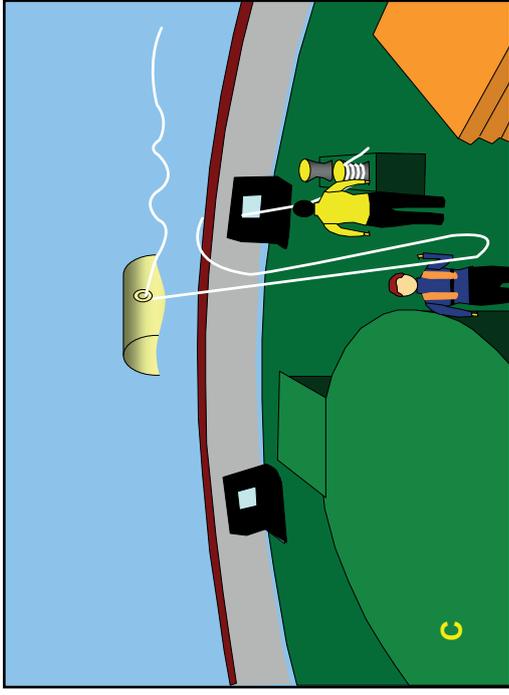
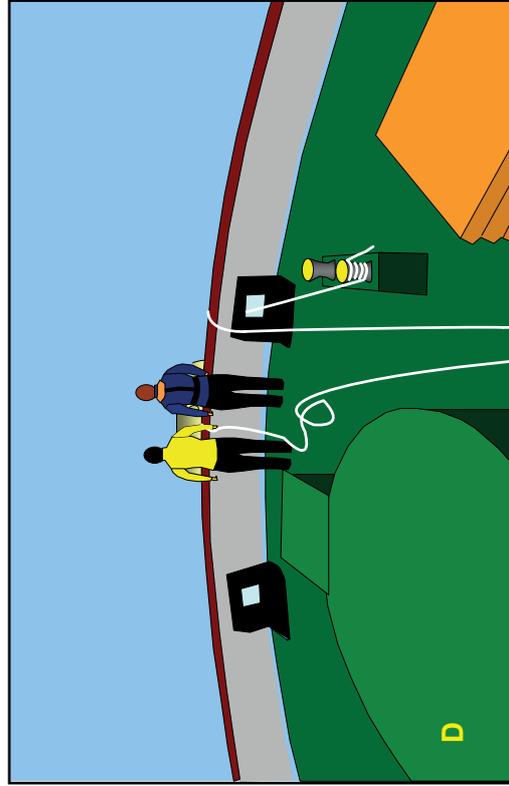
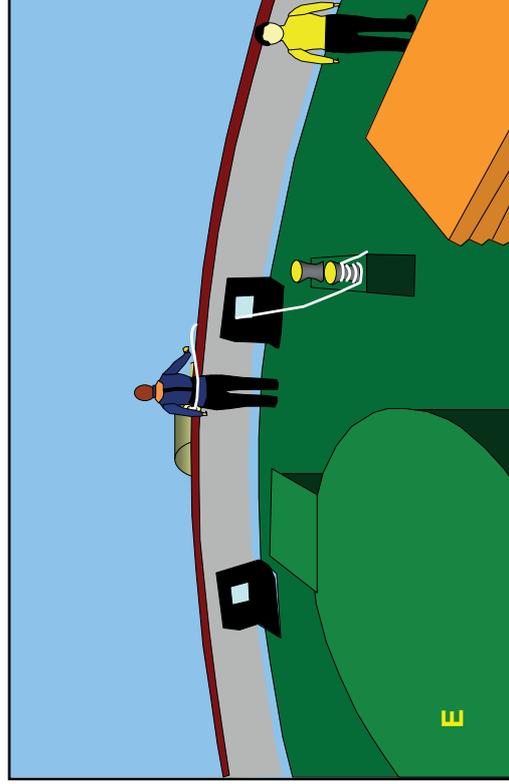
Figures 15a-e: Diagrammatic representation of the likely accident

Rope being taken over bulwark from outside of fairlead

Rope being coiled on deck by SDH2 and picked up by Benjamin

Benjamin walking rope towards bulkhead

Rope jammed between buoy and ship, investigated by SDH2 and Benjamin

SDH2 repositioned to get eye contact with the master just before the rope is pulled overboard by the propeller

Whether slip ropes were recovered through the fairlead or over the bulwarks had become a matter of personal preference among deckhands. There was no recognition that recovering the rope over the bulwark created a bight in the rope that, should the line become snagged, had the potential to pull persons over the bulwark into the river. Benjamin's injuries, the damage to his lifejacket, and the location post-accident of the zip fastener and nail clippers on the rubbing strake, all indicate that Benjamin was ensnared by the slip rope and dragged violently against the bulwark before being literally folded over the bulwark top rail and into the river. It is likely that the hole in the chamber of Benjamin's lifejacket was caused by the operating head being pressed in to his torso as he impacted the top rail. Although pulling the rope through the fairlead could also create a bight that the unwary could become caught in, there would be far less potential to be pulled overboard. However, it should be noted that being caught by such a bight would probably result in being knocked violently to the deck, with associated potential for serious injury.

Whatever the reason, the result was that the tail of the slip rope was allowed to lie in the water, whereupon it was sucked into the Voith Schneider propeller, with tragic consequences. A vigilant supervisor monitoring the operation and giving appropriate guidance/feedback to the master and deckhand could have prevented the dangerous situation developing, and warned the deckhands about standing in bights. However, it is important that the hazard of allowing ropes to enter the water in way of the propellers is included in the vessel's risk assessments, that control measures are identified, and that these are included in the procedures for mooring and unmooring.

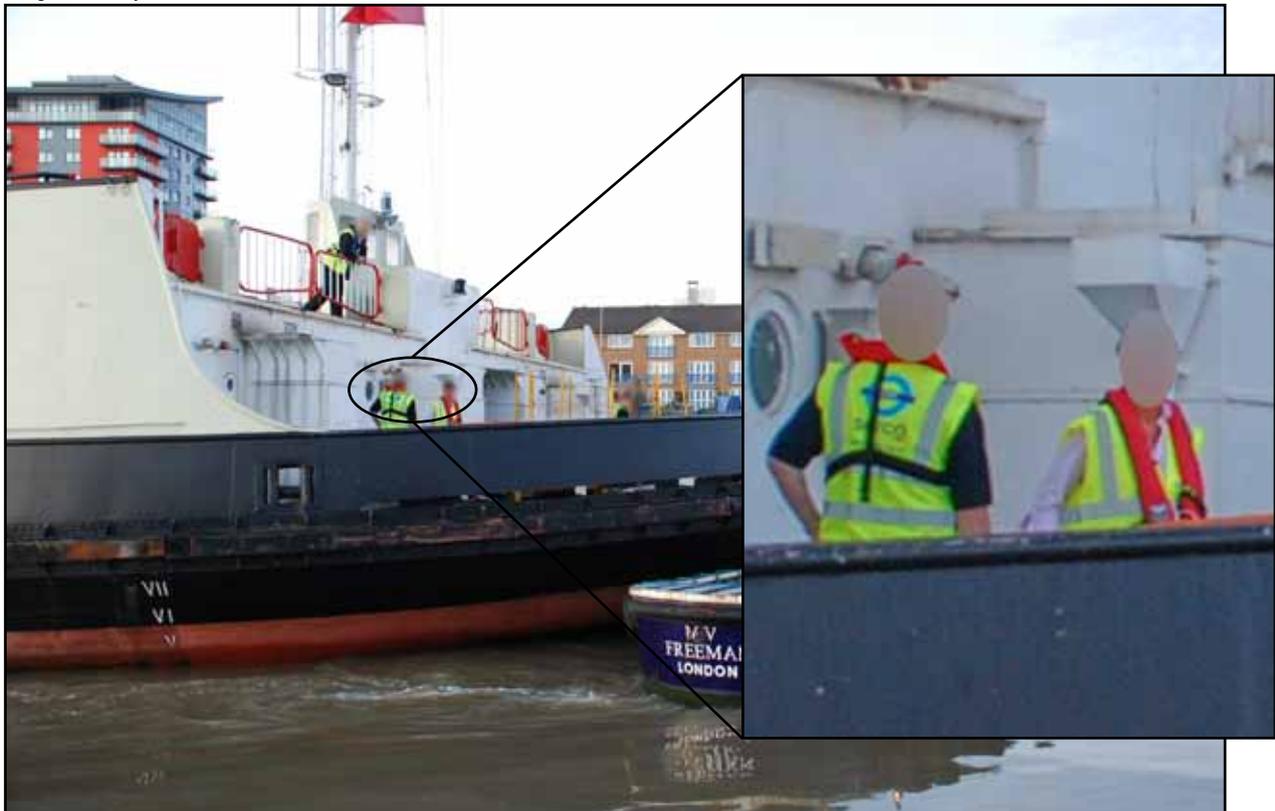
Benjamin wore his lifejacket with the crotch strap removed; this was not uncommon practice among crews of the Woolwich Free Ferry, which was noticed by MAIB inspectors during the investigation (**Figure 16**). However, that less than 2 weeks after the accident MAIB inspectors witnessed a crewman on the workboat wearing a lifejacket that was not secured together at the waist belt, was of even greater concern (**Figure 17**).

Figure 16: Serco staff member wearing lifejacket without crotch strap fitted

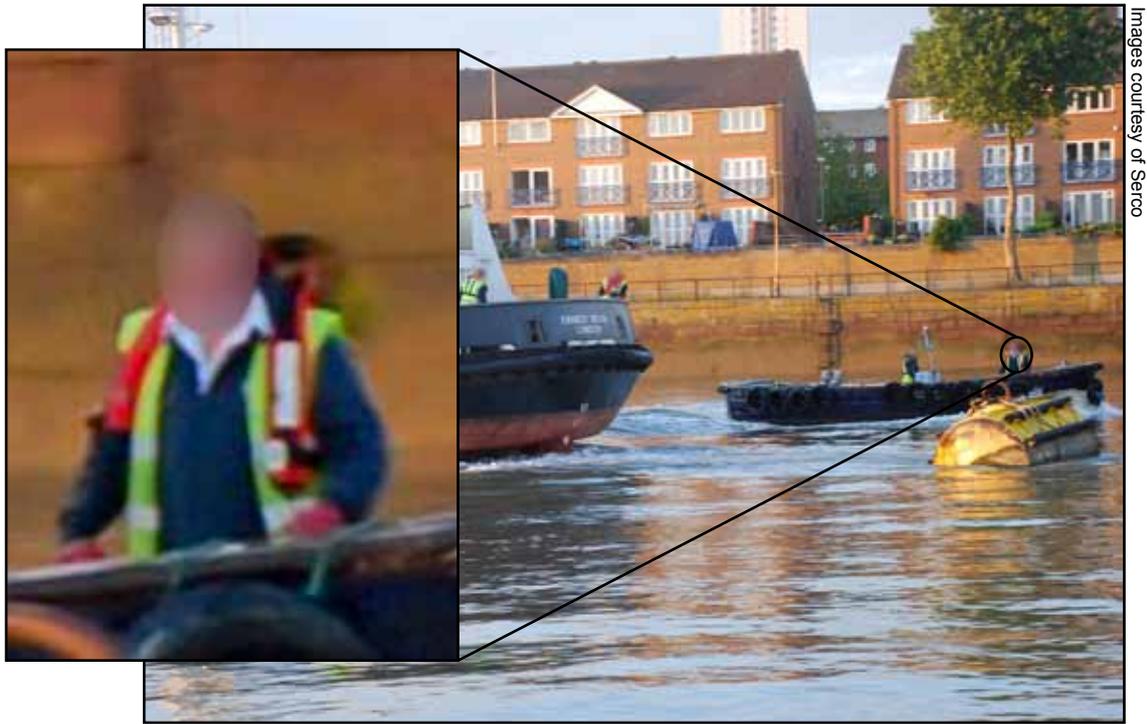
Figure 17: Woolwich Free Ferry staff member with unsecured lifejacket

The incorrect wearing of lifejackets by senior crew, which included lifejackets being worn with the crotch straps removed and, in some instances, without the waist belt being fastened, set poor examples to junior colleagues and was symptomatic of a weak safety culture.
