MV FREMANTLE EXPRESS

Fatality during mooring operation

Veracruz (Mexico)

15 July 2011

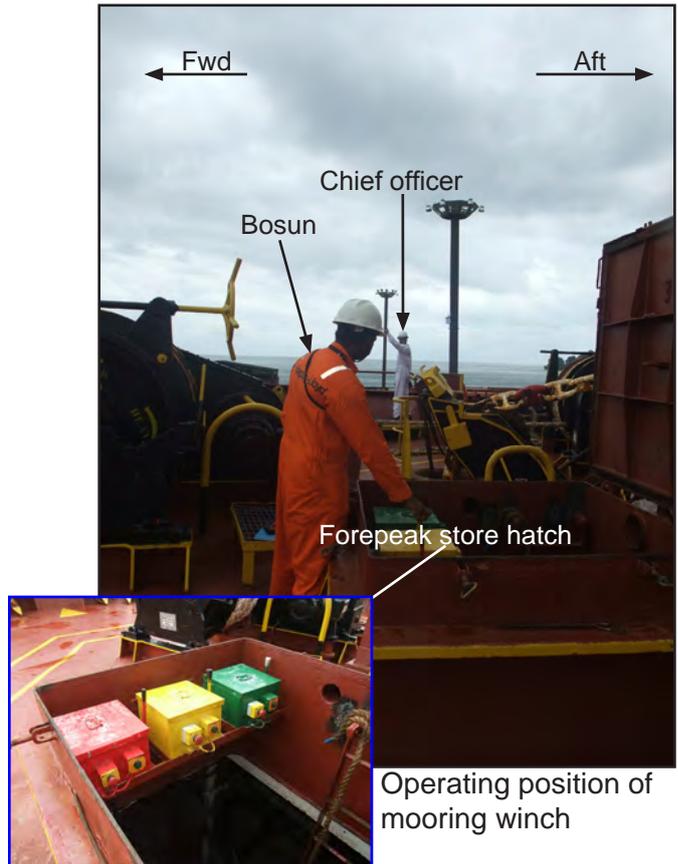
Figure 1

At 0942, the vessel approached her intended berth assisted by the two tugs, and the aft backspring was sent ashore. At 0944, the master instructed the chief officer to send the forward lines ashore. The cadet was tasked with throwing a heaving line to the mooring gang ashore while the trainee seaman and Shiva tended the lines. The bosun, facing aft, operated the winch controllers and took instructions from the chief officer who was standing on the starboard observation platform (**Figure 1**).

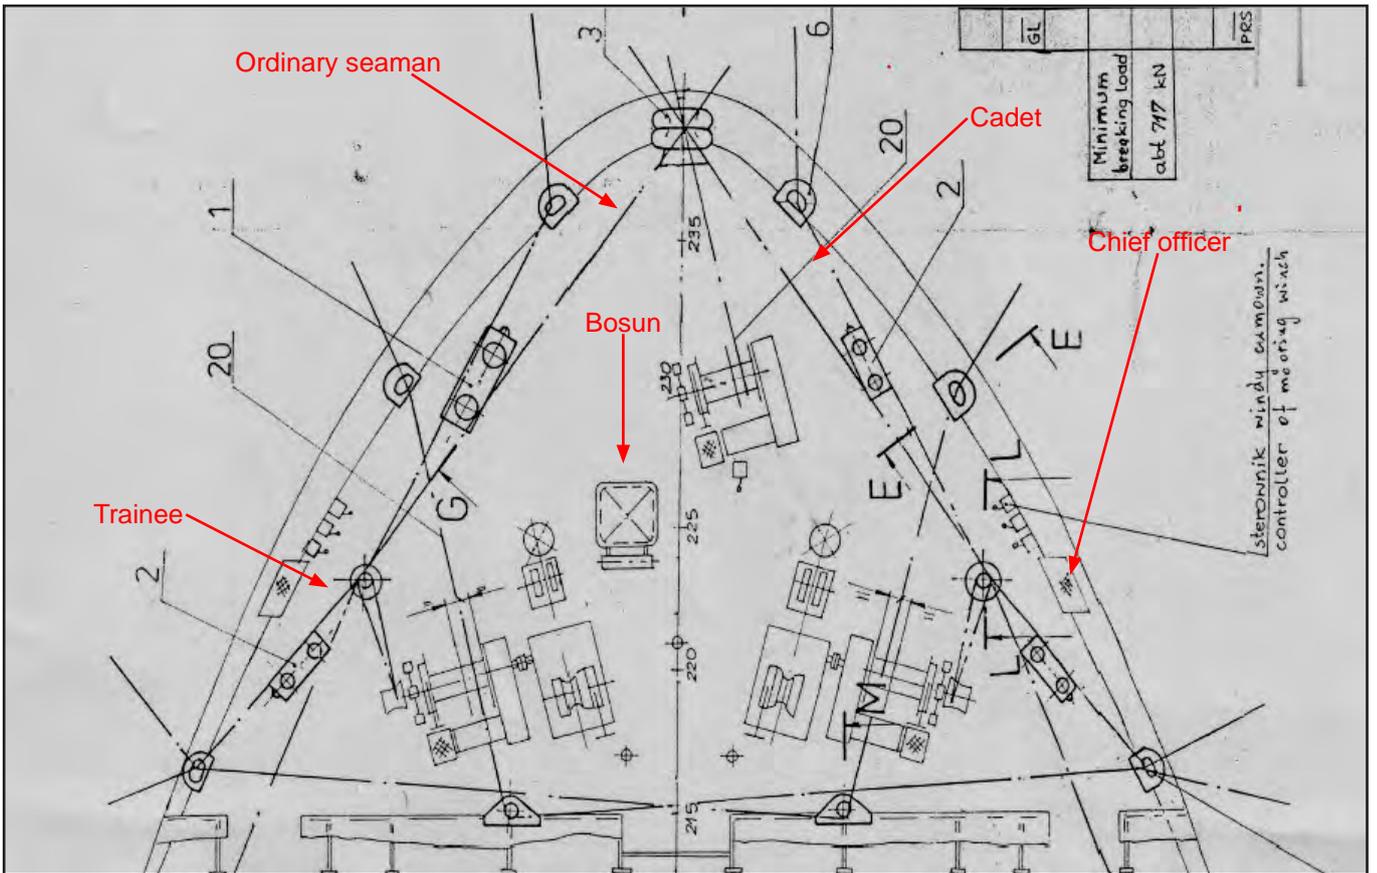
Figure 2

General layout of the forward mooring station and mooring arrangements

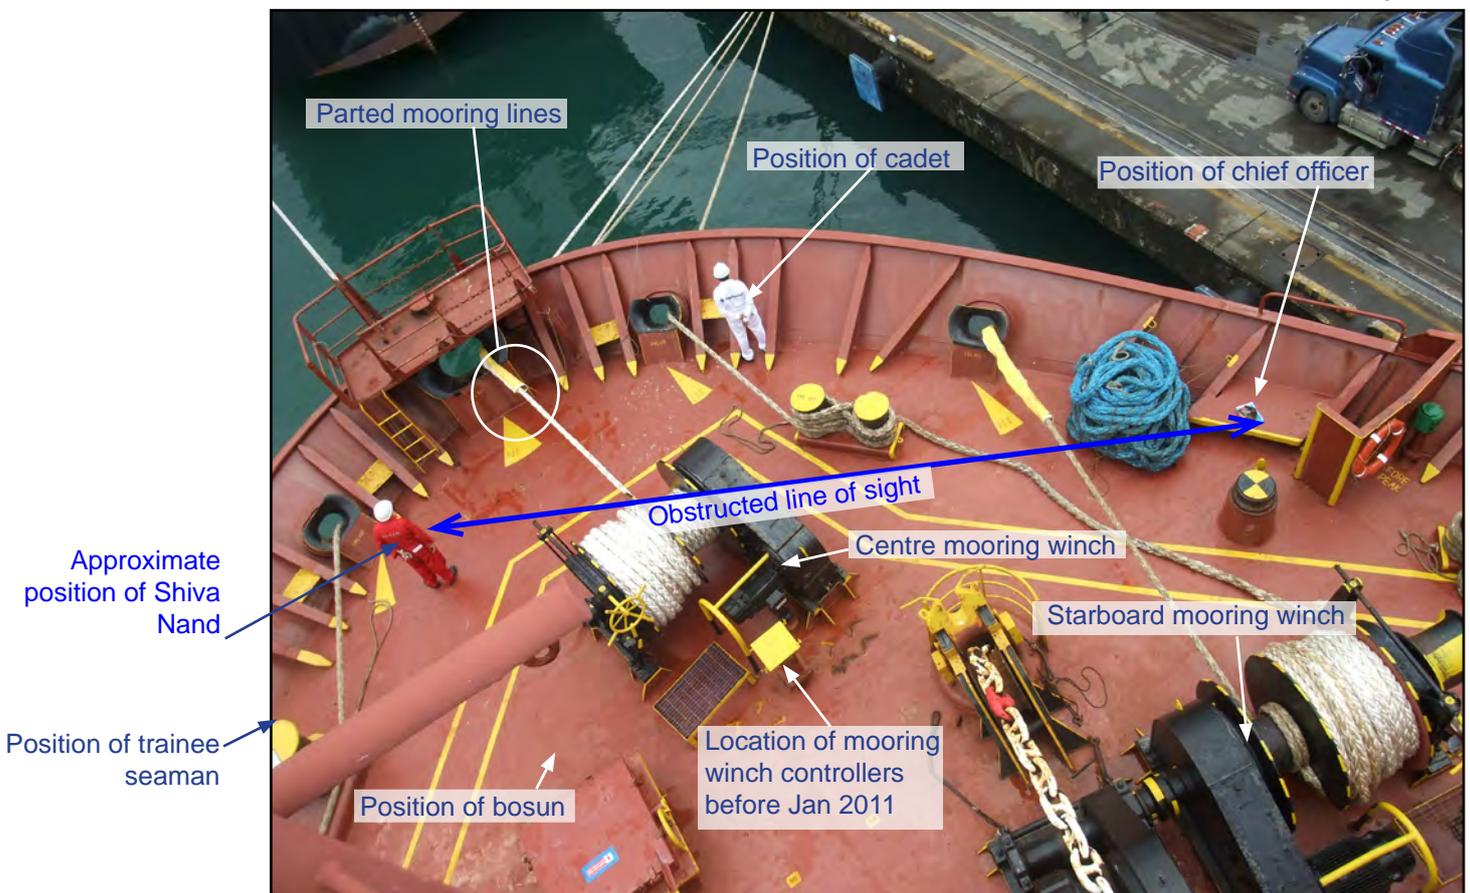
Figure 3

Reconstruction of forward mooring station

At 0955:21, the chief officer reported to the master that the headline had parted. The master enquired if anybody was injured. The chief officer's line of sight was obscured by the mooring winch (**Figure 3**) and he could not see Shiva. However, the bosun informed him that Shiva had been struck by the parted rope and had collapsed on deck. The chief officer promptly conveyed this to the master.

The forward mooring deck of *Fremantle Express* was spacious, with a designated walkway and snap-back zones clearly marked with yellow paint (**Figure 3**). The winch controllers had been positioned on deck, aft of the centre mooring

At the time of the accident, the chief officer was unable to monitor Shiva continuously as his line of sight to the OS was obscured by the central mooring winch (**Figure 3**). Had the bosun been operating the winch controls from the original, forward facing position, it is likely that he would have recognised that Shiva was entering a snap-back zone at a time when the headline was coming under tension and been able to provide a suitable warning to the OS and the chief officer.

The mooring winch controllers on the foredeck of *Fremantle Express* have been relocated to a position which affords the operator forward visibility.

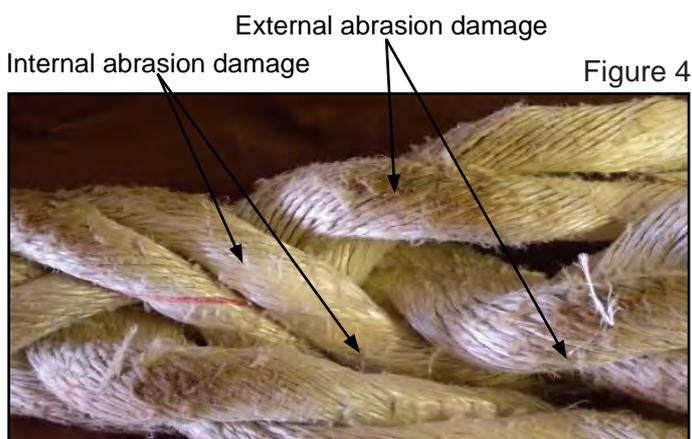
1. The representative sample had lost a significant amount of strength, with an optimistic calculation giving a residual strength of 66% of its original strength.
2. The main cause of this strength loss was external abrasion damage.
3. The abrasion damage existed before the failure incident.
4. Internal abrasion damage contributed to the failure, but to a lesser degree.
5. The pre-existing external abrasion damage on the failure zone was worse than the representative sample.
6. It is possible that thermal degradation had occurred.

Representative sample of mooring rope taken 4 metres from the eye

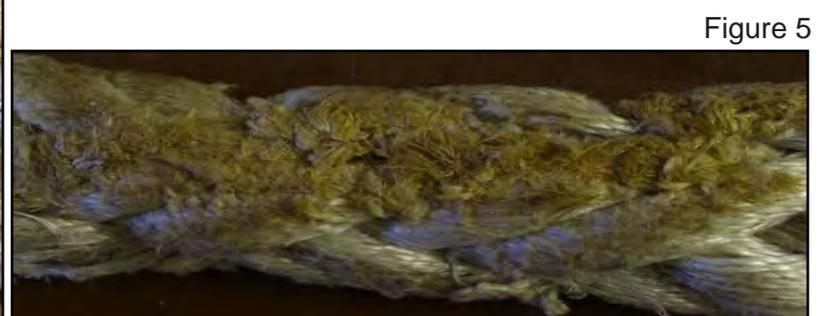
Section of the failure zone showing extreme abrasion damage

Records held on board *Fremantle Express* indicate that the ropes were inspected as required, and that some had been cropped when considered necessary. The mooring rope that parted had previously been cropped twice since being brought into service. Although its condition on 18 June 2011 was recorded as "satisfactory", the assessment made by TTI following the accident suggests that a lower standard of acceptability was being applied on board than that required in the company's instructions.

6. The accident could have been prevented had the company's rope retirement criteria been followed on board and had the damaged and degraded mooring rope been withdrawn from service.
