Serious injury on board the yacht *LIQUID VORTEX* 28 May 2011

SUMMARY

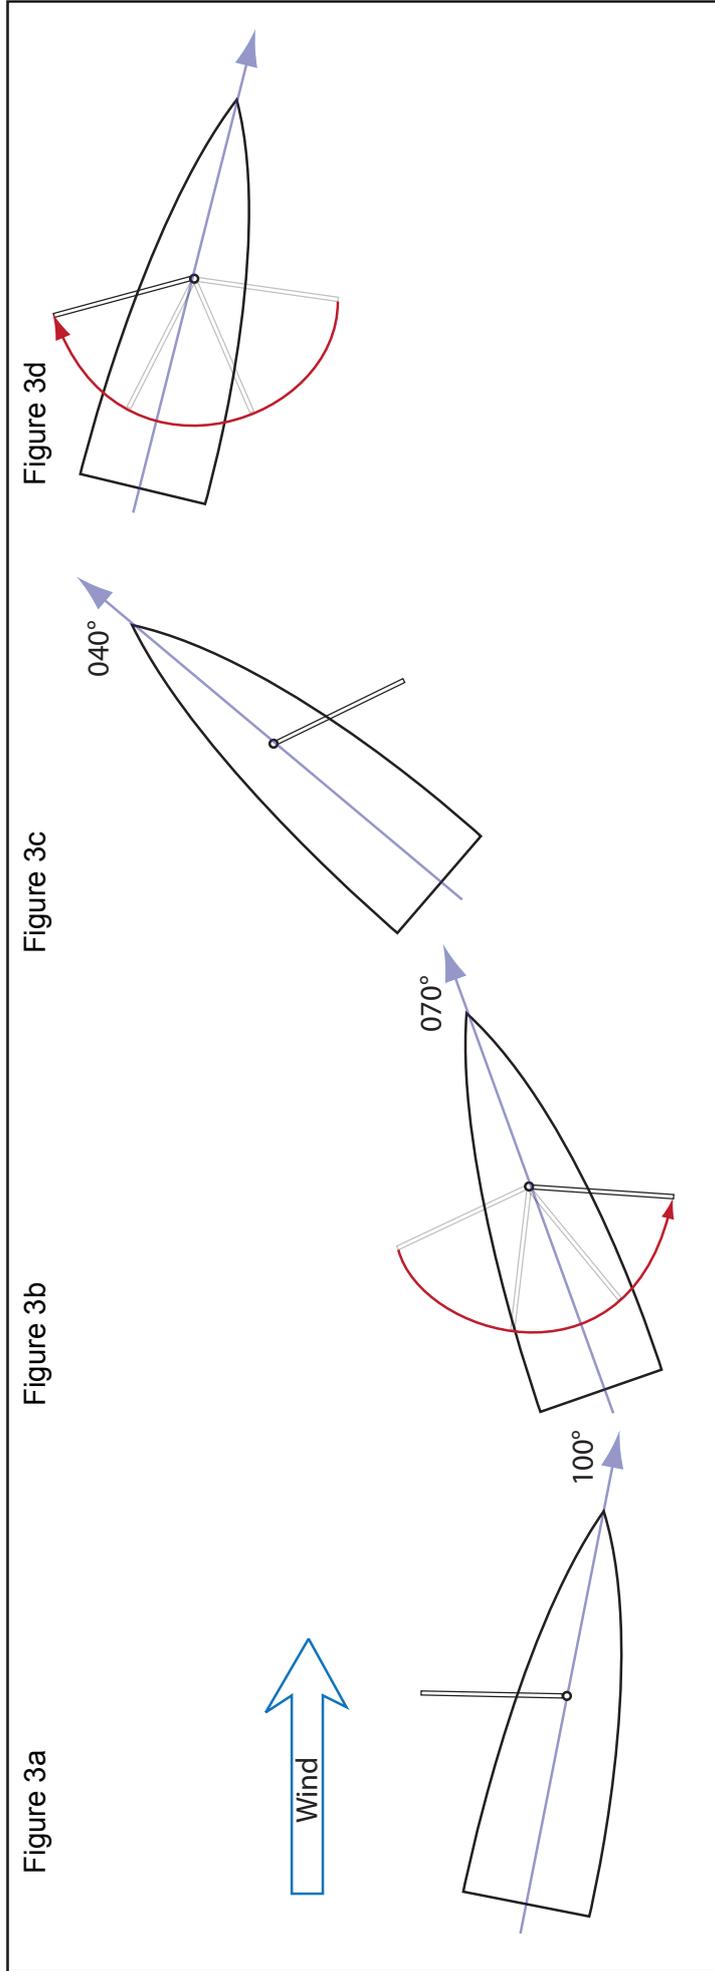
Figure 3

The helmswoman was uncertain about the skipper's instructions. She put the helm to starboard and, without warning, the yacht gybed, causing the boom, mainsail and between 5m and 6m of the mainsheet to swing rapidly across the cockpit from the starboard side to its port side (**Figure 3d**). The helmswoman was knocked to the cockpit deck (**Figure 4**). The crewman in the cockpit immediately took over the helm and the yacht was again gybed unintentionally.

Movement of the vessel and effect on boom position

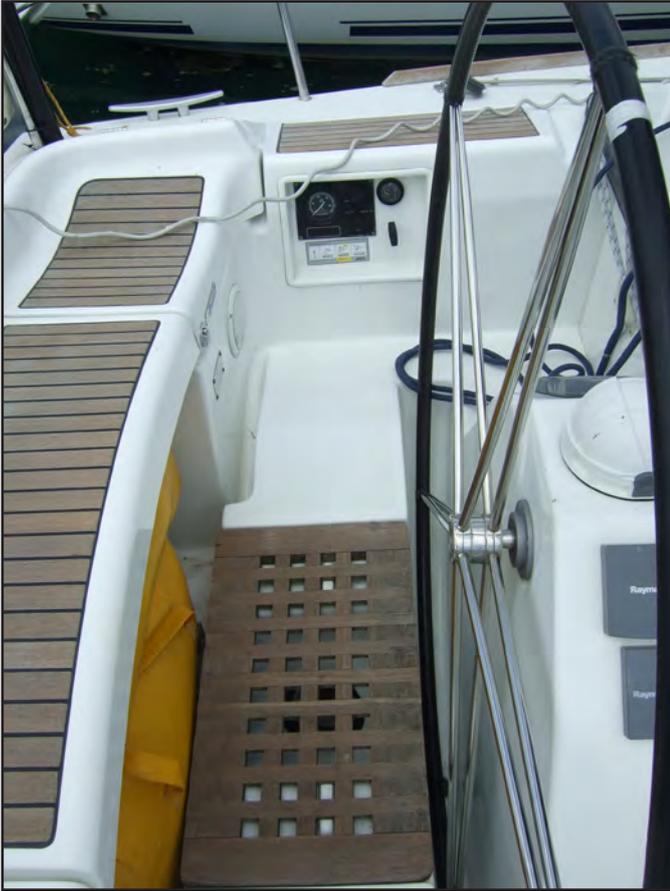
Figure 4

Cockpit deck behind the wheel where the helmswoman lay after the accident

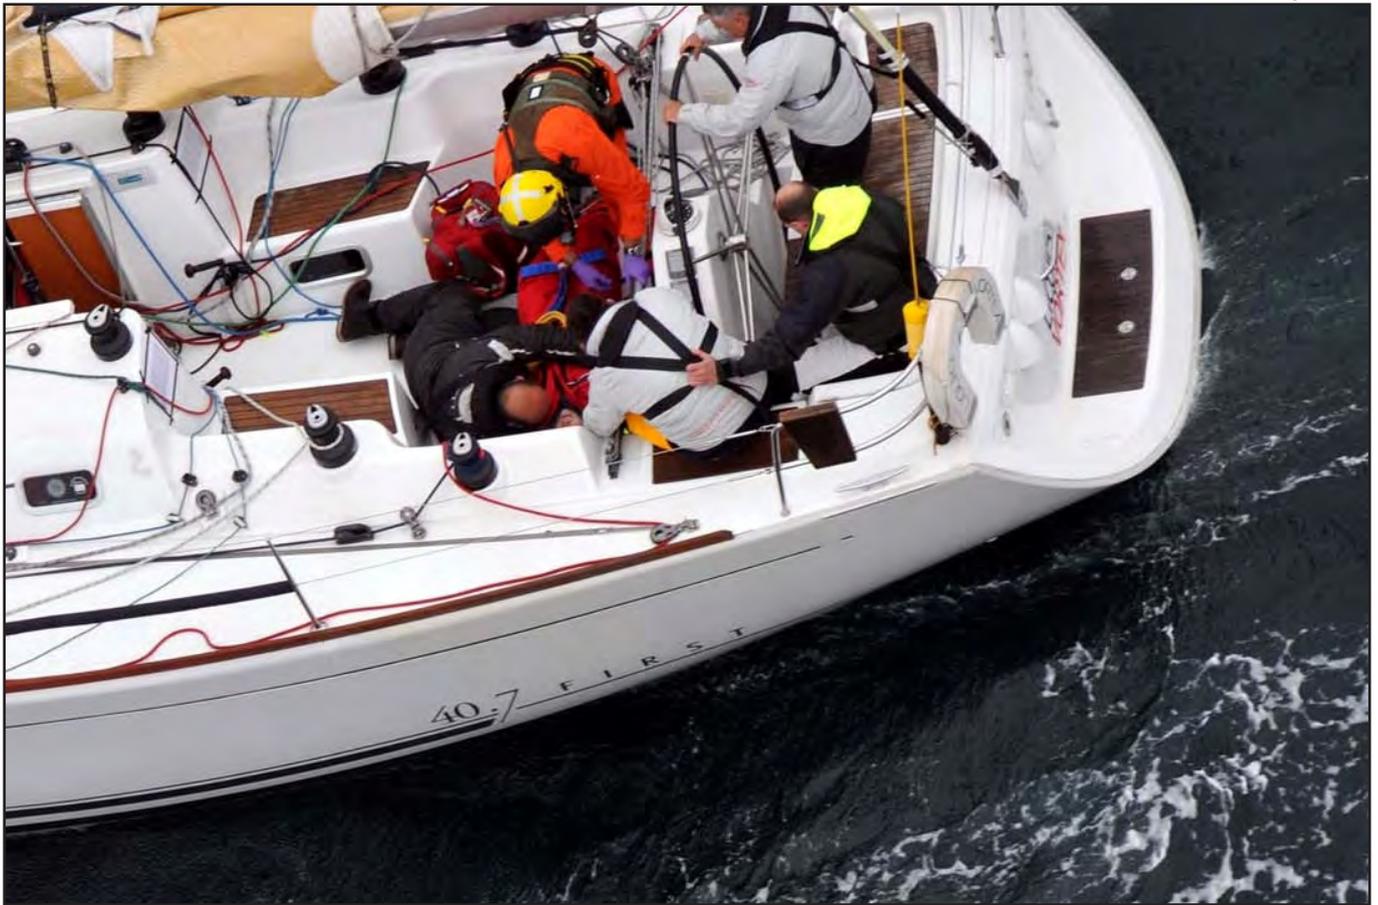
The “Mayday” call was heard by Brixham coastguard and, at 1019, a rescue helicopter was tasked to assist. It arrived on scene at 1047 and a winchman was lowered from the helicopter into *Liquid Vortex*’s cockpit (**Figure 5**). After an initial assessment, the helmswoman was then repositioned on the cockpit deck and examined by the winchman who was concerned that she might have sustained a neck or spinal injury. He was unable to fit her with a neck brace as her foul weather clothing was in the way, and instead used a rolled up towel to support her neck.

Winchman attending to helmswoman after she was repositioned in the cockpit

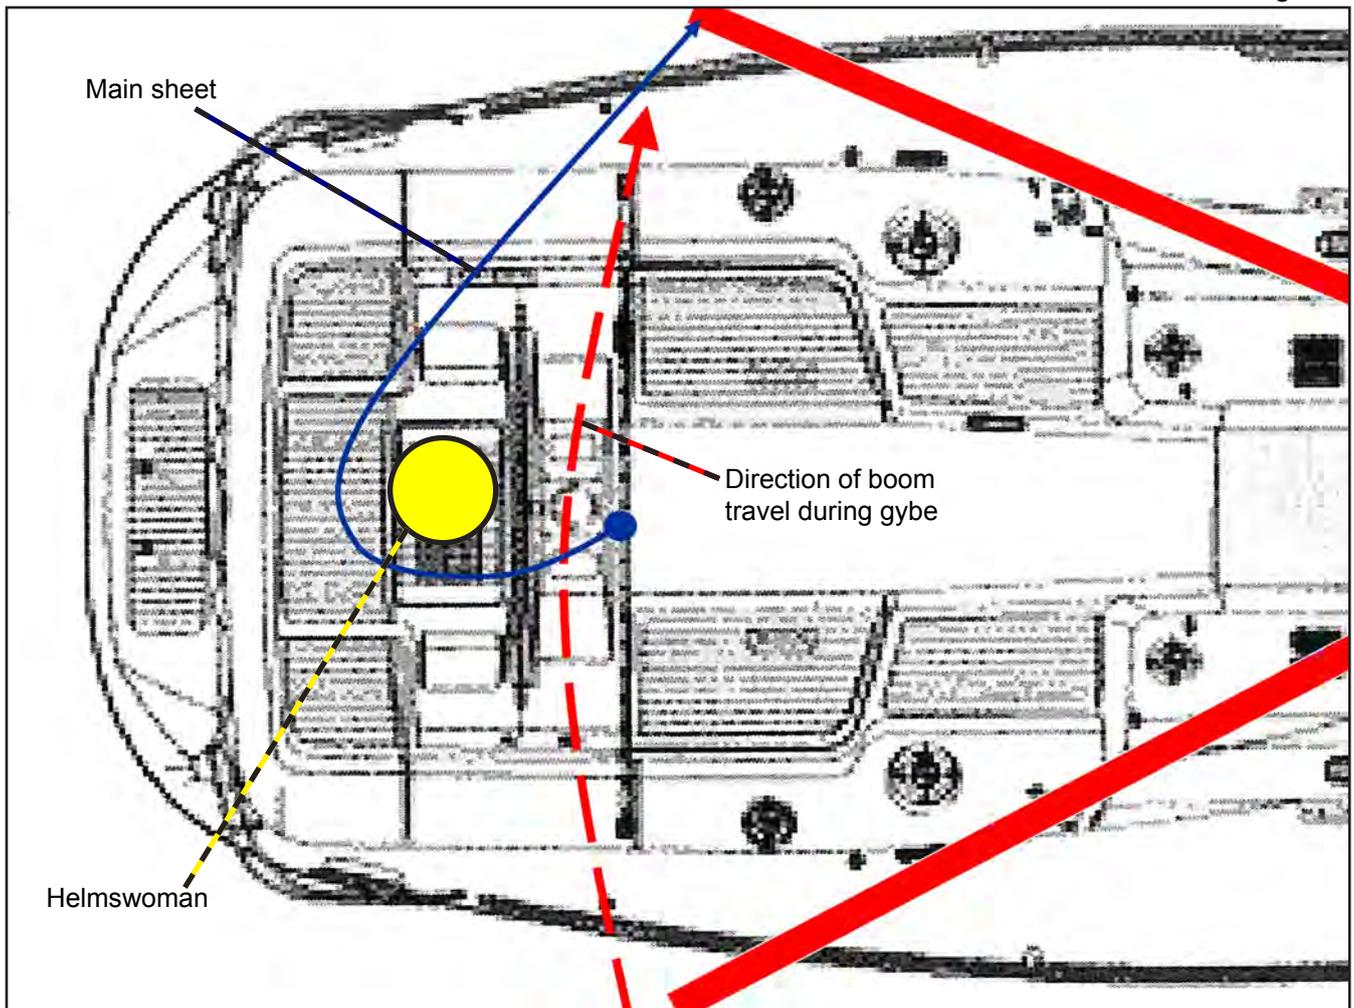
Figure 6

During the gybe, the mainsail, boom and mainsheet swung rapidly through about 140° from the starboard side to the port side. By design, the aft end of the boom was forward of the helm position (**Figure 6**) and would have swung in front of the helmswoman. However, the speed and force of the swinging boom would have caused

several metres of slack line in the mainsheet to be thrown outwards (aft) towards her. The rope burns on the helmswoman indicate that the mainsheet caught her jaw and then knocked her to the deck as it tensioned when the boom swung out onto the port side. Her spinal injury was consistent with her head striking the side of the cockpit with significant force.

Accidental gybe - movement of the boom and the mainsheet
