Report on the investigation of the
contact between the ro-ro cargo ferry

Clipper Point

at the Port of Heysham's South Quay,
and two berthed ships

on 24 May 2011

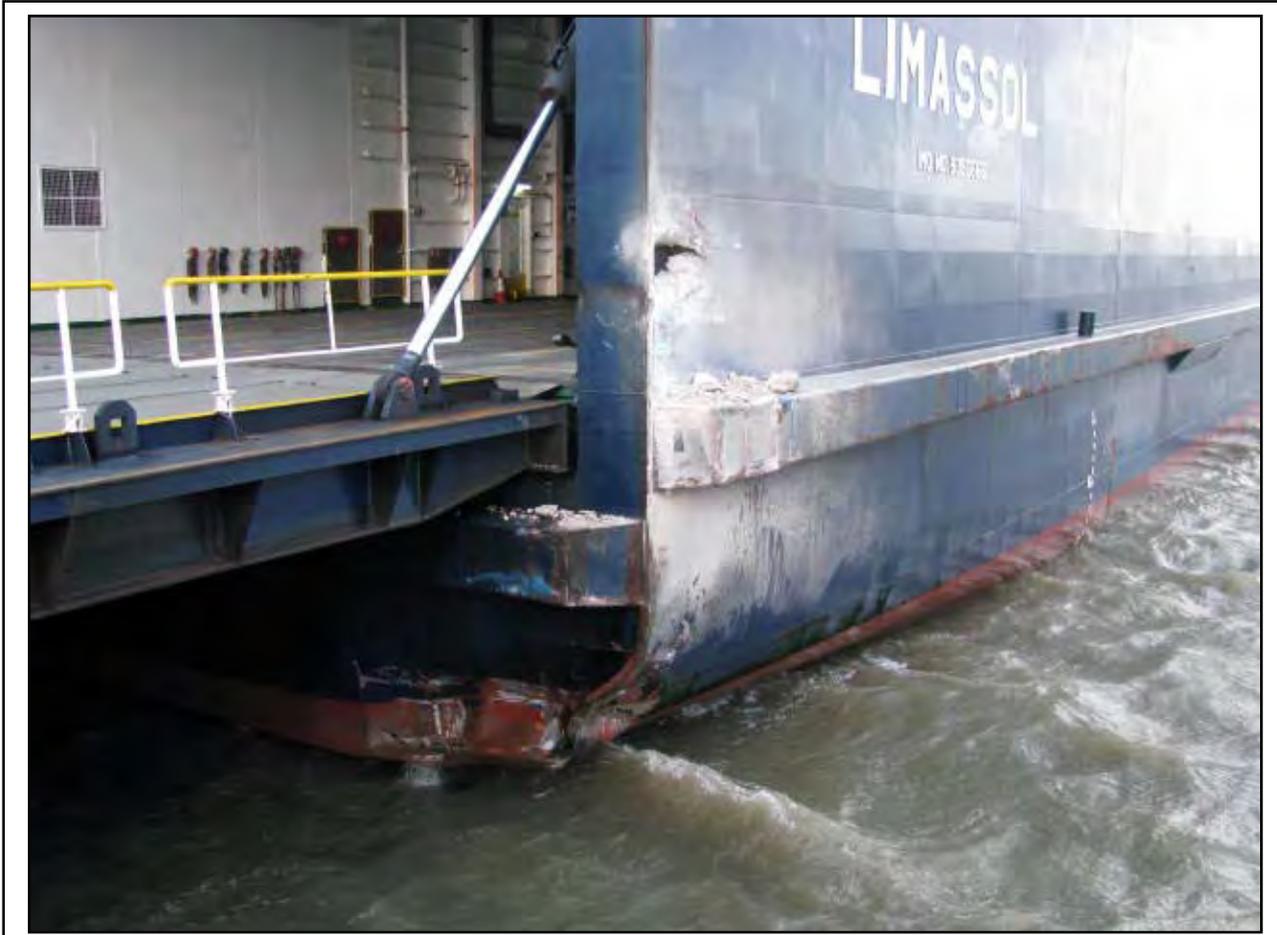
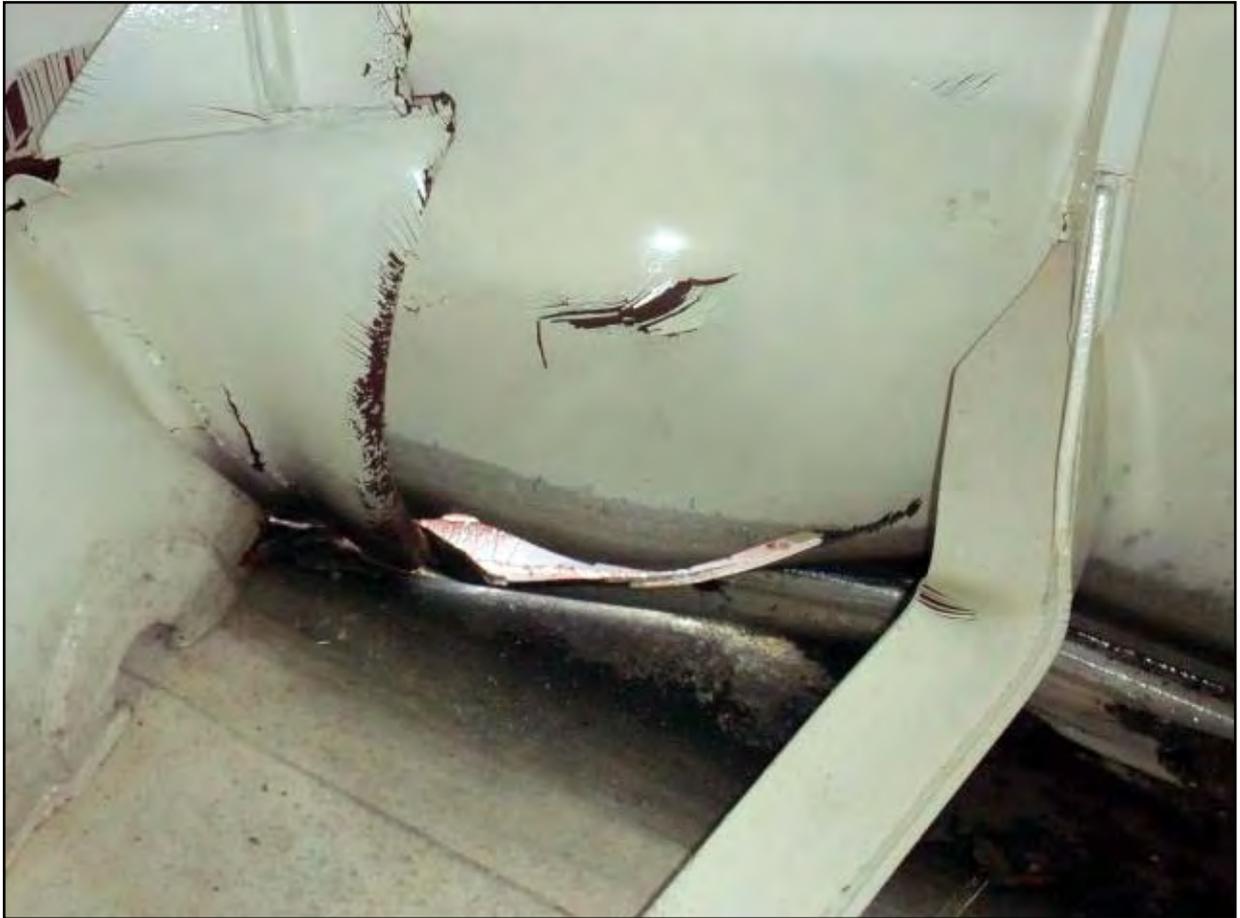
Figure 8: Damage to *Clipper Point*

At 0535 the steering gear bilge level alarm sounded in the engine control room. The chief engineer telephoned the master and told him about the alarm and then started to pump the bilge water overboard. The chief engineer went to the steering gear compartment and confirmed that it was holed. The master then filled the forward ballast tanks and emptied the aft ballast tanks to lift the hole in the stern clear of the water. The chief officer also had 11 self-drive trailers, which were parked at the aft end of the vehicle deck, driven ashore. By 0548, the damaged hull section was raised above the water.

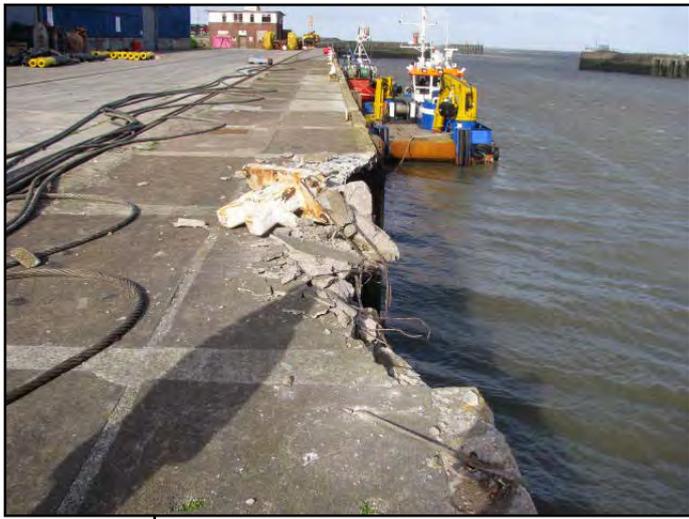
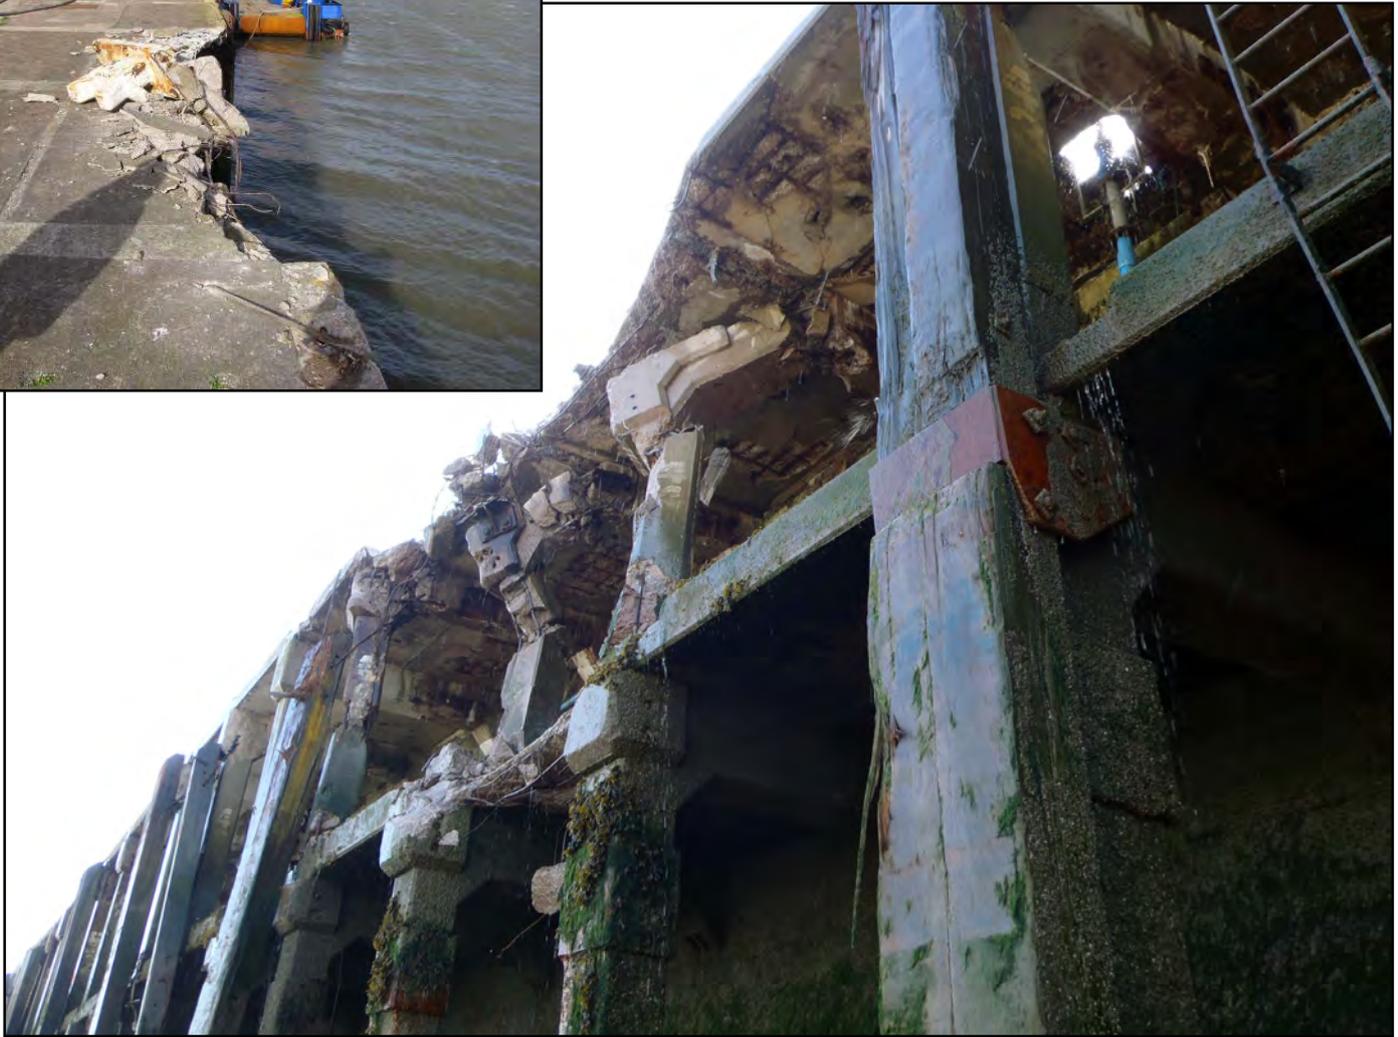
Figure 9: Damage to South Quay

The upper edge of South Quay was damaged over a length of around 5m, set in by 0.8m and one mooring bollard was dislodged. South Quay's lower level and supporting structure was also heavily damaged (**Figure 9**).

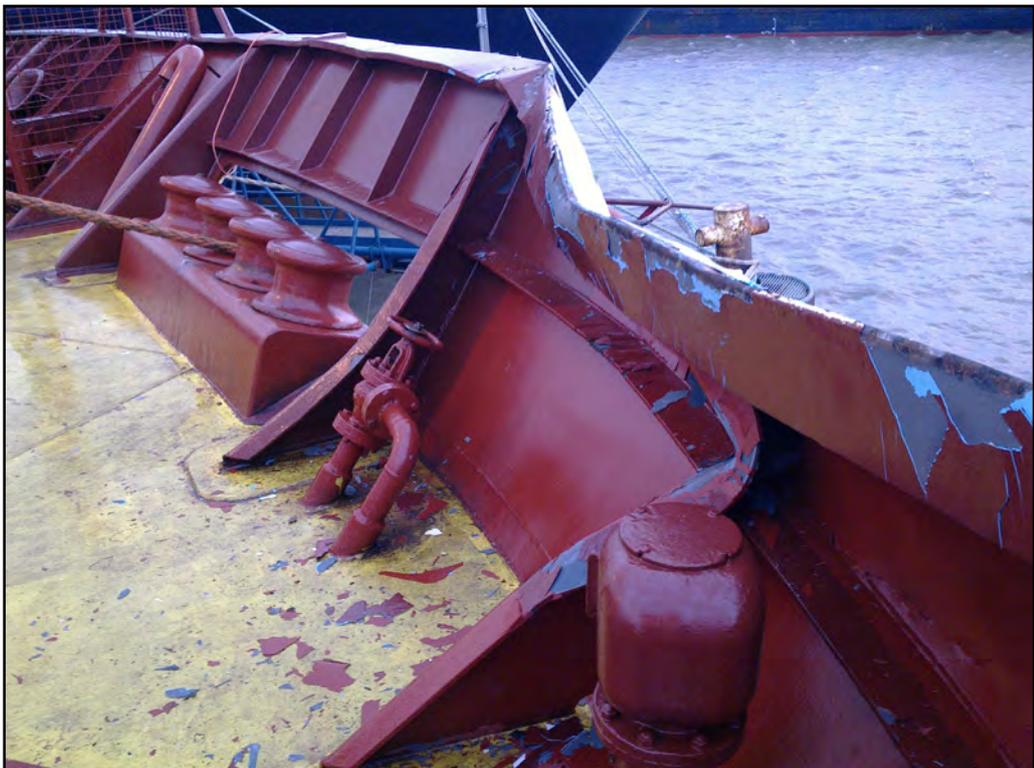
Figure 10: Damage to Scotia Seaways

Scotia Seaways' port bow bulwark plating and two internal frames were damaged over a length of around 3m (**Figure 10**). *Clipper Ranger's* port bow sustained minor damage to port bow bulwark plating.

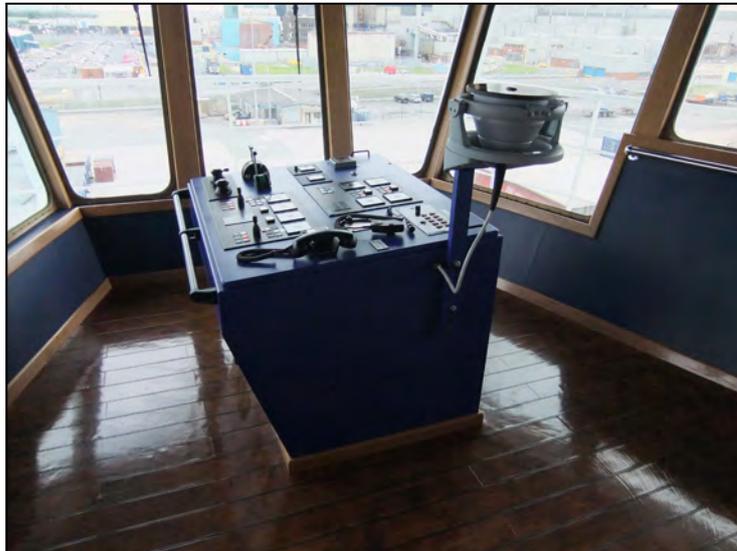
Figure 11: *Clipper Point* - Bridge wing consoles

Clipper Point's bridge wing ergonomics increased the workload on the bridge team at a critical time, limited their ability to move quickly to the console closest to the nearest hazard, and increased the risk of an error being made while control was being transferred between consoles. Improved controls and information displays would have improved the efficiency of the manoeuvring operation. Consequently, Seatruck's managers should consider what improvements can be made to enhance the operability and provision of appropriate information to the bridge team when working at the bridge wings of the P-class ships. Lessons learned from this exercise should be applied to all vessels in the Seatruck fleet.

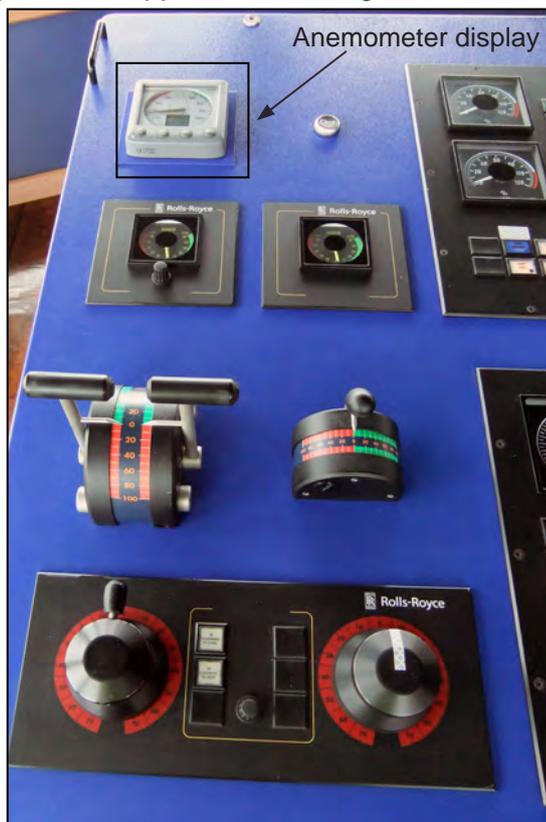
Figure 13: Bridge wing wind indicator

The electronic chart system (ECS) display, ship's heading, rate of turn, wind speed and direction, as well as log speed and ground speed information, were displayed on the centre console (**Figure 12**). The consoles at the bridge wings only provided wind speed and direction, shown on a square, 100mm sided display (**Figure 13**).
