## SUMMARY

## MV CMA CGM PLATON

### Contact with Bevans Wharf River Thames 15 May 2011

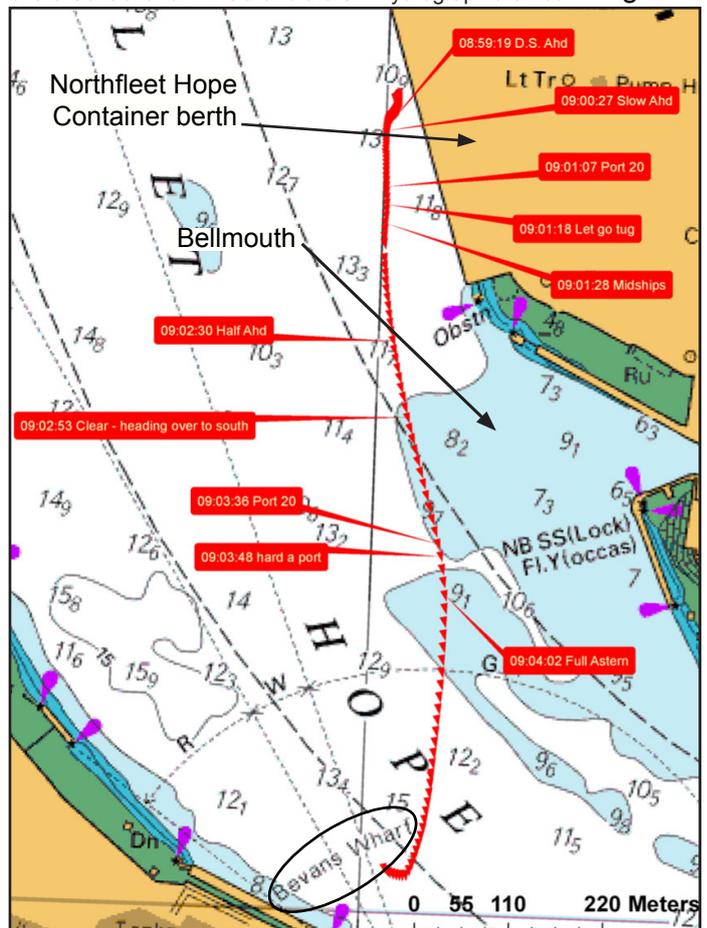
Reproduced from Admiralty Chart BA 2151 by permission of the Controller of HMSO and the UK Hydrographic Office **Figure 1**

At 1002, the engine was set to 'half ahead'. Soon afterwards, the pilot told London VTS that the vessel was clear of the berth, passing the bellmouth (**Figure 1**) and heading towards the south side of the river.

AIS track of vessel

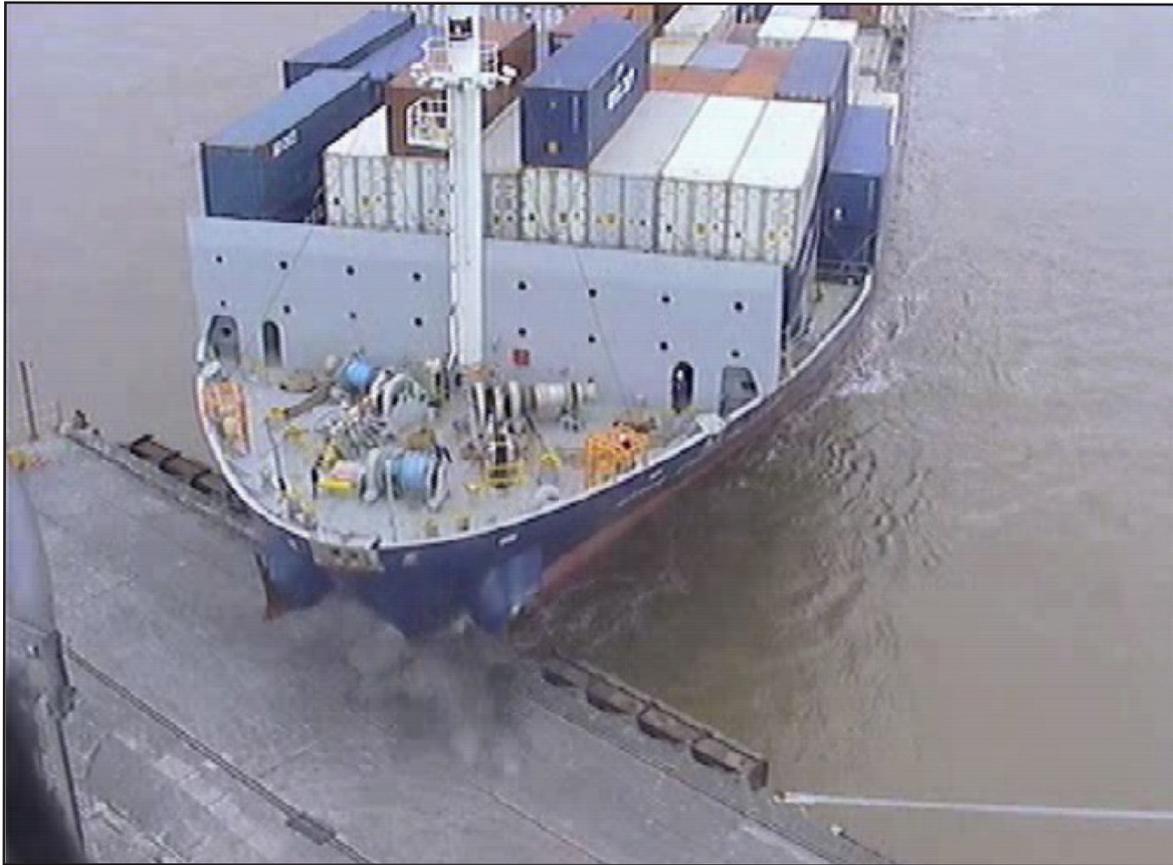
At 1004, the engine was set to 'full astern'. The pilot ordered *Svitzer Josephine* to return immediately to assist the vessel. Although *CMA CGM Platon*'s engine developed full astern power, this was insufficient to arrest her headway in the space available. The vessel narrowly avoided *Cristina Masaveu*, a cement carrier moored alongside Bevan's Wharf and, at 1006, at a speed of 3.7 knots her bow made contact with the quay (**Figure 2**). Shortly before the contact, the third officer, who was at the forward mooring station, dropped the port anchor in an attempt to slow the vessel.

CCTV image showing contact with quay

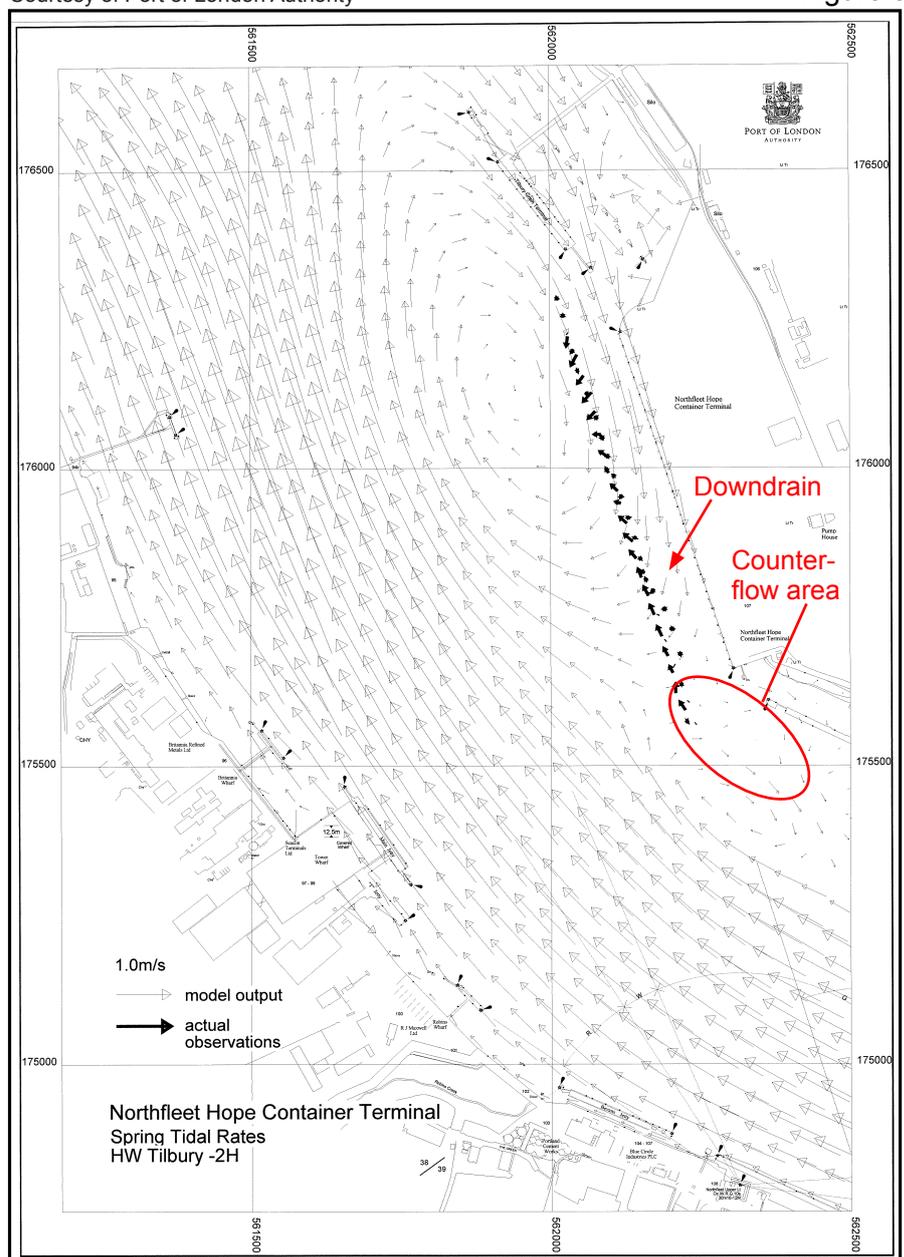
Figure 3

The tidal stream around Tilburyness is complex due to the fluvial flow of the river. During a flood tide, an outward flow of water known as the 'downdrain' near the face of Northfleet Hope Container Terminal interacts with the inward tidal stream to create a counter-flow off the berth, as depicted in **Figure 3**.

Tidal flow 2 hours before high water

1. As *CMA CGM Platon*'s bow entered the main flood tidal stream, her stern remained in the downdrain. This, together with the wind acting on her starboard quarter, caused a coupling effect, which resulted in the vessel unexpectedly turning to starboard.

| 2011/127 | Include in its procedures a requirement for vessels departing Northfleet Hope Container Terminal to retain the use of a tug until they have fully entered the stream when a strong tidal counter-flow is present off the berth. |
