Collision between MV *PHILIPP* AND FV *LYNN MARIE* 6nm south of the Isle of Man 9 April 2011

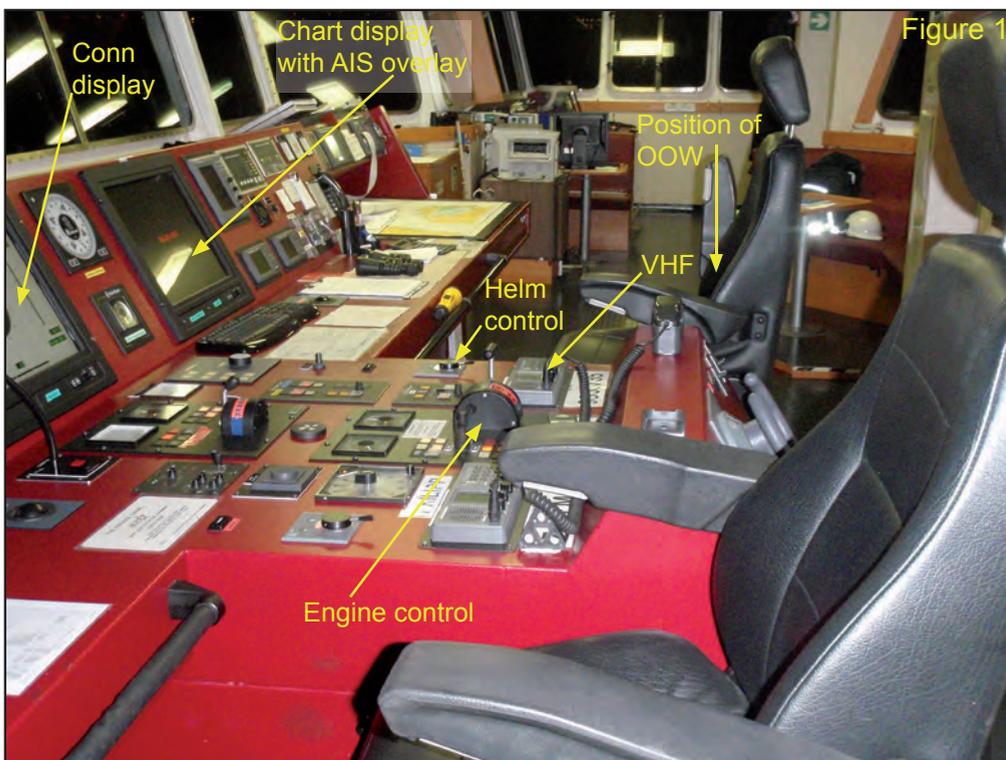
Figure 2

Centreline control console

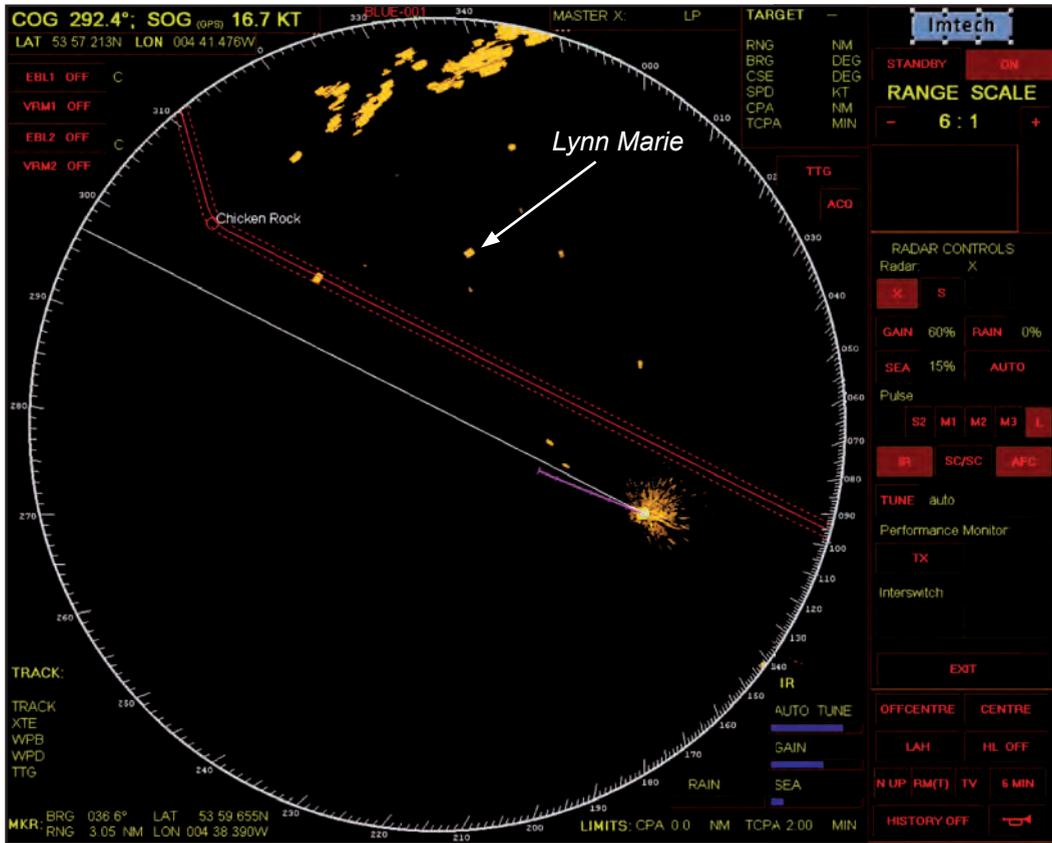
Figure 3

By 0445, the two southbound fishing vessels were clear on the port quarter. The lookout and chief officer then saw two further fishing vessels on the starboard bow (**Figure 3**). The nearer of the two fishing vessels was at a range of 2nm and was later identified as *Boys Pride*. The further of the two fishing vessels was later identified as *Lynne Marie*. The chief officer was also concerned about a number of other fishing vessels on *Philipp's* starboard side, and he set the autopilot heading to 298° to alter the vessel's heading to port in

04:38:21 - just before alteration of course to starboard - 314°

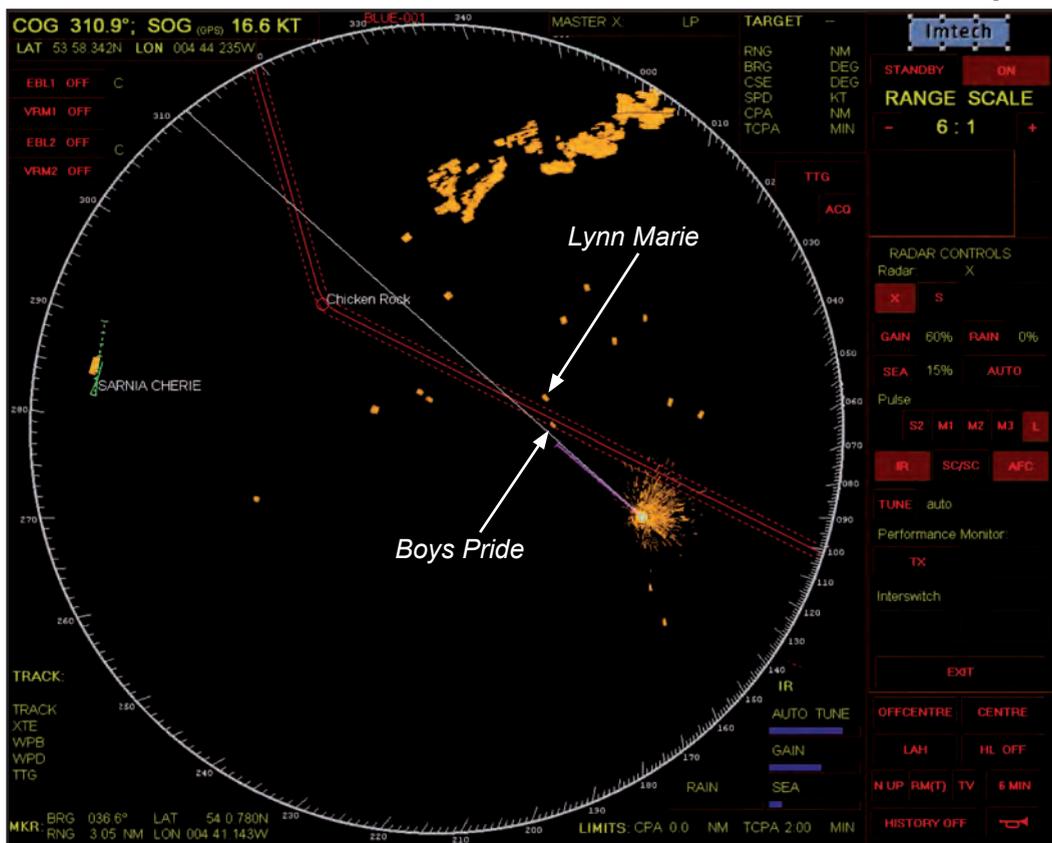
Figure 4

order to avoid the two fishing vessels. At 0449, as *Boys Pride* began to cross *Philipp's* bow (**Figure 4**), the chief officer adjusted the autopilot heading further to port to 285°.

04:45:46 - just before alteration of course to port - 298°

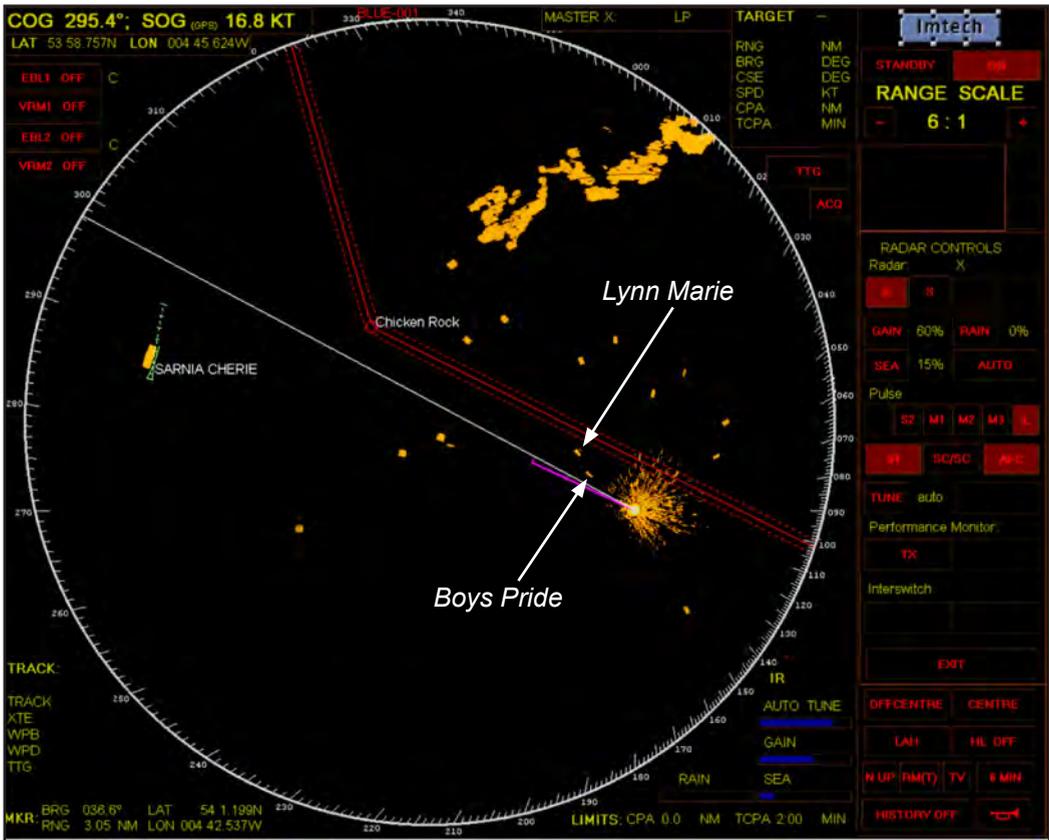
Figure 5

Boys Pride soon passed close down *Philipp's* starboard side, and at 0451 the AB reported that *Lynne Marie* was now very close on the starboard bow (**Figure 5**). The fishing vessel's red side light, white masthead light and aft deck lights were clearly visible. The chief officer moved from his seat and

04:49:00 - Boys Pride fine to starboard just before alteration of course to port - 285°

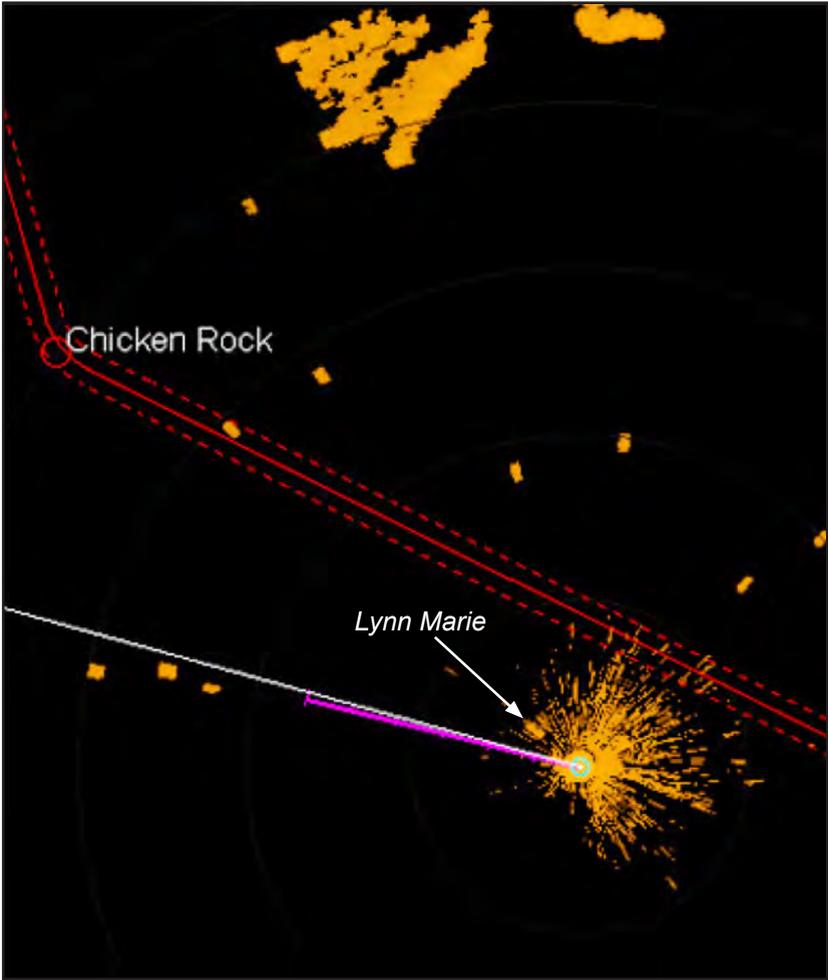
04:51:44 - Lynn Marie close on starboard bow just before alteration of course to port - 243°

adjusted the autopilot override joystick sited on the centreline console in order to turn the container ship to port towards a similar heading to *Lynn Marie's*; a maximum of 8° of helm was applied.

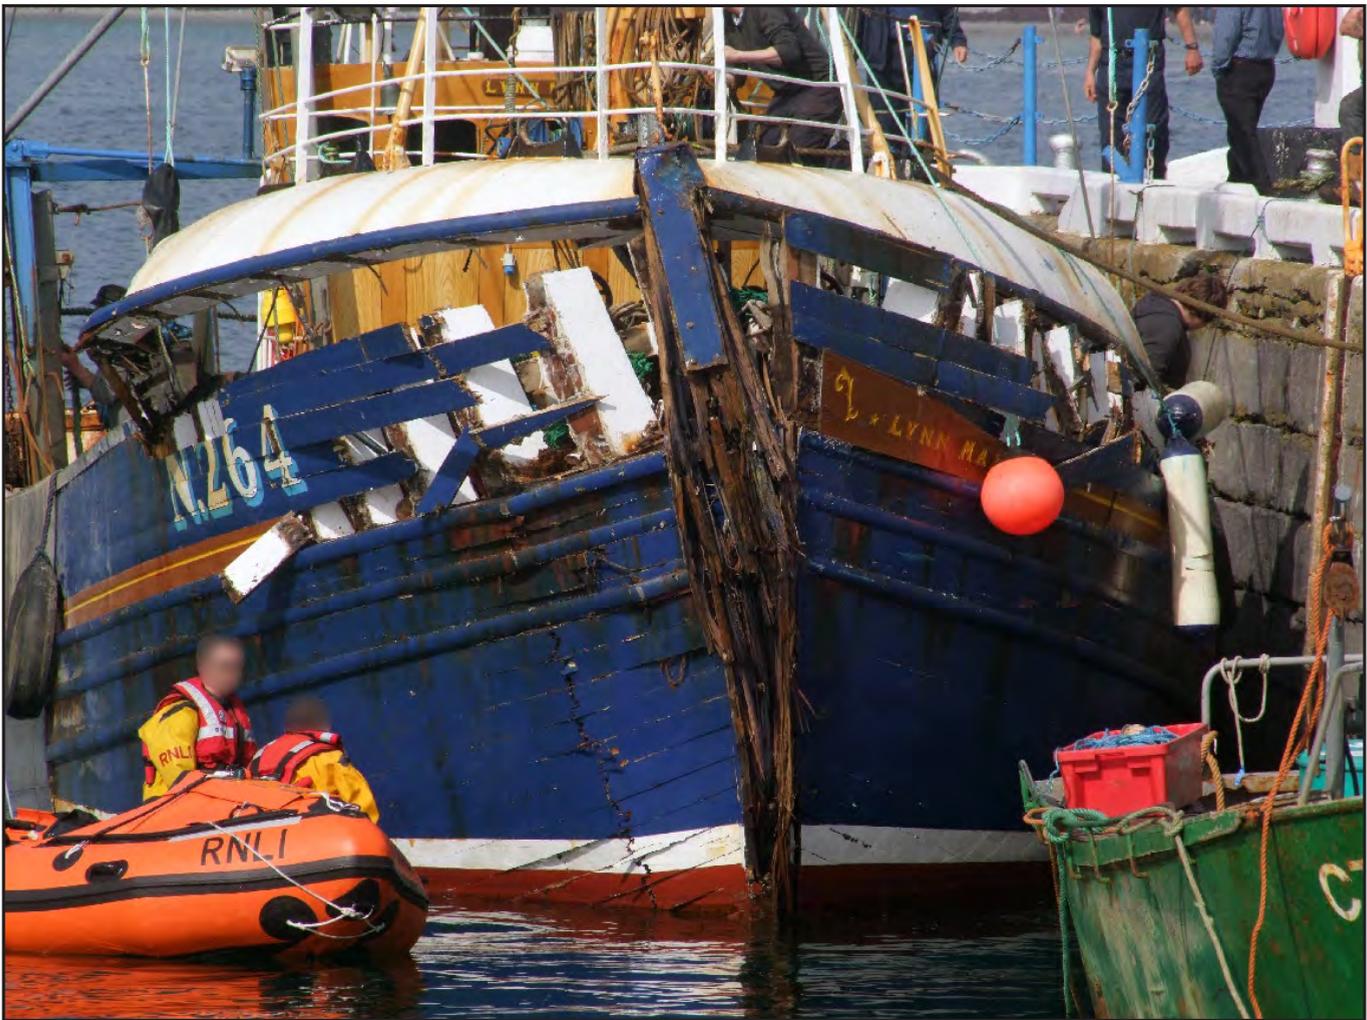
Lynn Marie suffered major damage to planking and frames on the port and starboard bow, stem post, whaleback and port outrigger (**Figure 6**).

Damage sustained to *Lynn Marie*'s bow

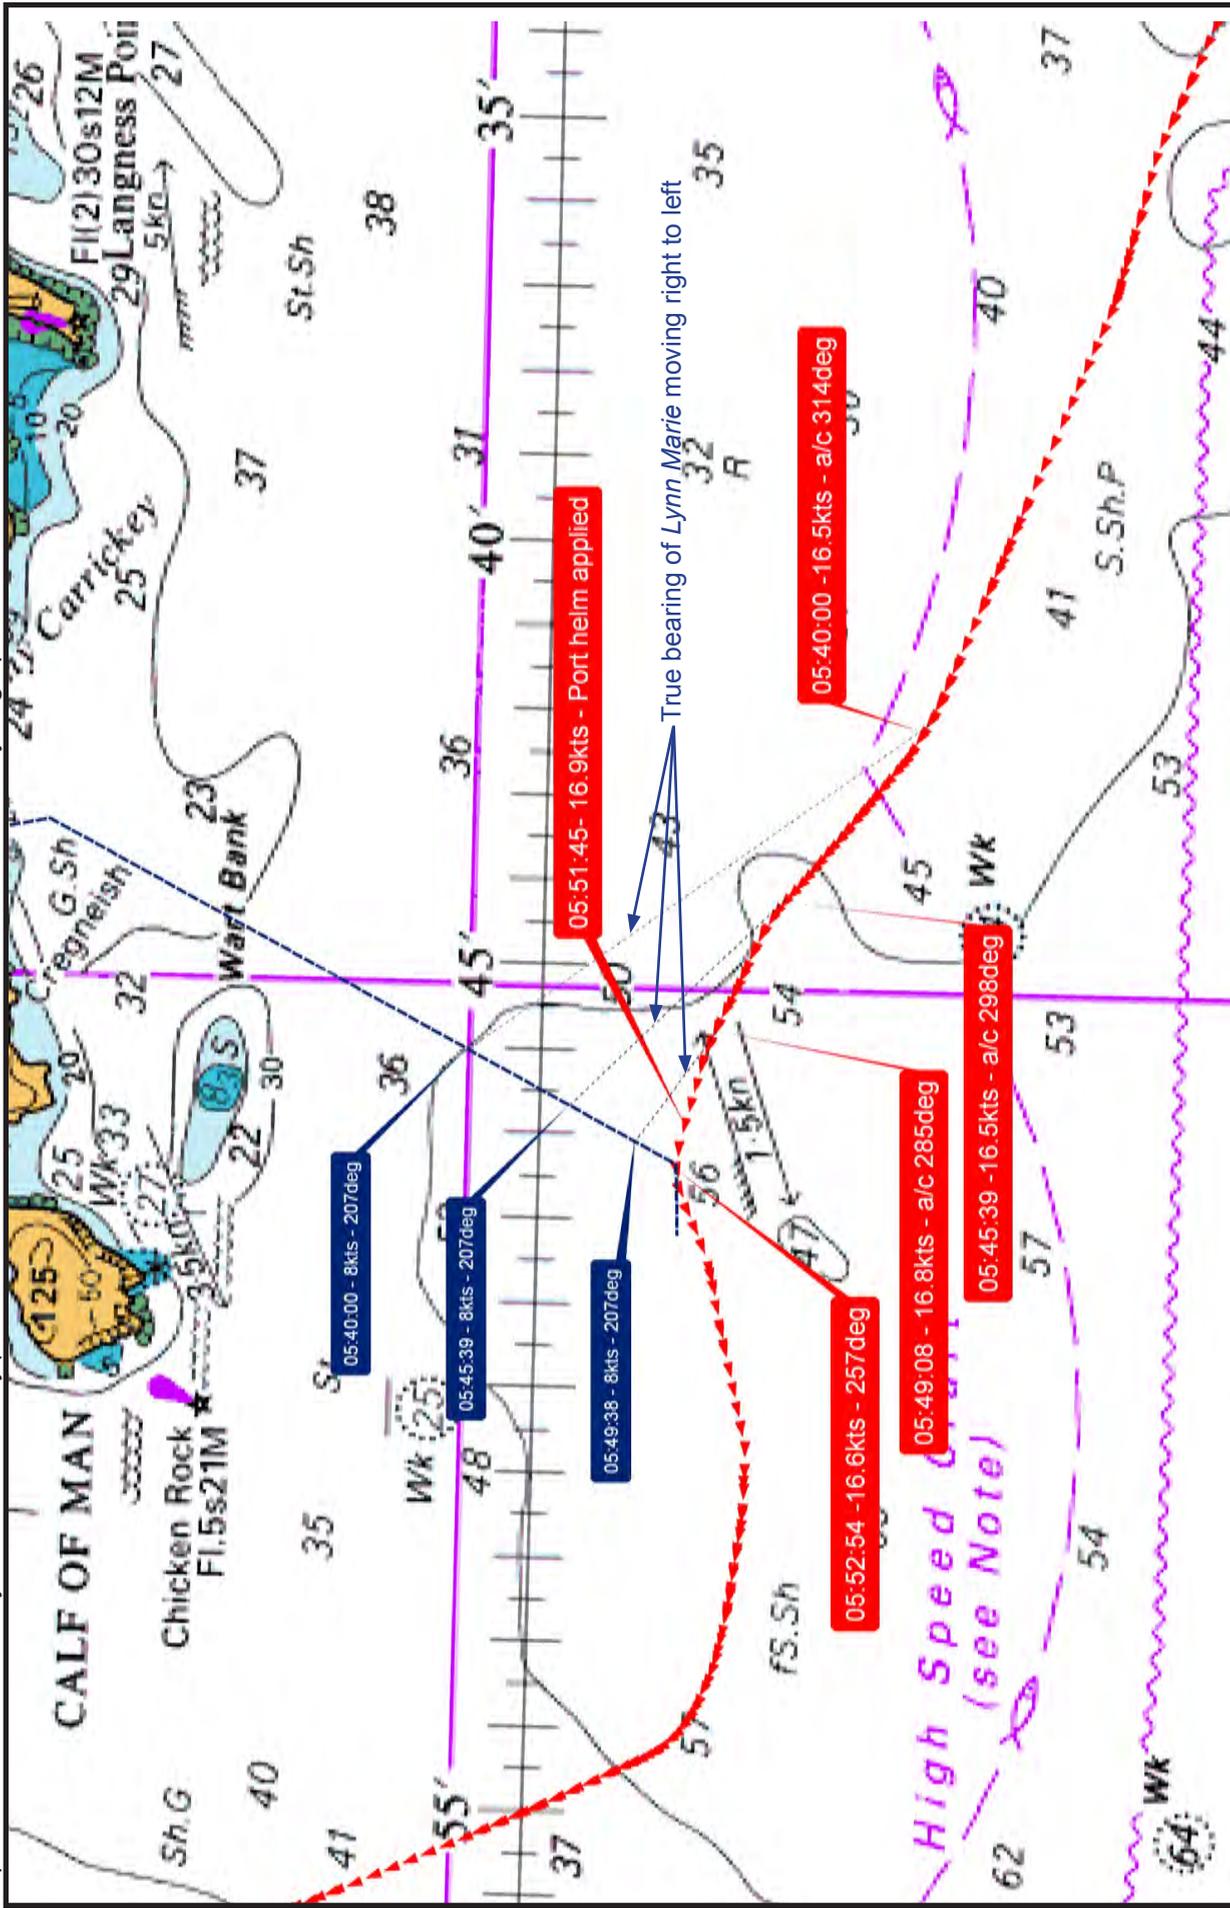
A reconstruction of the ground tracks of *Philipp*, based on AIS and SVDR information, and of *Lynn Marie*, based on GPS information, is shown at **Figure 7**. From this reconstruction it is evident that between 0440 and 0450 the compass bearing of *Lynn Marie* from *Philipp* moved steadily from right to left, indicating that she was passing ahead of the container ship. This was also the case for *Boys Pride*. It is estimated that had *Philipp*'s chief officer kept the container ship heading 314°, instead of making successive small alterations to port, *Boys Pride* would have passed 1 mile ahead of *Philipp*, with a CPA of 3 cables on the container ship's port bow. *Lynn Marie* would have passed 1.5 miles ahead of *Philipp*, with a CPA of 6 cables also on the container ship's port bow.

The chief officer's adjustments of *Philipp*'s autopilot heading to port resulted in changing the CPA of *Boys Pride* from *Philipp*'s port bow to her starboard beam. More importantly, however, the adjustments to the autopilot and the chief officer's use of port helm shortly after 0451, led to the container ship following a curve of pursuit toward *Lynn Marie*'s port quarter while travelling at twice the speed of the fishing vessel.

Reconstruction of Philipp and Lynn Marie's ground tracks

Figure 7 shows that the collision between *Philipp* and *Lynn Marie* resulted from a crossing situation in which *Philipp* was obliged to give way if a risk of collision existed. As *Philipp*'s chief officer had not accurately assessed the CPA of either *Lynn Marie* or *Boys Pride*, and because he was concerned by the proximity of other vessels on *Philipp*'s starboard side, he opted to alter course to port in increments to avoid the two fishing vessels ahead. In doing so, the chief officer's actions increased the risk of collision with both of the fishing vessels. His actions were also contrary to Rules 7, 8 and 15 of the COLREGS, which require:
