## Fatal injuries to a crewman during mooring operations on **FORTH GUARDSMAN**

**South of Jura  
13 March 2011**

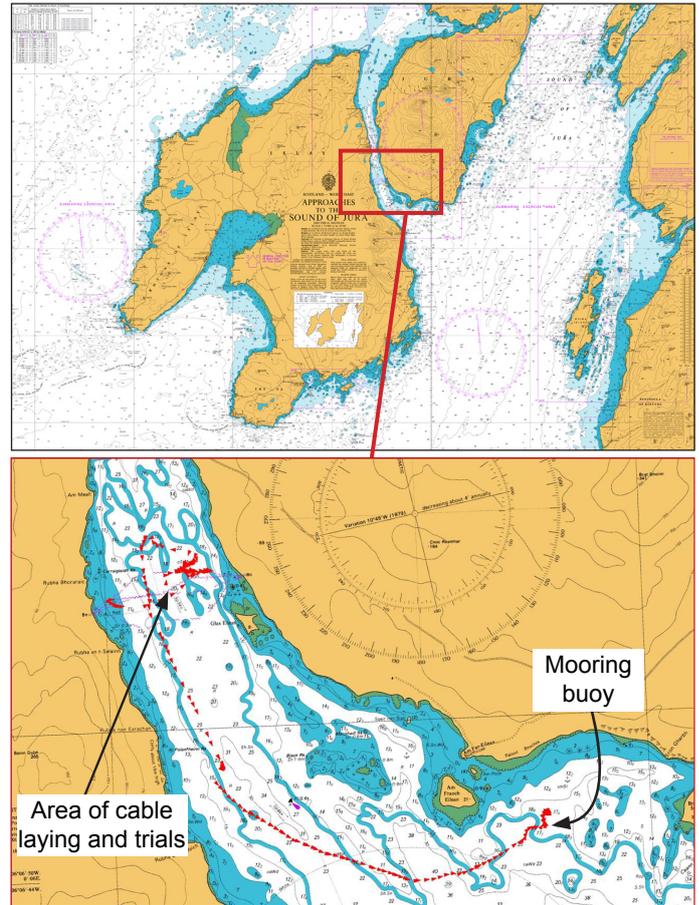
Reproduced from Admiralty Chart BA 2481 by permission of the Controller of HMSO and the UK Hydrographic Office **Figure 1**

As jetty space in the locality was limited, BMC had positioned a mooring buoy south of Jura where its vessels could lay-over when not in operation. One end of a 25m length of 60mm polypropylene mooring line had been fixed to the mooring buoy, and a messenger line with a flyer buoy attached was secured to the other end (**Figure 1**).

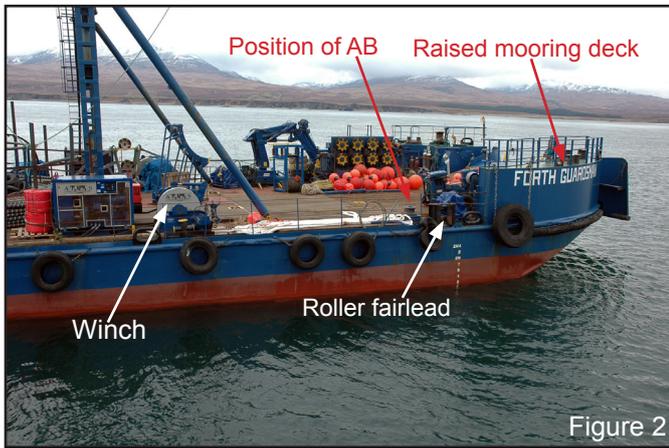
Figure 2

The master, superintendent (a former *Forth Guardsman* master) who was on board for the trials, and the mate discussed the options for securing to the mooring buoy. They decided that handling and connecting the mooring line on the raised forward mooring deck could be difficult, and there was a risk of the line snagging on the adjacent cable laying equipment or tyre fendering. Consequently, they concluded they would pick up the mooring line from the main deck, which was nearer the water line, and shackle it to the wire from one of the 4-point mooring winches (**Figure 2**).

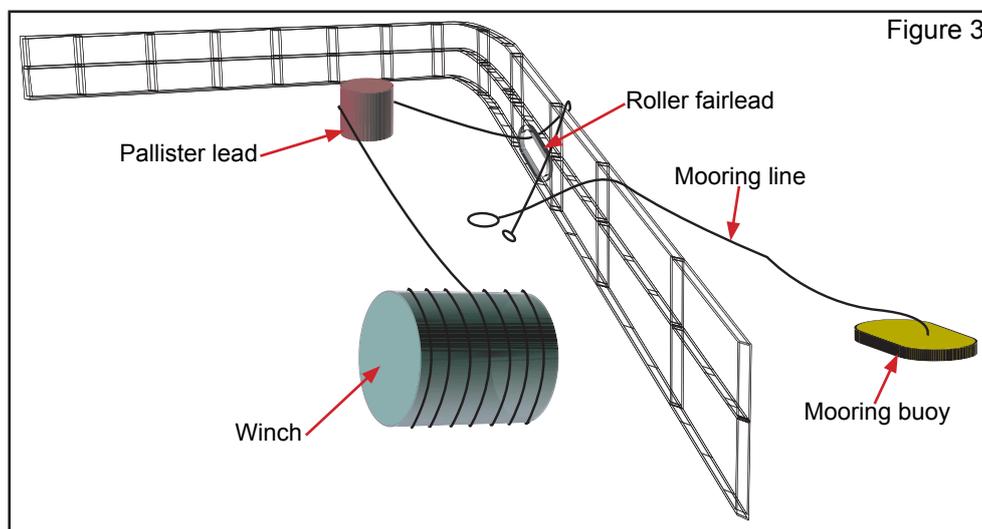
Figure 3

The mate produced a method statement and risk assessment for the operation, and a toolbox talk attended by all six crew was held during the morning. The plan was that the mate and the AB, Boguzlaw Kopec, would go forward to make fast. The master would be on the bridge for the final approaches to the buoy, with the mate directing him via very high frequency (VHF) radio. AB Kopec would use a boathook to pick up the messenger line's flyer buoy, and the mate would then pull in the messenger line to bring the mooring line's eye inboard over the guardrail. In preparation for the connection, the wire from the winch would be fed outboard through a roller fairlead and brought back inboard over the guardrail. The eyes of the mooring line and the wire would be connected on deck using a shackle (Figure 3).

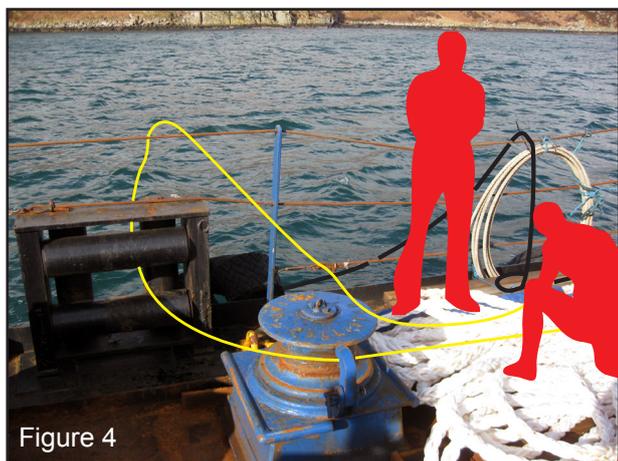
Figure 4

AB Kopec hooked the messenger line at the second attempt and he and the mate pulled the mooring line inboard by hand. He then passed the eye to the mate so he could shackle it to the hard eye of the wire. Unwittingly, the AB then stood in a position that would place him in an open bight as soon as the two lines were connected. The mate knelt on the deck, looking down while he secured the shackle, and was unaware that *Forth Guardsman* was beginning to move away from the buoy (Figure 4).

- The open bight was created when the mooring line was shackled to the wire. The method that AB Kopec chose to make the connection left him standing in a dangerous place when the line came under tension.

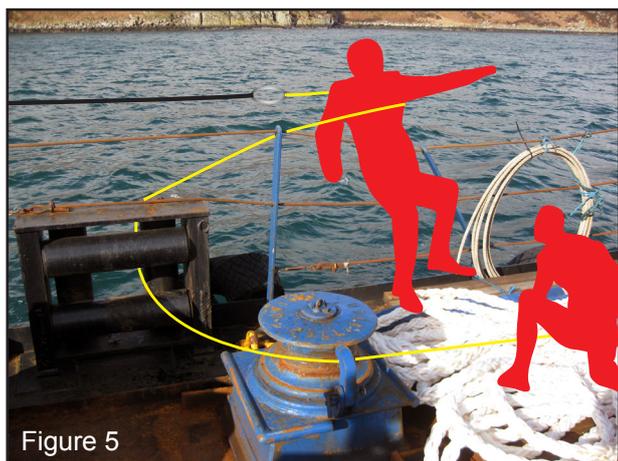
Figure 5

At approximately 1912, the mooring line became taut, pulling the now closed but not secured shackle out of the mate's hands and tightening the wire across AB Kopec's chest (Figure 5). The mate was unable to take the weight off the wire by hand, and called the master by VHF to bring *Forth Guardsman* ahead. However, before the master had done so, one of the stanchions buckled and AB Kopec was pulled over the guardrail and into the sea.

- Developed procedures for single point mooring operations.
- Instructed that all single point mooring operations on *Forth Guardsman* are to be conducted by three people.
- Reminded its crews to adhere to the guidelines on mooring operations contained within the MCA's Code of Safe Working Practices.
