SBS TYPHOON

Contact in Aberdeen Harbour, 26 February 2011

SUMMARY

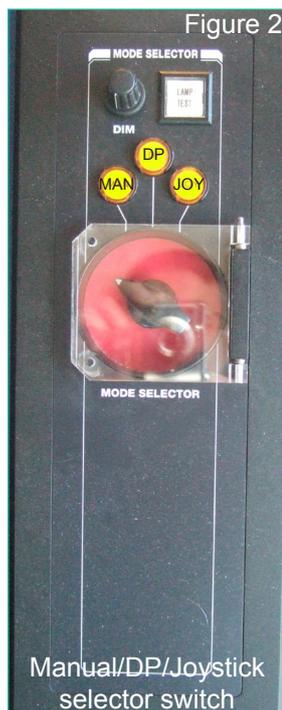
Two operator stations, located at the aft end of the bridge, controlled the vessel when in the “DP” mode. Individual tunnel thrusters, CPPs and rudders could be selected for DP control when the mode selector switch (**Figure 2**) was in the “DP” position. The vessel's desired position was compared against gyro, differential global positional and laser referencing system, and wind and motion sensor information. The resultant command signals for pitch or rudder movement were generated by separate IO modules within the DP controller cabinet. The command and feedback signal type (ie voltage or milliamps (mA)) was determined by the configuration of the specific thruster, CPP or rudder controller.

Moving the mode selector switch from the “DP” position to either the “manual” or “joystick” positions would set the thruster and CPP pitch to zero and rudders to midships until the new control station took command and an alteration was made. When the mode selector switch was set to the “DP” position it was not possible to manually control CPPs, thrusters or rudders.

Rigorous trials were carried out to check the correct operation of the CPP and thruster pitches from each of the control positions. No defects were found. Although there was misalignment of the “manual”/“DP”/“joystick” mode selector switch positions when compared to the illuminated etched positional legends on the mounting panel, the switch functioned correctly.

5. Actions taken by the chief officer to limit damage were hampered by the defective port main engine emergency stop and the mode selector switch not being moved from the "DP" to the "manual" position.

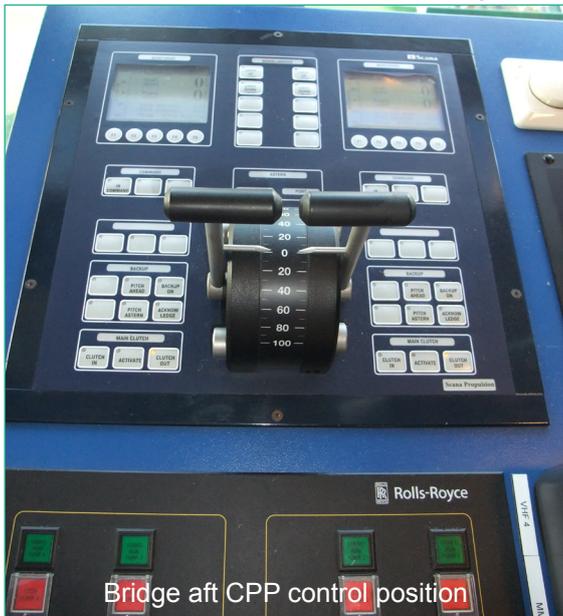
Figure 3

After the technician had discussed this requirement with the ship's officers, the chief engineer engaged the main shaft clutches and passed CPP control to the bridge. The chief officer confirmed he had pitch control of both propellers from the forward and after control positions (**Figure 3**), the latter of which was sited adjacent to the DP operator's position. At 1524, the chief officer moved the "manual"/"DP"/"joystick" mode selector switch to the "DP" position (**Figure 2**). As he did so, full ahead pitch was applied to both CPPs and the vessel started to move along the quayside. The mooring lines, which were only secured using turns on one half of the mooring bitts (ie not in figures of 8) or on winch drums, had not been doubled up and were payed out under load. One line parted.

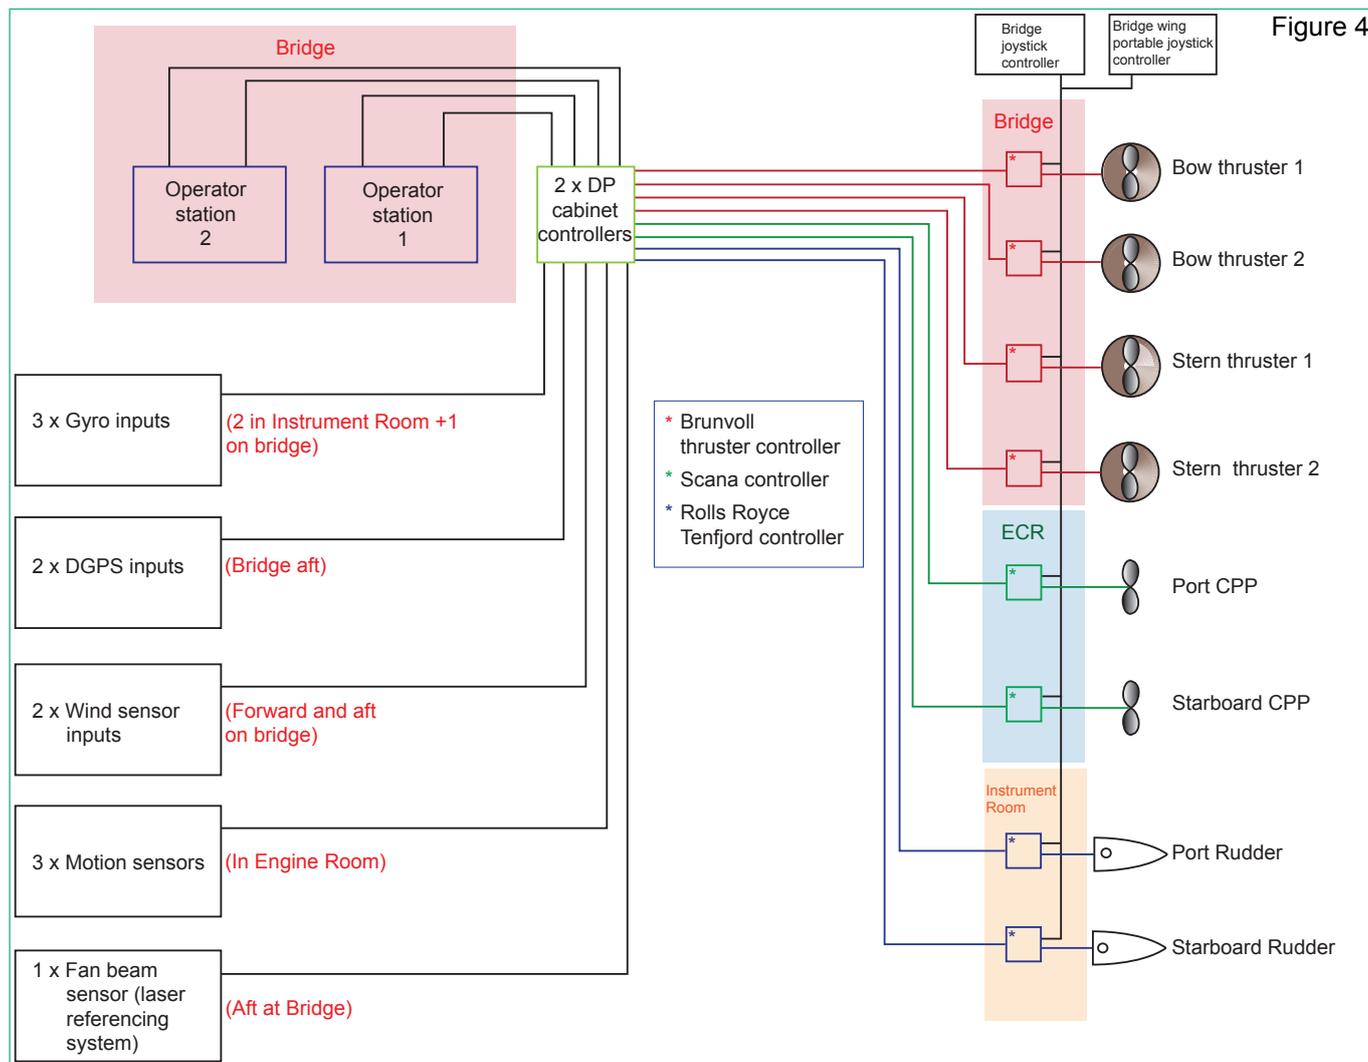
Figure 4

Schematic of Kongsberg K-Pos DP-21 System

Post-accident checks by Kongsberg Marine AS re-confirmed that an incorrect IO configuration of a command signal range of 4-20mA and an actual value of 12mA had been set for the pitch order instead of the "+/-10 volts" specified. With the 12mA value set in this configuration, it was found that there were +13.5 volts at the output from the IO modules, and this was also observed at the CPP Scana controllers. The Scana controllers operated in the range of +/- 10 volts. When the "manual"/"DP"/"joystick" mode selector switch was set to the "DP" position, +13.5 volts was received by the Scana controller. A voltage of this size and polarity equated to greater than full pitch ahead, and this led to the vessel's unexpected and uncontrolled movement along the quay.

The K-Pos DP-21 system configuration should have been checked during the FAT in accordance with the checklist at Section 5.3.10 – "Thruster Interfaces" of the "FAT Procedure" documentation. However, the technician carrying out the checks did not set up the system with a voltage command instead of an mA command, which appears to have been the default setting. Neither the quality assurance procedures nor those personnel witnessing the FAT identified the error, so it was not corrected.

- Revised the FAT procedures to include specific checks for the verification of IO configuration software.
- Amended the HAT documentation to include:
 - Guidance on liaison with customers, compliance with permit to work procedures and the conduct of risk assessments for the entire project.
 - Instructions to technicians that the master retains responsibility for safety, that equipment must not be operated until all 'emergency stop' systems have been tested, and that a responsible person oversees equipment operation and takes control if necessary.
 - A requirement to prove all IO signals are correct with the thruster, CPP and rudder manufacturer before switching to "DP" or "joystick" control.
