Grounding of **K-WAVE** near Malaga, Spain 15 February 2011

SUMMARY

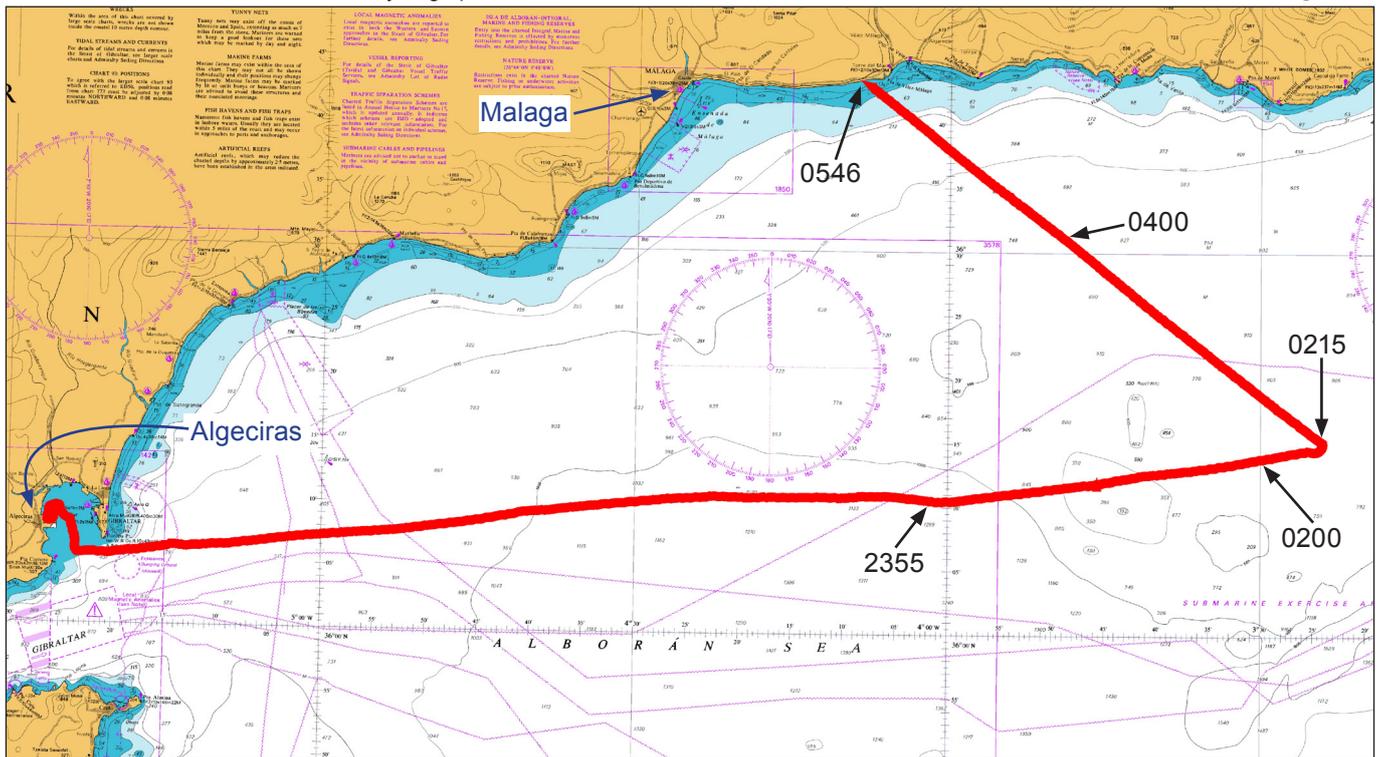
Extract from chart 0773 showing the course of K-Wave on 14, 15 February 2011

At 0216, in an unscheduled departure from the passage plan, the vessel's course was altered from 081° to 305°. No alarms sounded on the bridge during this alteration of course, and the bridge remained silent until the vessel grounded at 0546 on a gently shelving, sandy, shoreline 13 miles east of Malaga. At 0557 the crew of a local fishing boat informed the Spanish coastguard that a merchant vessel appeared to have grounded.

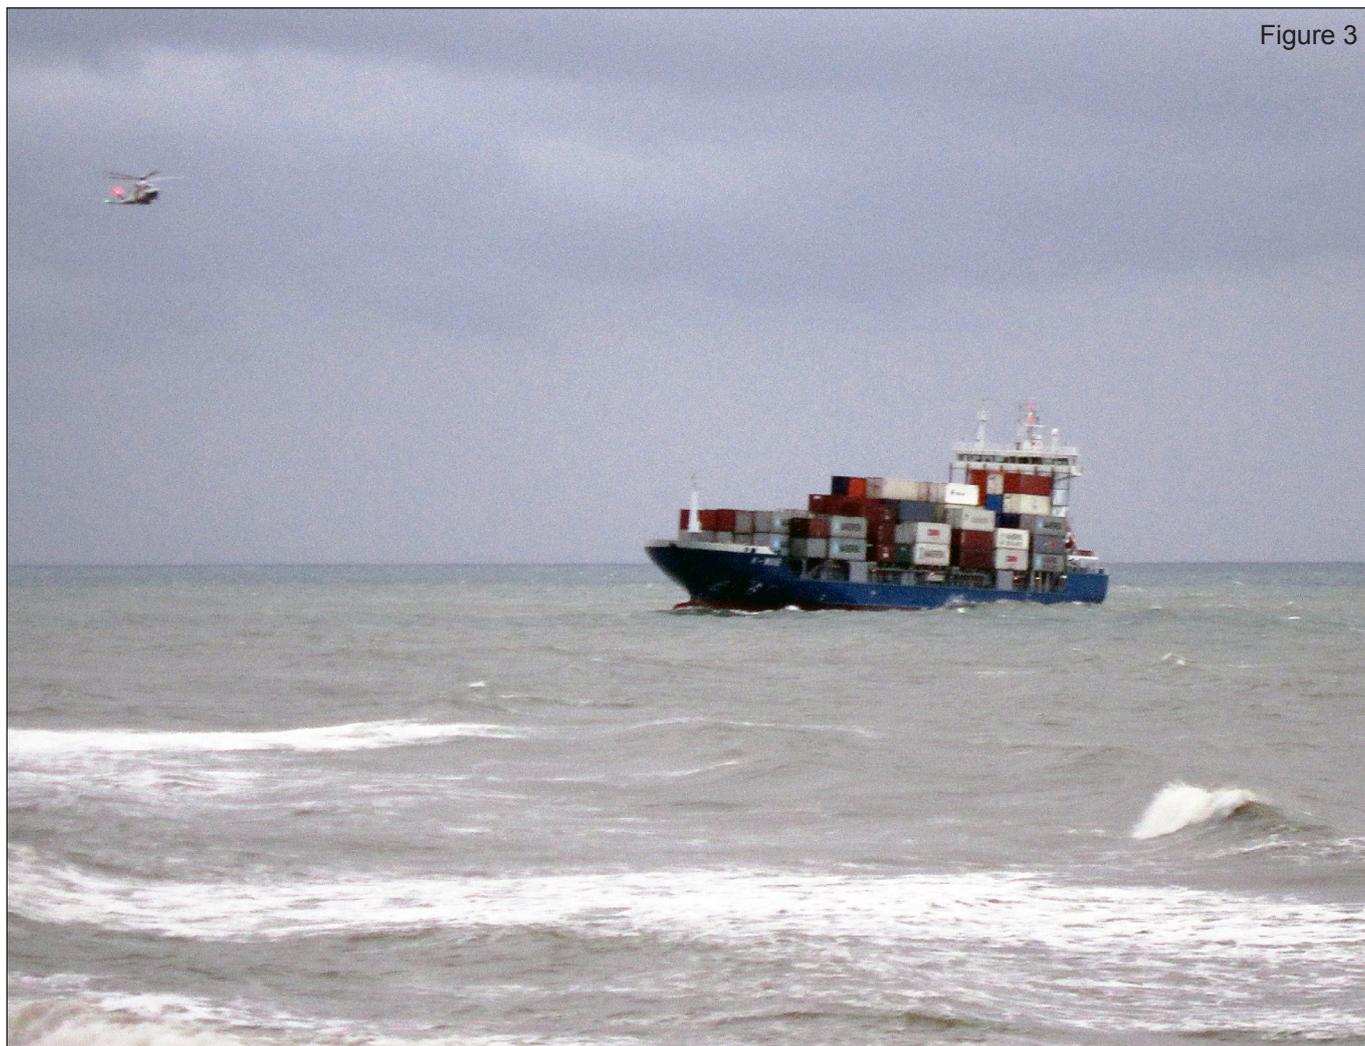
Figure 3

At about 0930, a coastguard rescue helicopter arrived on scene (**Figure 3**) and the master advised its crew that there was no need for anyone

Coastguard helicopter arriving on scene
