Tombarra inspection report dated 23/3/2011

INSPECTION REPORT

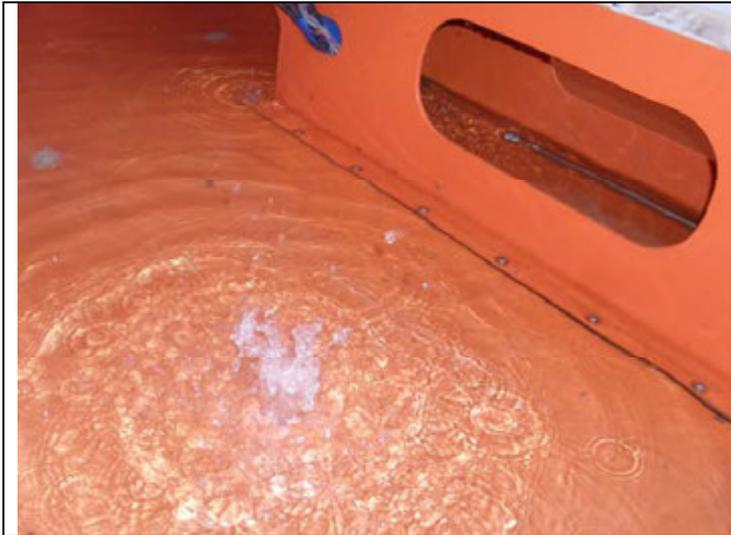
When the sealed holes or damages where opened, air was flowing with pressure.

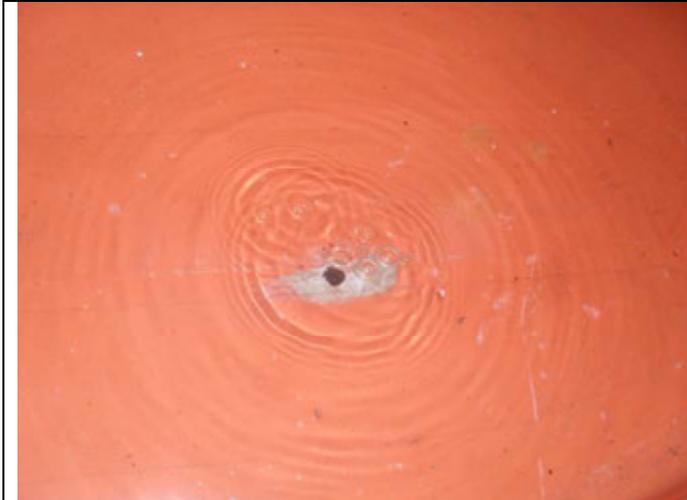
Same comment as above.

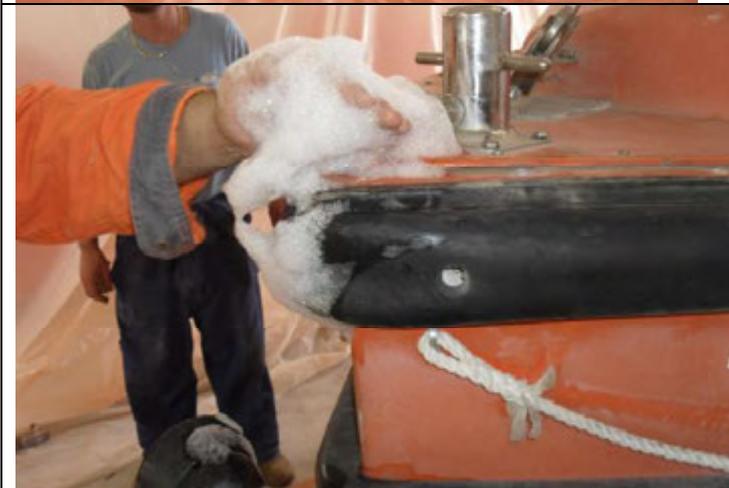
A lot of air was getting out of this damaged area between the hull and deck.

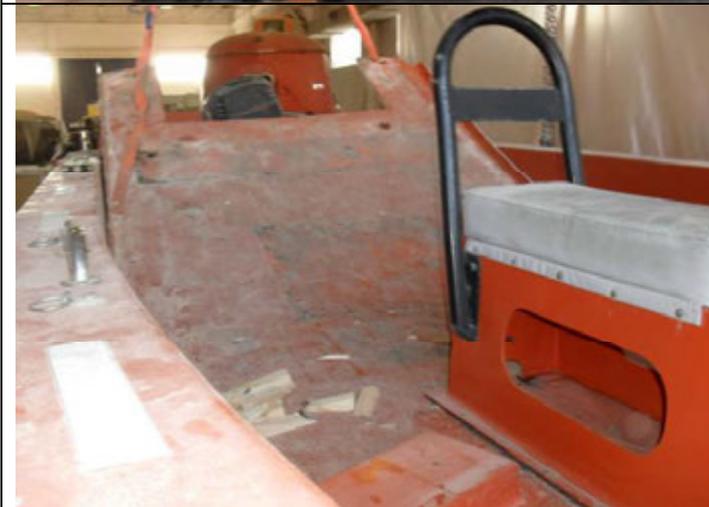
The deck was cut and removed from the boat.

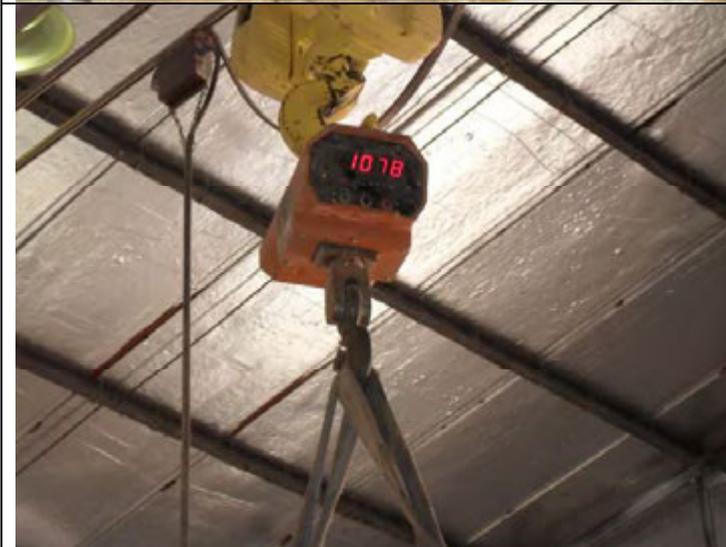
The foam and water was removed and the boat was weighted. The weight was found to be 1078.

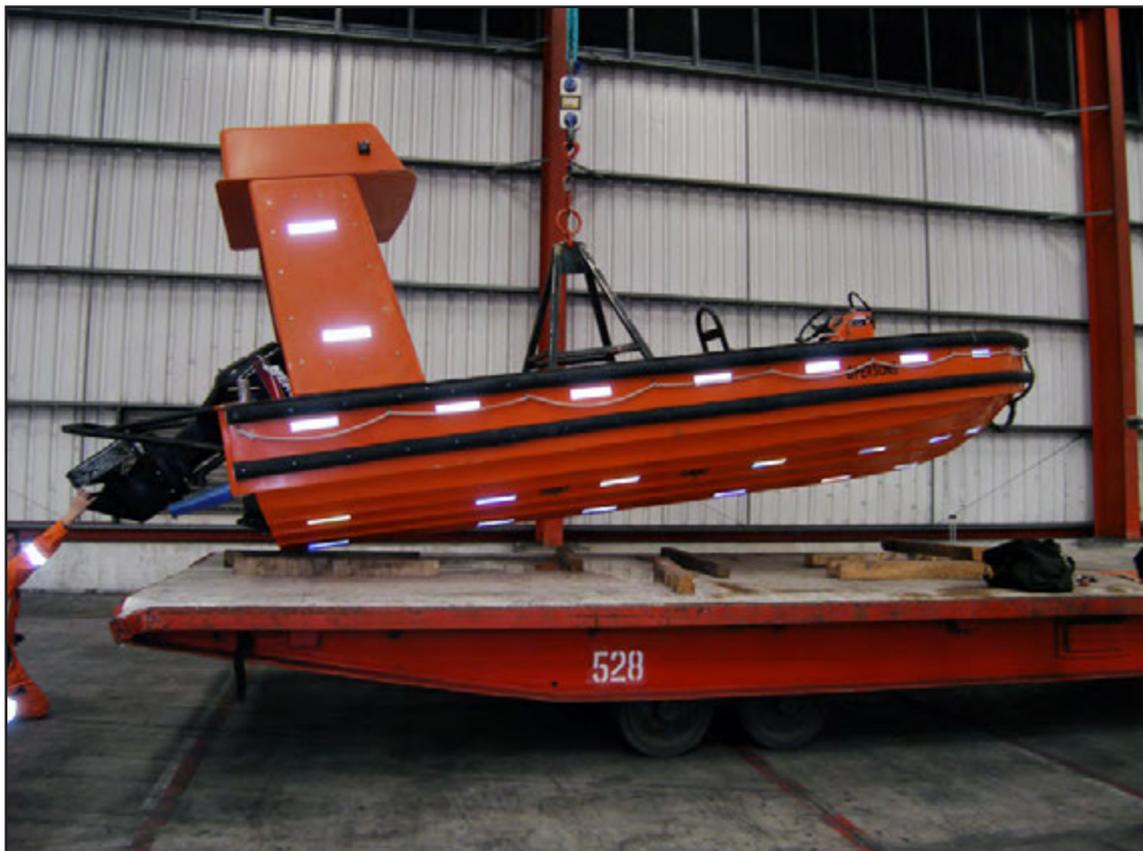
Weighing of the rescue boat
