MAIB SAFETY BULLETIN 2/2011

Malfunction of a proximity switch, which resulted
in failure of a fall wire with the loss of one life
on the car carrier *Tombarra*

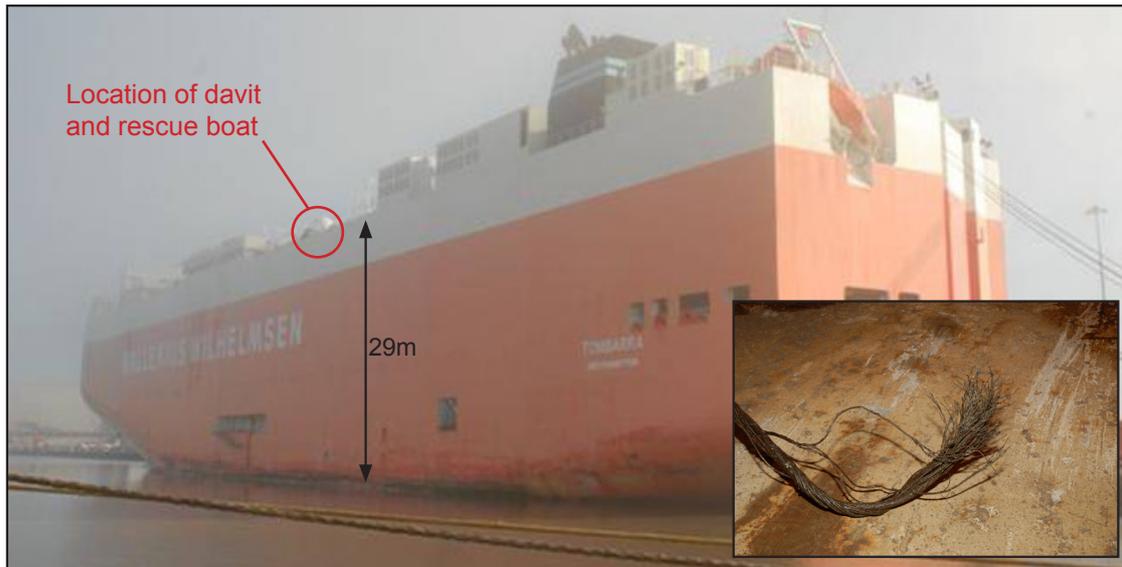
Figure 1

At approximately 1550 (UTC) on 7 February 2011, the fall wire of the rescue boat on board the UK registered car carrier *Tombarra* parted when the vessel was alongside in Royal Portbury Docks, Bristol, UK. The accident occurred as the rescue boat reached its stowed position on the davit following a monthly drill. Hoisting was not stopped before the davit reached its stowed position. The proximity switch, that should have cut electrical power to the winch motor before the davit reached its stops, failed to function. The rescue boat and its four crew fell nearly 29m (**Figure 1**) into the water below. One of the boat's crew died and two were hospitalised.

Vessel and parted fall wire

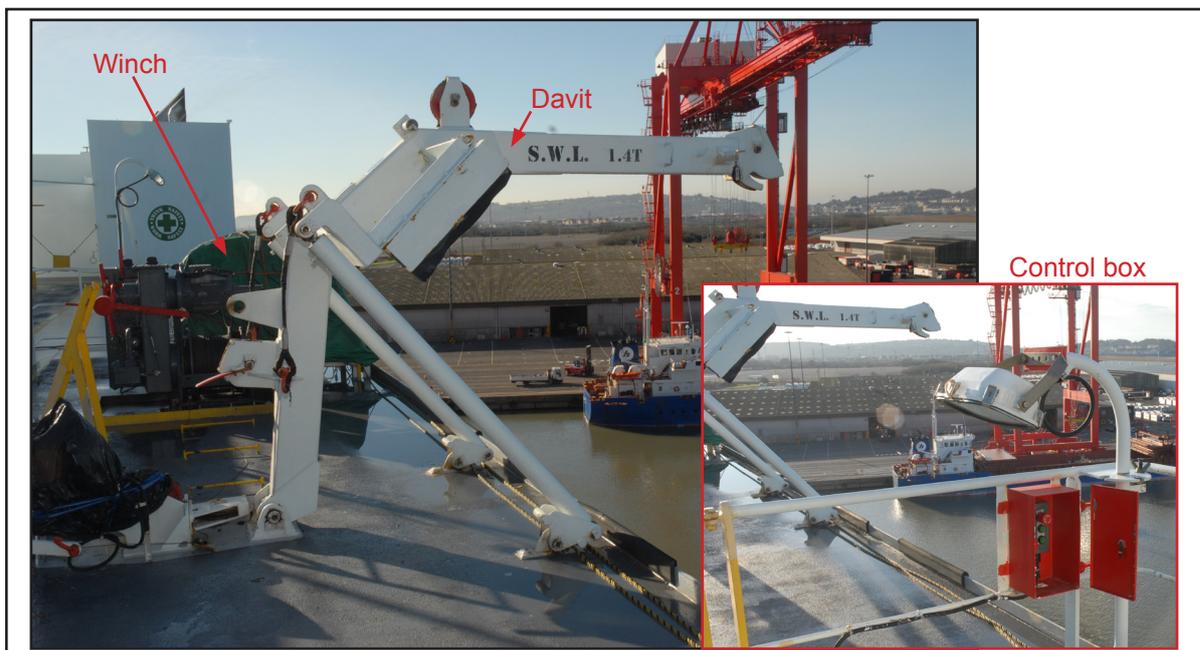
Figure 2

The 12mm diameter fall wire had a certified minimum breaking load of 141kN. Its safe working load (SWL) was 23.5kN based on a factor of safety of six. The wire was fitted to a single-arm davit (SA 1.5) (**Figure 2**), manufactured by Umoe Schat-Harding Equipment AS (Schat-Harding). The davit system was powered by a Schat-Harding W50 two-speed electric winch with a nominal pull of 50kN.

Davit system

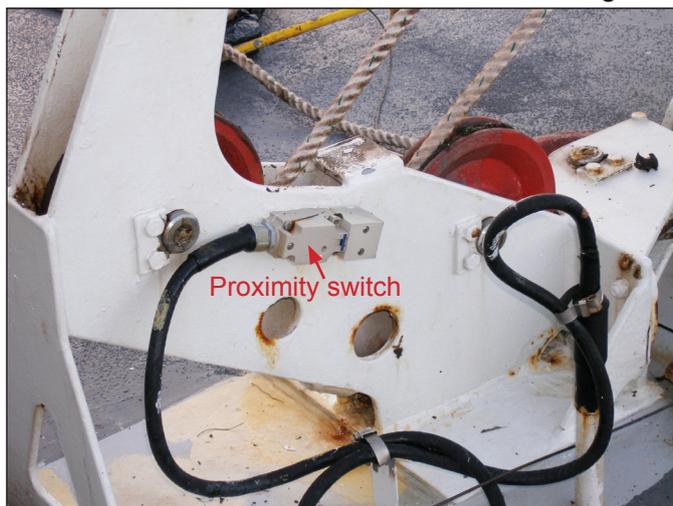
Figure 3

The winch was operated by a control panel sited forward of the davit. The boat was hoisted using the buttons on the control panel until the davit was near the stowed position. It was then intended that hoisting be completed manually by the use of a winch handle adjacent to the winch motor. To prevent the inadvertent operation of the winch when the rescue boat was in its stowed position, an inductive proximity sensor/switch (Telemechanique XS7-C40FP260) was fitted on the davit (**Figure 3**). The switch was intended to cut off power to the winch when the davit closed to within approximately 12mm of the sensor.

Proximity switch on davit

Schat-Harding has issued a Product Awareness Notice (PAN) to its customers highlighting the need to test the proximity switches fitted on its SA 1.5 and SA 1.75 davits on each occasion before hoisting operations commence, and recommends that the proximity switch is replaced every 2 years; it also highlights the need for caution when using pressure washers on deck.

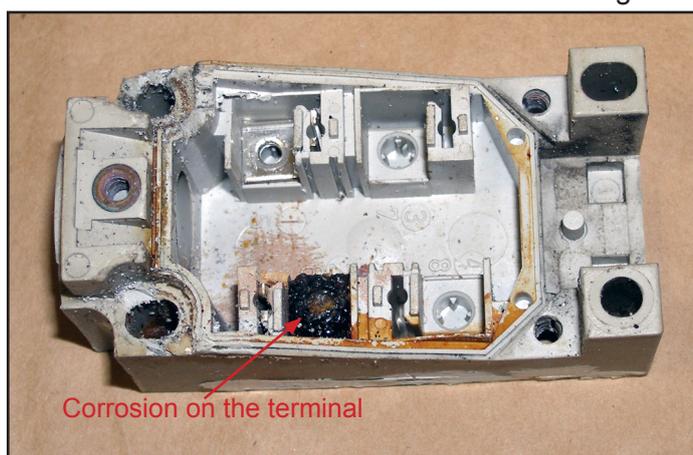
Figure 4

Corrosion on the terminal

Water ingress into proximity switch

The switch was installed in 2006, and prior to the accident it was not tested before hoisting was commenced. Inspection identified that the switch body had been penetrated by water (**Figure 4**). However, detailed analysis highlighted that the switch malfunctioned due to an unrelated electronic fault. The MAIB is aware of both inductive proximity and mechanical limit switches fitted on other vessels that have also failed to operate correctly. However, none are known to have resulted in a similar accident.

- The fitting of the proximity switch was not compliant with its manufacturer's instructions. As a result, the gland and cable entry were higher than the switch body and its susceptibility to water ingress was increased.

- In the case of vessels fitted with the Schat-Harding SA 1.5 and SA 1.75 davits, follow the advice contained in the PAN recently issued by the manufacturer or urgently contact Schat-Harding¹ if a PAN has not been received.
- Ensure that all devices (inductive or mechanical) fitted to boat davit systems to prevent overload are tested on each occasion before a boat is hoisted and that such devices are not relied upon during operation.
- Follow manufacturers' recommendations regarding the maintenance and periodic testing, examination and replacement of safety devices, seeking clarification from manufacturers where ambiguity exists.
- Verify the effectiveness of watertight seals on electrical equipment fitted to boat davit systems on weatherdecks.
