SUMMARY

FV JACK ABRY II

Grounding on the Isle of Rum, 31 January 2011

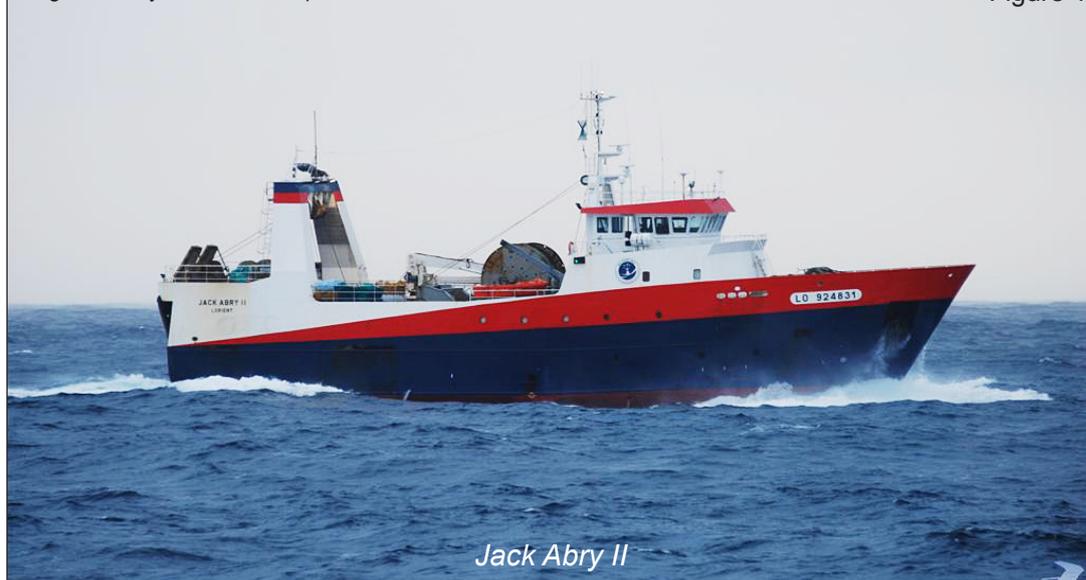
Figure 1

Jack Abry II

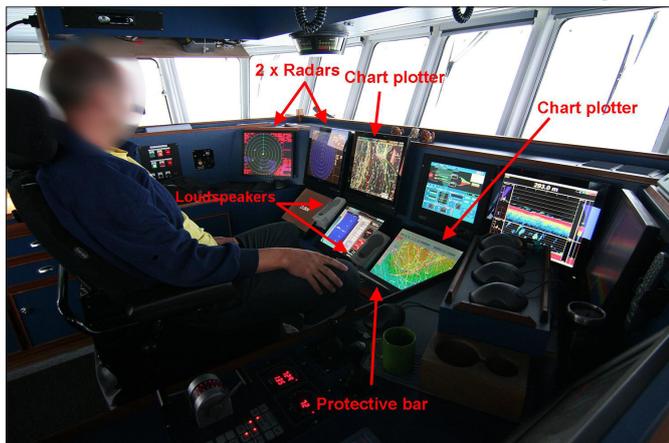
Figure 2

Between 2100 and 2200 the skipper undertook paperwork at the chart table and then sat in the wheelhouse chair (**Figure 2**). He was navigating on autopilot using two radars (set on 6 and 12 miles range respectively) and a chart plotter located in front of the seat. The plotter display was partially obscured as he was sitting with his feet resting on a protective bar placed in front of the screen; the owner had installed this bar after the display screen had previously been damaged by a watchkeeper resting his feet on it. A second chart plotter had been switched off at 2101 as the skipper was using this computer to listen to music.

Wheelhouse, looking forward to port

The ergonomics of the navigation position, with the active chart plotter display immediately in front of the seat, were also not ideal. The bar fitted on the console following previous damage to the display acted as a convenient foot rest. This led to the screen being partially obscured by the skipper's feet, and consequently only being periodically checked. Had the skipper more frequently corroborated the vessel's position both by radar and chart plotter, it is unlikely that he would have lost situational awareness.

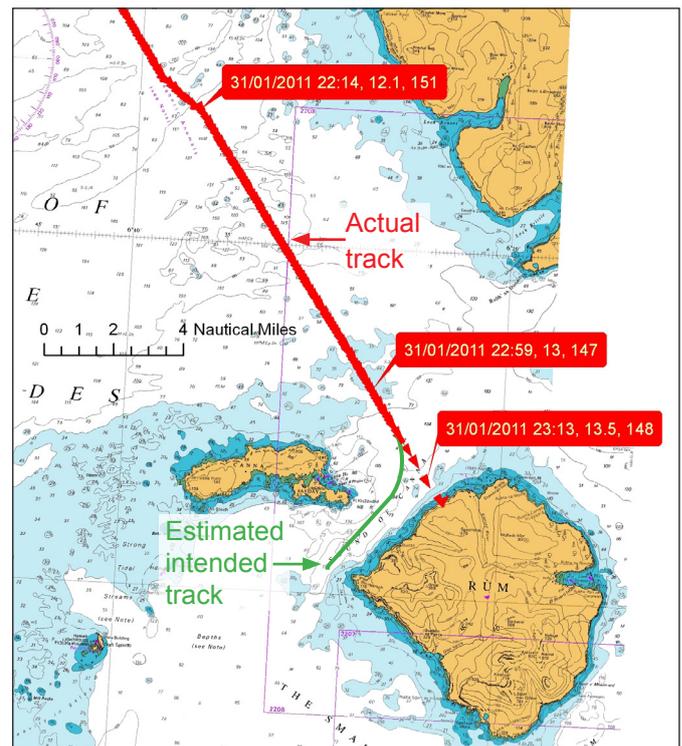
Figure 3

At 2207, the skipper made a small alteration to *Jack Abry II*'s course to pass another vessel, and he altered course back onto his intended track at 2214 (**Figure 3**). Although the skipper normally came off duty at 2300, he decided on this occasion to remain on watch for a while longer. Not only did he want to navigate the vessel through the Sound of Canna before handing over the watch, but he had also perceived that the mate was tired and would benefit from more rest. The only other person on duty was the 3rd engineer in the engine room.

With the vessel approximately 4 miles from the Isle of Rum, the skipper misinterpreted the radar display, which was showing extensive radar clutter from the squally showers. This caused him to lose situational awareness and believe that the island was further away than it actually was. His next recollection was of the vessel running aground on the Isle of Rum. The accident occurred around low water at about 2316 with the vessel making 13.5 knots (**Figure 3**).

Track of *Jack Abry II*

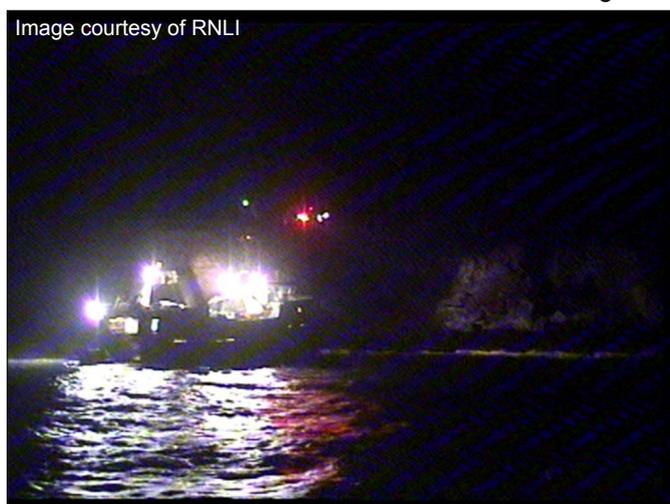
Figure 4

At 0100, the helicopter arrived on scene (**Figure 4**) and winched all 14 crew safely off the vessel. Two of the crew (but not the skipper) were reported as smelling of alcohol. No alcohol or drug testing was conducted following their arrival in Stornoway at 0226.

Stornoway coastguard helicopter on scene

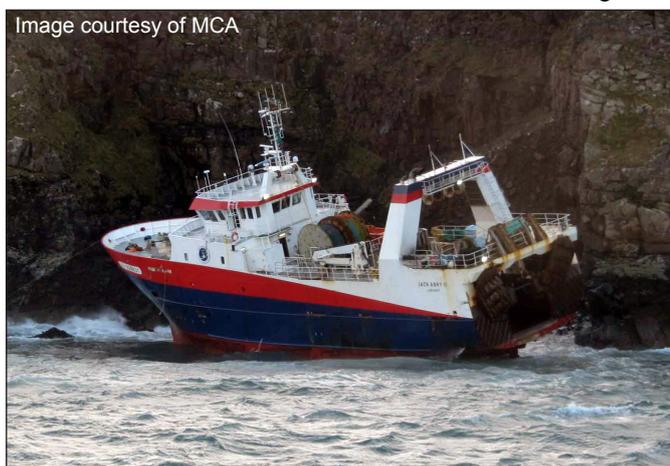
Figure 5

By the time the ALB returned to the scene later that morning, *Jack Abry II* had settled a short distance along the coast (**Figure 5**). The ongoing poor weather led to further damage and the vessel was eventually declared a constructive total loss.

Jack Abry II aground, 1 February 2011
