Report on the investigation into  
the collision between the fishing vessels  
***Sapphire II and Silver Chord***  
resulting in the foundering of *Sapphire II*  
off Stornoway, Scotland  
12 January 2011

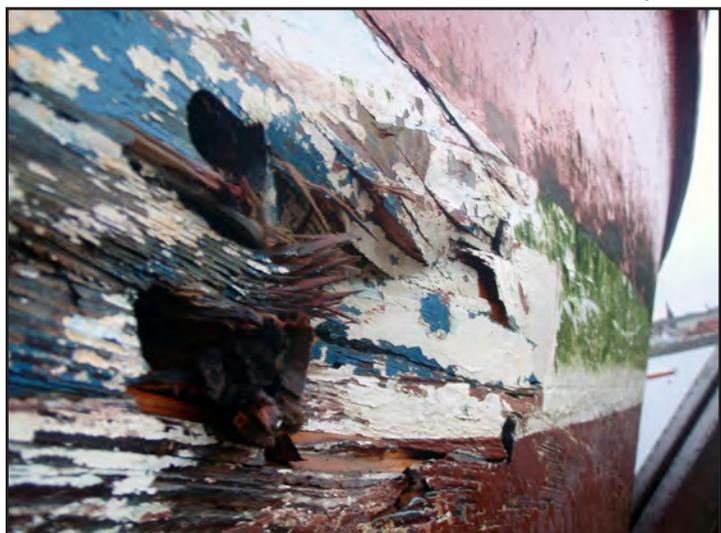
Figure 4

On 14 January 2011, *Silver Chord* was taken out of the water and inspected. The hull was damaged in way of the stem bar on both port and starboard sides around the boot topping area. On the port side, two planks had been damaged (**Figure 4**) and the hull had been penetrated at the waterline in way of the fore peak space. On the starboard side there was evidence of impact damage, but no penetration of the hull.

Damage to *Silver Chord's* port bow

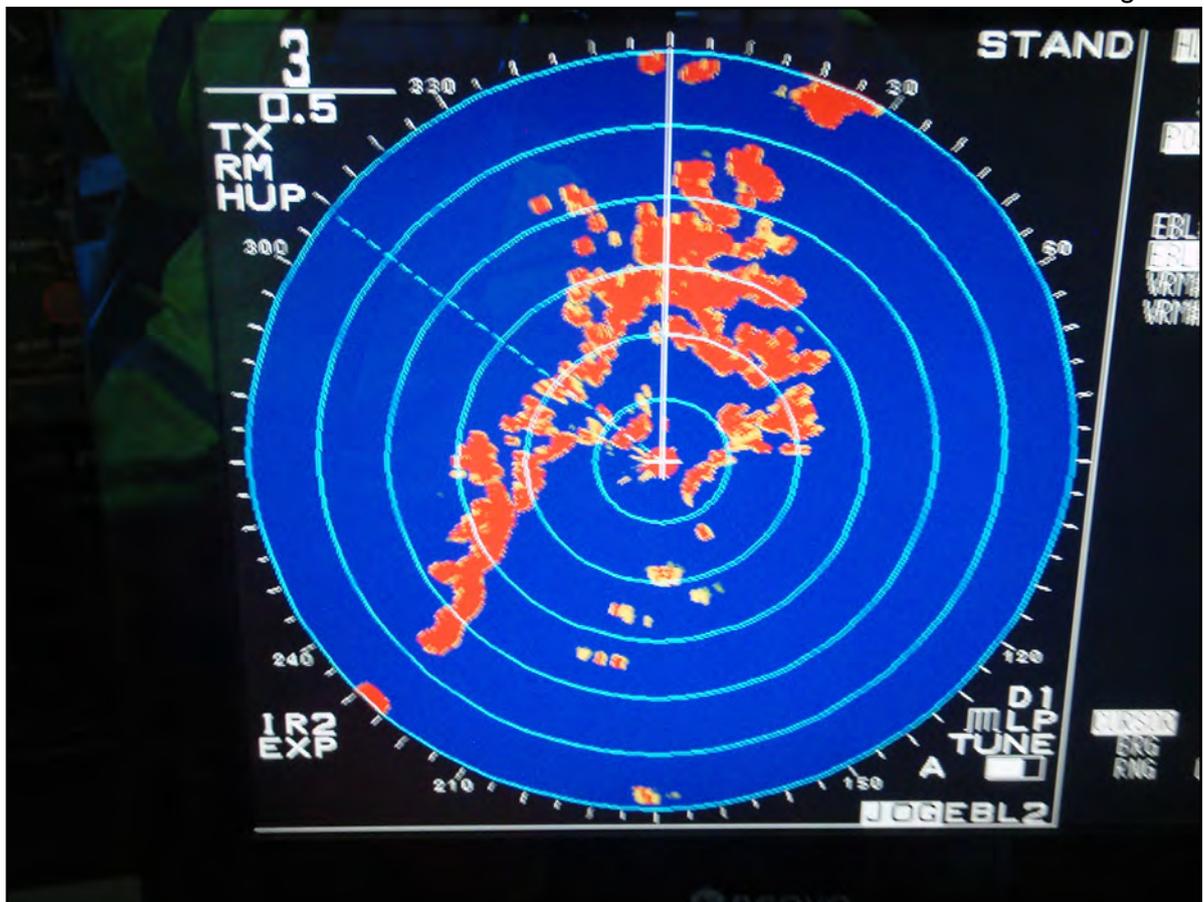
Figure 5

*Silver Chord*'s radar on the 3nm range scale

Similarly, as *Silver Chord's* radar was set to the 3-mile range scale, the radar target of *Sapphire II* would also have been displayed from about 1807 onwards. This was also not seen by the skipper. As *Sapphire II* was on a steady or near steady bearing on the ship's head throughout, it is possible the radar target of *Sapphire II* might have been occasionally obscured by the radar ship's head marker. However, it is highly unlikely to have been completely obscured each time the skipper visited the wheelhouse.

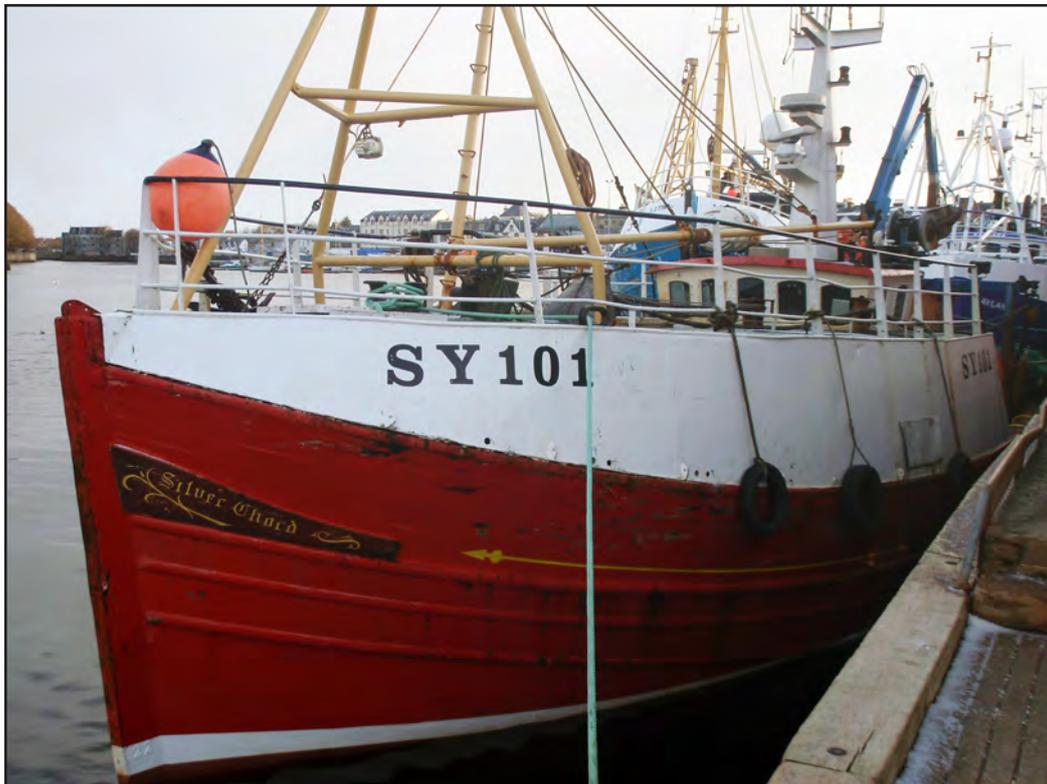
Figure 6

The view ahead of the vessel from the steering position sited on the centreline of the wheelhouse was partially obstructed by the vessel's shelter and deck fixtures, which were fitted in the late 1980s (**Figures 6 and 7**).

*Silver Chord* - shelter and deck fittings

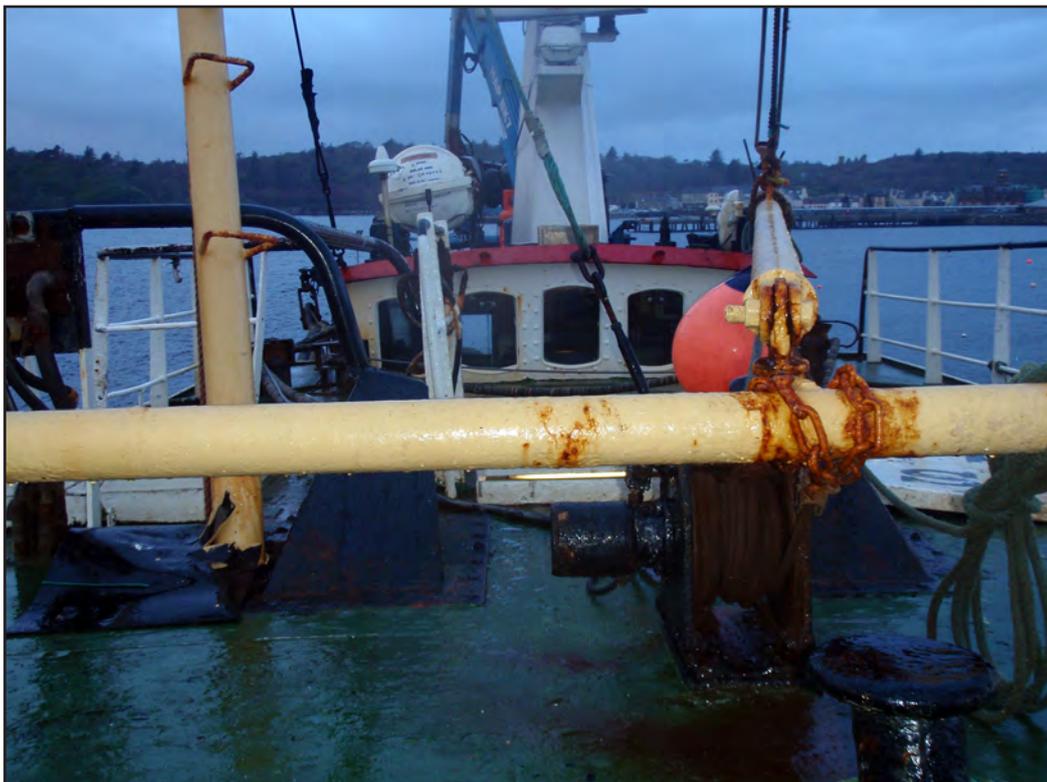
Figure 7

*Silver Chord* - view of wheelhouse from forward

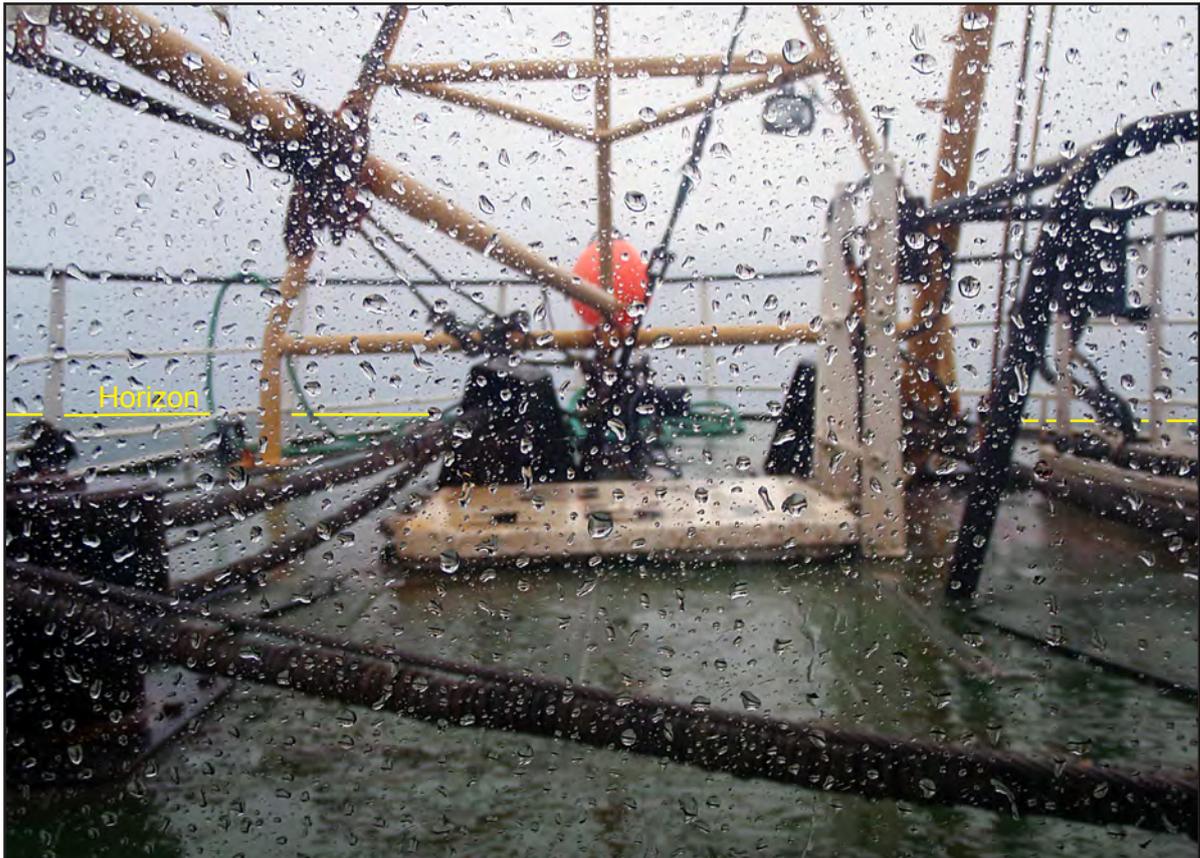
Figure 8

However, because of the restricted view ahead from the wheelhouse (**Figure 8**), the skipper's view of *Sapphire II* could have been obscured by the shelter or the deck fittings, particularly during the early stages of the passage. Nevertheless, as the distance between the vessels reduced, *Sapphire II's* lights would inevitably have become brighter and more apparent. Therefore, notwithstanding the partially obstructed view ahead, the skipper's visual lookout during his periodic visits to the wheelhouse in the 52 minutes from leaving the fishing grounds, was not effective.

*Silver Chord* - view ahead from the steering position

MGN 314 (F) advises skippers of vessels such as *Silver Chord*, which were built before November 2002, and do not have a clear view ahead, to conduct a risk assessment and identify control measures to minimise the effect of any obstructions. The absence of any control measures in this context on board *Silver Chord* strongly indicates that such an assessment has either never been conducted, or that the solutions available were considered to be impractical or too expensive. It is also evident that the restricted visibility from the wheelhouse had not been identified as a deficiency during the vessel's 5-yearly inspections.
