FV BLUE ANGEL

Manoverboard

West of Gigha

6 January 2011

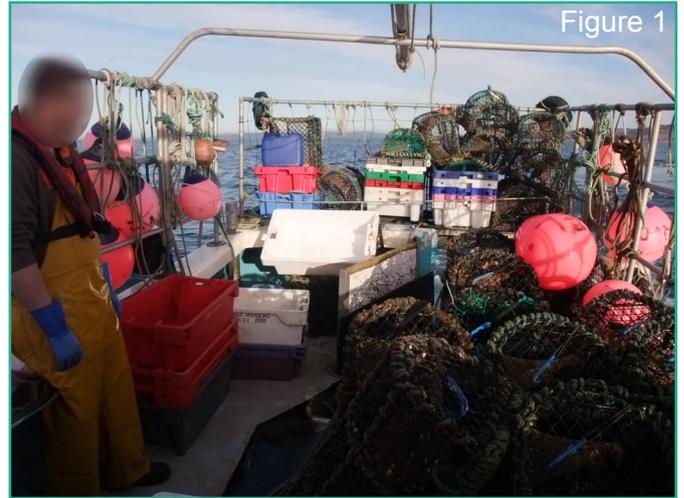
Figure 1

The normal practice when shooting creels was for the skipper to remain in the wheelhouse to steer the boat and to record on his chart plotter the position where the fleet was being laid. One crewman stood or sat by the wheelhouse door; the other crewman stood on the starboard side of the deck (**Figure 1**). Both crewmen monitored operations on deck ready to intervene if, for any reason, the creels did not shoot correctly. The two crewmen rotated these roles after each fleet was shot.

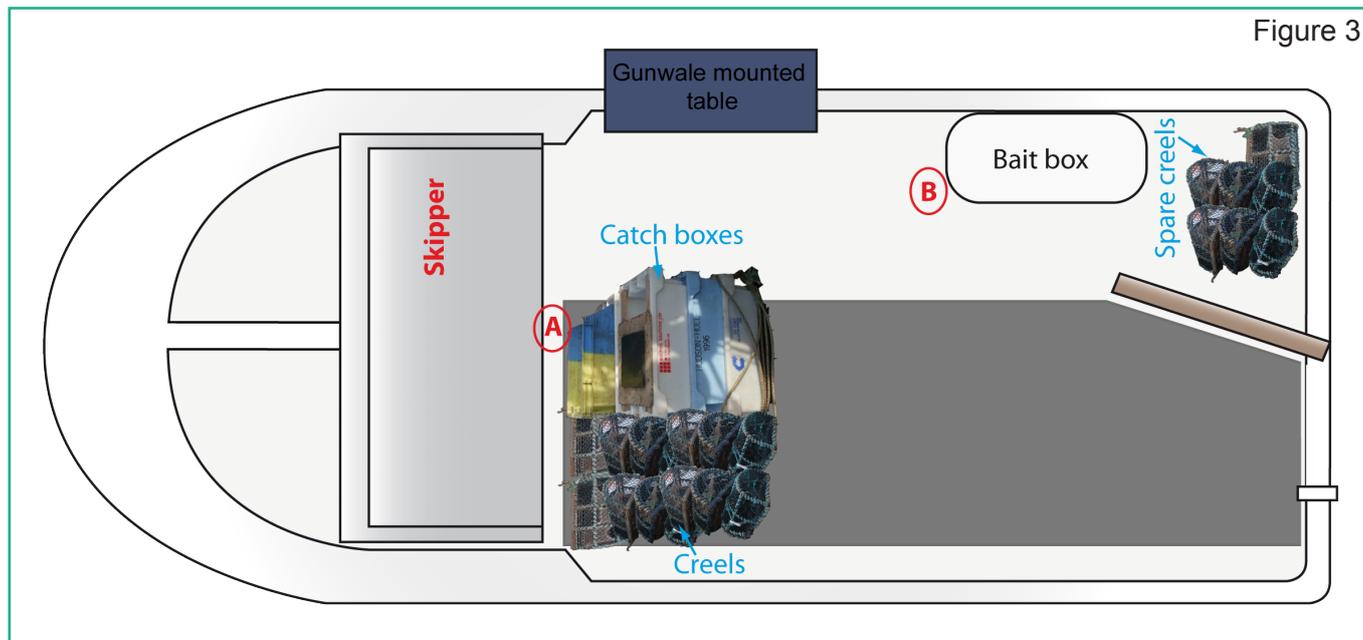
Figure 3

At 1247 the crew began to shoot the seventh fleet of the day. The wind had decreased to a north-westerly force 3. One crewman (crewman A) stood by the wheelhouse door, while the other crewman (crewman B) stood on the starboard side of the deck (**Figure 3 and 4**). *Blue Angel* was travelling at approximately 5.5 knots and the creels were shooting over the stern at a rate of approximately 1 every 9 seconds until the eighth creel became jammed in the stern opening. Crewman B shouted that a creel was jammed, and went aft to clear it.

Space on deck was limited when the creels were positioned ready to shoot and the back rope was laid out, and the spare creels, bait boxes and catch boxes restricted the space further. At the time of the accident the spare creels were stored behind the shooting guide, making it very difficult for a crewman to stand there, safely separated from the back rope, when clearing a jammed creel (**Figure 3**).

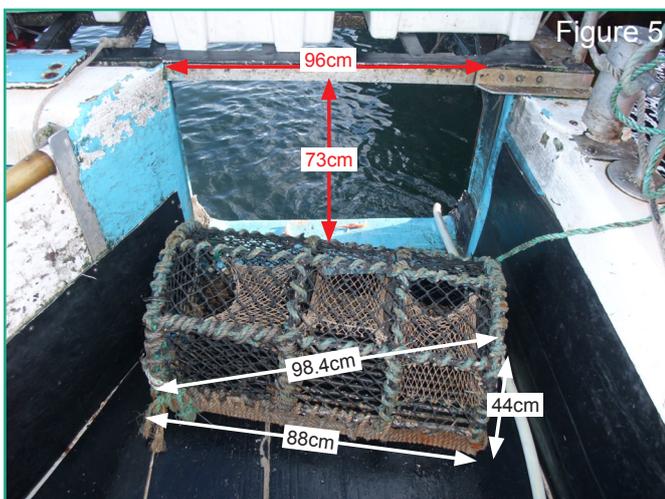
Blue Angel's creels measured 98.4cm across the diagonal, and consequently it was not unusual for them to jam in the vessel's 96cm wide transom opening during shooting operations. Had this

opening been larger, or the creels smaller, the risk of a single creel becoming jammed during shooting would have been significantly reduced (Figure 5).

- 2011/125 Improve the creel self-shooting system used on board *Blue Angel* to ensure the crew are safely separated from the back rope during shooting operations.
