Report on the investigations into
the loss of the skipper from fv
Discovery
during single-handed fishing operations
3 miles east of Fraserburgh
9 October 2010
and
the loss of the skipper from fv
Breadwinner
while fishing single-handedly
5.5 miles east of Score Head, Bressay
20 January 2011

DISCOVERY INVESTIGATION

BREADWINNER INVESTIGATION

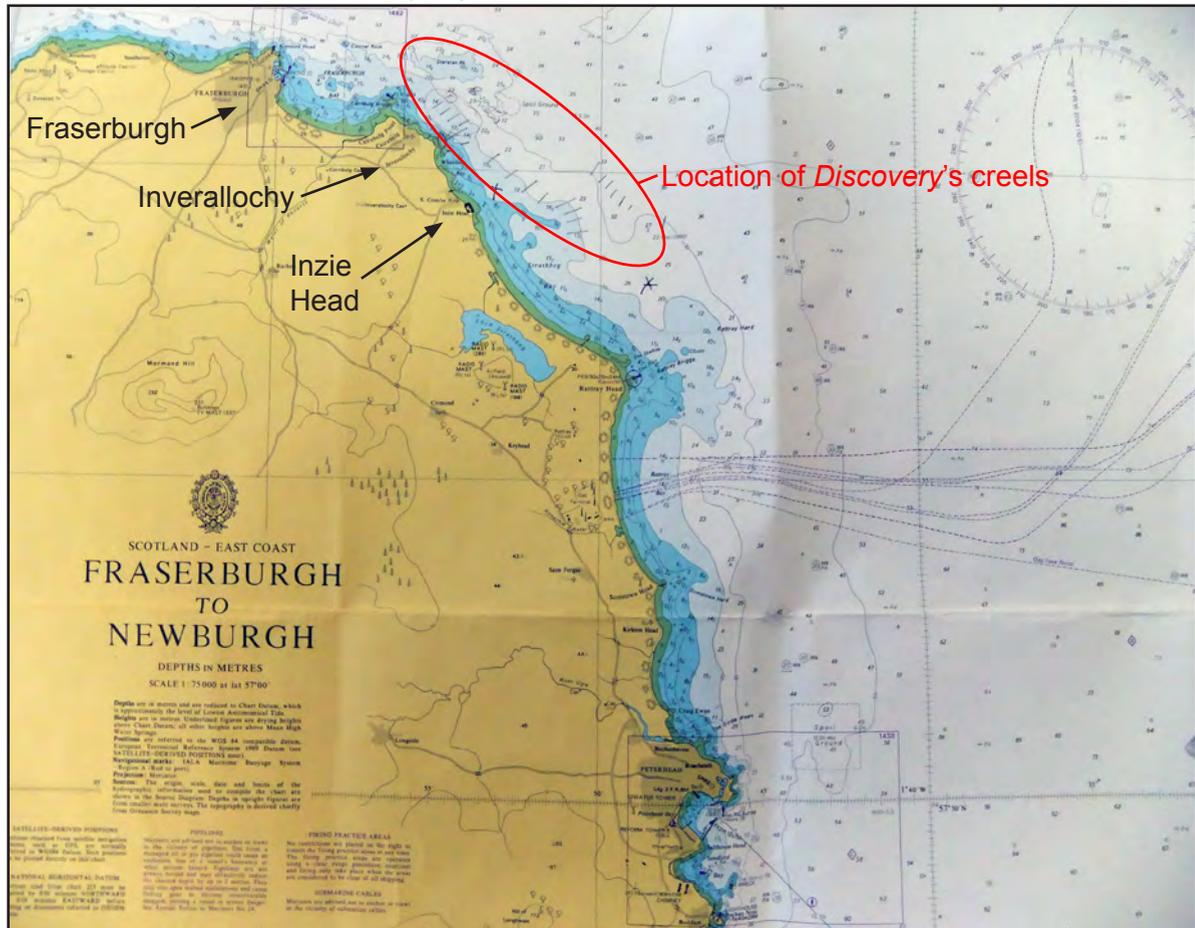
Figure 1

Location of *Discovery's* creel leaders

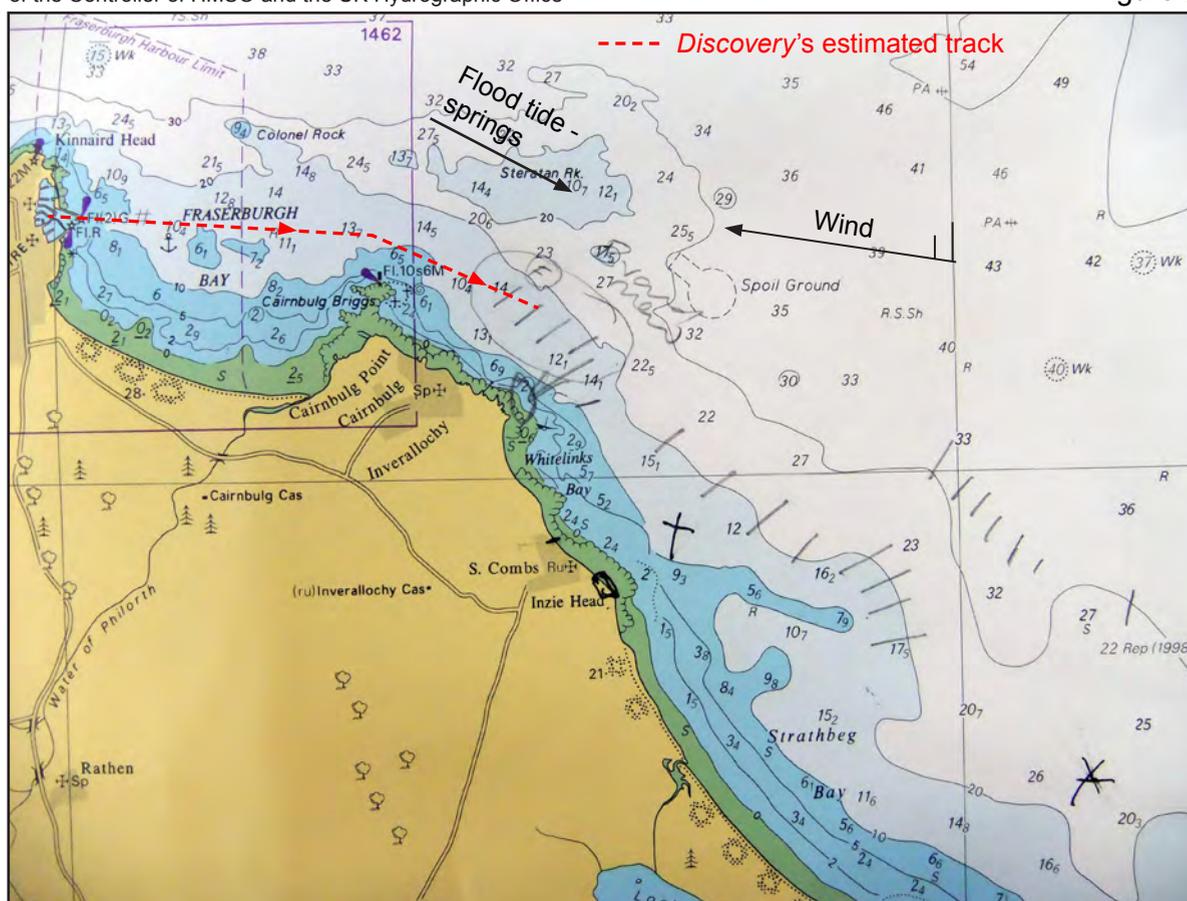
Figure 2

Discovery's track and environmental conditions

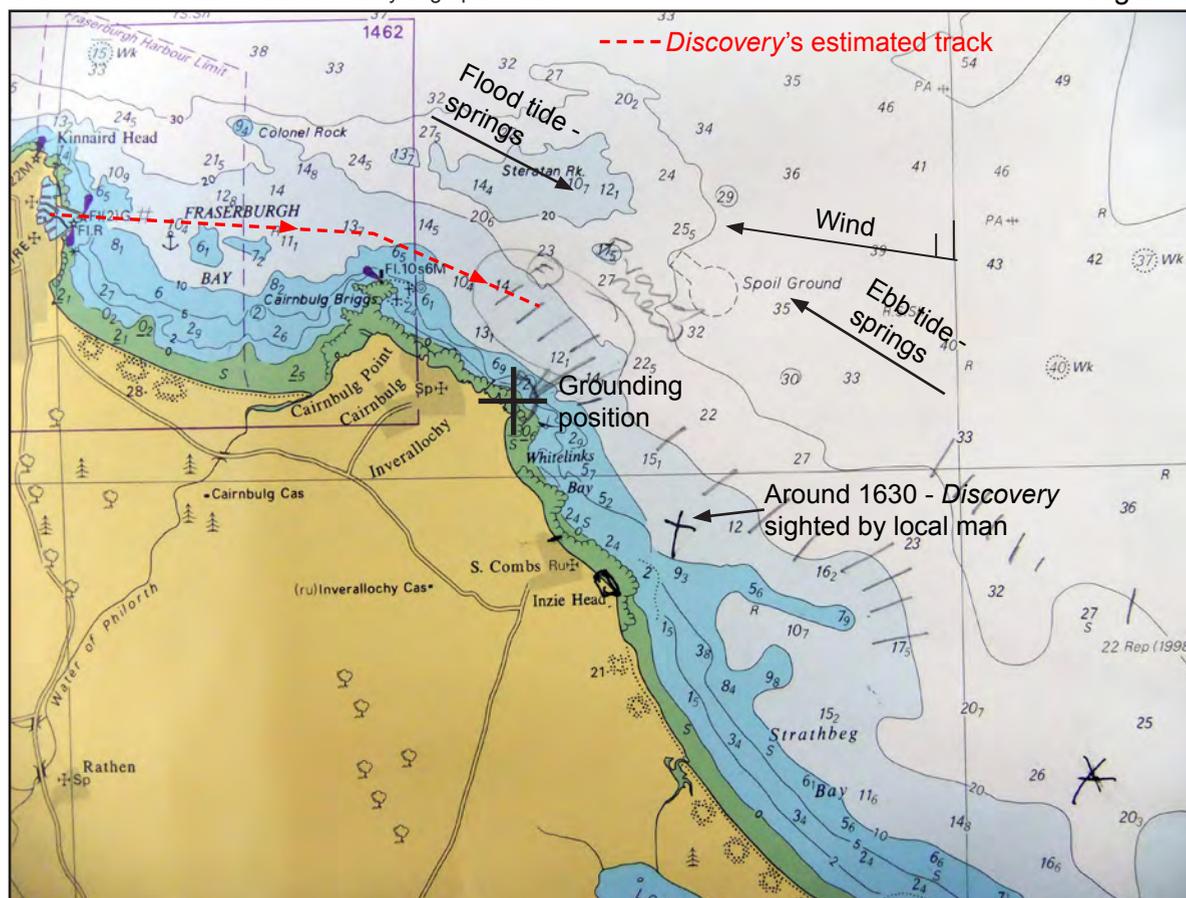
Figure 3

Discovery's grounding position

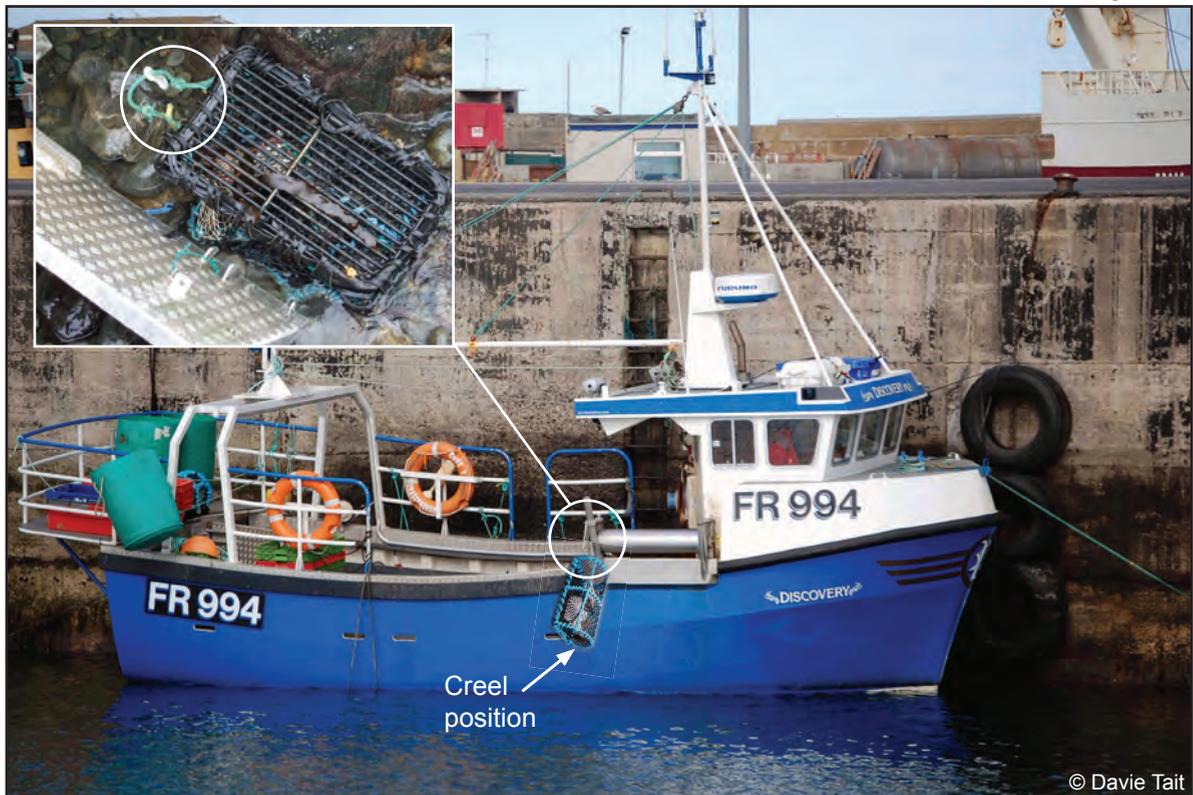
Figure 4

Location of creel found on *Discovery's* starboard side

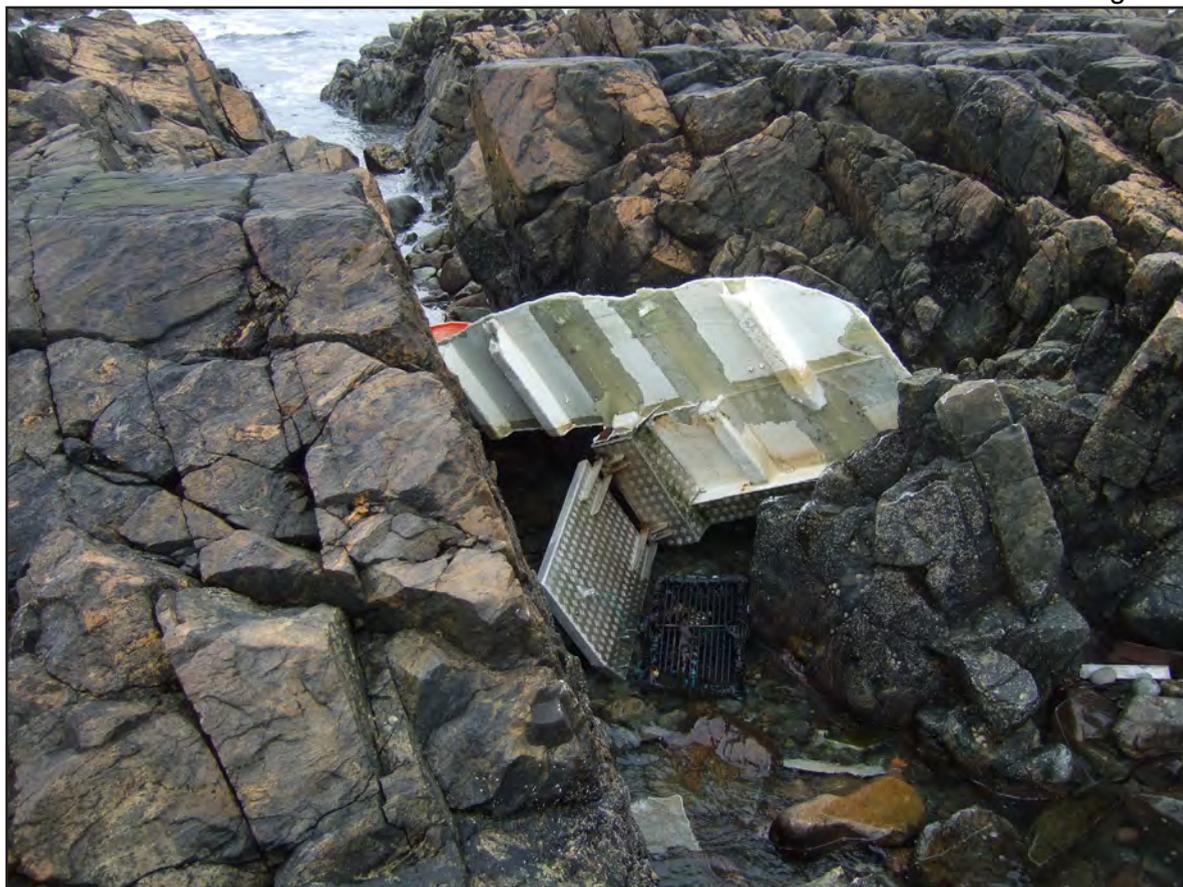
Figure 5

Over the next 3 days *Discovery* was broken up by the wave action on the rocky shoreline (**Figure 5**).

Wreck of *Discovery* - stern section

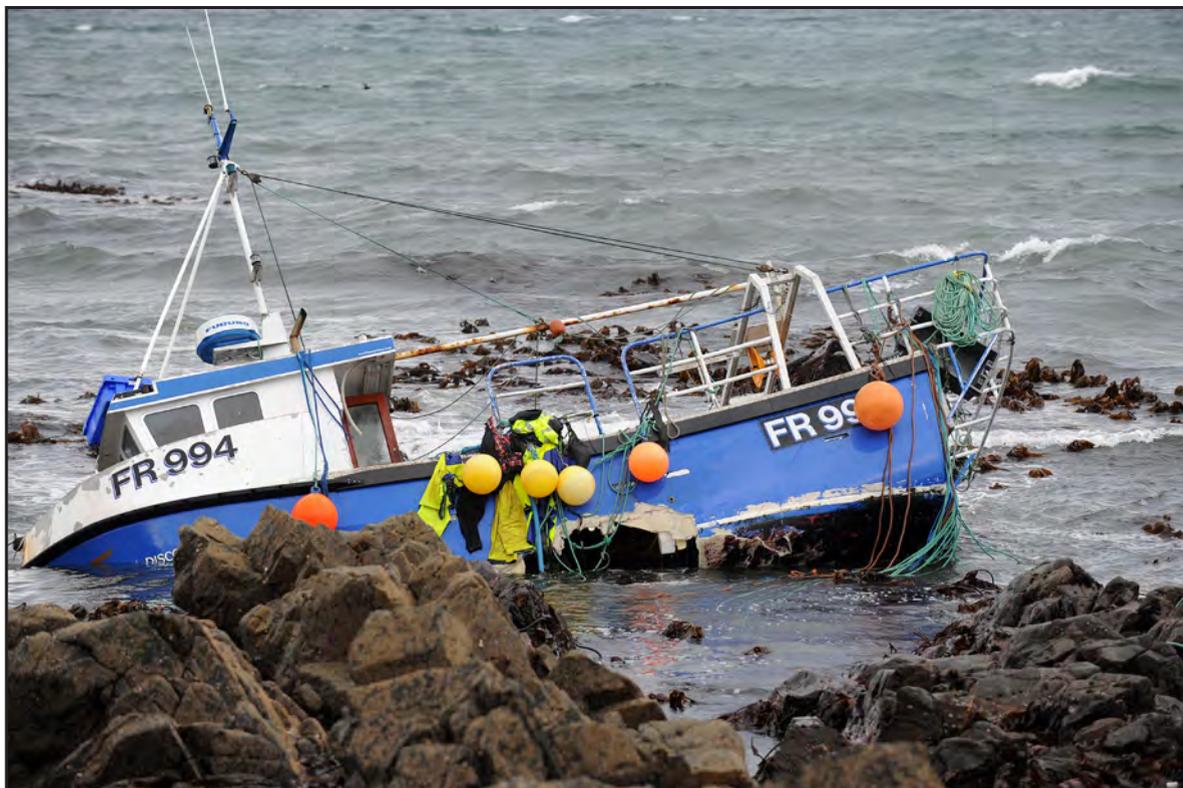
Several ropes were hanging over *Discovery's* side, with at least one rope hanging loosely around her propeller.

Discovery with holed engine compartment

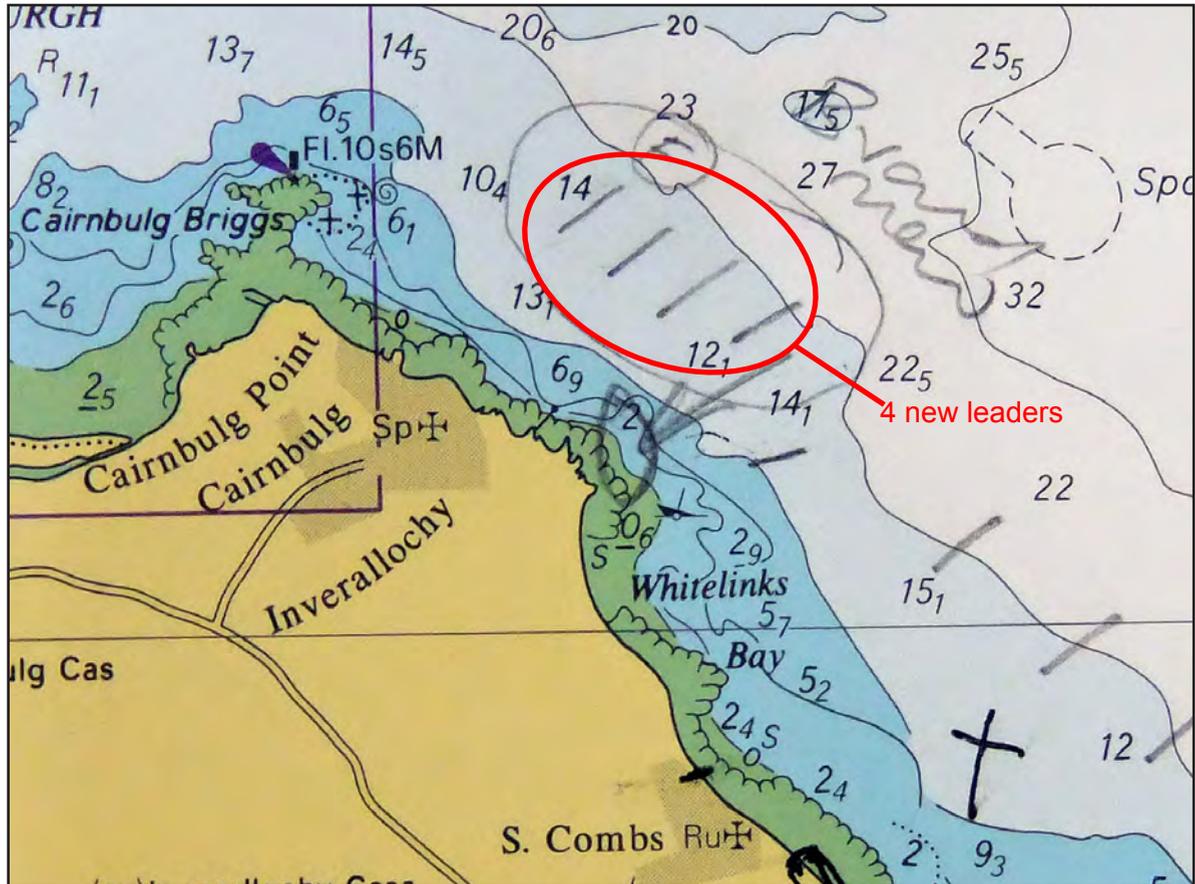
Location of the missing leader

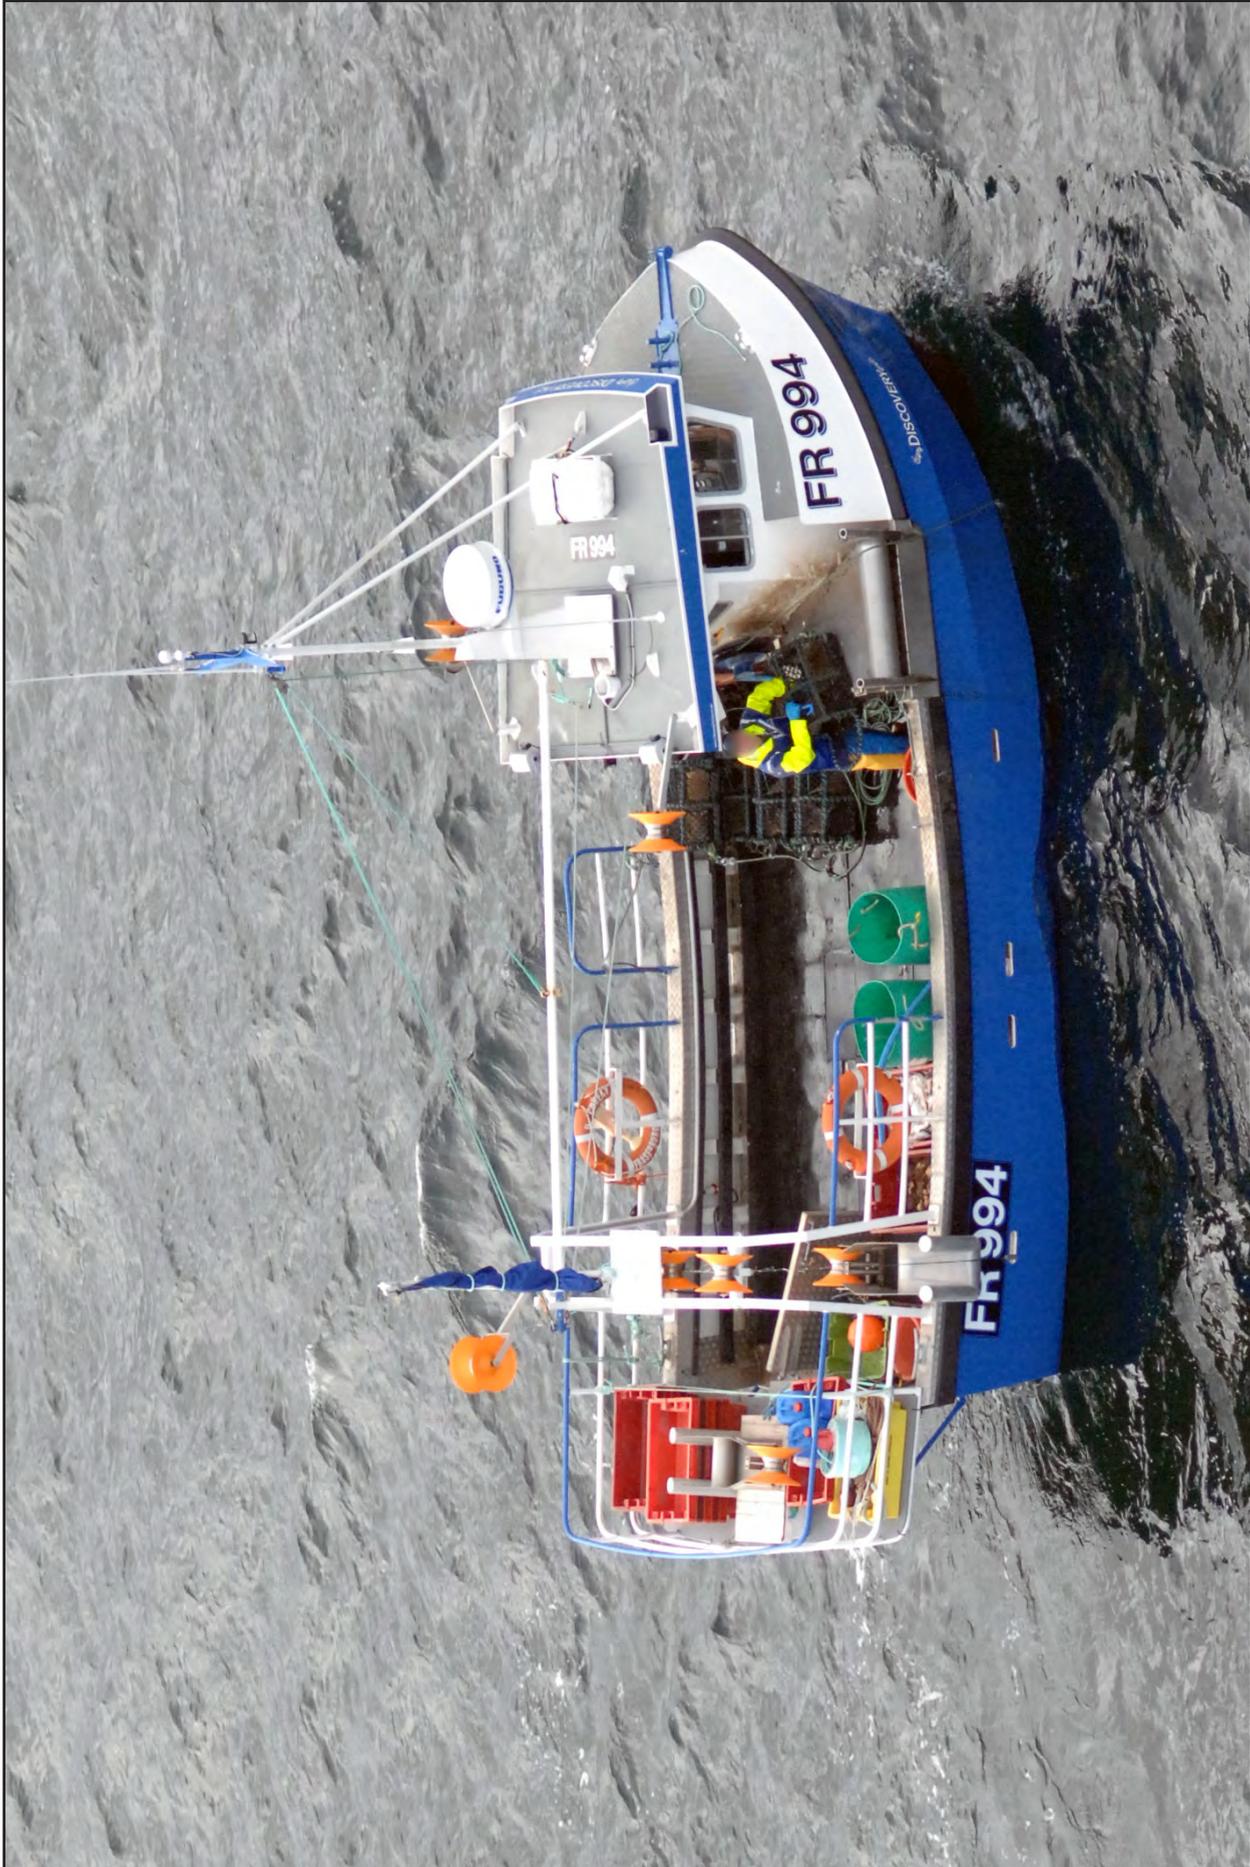
Discovery - fishing single-handedly

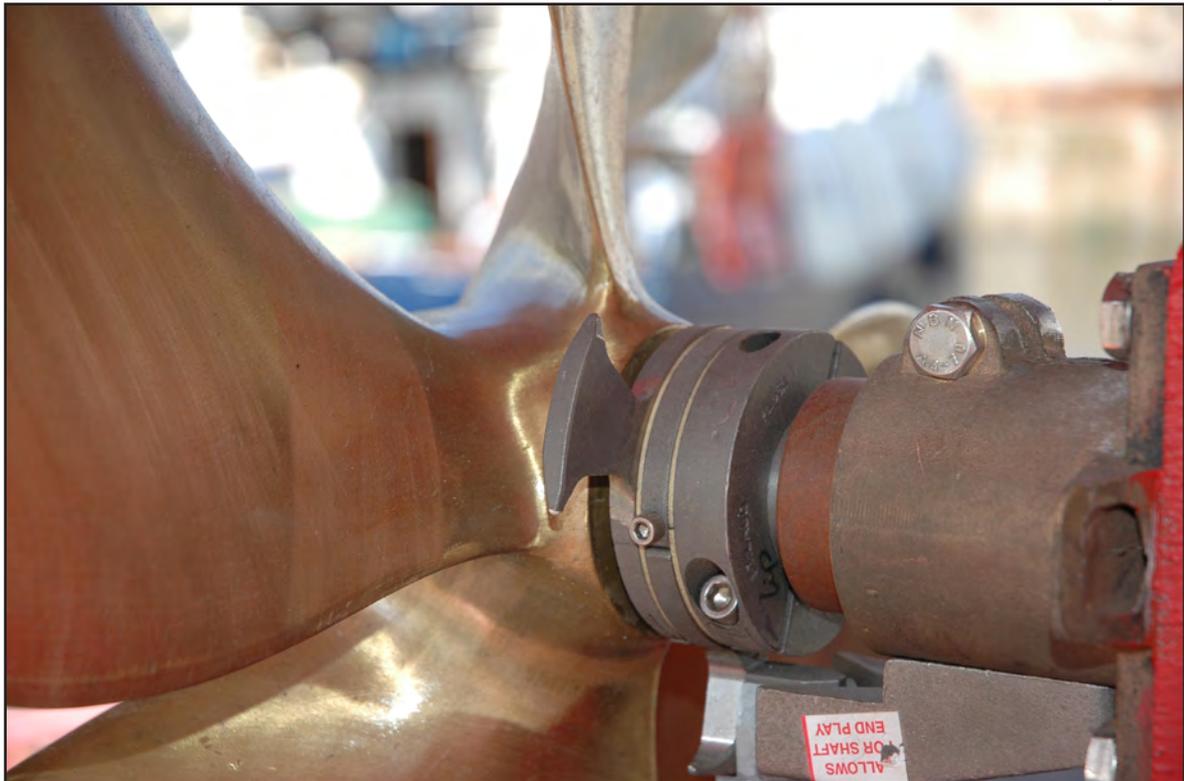
Figure 9

Rope cutter fitted to the propeller shaft arrangement

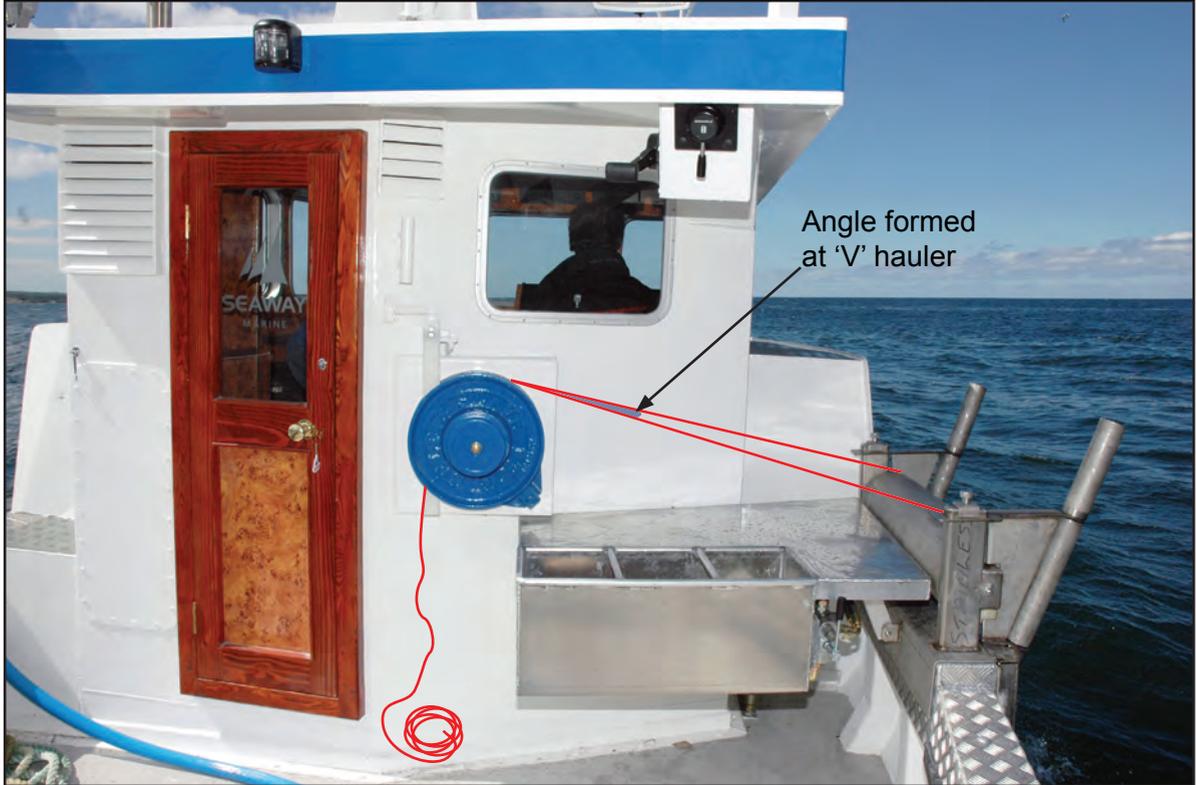
Figure 15

Hauler and roller - alignment with vertical bulwark rollers

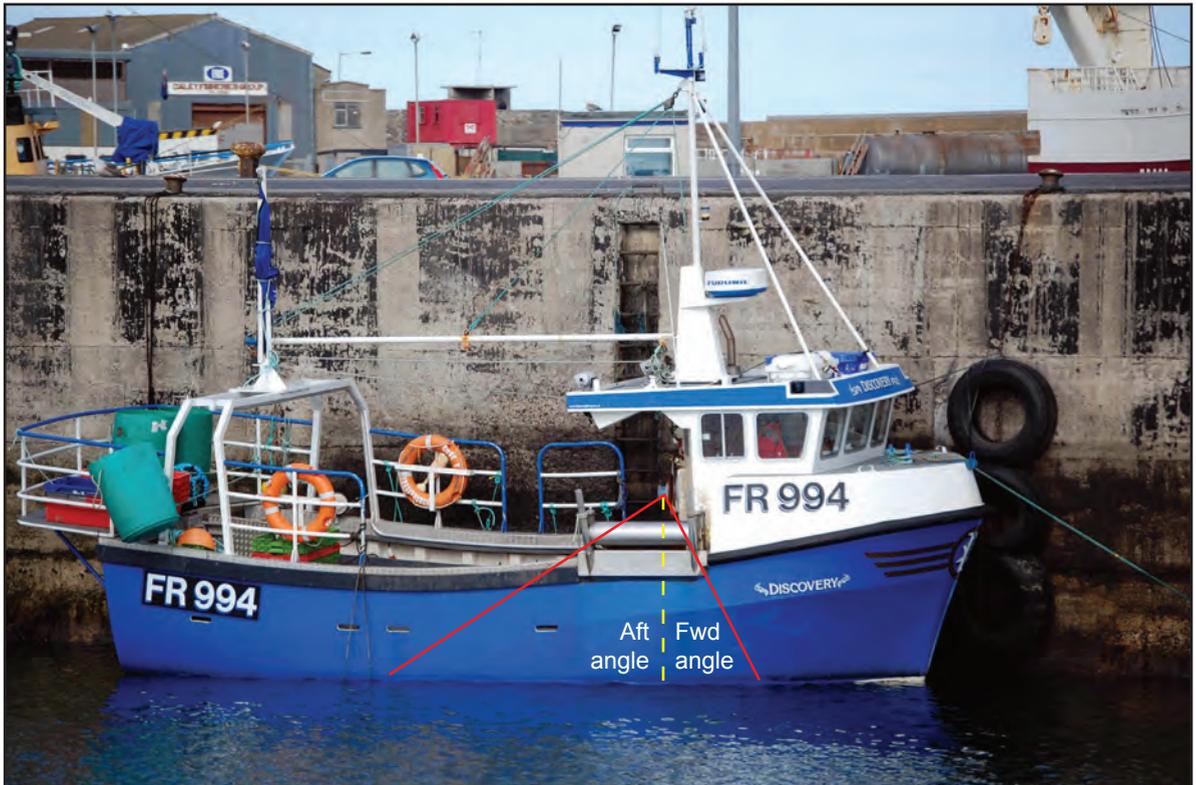
Figure 16

Alignment of 'V' wheel hauler onto bulwark roller

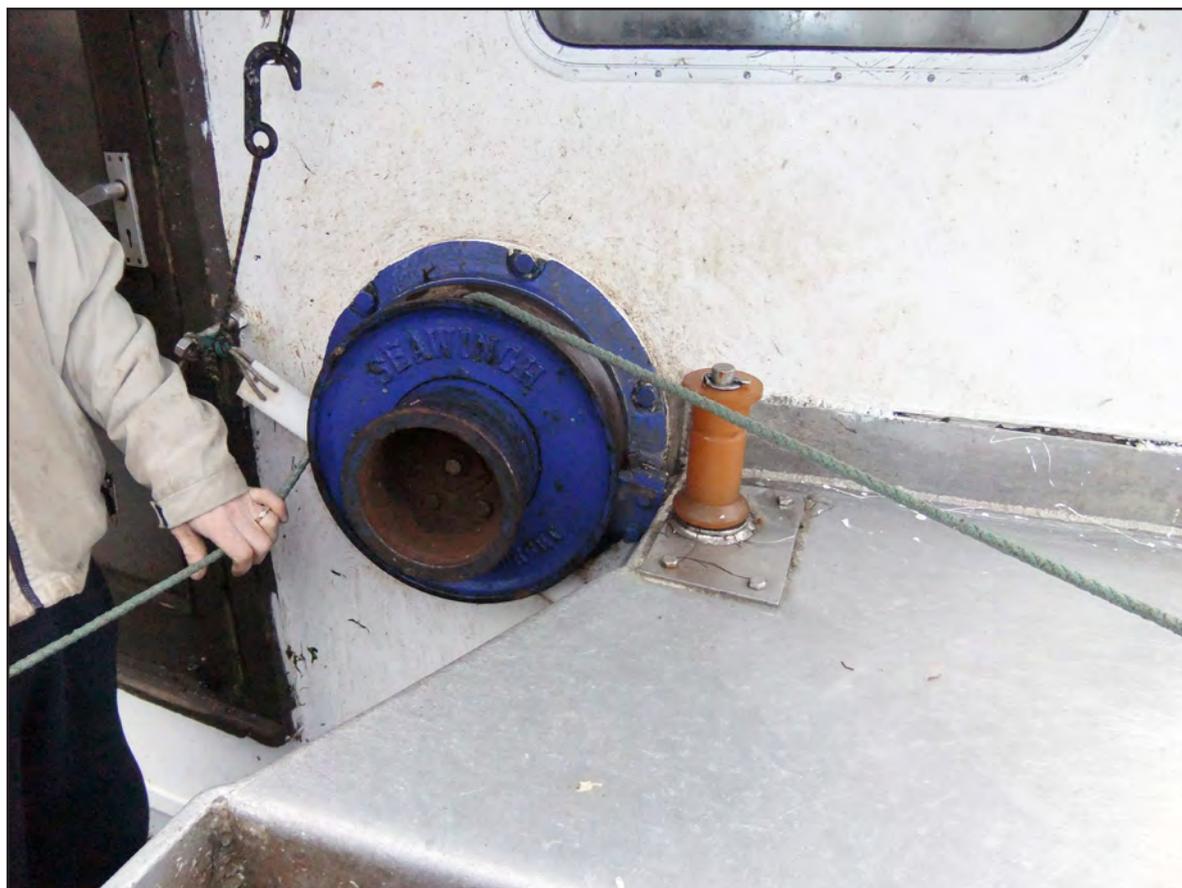
Figure 19

Back rope led to hauler without using vertical guide

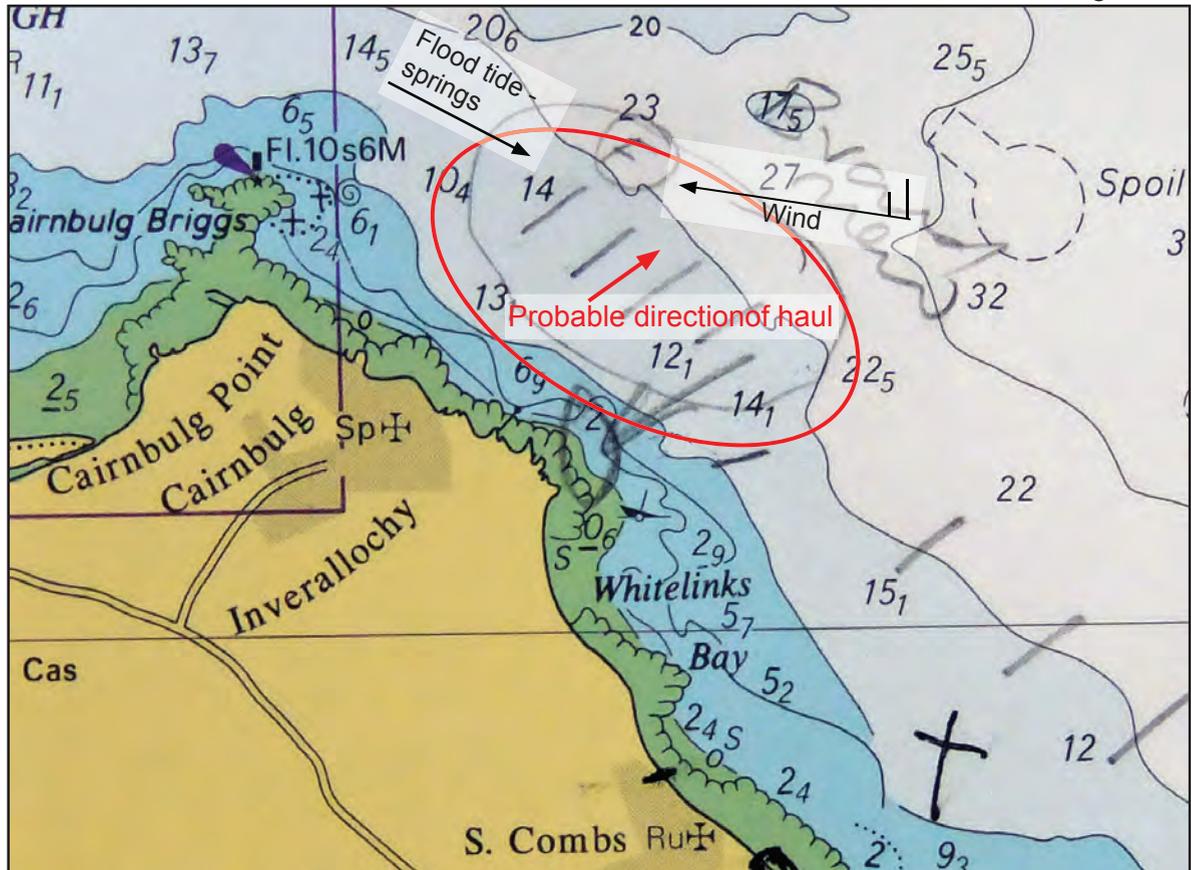
Figure 20

Location and probable direction of haul

It is considered most likely that Bruce Pearson was lost overboard at around 1130, as the third from last creel of the first leader of the day was being hauled on board. Although it is less likely, due to the small amount of catch on board, if Bruce Pearson had been hauling the second leader the accident would have occurred about 30 minutes later.

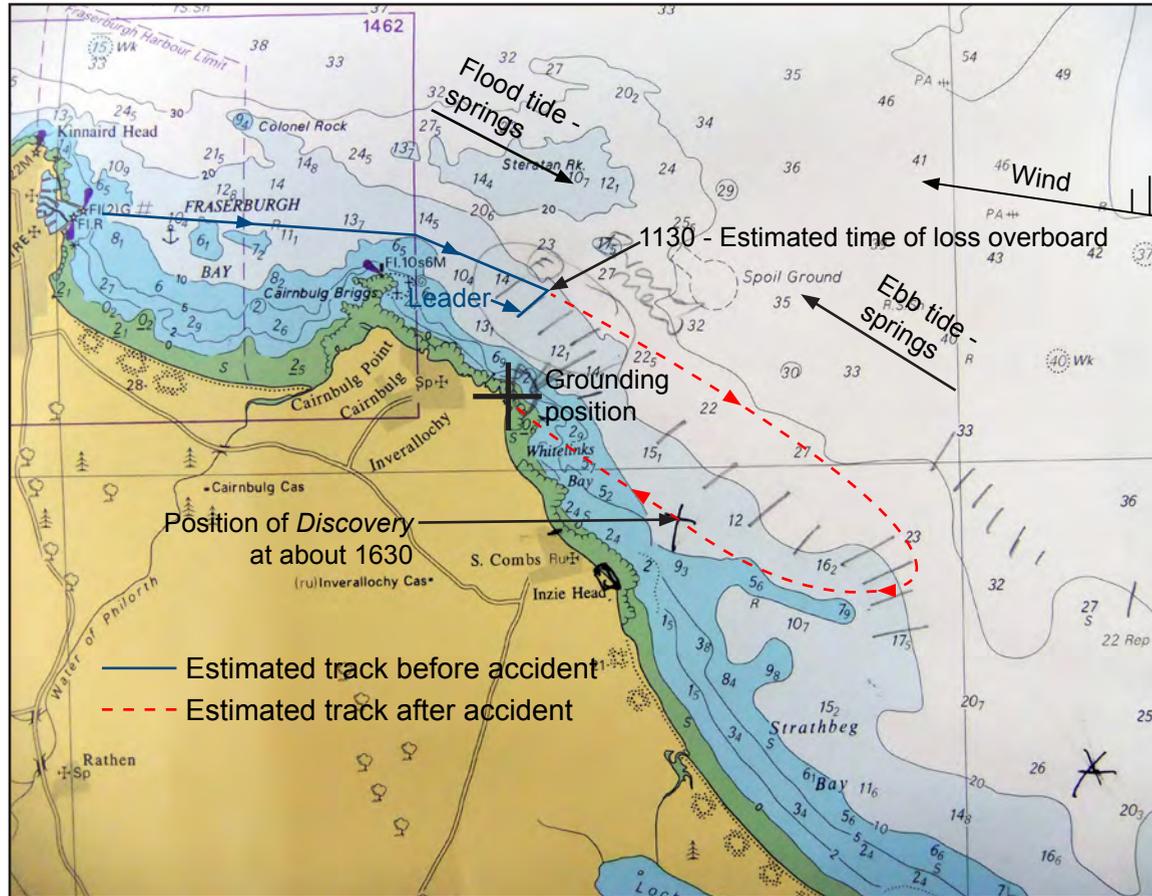
Figure 21

Estimated track of *Discovery* after the accident

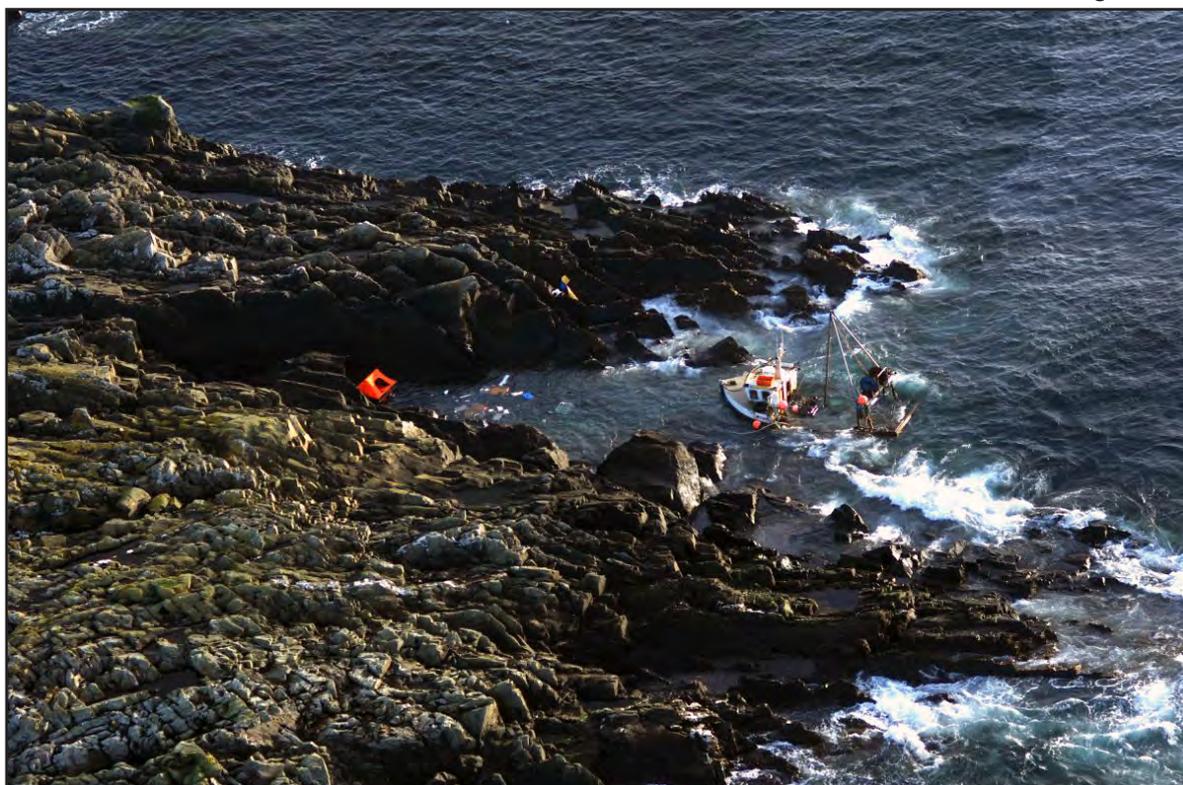
Figure 23

Breadwinner located on Grif Skerry

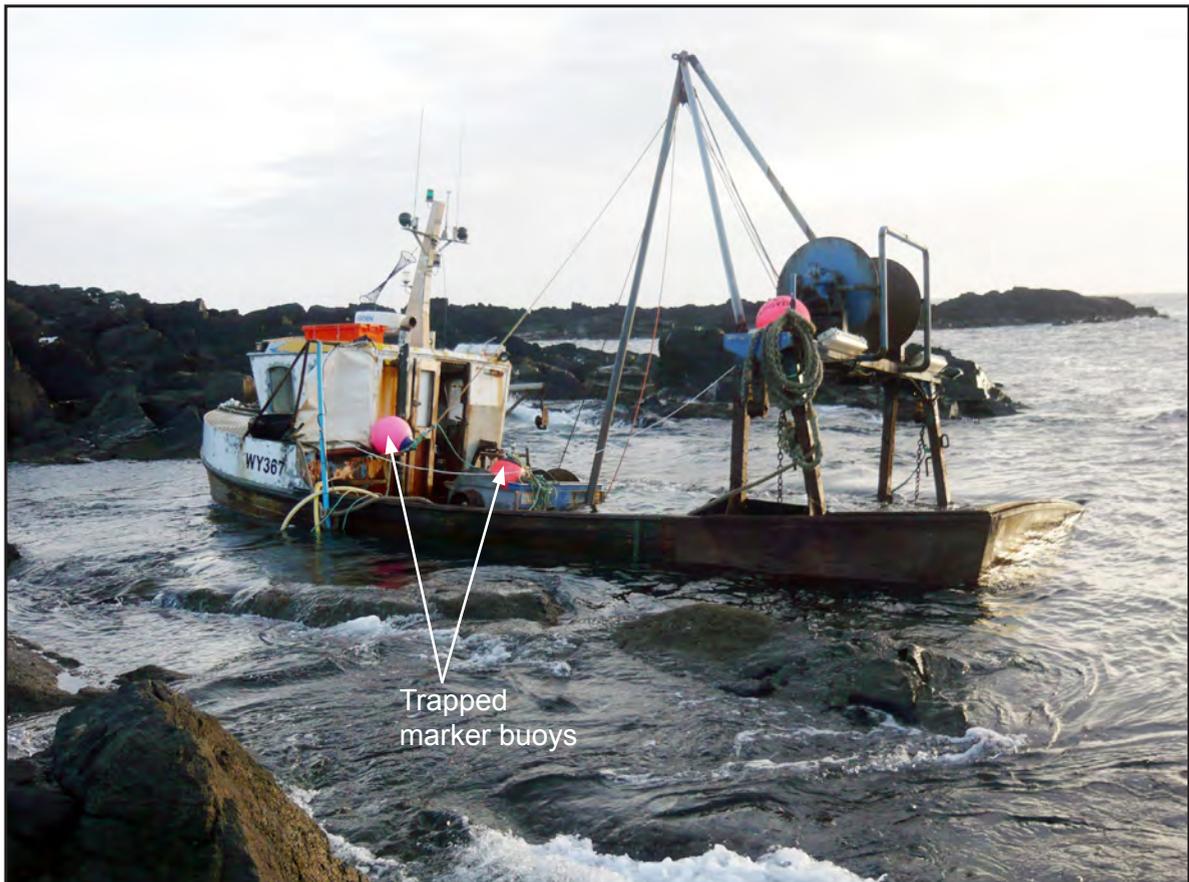
Figure 24

Trapped marker buoys on *Breadwinner*

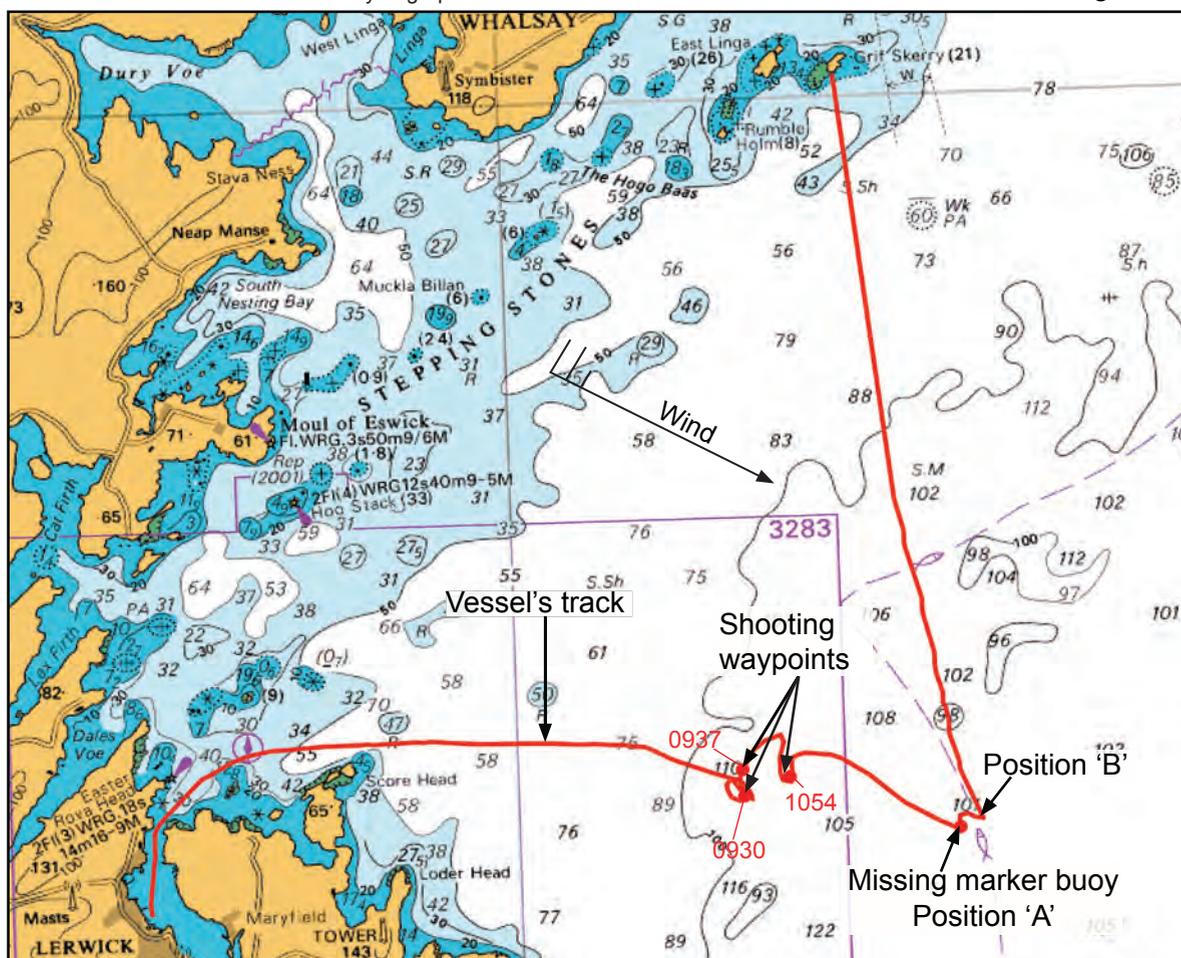
Figure 25

Breadwinner's track on 20 January 2011

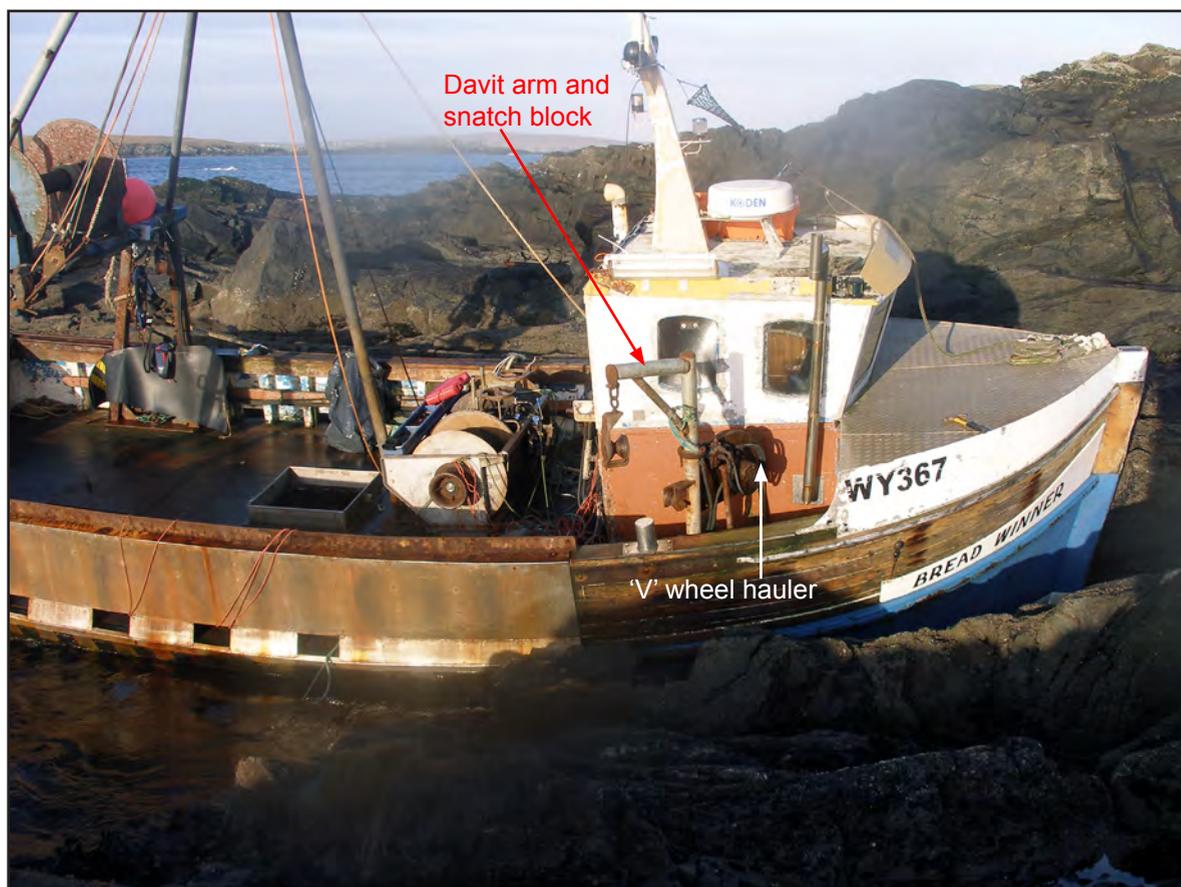
Abaft of the wheelhouse sat an athwartships Spencer Carter 1.5 tonne trawl winch, which was well greased and had good condition trawl warps on the main barrels. A net drum sat on top of the aft trawl gantry, but this had never been used by Mr Smith. A hydraulically operated 'V' wheel creel hauler was fixed on the forward starboard shoulder of the boat, to assist hauling through a davit-mounted snatch block (**Figure 26**). A new Cummins 220hp main engine had been installed personally by Mr Smith in October 2010.

Hauling arrangement on *Breadwinner*
