Report on the investigation of
the collision between the fishing vessel
Homeland
and
the ro-ro passenger vessel
Scottish Viking
4.2 miles off St Abb's Head
5 August 2010
resulting in one fatality

Report No 4/2011
March 2011

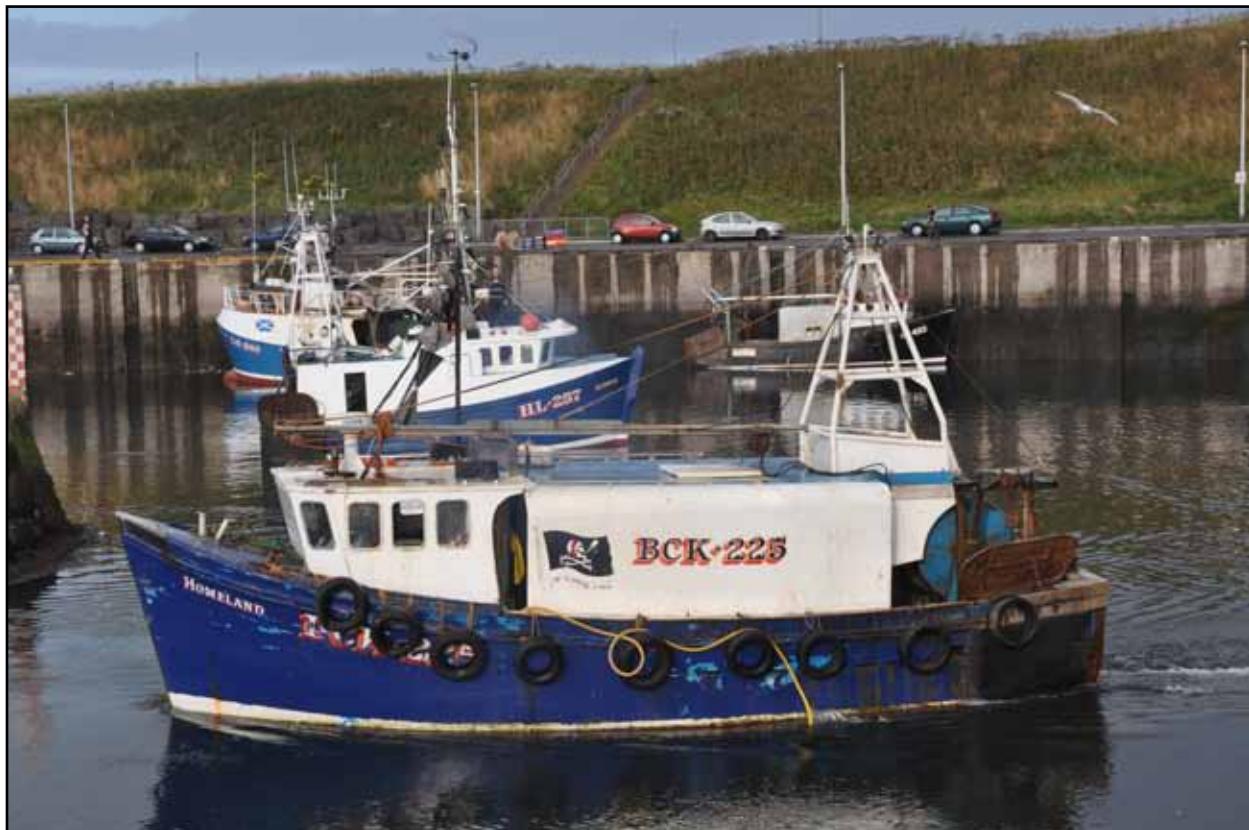
Figure 1

Homeland - taken before departure from Eyemouth

The vessel was built in 1981 in Polruan and was required to comply with The Fishing Vessels (Code of Practice for the Safety of Small Fishing Vessels) Regulations 2001, as amended. She was equipped with a magnetic compass linked to an autopilot, radar, chart plotter incorporating a global positioning system (GPS), and VHF radio. The vessel was also fitted with a shelter, which allowed the crew to handle and gut fish on the aft deck during inclement weather. However, when the crew were standing inside the shelter, they had very limited all round visibility (**Figure 1**).

1. *Homeland's* shelter significantly restricted all-round visibility from the aft deck. [2.4]
2. The incorrect sounding of the whistle by a give-way vessel could prevent a stand-on vessel from taking appropriate last-minute action to prevent a collision. [2.8]
3. *Scottish Viking's* navigating officers preferred to interrogate AIS targets instead of using ARPA. [2.9]
4. Navigational audits while the vessel is underway give an auditor a better opportunity to assess if the company's policies and procedures are being followed. [2.11]
5. Had Daniel McNeill been wearing a lifejacket, his chance of survival, and detection by the rescue services, would have improved significantly. [2.12]

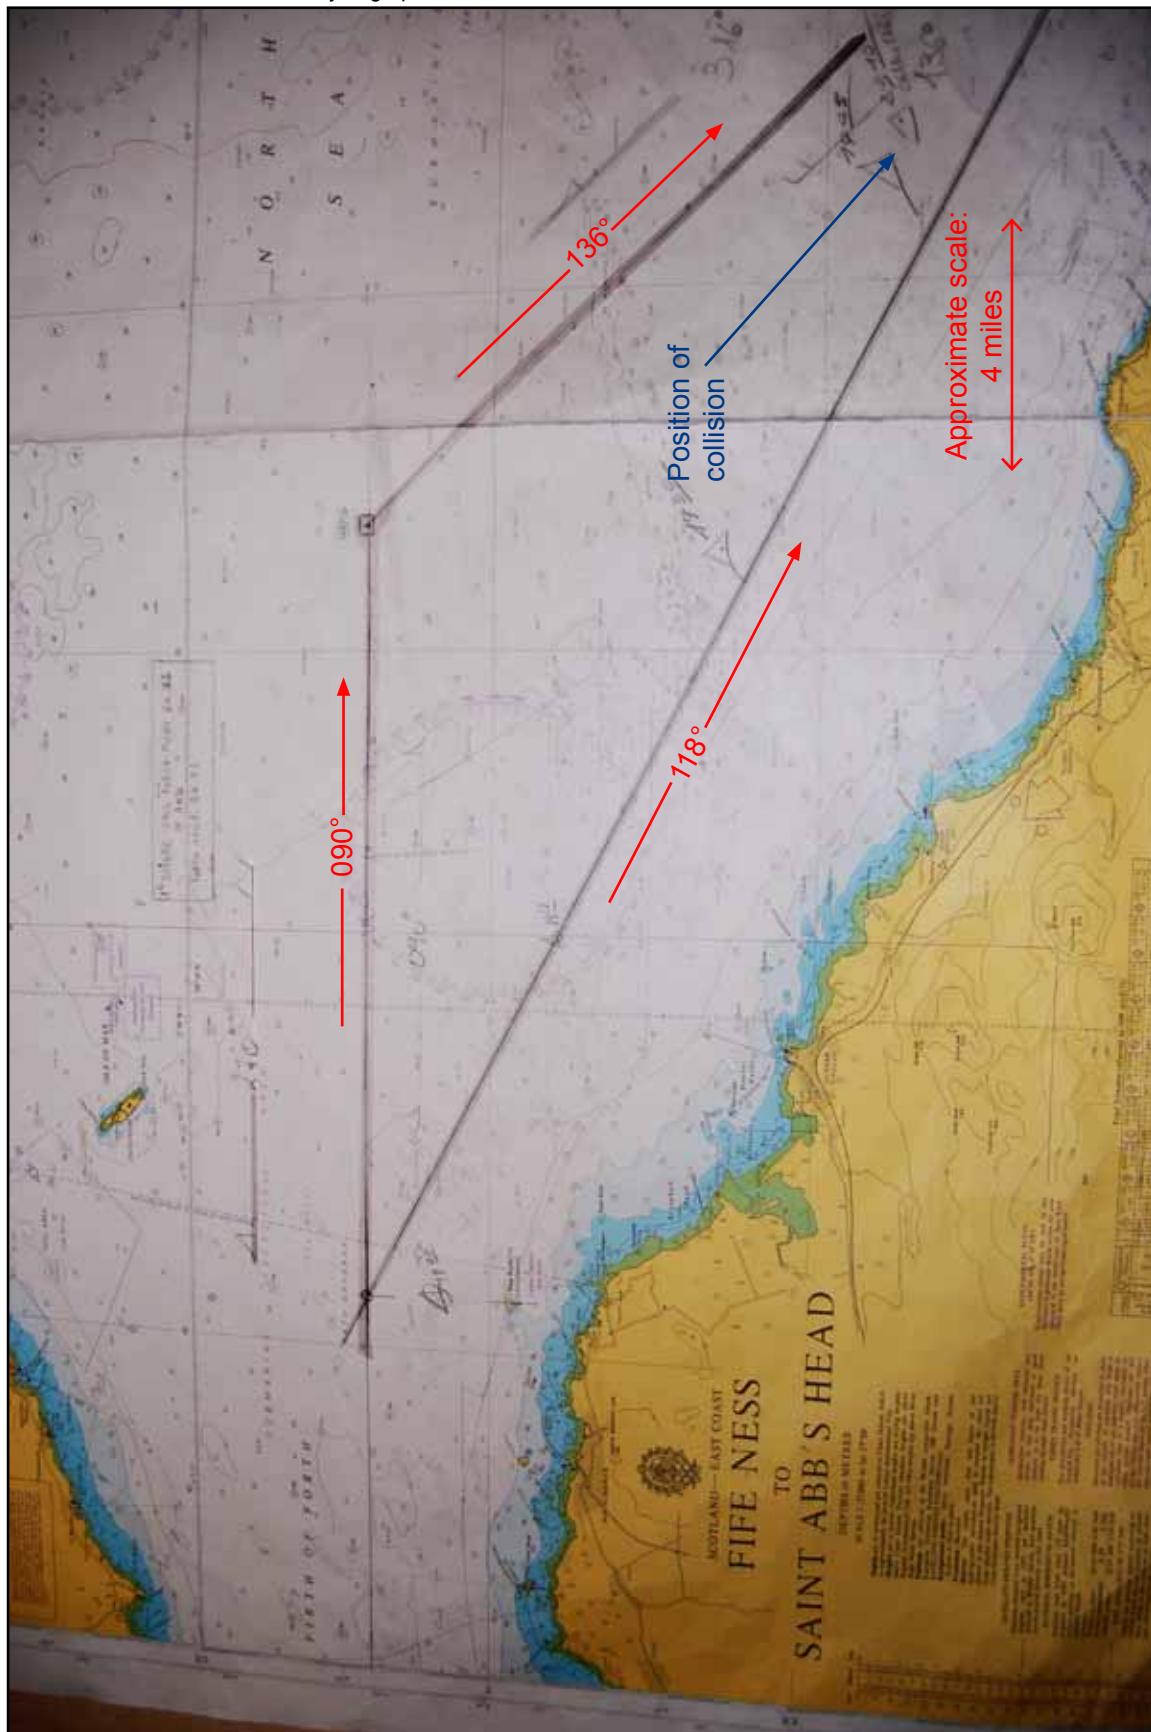
Figure 2

At 1912 and 1930 the second officer plotted the vessel's position on the chart and found she was north of the charted courseline of 118° (**Figure 2**). At 1932 the 8-12 AB arrived on the bridge and, after a short handover, the 4-8 AB departed. At 1936, the second officer initiated an alteration of course to 118° using the autopilot. He then interrogated an AIS target on the starboard radar. The target was 6.52 miles ahead with a closest point of approach (CPA) of 0.24 mile in 16.5 minutes (**Figure 3**). At 1939, the second officer altered course to 122° , which resulted in an increased CPA of 0.93 mile with the vessel ahead (**Figure 4**).

BA Chart 175 - Fife Ness to Saint Abb's Head

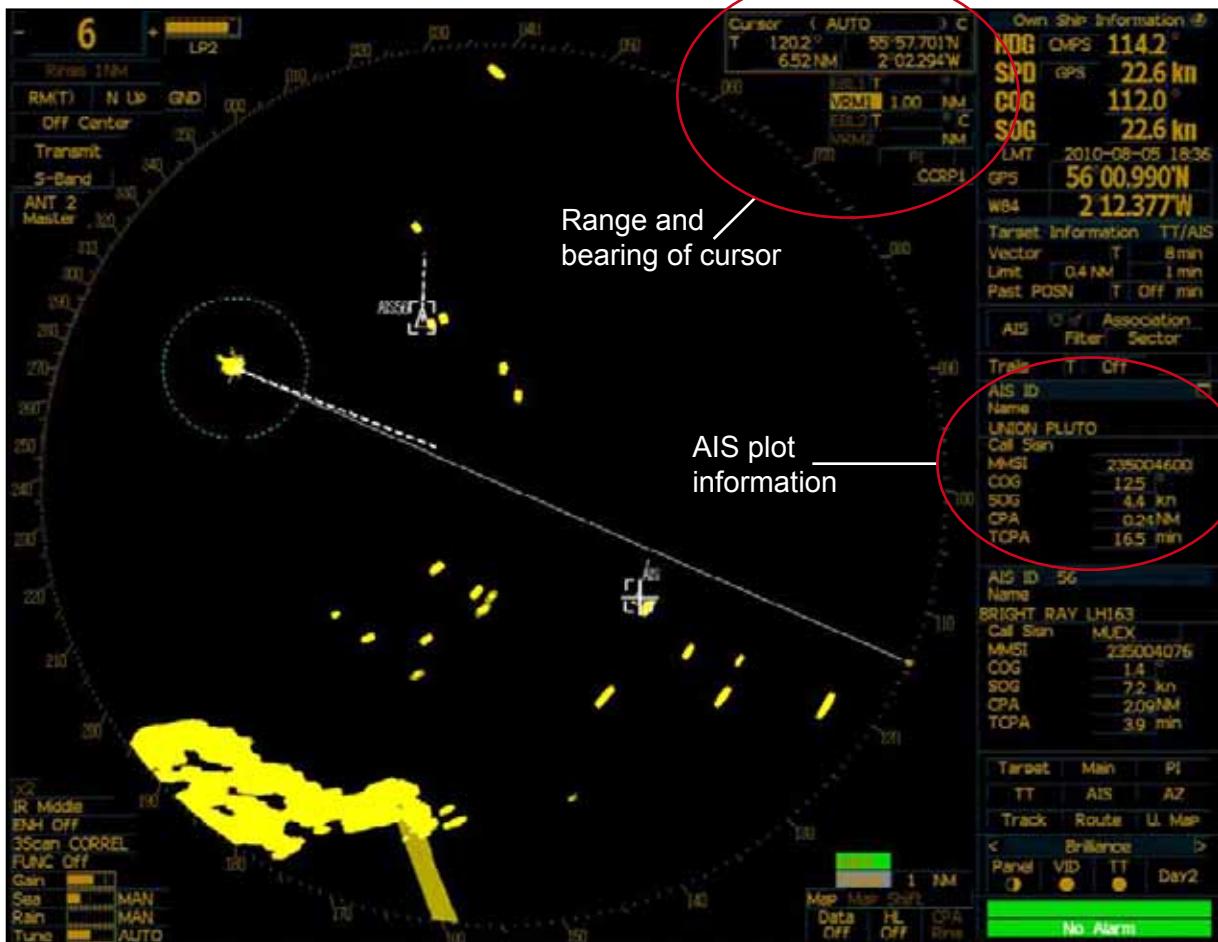
Figure 3

Scottish Viking - screen shot of radar at 1936

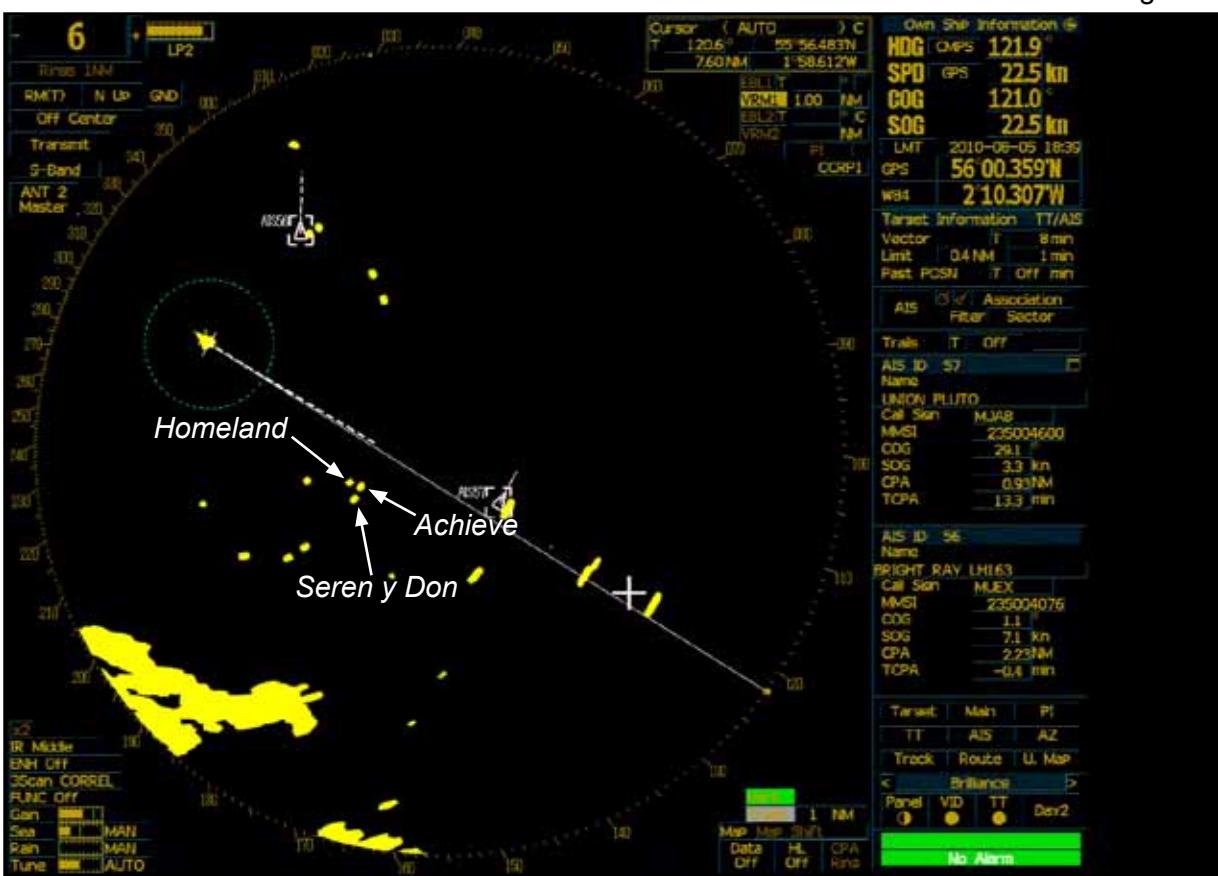
Figure 4

Scottish Viking - screen shot of radar at 1939

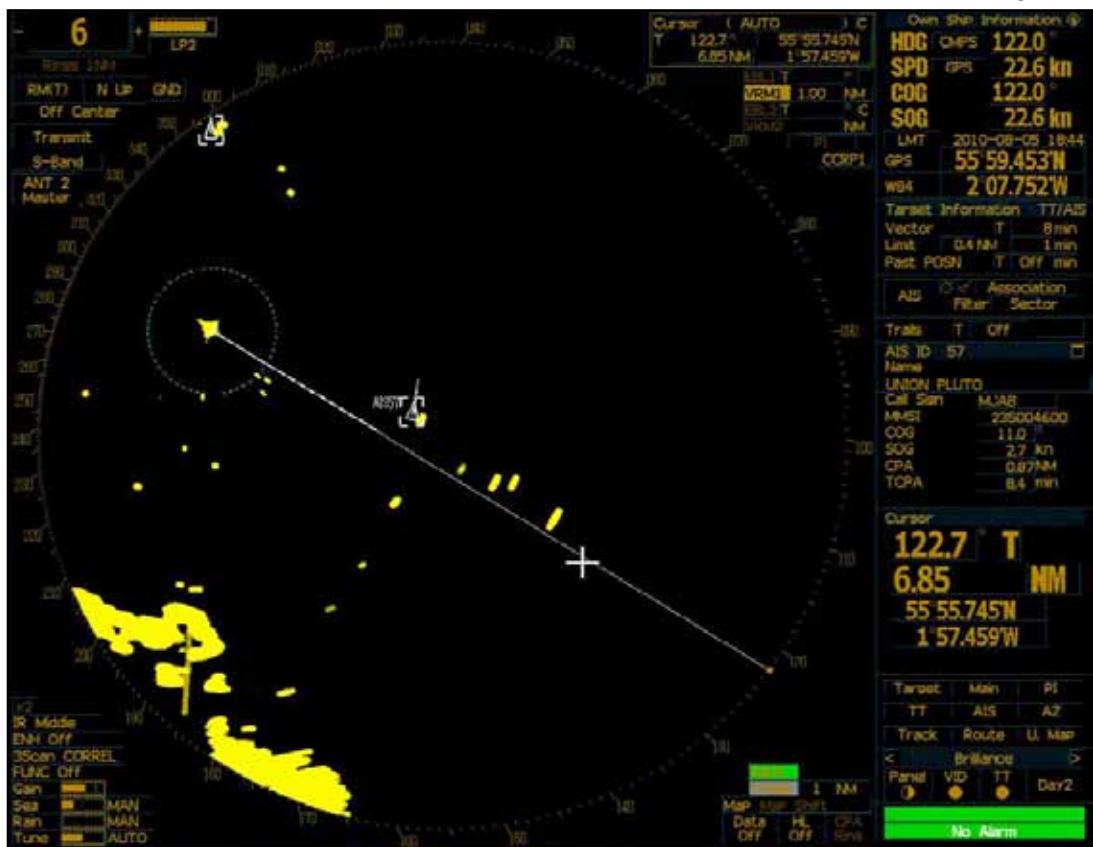
Figure 6

Scottish Viking - screen shot of radar at 1944

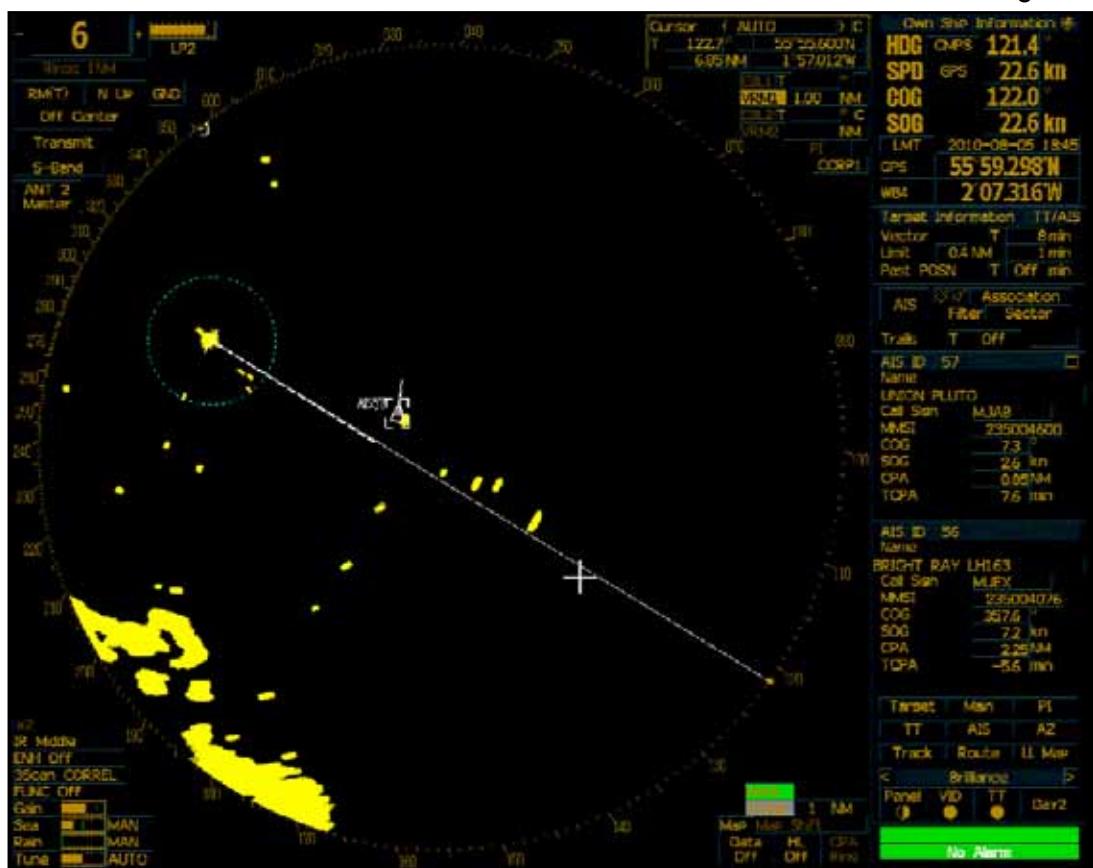
Figure 7

Just after 1945, the second officer initiated an alteration of course of up to 10° to port (**Figure 7**) on the autopilot. The AB again voiced his concern and questioned the sufficiency of the second officer's action. The second officer then moved to the starboard bridge wing (**Figure 5**). Both saw the second fishing vessel (*Achieve*) make a bold alteration to port (**Figure 8**).

Scottish Viking - screen shot of radar at 1945

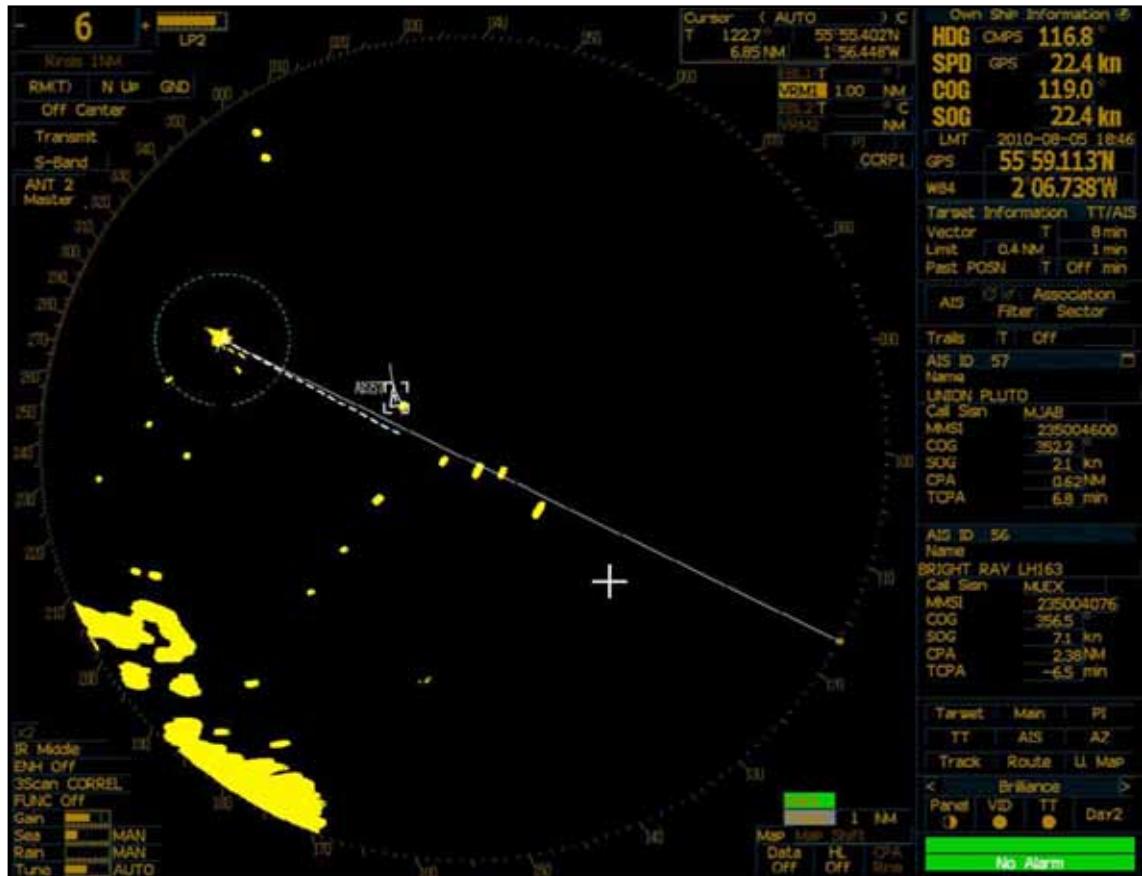
Figure 9

At 1946, as the range with *Homeland* continued to decrease, the second officer ordered the AB to commence manual steering and alter course to port (**Figure 9**). The AB complied. The second officer also sounded one short blast on the vessel's whistle. The AB applied about 20° port helm, which caused the vessel to heel significantly to starboard. Almost immediately, he turned the wheel the other way to correct this heel. A few seconds later the second officer told the AB that the vessel had collided with the fishing vessel, and instructed him to call the master.

Scottish Viking - screen shot of radar at 1946
