SERIOUS MARINE CASUALTY

REPORT NO 15/2011

AUGUST 2011

At 0832 on 29 May 2010 the 3252gt Norwegian registered platform supply vessel (PSV), *Skandi Foula* (**Figure 1**), made heavy contact with the moored Panamanian registered supply vessel *OMS Resolution* (**Figure 2**), in Victoria Dock, Aberdeen.

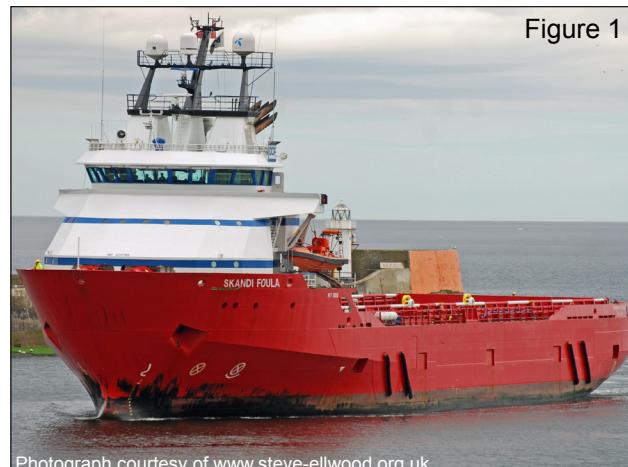
Figure 1

Skandi Foula

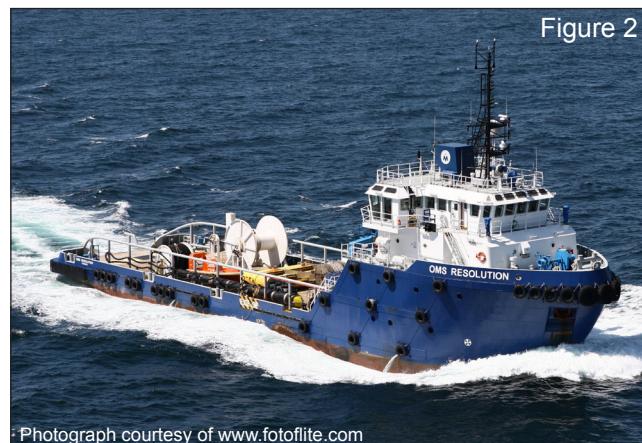
Figure 2

OMS Resolution

generator to cater for the increased power demand. However, before extra power could be delivered, *Skandi Foula*'s bow made heavy contact with the bridge wing of the moored PSV, *OMS Resolution*, shattering windows and damaging metalwork. *Skandi Foula* sustained damage mainly to her port bulwark area.

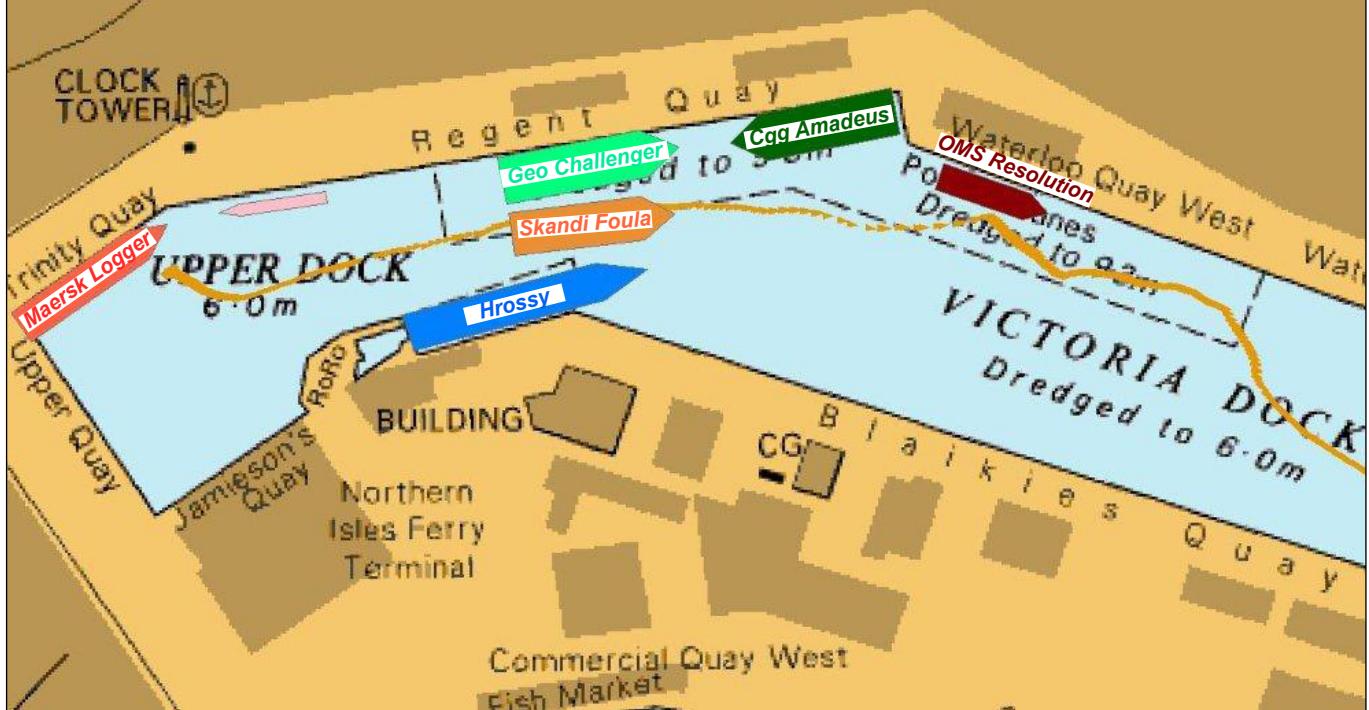
Figure 3

At 0825, *Skandi Foula* had cleared the berth and the master handed control to the chief officer so he could drive the vessel ahead and through the narrow channel between the moored *Hrossy* and *Geo Challenger* (**Figure 3**). At the narrowest part of the channel the gap reduced to just 6m on either beam, and the master remained at the aft station so he could monitor the vessel's stern in relation to the other vessels and inform the chief officer if necessary. Two second officers were also on the bridge, monitoring the gaps on either side.

Area of accident and relative ship positions, with *Skandi Foula*'s track from GPS

Skandi Foula had to be manoeuvred through a narrow gap between vessels moored on a bend (**Figure 3**) that provided little margin for error.

1. Implemented a beam restriction for vessels moored opposite the ferry terminal.
2. Upgraded the port's ship bridge simulator to provide enhanced training.
3. Hosted port safety meetings with ship masters.

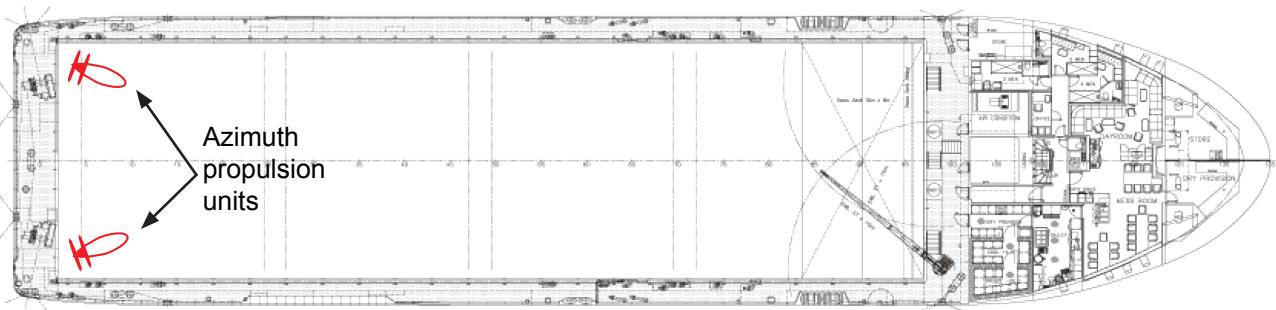
Figure 4

Plan of *Skandi Foula* indicating approximate direction of azimuth propulsion units

This was the first time the chief officer had operated *Skandi Foula*'s controls and he had limited previous experience with manually-operated azimuth propulsion systems. The azimuth thrusters were each set at approximately 15° to 20° outward angle (**Figure 4**) to provide both forward and transverse momentum by varying the power applied to each unit. It was low water and under keel clearance was 3.0m.

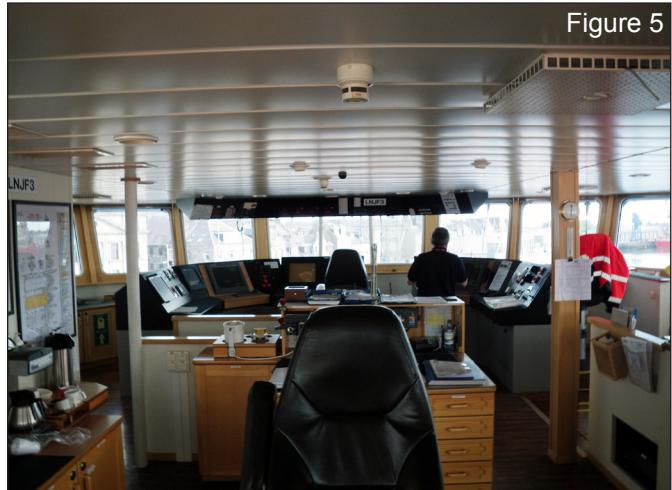
Figure 5

The master manoeuvred *Skandi Foula* away from *Maersk Logger*. Once clear of *Maersk Logger*, he passed control to the chief officer at the forward station to take the ship through the narrow gap between the moored craft, but he stayed at the aft controls to monitor the vessel's stern. Monitoring the forward progress of the ship from the aft station was difficult (**Figure 5**), and this was exacerbated by the ship's high freeboard due to her shallow draught. By remaining at the aft controls the master reduced his ability to monitor the overall progress of the vessel and his ability to oversee the actions of his newly joined chief officer.

Master's view forward from the aft control station
