High-speed craft, motion, ergonomics and injury:
A summary report for the MAIB

HIGH SPEED CRAFT;
MOTION, ERGONOMICS & INJURY:
A summary report for the MAIB.

Fitness for Úurpose Qspection of RIB carried out by PLA
on 21 October 2009

Fitness for Purpose Inspection of the passenger boat – 'CAPITAL RIB' on 21st October 2009

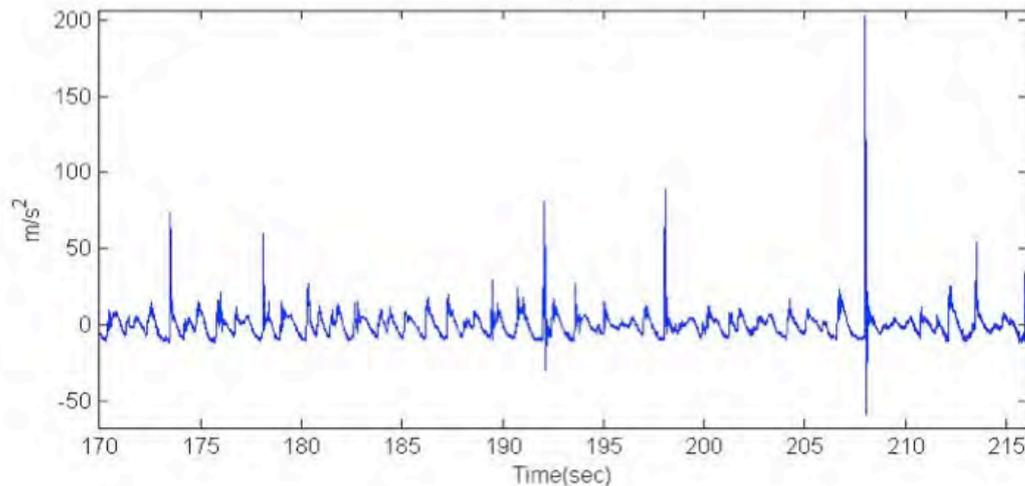
i) High Speed Craft (HSC) have been shown to experience impacts in excess of 20g perpendicular to the deck, and in excess of 10g parallel to the deck. An example of typical motion experience in a HSC is shown in Figure 1. This illustrates a section of a three hour transit in a 28' RIB, travelling at ~40 knots, in a sea state 1-2. Note the predominance of impacts of around two to three g, a number of impacts around seven g, and a twenty g impact.

Figure 1. An example of the deck motion (gZ) of a 28' RIB travelling at ~40 knots in a sea-state 1-2.

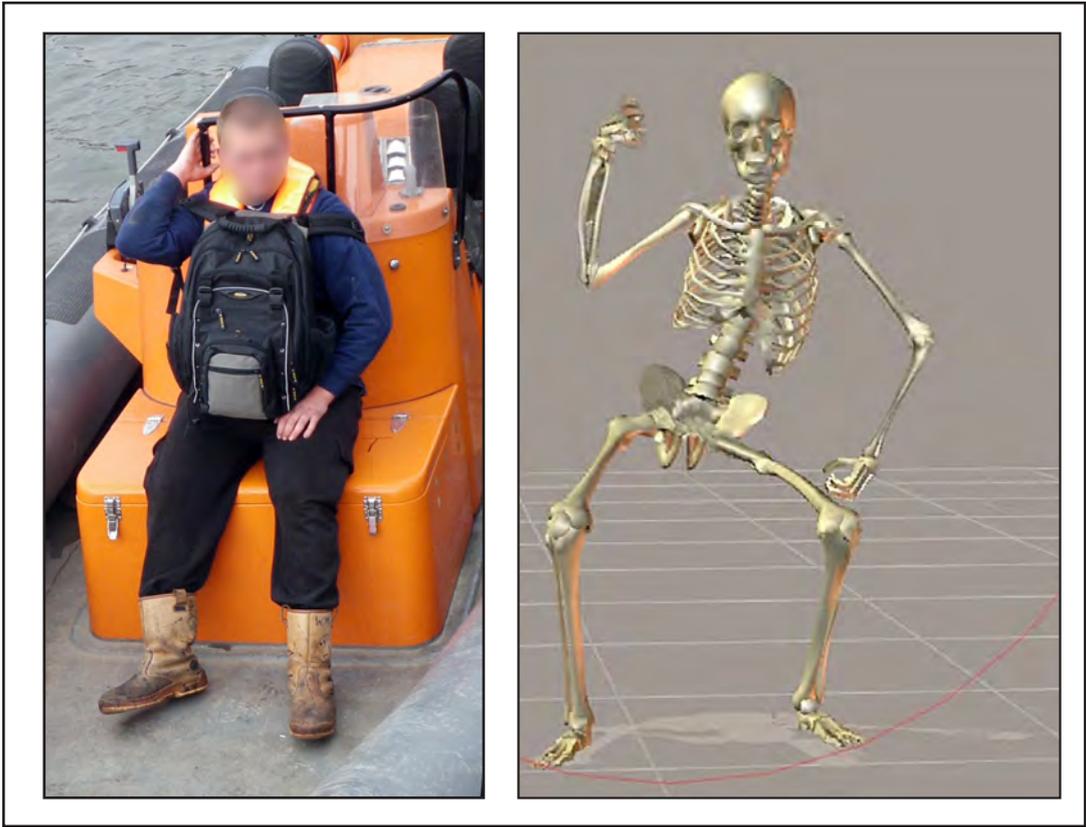
Figure 2. An illustration of the casualty's anticipated posture during the transit

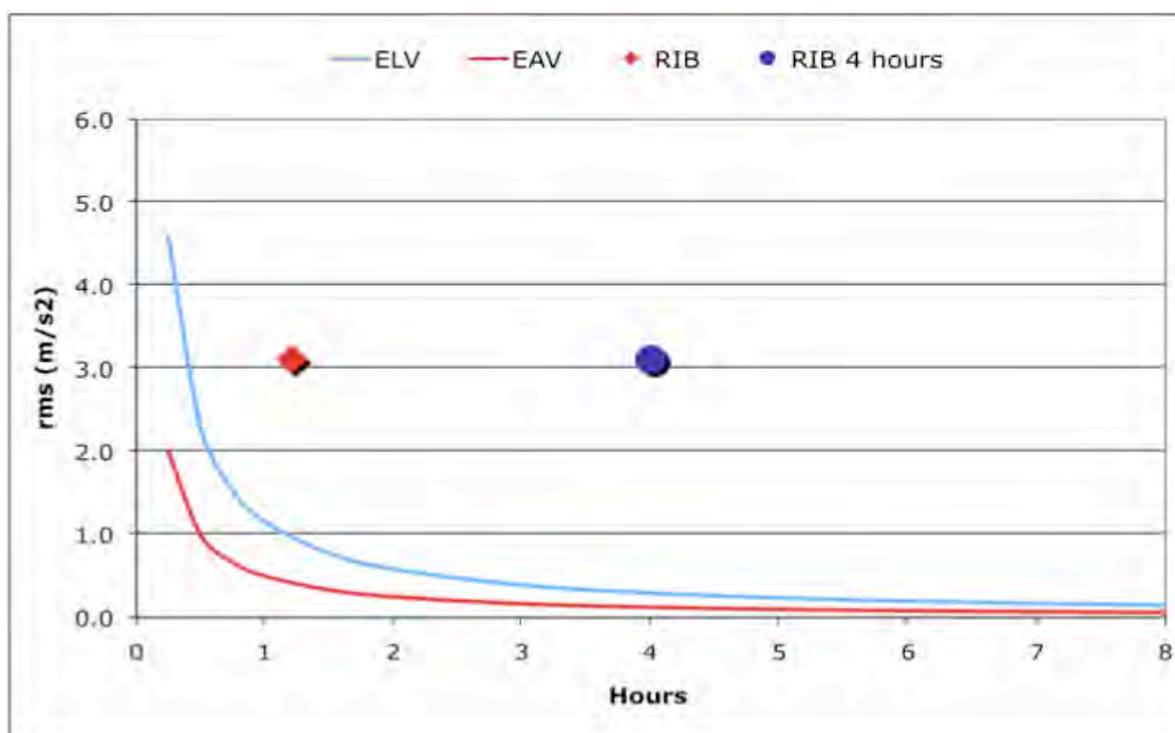
Figure H An example of how a 28' RIB travelling at ~40kts in a sea state 2 will exceed the EU WBV Exposure Action and Limit Values.

- iv) Compliance with this legislation by the HSC industry sector will assist in reducing both the risk of the acute injuries described above and chronic injuries that are common in professional HSC operators.

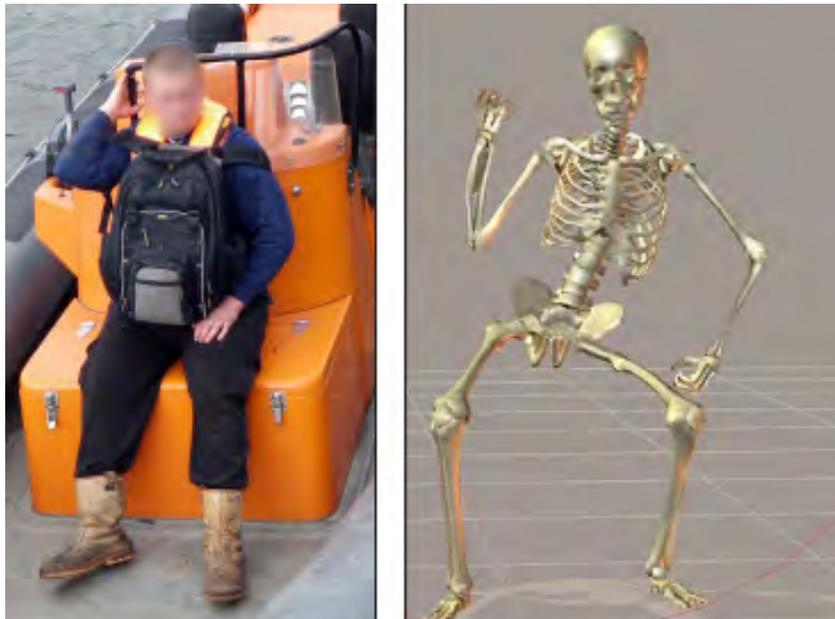
At approximately 0708 on 6 May 2010 a male passenger on a *Delta 8.5m* rigid inflatable boat (RIB) suffered lower back wedge compression fractures while the boat was transporting him, together with fellow workers, to a jack-up rig on the River Thames.

The injury occurred when the man landed heavily onto the lid of a locker, which was used as a seat, after he had been momentarily lifted off the lid due to the motion of the craft. At the time of the accident there was a light wind with a slight sea.
