Report on the investigation of  
a sea cadet's fatal accident on board  
the sail training ship

***TS Royalist***

2 May 2010

**Report No 2/2011**  
**March 2011**

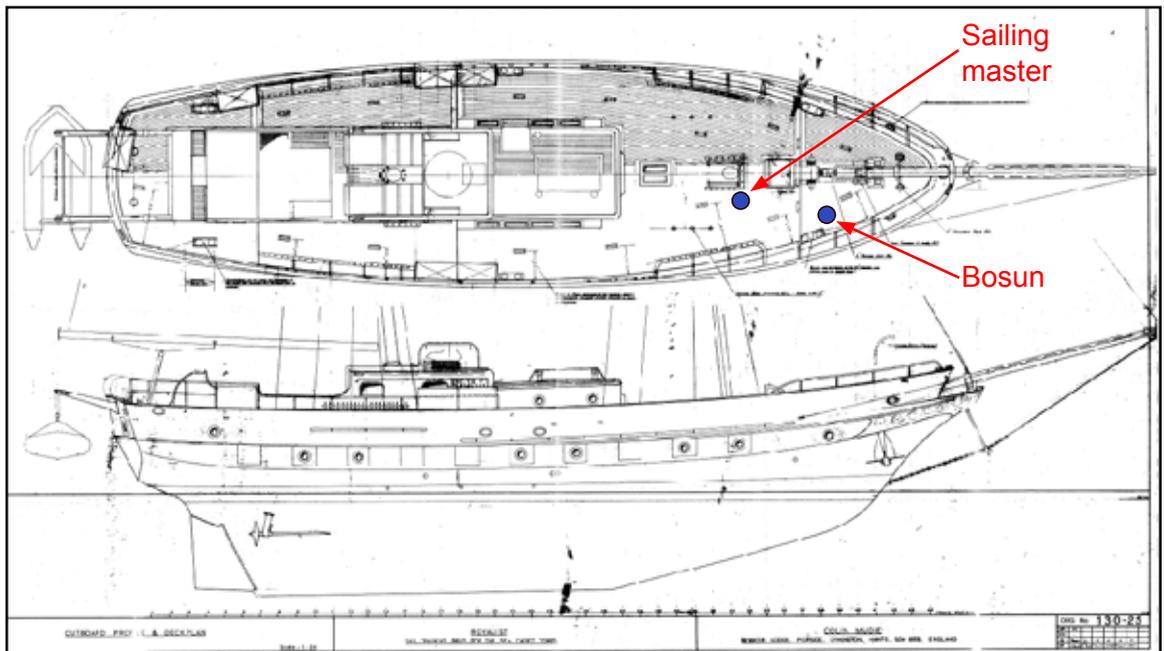
Approximate locations of sailing master and bosun

The main course was quickly furled and several cadets were sent from the main mast to assist the cadets working on the fore mast. The sailing master also went forward but remained aft of the bosun on the vessel's starboard side (**Figure 5**).

Although the sailing master and bosun were only about 8m below the cadets, it is highly likely that the effectiveness of their supervision was reduced by several factors. First, the view of some of the cadets aloft from the deck would have been partially obstructed by the fixed rigging. Second, it would have been extremely difficult to differentiate between the cadets and to monitor the actions of individuals because all the cadets were wearing red oil skins and were

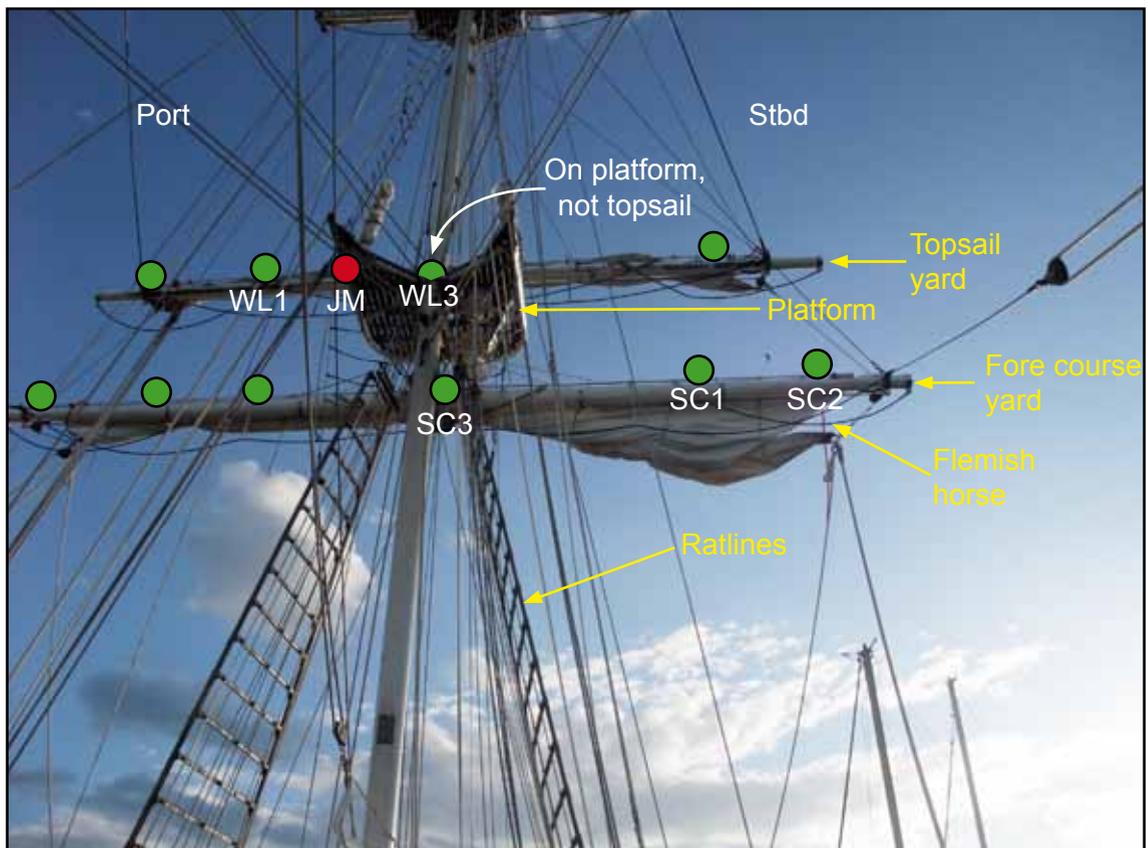
Position of the cadets on the fore mast

On the fore mast, four cadets were furling the fore topsail. One cadet was on the starboard yard and three cadets were on the port yard (**Figure 6**). Jonathan helped WL1 to stow the sail on the port yard while guiding a less experienced cadet on the port course yard below. WL1 was having difficulty in managing the task she had been set and, although not told to do so, Jonathan moved across to the starboard topsail yard to assist the lone cadet.

Six cadets were nominated to furl the fore course sail. Three cadets were on the port yard and two cadets (SC1 and SC2) were on the starboard yard; SC1 was about midway along the yard and SC2 was standing in the Flemish horse at the yard arm (**Figure 6**). SC2 was having difficulty in leaning over the yard to furl and secure the sail, and did not feel comfortable. The sixth cadet, the starboard forward watch leader (WL3), also felt uncomfortable aloft and remained on the platform or 'top' around the mast between the fore course and topsail yards.

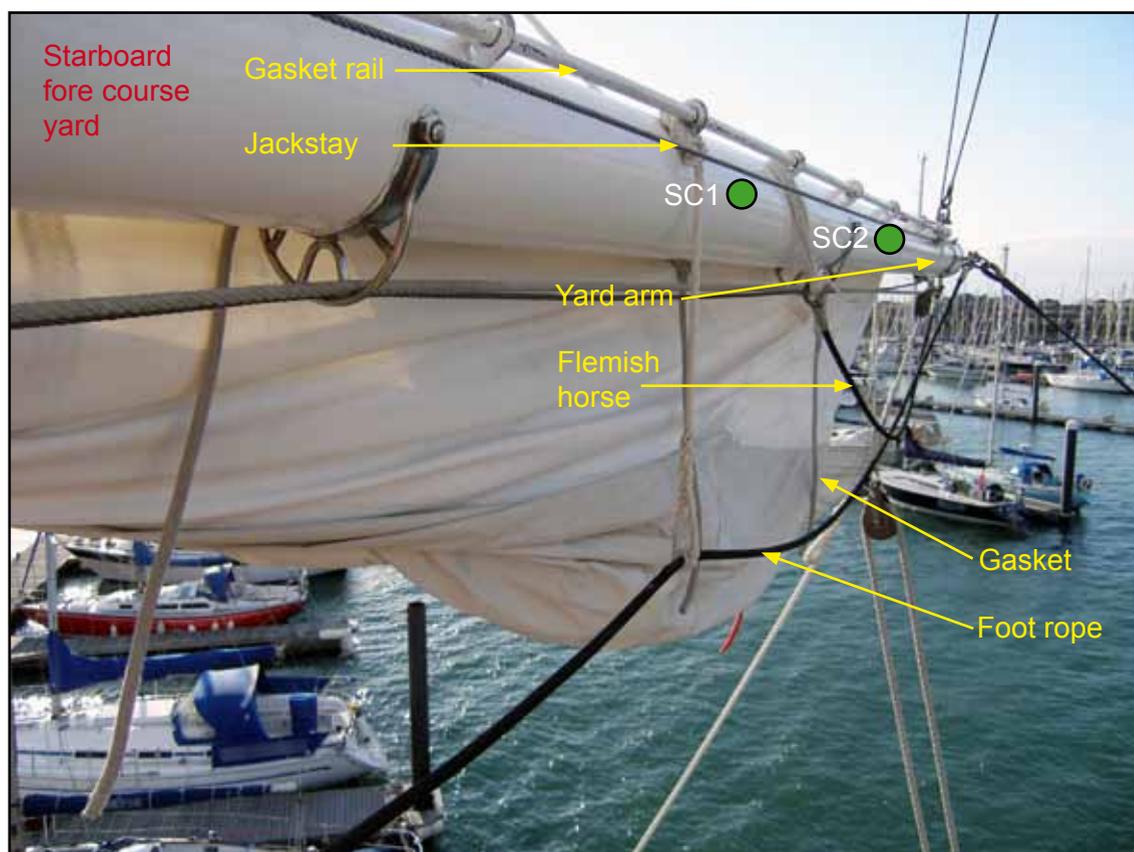
Starboard fore course yard

Jonathan climbed down from the platform via the futtock shrouds; it is not known if he clipped onto the vertical safety line available during this descent. He then stepped on the course yard foot rope between SC3, who was standing close to the mast, and SC1. Jonathan then clipped his belt harness lanyard on to the wire jackstay (**Figure 7**).

Jonathan started to help SC1 furl the sail. He then told her that he wanted to pass her so that he could assist SC2. SC1 told him not to; she would help the other cadet. Without further discussion, Jonathan unclipped his belt harness lanyard and tried to step around SC1, leading with his right arm and his right foot. SC1 immediately shouted to Jonathan to stop and to re-attach his belt harness. This instruction was heard by a cadet on the deck below. Jonathan managed to grab the metal gasket rail between the female cadets, but when his right foot stood on the foot rope between the girls, the foot rope swung forward causing Jonathan to lean backwards. Jonathan was unable to hold on and, although SC1 tried to grab his arm, she was unable to prevent him from falling towards the deck.

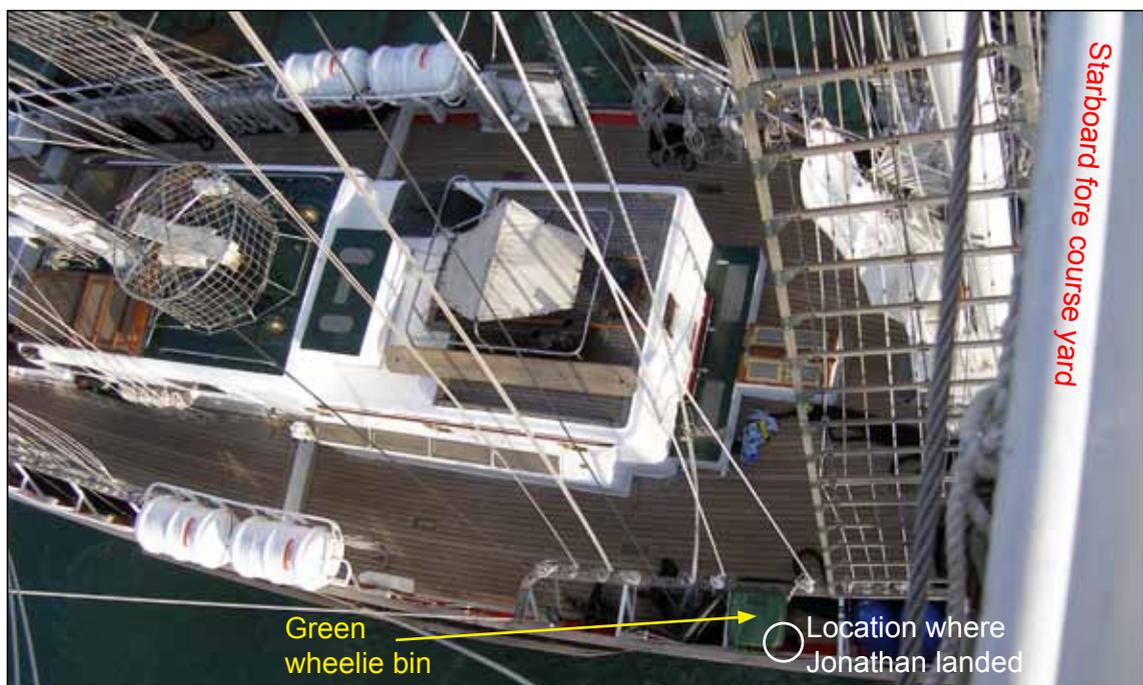
View of deck from starboard fore course yard

Jonathan landed face-down on the starboard gunwale and a green wheelie bin (**Figure 8**). He then fell in to the sea. Jonathan quickly surfaced face-up; his arms were outstretched and he showed no signs of movement. Although both the sailing master and the bosun caught sight of Jonathan as he fell, neither knew which yard he had fallen from.

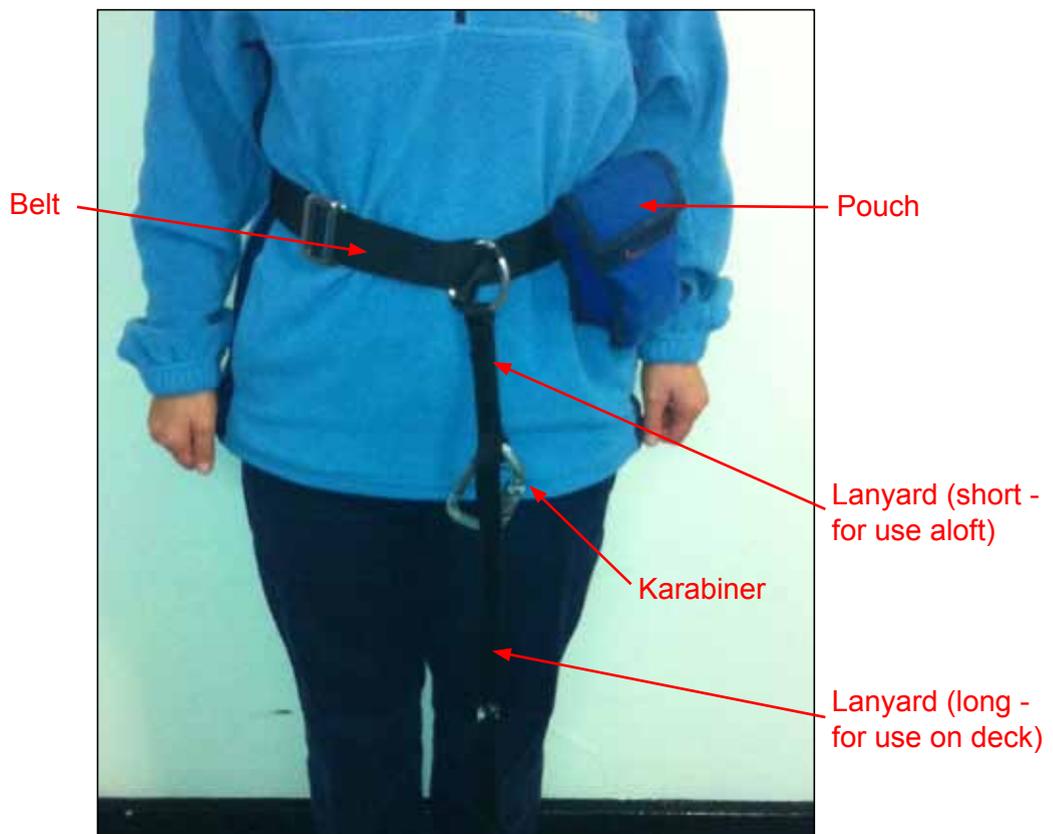
Belt harness

The harnesses used by the crew and cadets on board TS *Royalist* were interwoven polyester webbing belts fitted with a single lanyard (**Figure 10**).

The waist belt was 50mm wide and was fitted with a metal joining buckle. The lanyard was also made from polyester webbing and was 72cm long and 25mm wide, with a loop in the end. A self-closing karabiner<sup>7</sup> was fitted on the lanyard<sup>8</sup>, 13cm from the waist belt, which could be operated with one hand. It also locked automatically when closed. A pouch on the side of the harness was used to store the lanyard and karabiner when not in use.

The belt harnesses with a single lanyard used on board TS *Royalist* were intended to prevent the cadets from falling when aloft. However, this type of harness is a fall restraint device, which is intended to prevent the wearer from getting to a position from where it is possible to fall. It is not suitable as a fall arrest device because the belt only supports the wearer by the waist, although the risk of injury is mitigated to some extent by the lanyard's short length, which thus restricts the distance a person can drop. However, the potential for injury remains. Furthermore, given the material breaking load of the lanyards and the absence of markings on the harnesses to indicate that they met the relevant EC standards (paragraph 1.7.1), their ability to withstand the shock loading of a person falling is questionable.

The provision of only one lanyard also necessitates the wearer to 'unclip' while moving around when aloft due to the arrangement of vertical safety lines and horizontal wire jackstays. During the periods a cadet is 'unclipped', the risk of falling is significantly increased.

However, the STI guidelines also state that account must be taken of the specific rig of a vessel. In this case, it is evident that MSSC preferred the waist belt with one lanyard to the recommended full body harness with two lanyards, which it had trialled and which is used by other operators, on the basis that it was simpler to use, less cumbersome, and suitable for use on deck as well as aloft provided the cadets were properly trained in their use. These were important considerations given the age range and mixed abilities of the embarked cadets and the limited space on the masts and associated rigging on board TS *Royalist*. Nonetheless, not only were the belt harnesses and lanyards unsuitable for fall arrest, they were neither manufactured nor tested to comply with current standards. In addition, despite the frequent on board inspections conducted, no records of these inspections were maintained. Consequently, despite their good safety record, the belt harnesses cannot be considered to have been fit for purpose.

Jonathan's belt harness and lanyard did not fail, and there was no record of a belt harness failing on board. However, despite MSSC's reviews of the harnesses, the continued use of the belt harnesses with single lanyards, and the maintenance regime followed, indicate that MSSC had not adopted best practice found elsewhere in the sail training sector of the marine industry. They also indicate that MSSC had not complied with the spirit of the regulatory standards for PPE applicable to the merchant marine industry and to adventurous training activities ashore.

STI guidelines advise that sail training vessels use a full body harness fitted with two lanyards. This is a fall arrest device, intended to be used in situations when a fall is likely, and designed to minimise the risk of injury to the wearer, suspend them in an upright position and maximise the chance of their safe recovery or rescue, if required. The provision of two lanyards also enables the wearer to 'clip' on to the next line or wire before 'unclipping' from the line or wire in use. Although two lanyards present twice the snagging hazard of a single lanyard (and a degree of synchronisation, discipline and practice is required), the increased protection from falling is clear.

Following discussions with the RN, MSSC withdrew TS *Royalist* from service in September 2010 for refit, and pending a review of the equipment and procedures used by cadets when aloft. It has also continued to investigate the provision of a suitable replacement harness and is progressing the development of an SMS for its offshore operations.
