Report on the investigation of  
a lifting equipment failure  
on board the floating sheerleg

***Cormorant***

102 berth, Southampton

**Report No 15/2010  
November 2010**

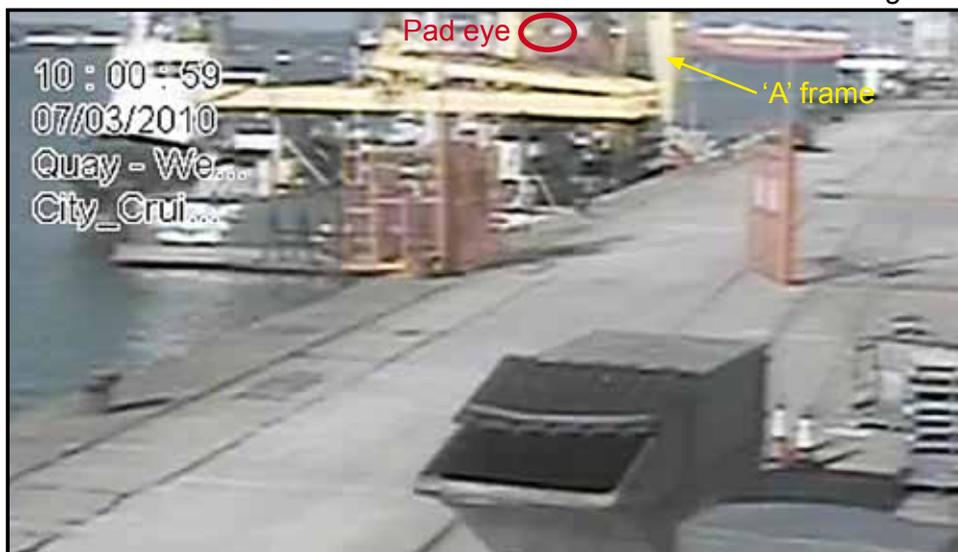
Figure 3

Failure of the port preventer deck pad eye

The sections of the port and starboard pad eye that remained on the deck and on the preventer wire were removed from the vessel and were sent to the Test House, Cambridge for metallurgical examination. Observations of the examination included:

- Clear fracture origins were apparent at the plate fracture sites consistent with a single generally low ductility overload event.
- On the port plate one fracture comprised largely shear which in contrast to the other three fractures was exclusively ductile in nature.
- The steel plate adjacent to all fracture sites had undergone extensive yielding.
- All of the fillet welds retaining the ring had sheared through the throats, exposing some worm-hole porosity.
- A conservative estimate of a single event fracture force required was 4,713kN, approximately 480t, or 240t simultaneously on each fitting.
- The corrosion wastage and welding defects identified during examination were not thought to be significant in the failure process.

*The two preventer pad eye plates had failed in a simultaneous single overload event, exposing no evidence of previous fatigue cracking. Though some evidence of light local corrosion wastage was apparent in both plates, the presence of prior corrosion wastage was not considered significant in the failure process. Similarly, the widespread evidence of welder attributable welding defects was also not considered significant...*

*The preventer pads appeared to have failed in response to a fracture force, which calculations suggest was an order of magnitude greater than the normal rigging load. Consequently, our opinion is the preventer pads had been designed with a suitable safety margin and that failure had resulted from an operation defect rather than a latent design, materials, or workmanship type defect.*

Metallurgical analysis of the pad eye fittings (**Annex A**) estimated that a load of 240t was required for each pad eye to fail in a simultaneous single event. Therefore, there is no doubt that the pad eye fittings, which were designed with an SWL of 110t, were significantly overloaded. There is no evidence to indicate that the failure of any of the machinery, wires, and other loose gear contributed to the accident.

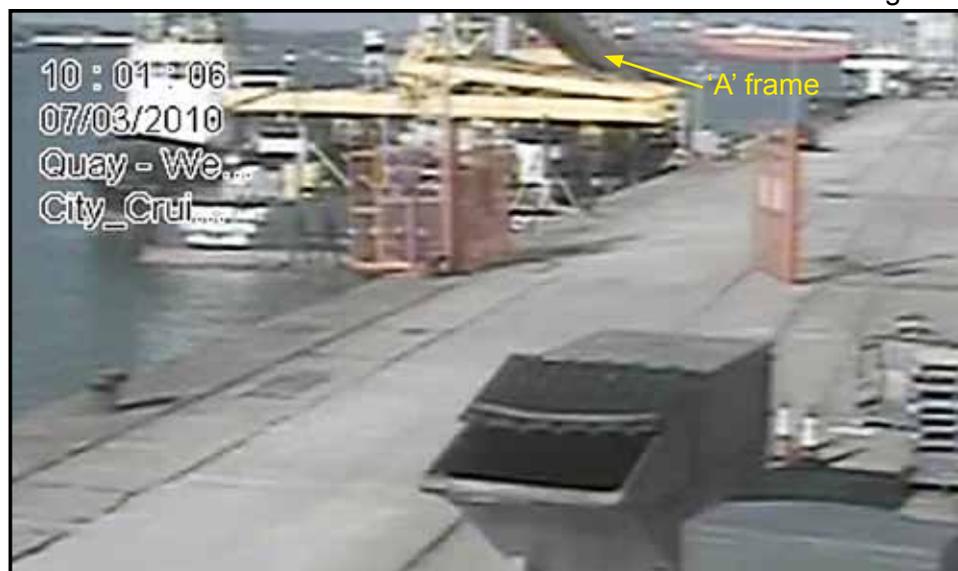
Figure 4

At 1001, just as the hoisting and preventer wires were about to come into line, the port and then the starboard pad eyes holding the forward preventers broke away from the deck and were catapulted about 20m into the air (**Figure 3**). Seconds later, the 'A' frame pivoted forward slightly before it, and the preventer and luffing frames, fell backwards onto the main deck (**Figure 4**). As the frames fell, the mate took cover under a winch, the engineer stepped into the accommodation, and the master shouted to the AB and the agent to take cover. There were no injuries.

'A' frame falling on to the deck and wheelhouse

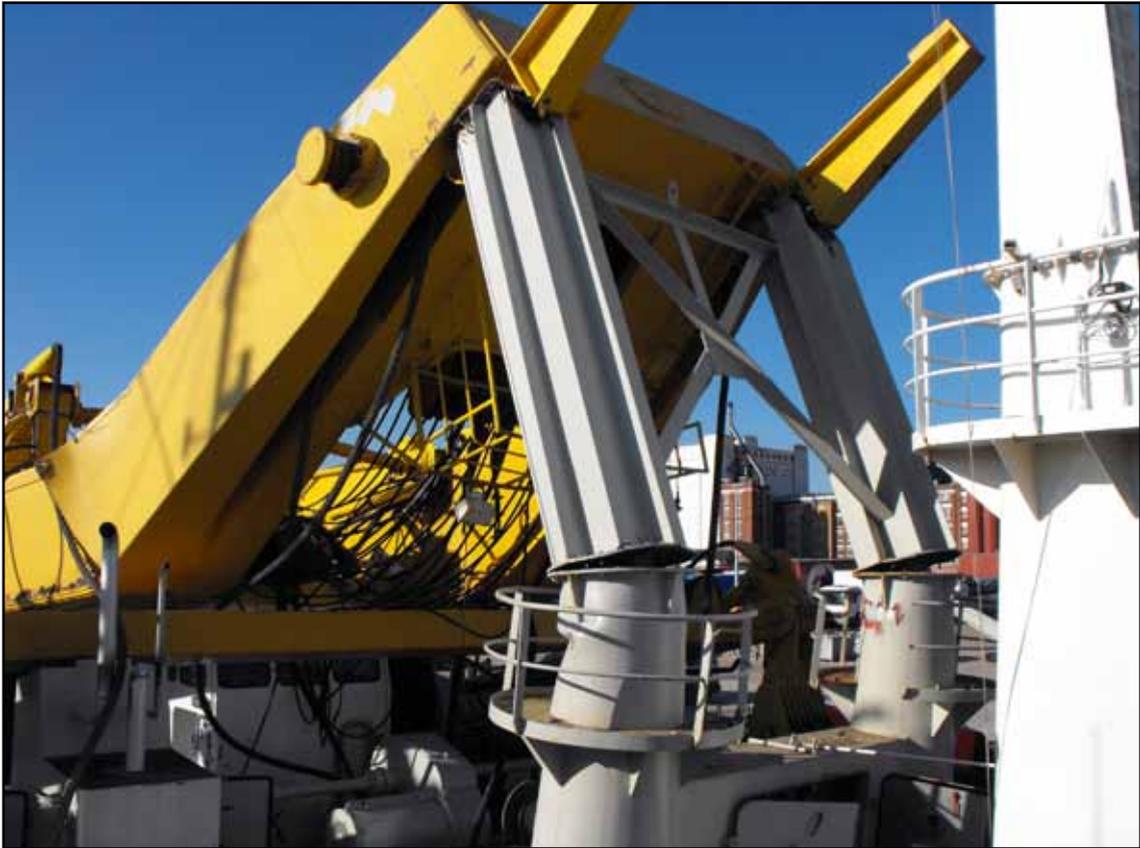
Figure 5

- Fracture of the steel plates forming the pad eyes fitted to the deck.
- Buckling of the 'A' frame and its foundation (**Figure 5**).
- Buckling of the preventer and luffing lifting frames.
- Impact damage to the forward section and deck head of the wheelhouse caused by the 'A' frame cross-member (**Figure 6**).
- Impact damage to winch supply drums, wires and lifting blocks.

Buckling to the 'A' frame and its foundation

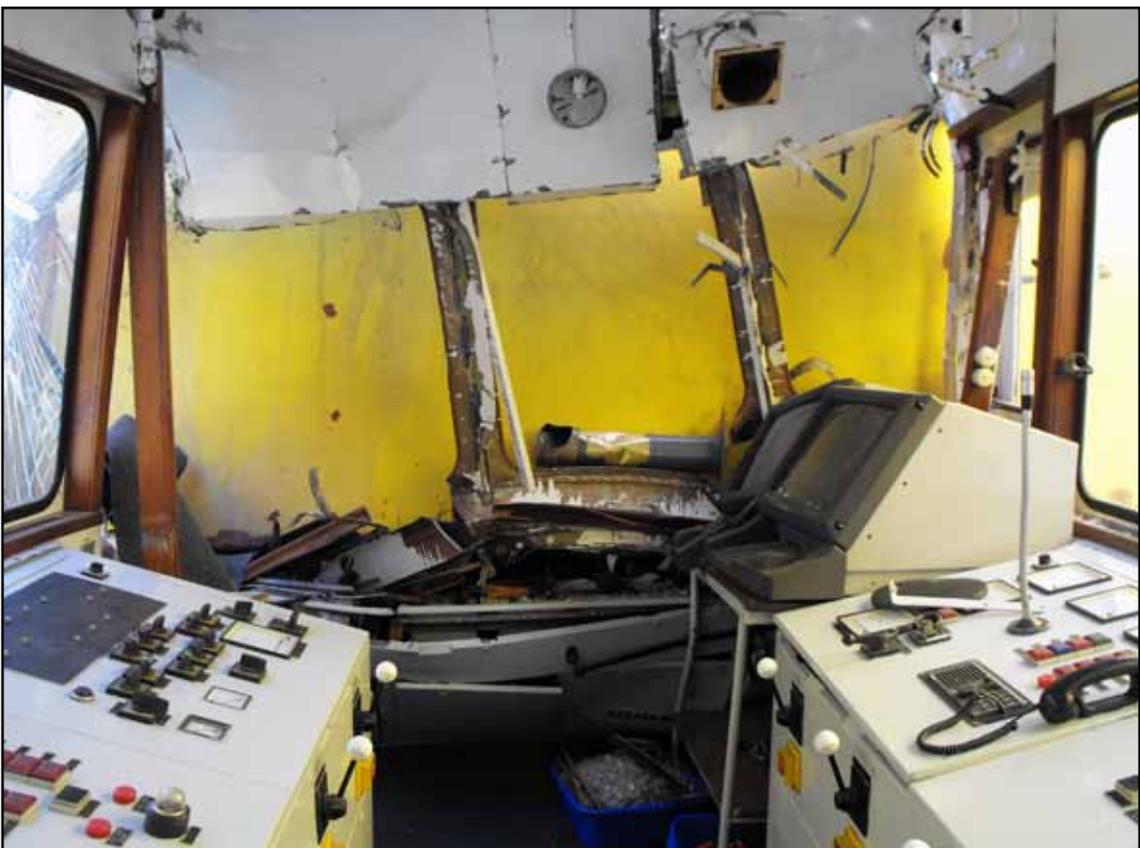
Figure 6

Wheelhouse damage

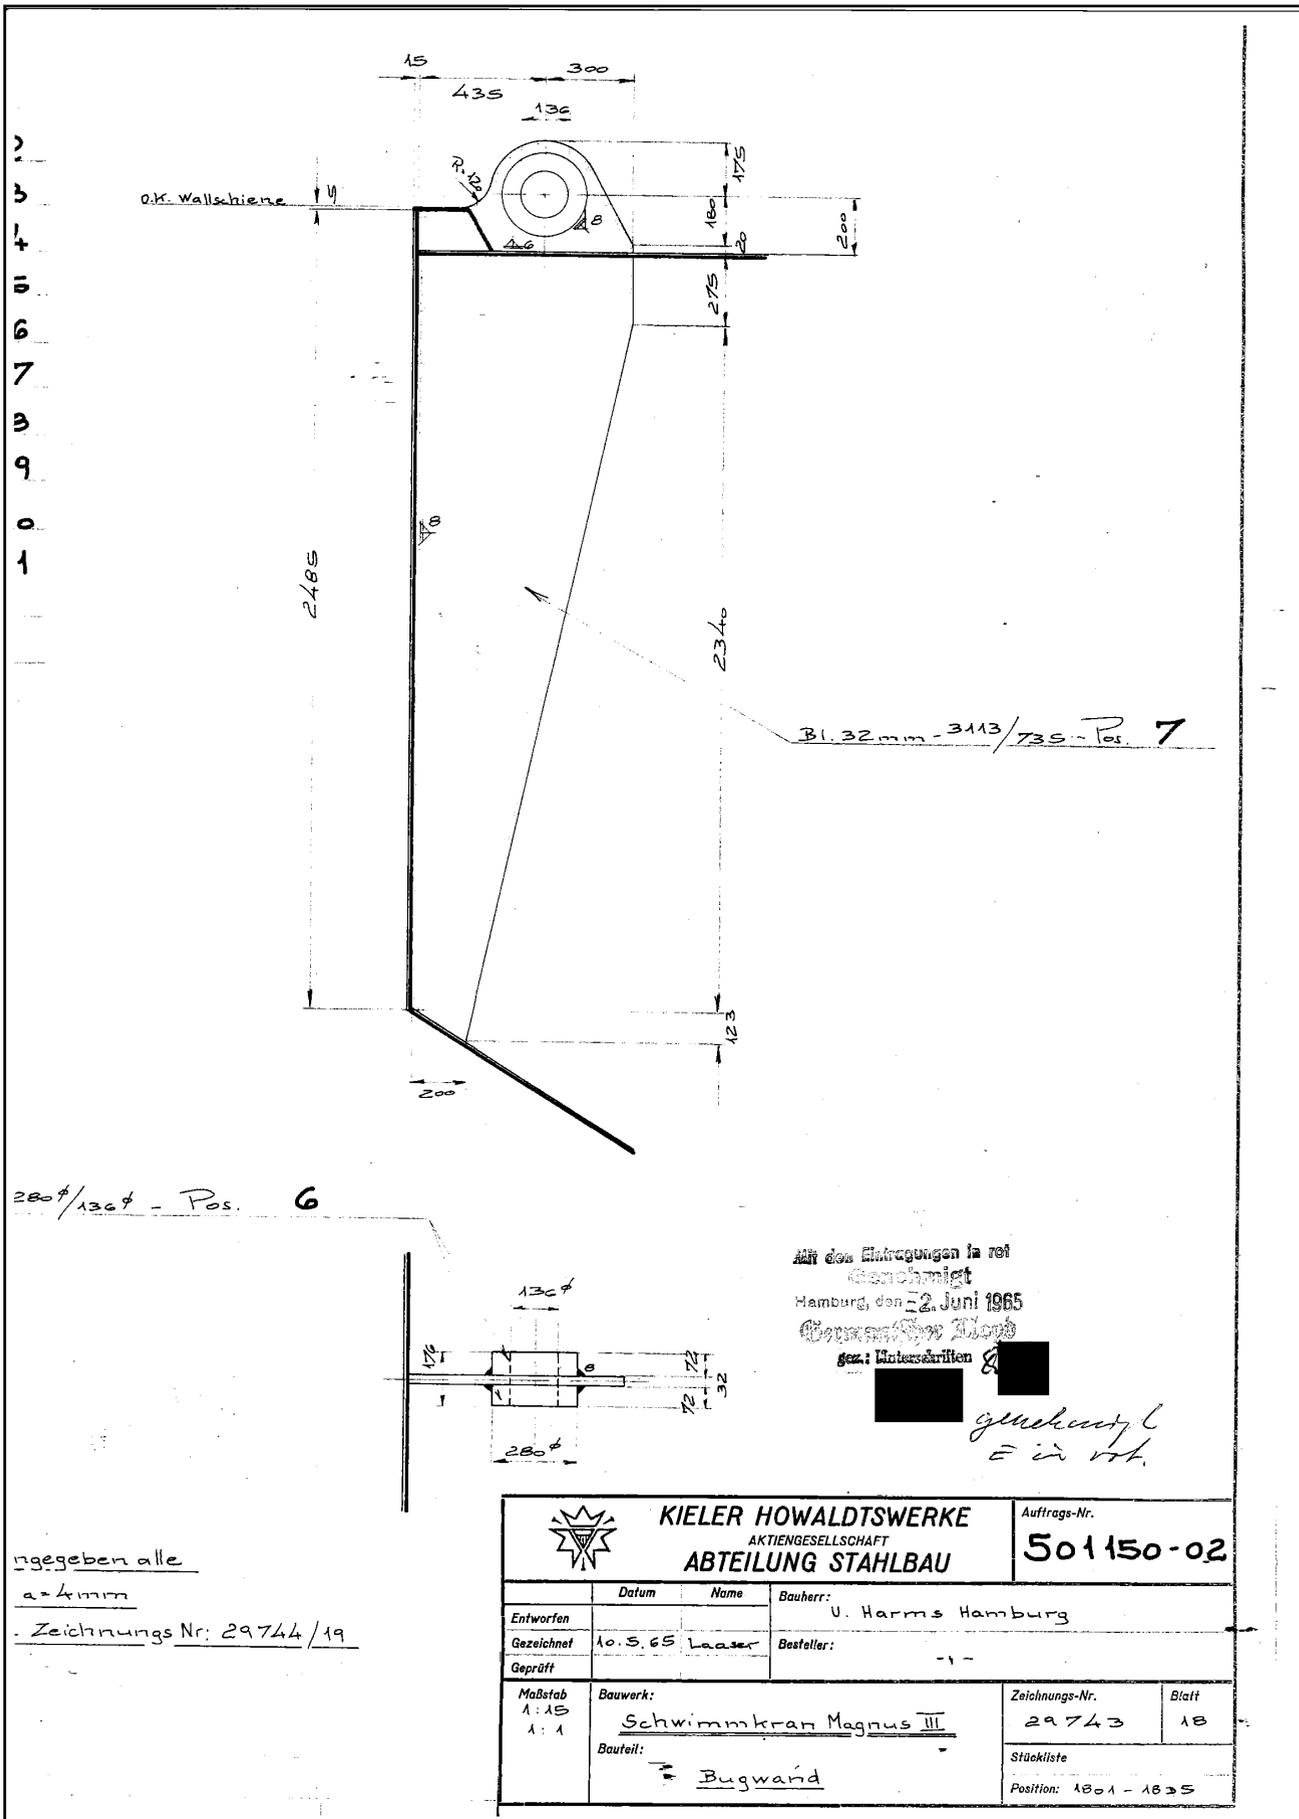
Figure 8

Design of pad eye and structure

In this case, the condition of the pad eye fittings was not contributory to the accident. However, corresponding deck fittings on board a similar vessel were subsequently subjected to non-destructive testing, and failed due to cracked welds. This finding, along with the failures to other non-cargo lifting appliances highlighted in paragraph 1.10 clearly demonstrates the need for owners to identify, record, examine and test all lifting appliances and loose gear on board their vessels, regardless of their use. In the longer term, a single, harmonised international regulation covering all lifting appliances used on board ships would be less confusing and easier to administer.

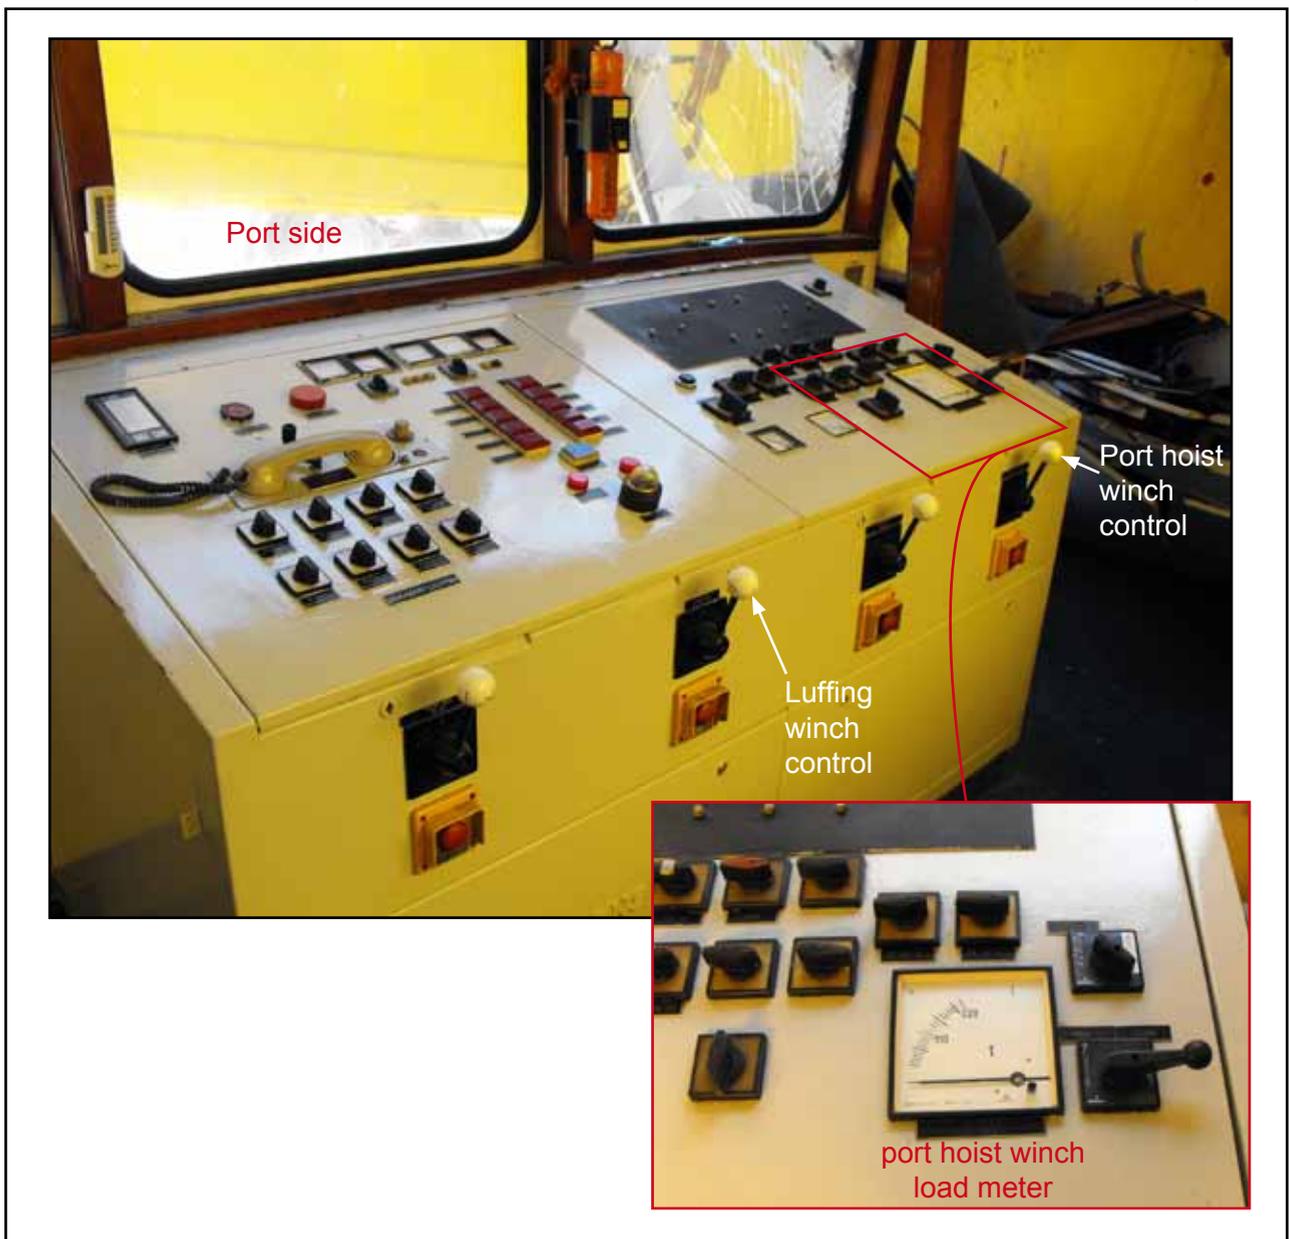
Figure 10

Control for port hoist winch and luffing winch control

Finally, there were no signs or labels to show the directions of heave and slack by the winch controls. The master of *Cormorant* had many years of experience operating the crane, but such labelling provides a simple reference that might have prevented the luffing winch from inadvertently being operated in the wrong direction.

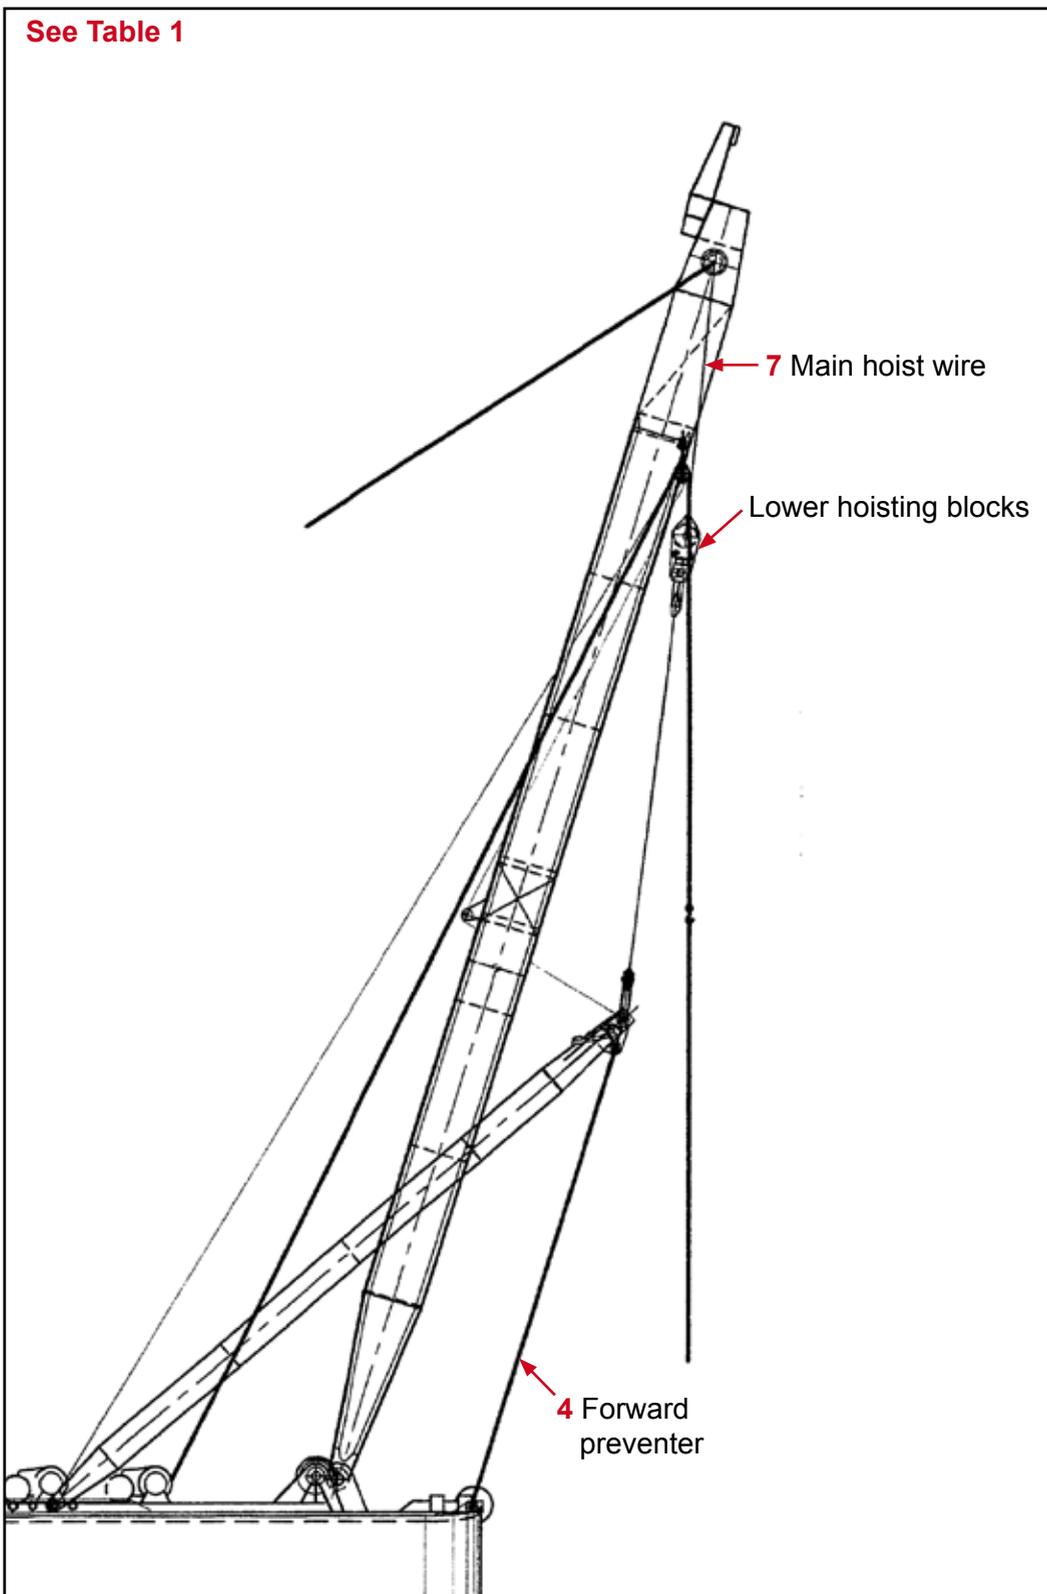
When the rigging operation re-commenced, there was slack wire in the luffing purchase, and therefore the low load meter reading on the hoist wires observed by the master was expected. By heaving on the hoist winch, albeit at its slowest speed, a load was exerted on to the hoist and preventer wires which moved the 'A' frame forward. If the luffing winch remained stopped, the luffing wires would have tensioned and the load exerted by the hoisting winches would have been carried by the hoist and preventer wires to the pad eye fittings on the deck. Notwithstanding that each winch was capable of exerting a maximum pull of just over 220t, this was only 20t short of the estimated fracture force required.

Alternatively, it is equally likely that after putting the hoist winches to heave, the luffing winch was also set to heave rather than to slack back. Consequently, when all the slack in the luffing wire had been taken up, the hoist and luffing winches would have exerted a load in excess of 240t on the pad eyes.

Position of 'A' frame at its point of collapse

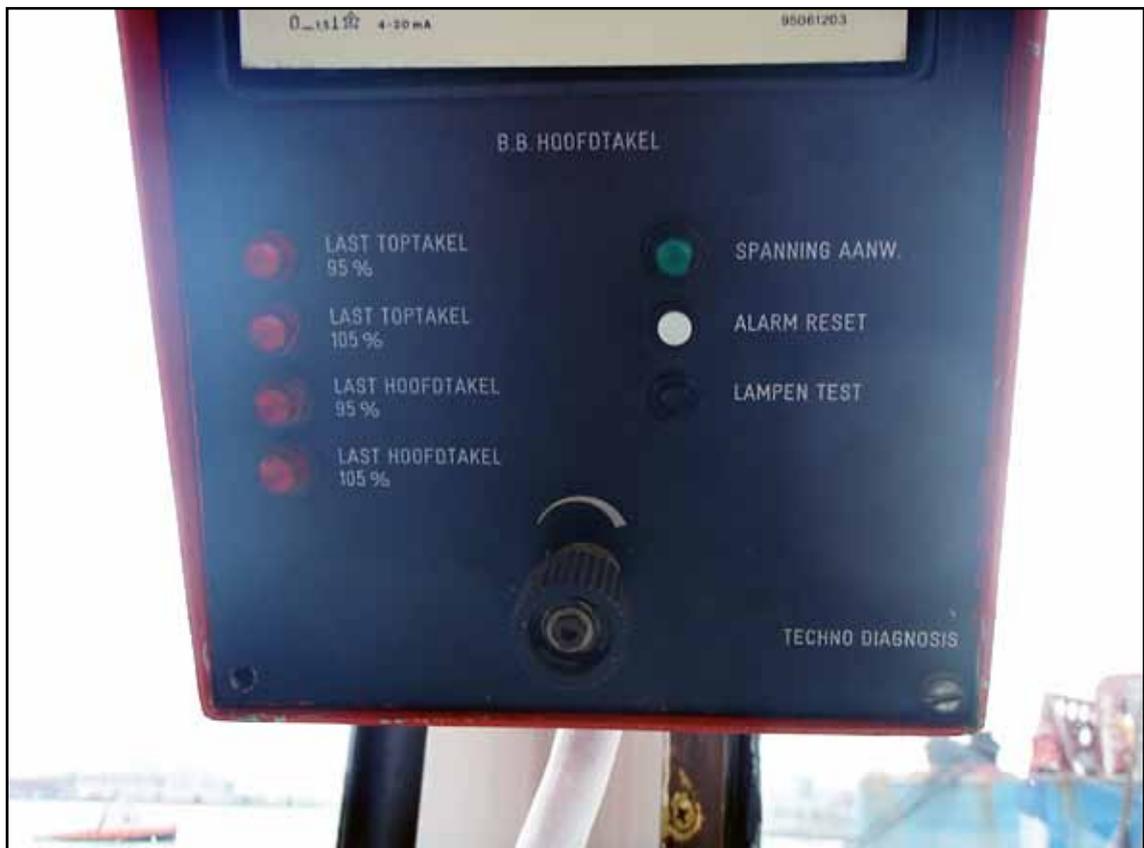
Figure 12

Overload warning and alarm display
