Test House report

PRELIMINARY REPORT IN RESPECT OF FRACTURED PORT AND STARBOARD HEAVY LIFT CRANE DECK PREVENTER PAD EYES

EX MV CORMORANT

THE TEST HOUSE JOB NUMBER: T00384

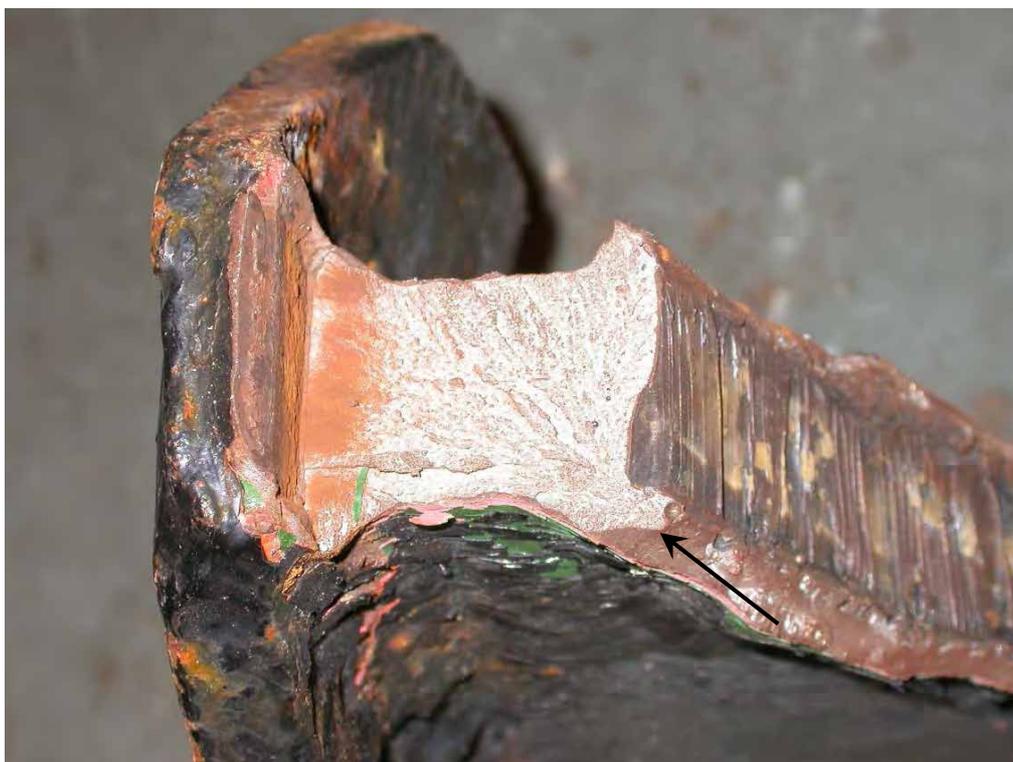
A clear fracture origin was apparent at each of the fractures in the steel plate (Figures 1 and 2). The two origins were in the ring retaining fillet welds and the fractures were consistent with a single generally low ductility overload event.

Figure 1: Fracture in the starboard plate (fracture origin shown arrowed).

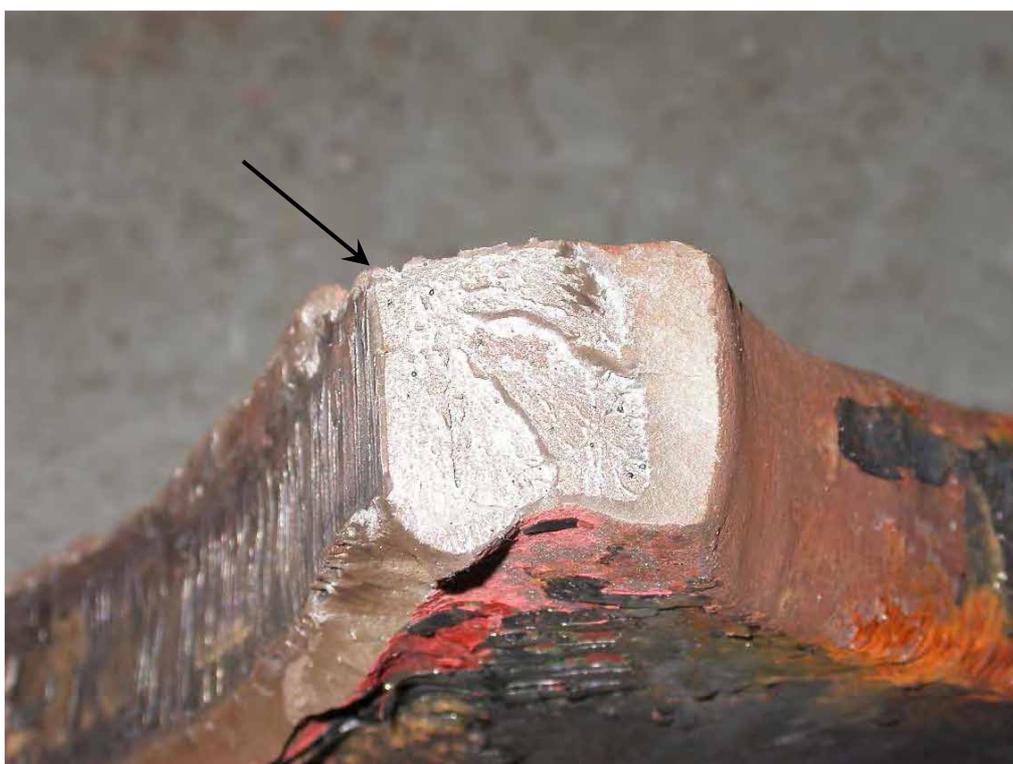
Figure 2: Second fracture in the starboard plate (fracture origin shown arrowed).

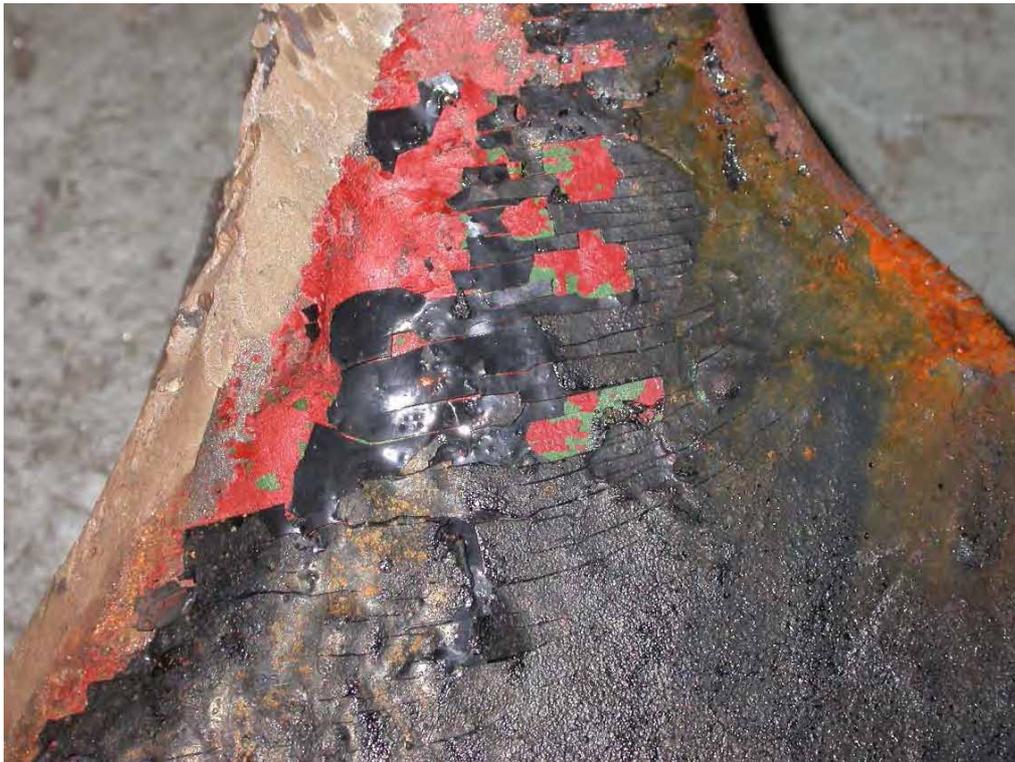
The steel plate adjacent to the two fracture sites had undergone extensive yielding, as was evidenced by the presence of widespread cracking in the paint (Figures 3 and 4).

Figure 3: Evidence of post yield point type straining (as evidenced by cracking in the paint) for a considerable distance back from the starboard side fracture site.

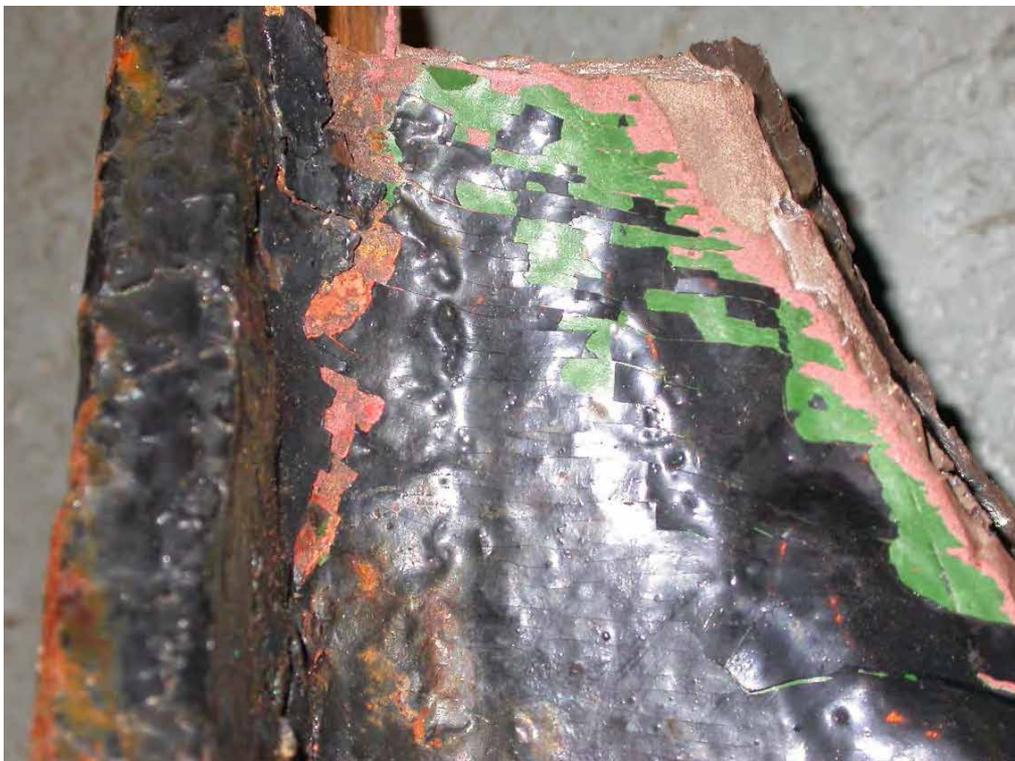
Figure 4: As figure 3, but viewed from the opposite plate side.

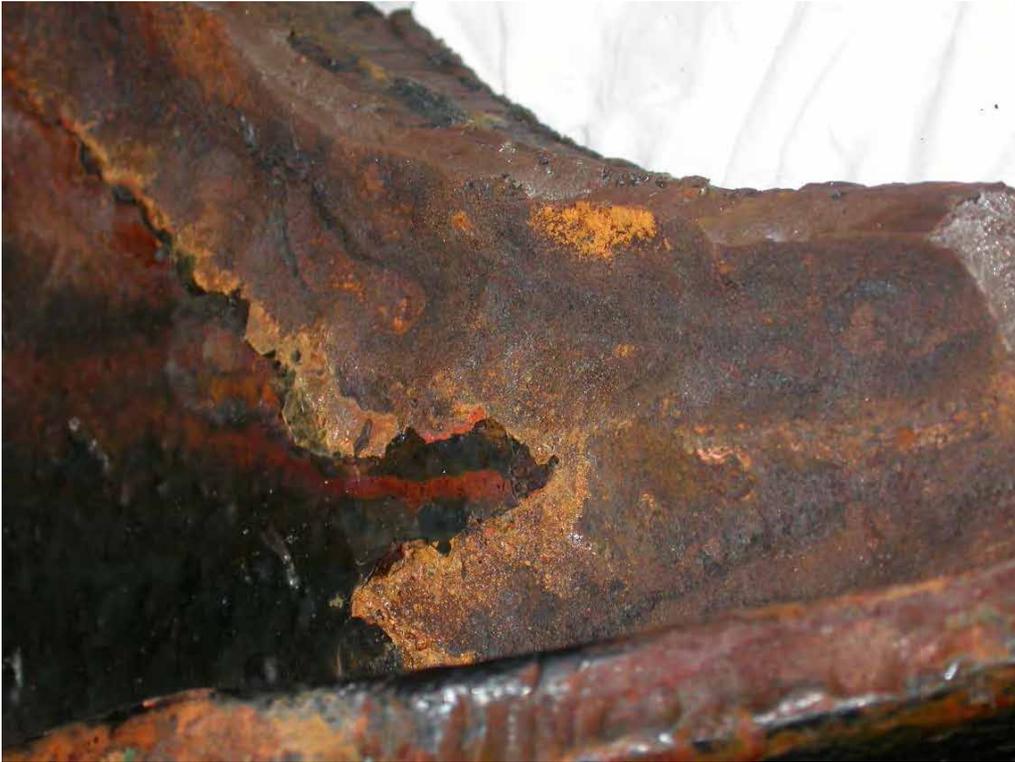
Evidence of earlier corrosion wastage was apparent on one of the plate faces adjacent to the fracture site (Figures 5 and 6). The wastage had reduced the local plate thickness by 3 to 4mm.

Figure 5: Starboard side plate, showing local corrosion wastage apparent at one of the plate faces adjacent to the fracture site.

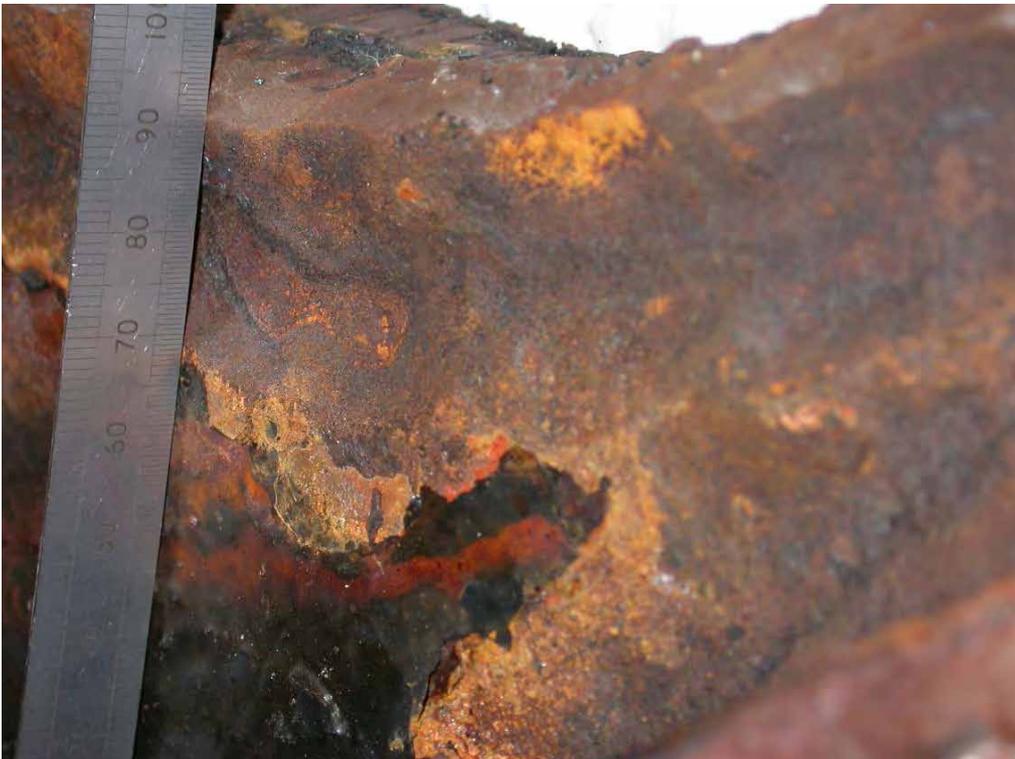
Figure 6: Detail of local corrosion wastage shown in figure 5.

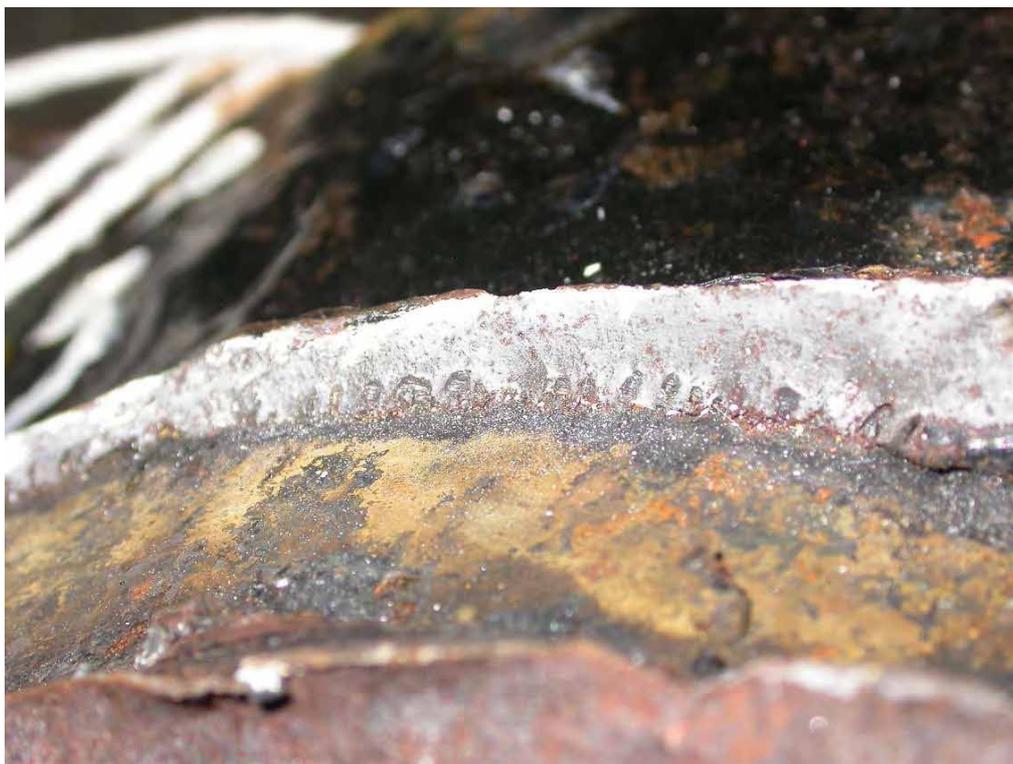
The two fillet welds retaining the ring had sheared through their weld throats, exposing some worm-hole porosity and local lack of fusion sites (Figures 7 and 8). The weld fractures were apparent over a 490mm length of the rings circumference and the average weld throat thickness was of the order of 8mm.

3.4 Widespread evidence of welding defects, in the form of root worm-hole porosity and isolated sites of local lack of weld fusion, were apparent in both the starboard and port ring retaining welds. The presence of weld defects, though indicative of poor workmanship, was not thought to be significant in the failure process.

Figure 7: Sheared starboard ring retaining fillet weld, showing root worm-hole porosity.

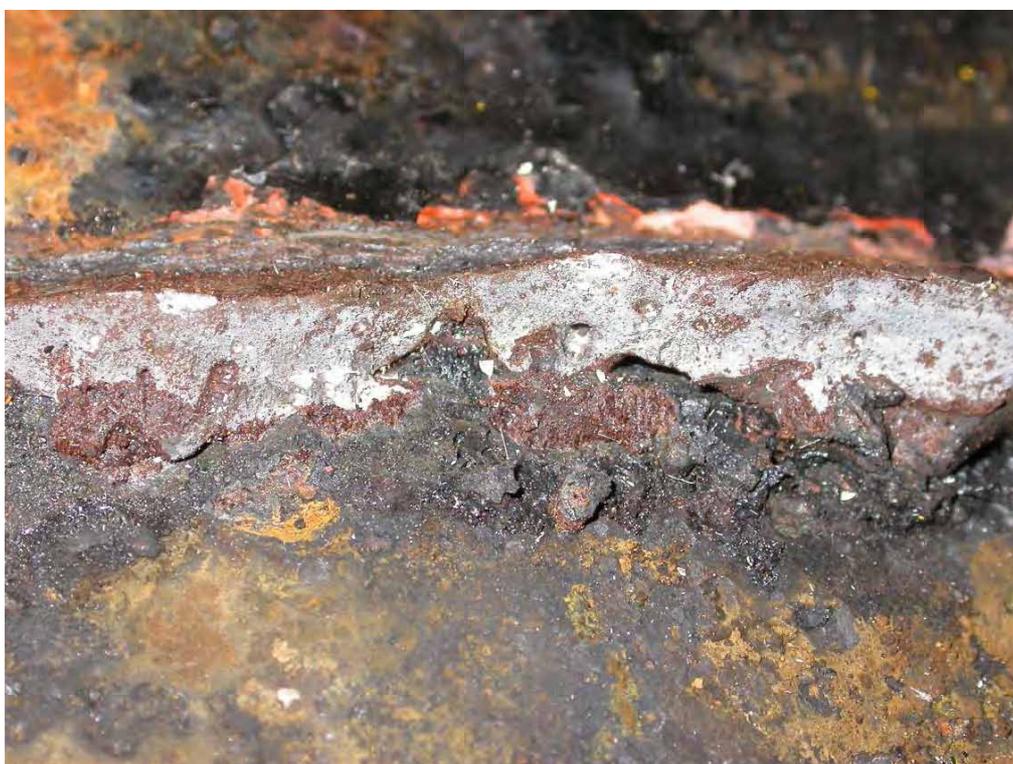
Figure 8: Sheared starboard ring retaining fillet weld, showing local lack of fusion.

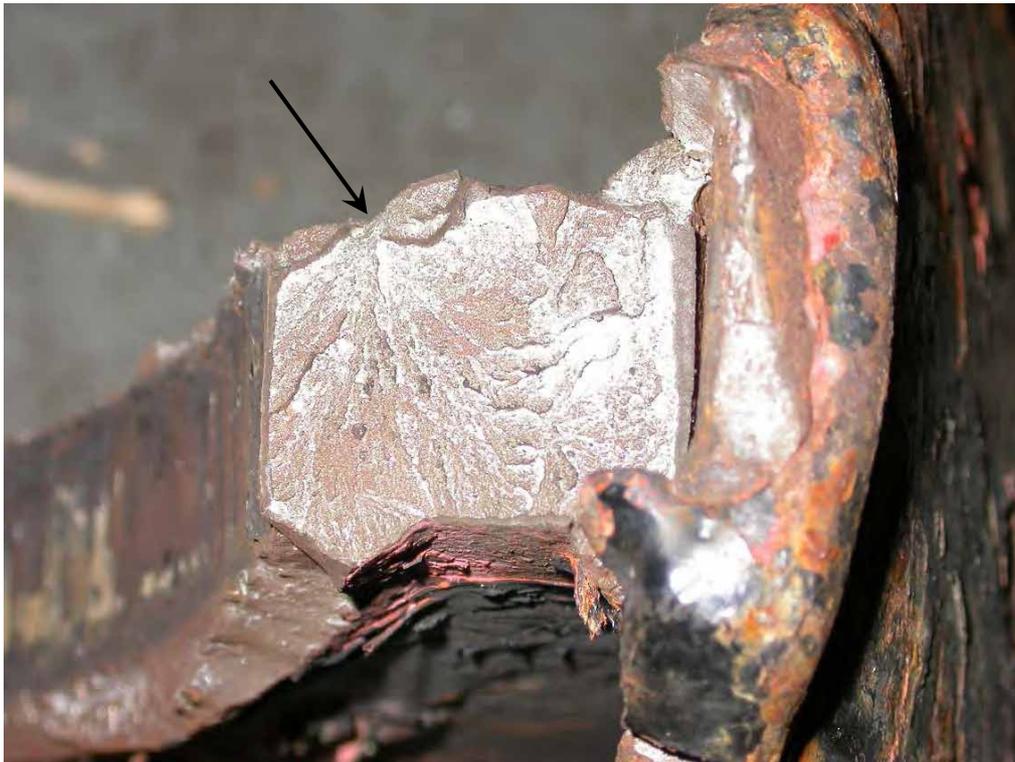
A clear fracture origin was apparent at one of the plate fracture sites (Figure 9), which was located in one of the ring retaining welds. The fracture at this plate side was consistent with a single generally low ductility overload event. The fracture at the second site comprised largely shear (Figure 10), which had progressed from the plates inner flame profiled edge and towards the outer plate

Figure 9: Fracture in the port plate (fracture origin shown arrowed).

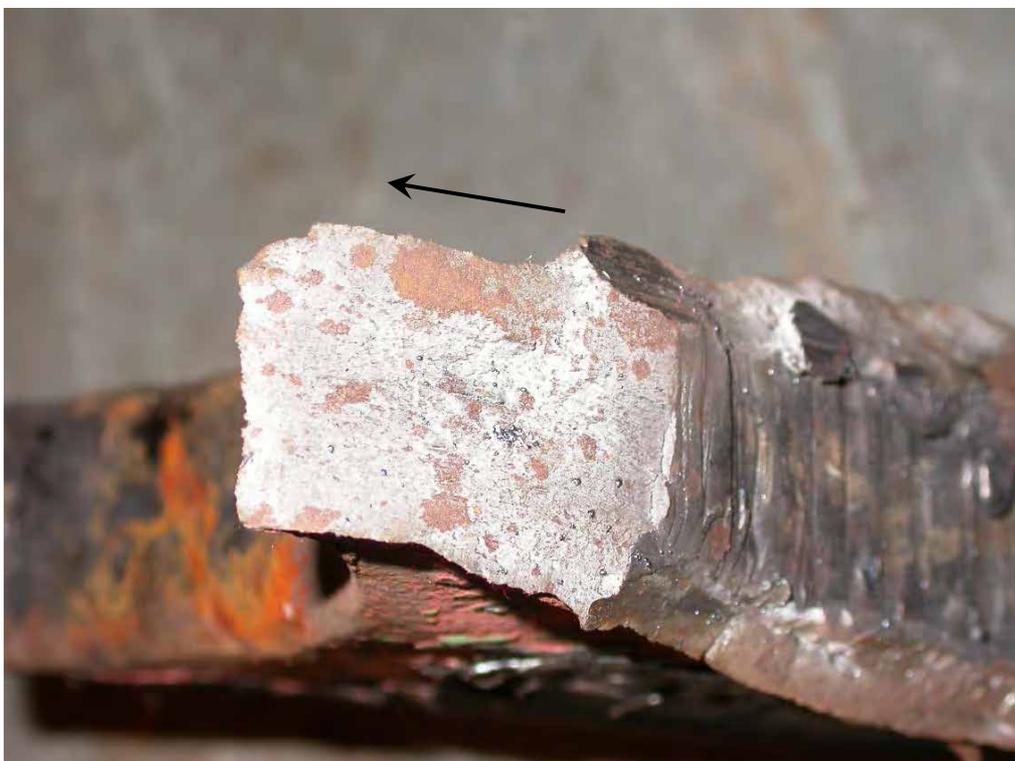
edge. This fracture, in contrast with the other three plate fractures, was exclusively ductile in nature.

Figure 10: Shear fracture in the port plate (shearing direction shown arrowed).

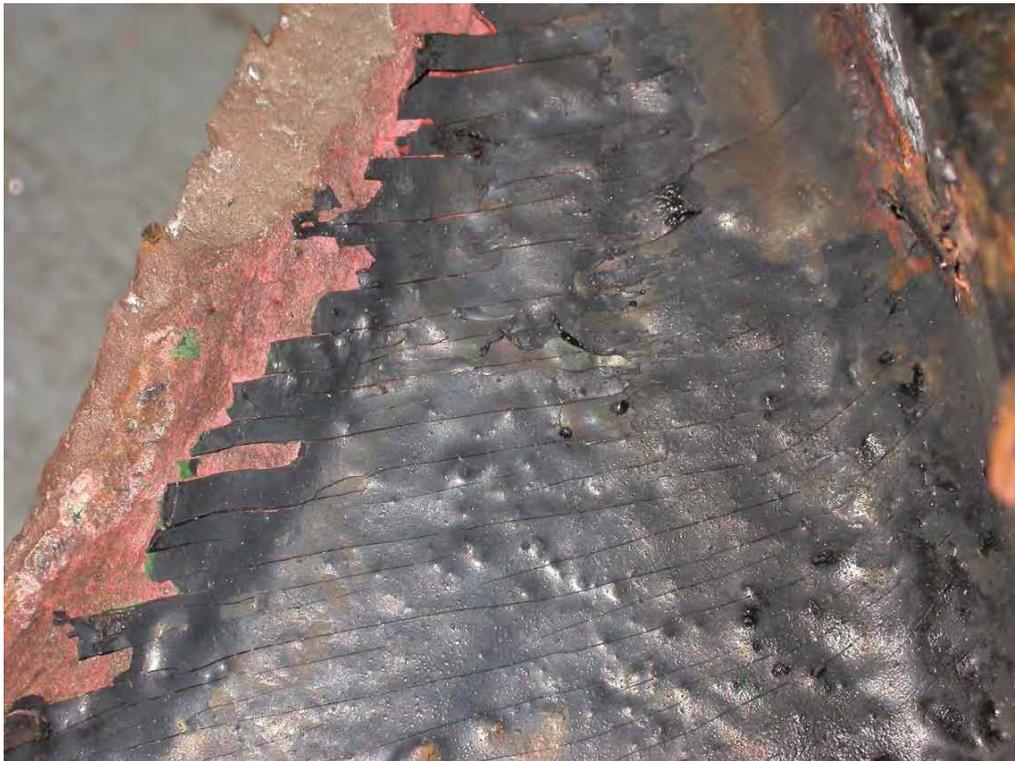
The steel plate adjacent to the two fracture sites had again undergone extensive yielding, as was evidenced by the presence of widespread cracking in the paint (Figures 11 and 12).

Figure 11: Evidence of post yield point type straining (as evidenced by cracking in the paint) for a considerable distance back from the port side fracture site.

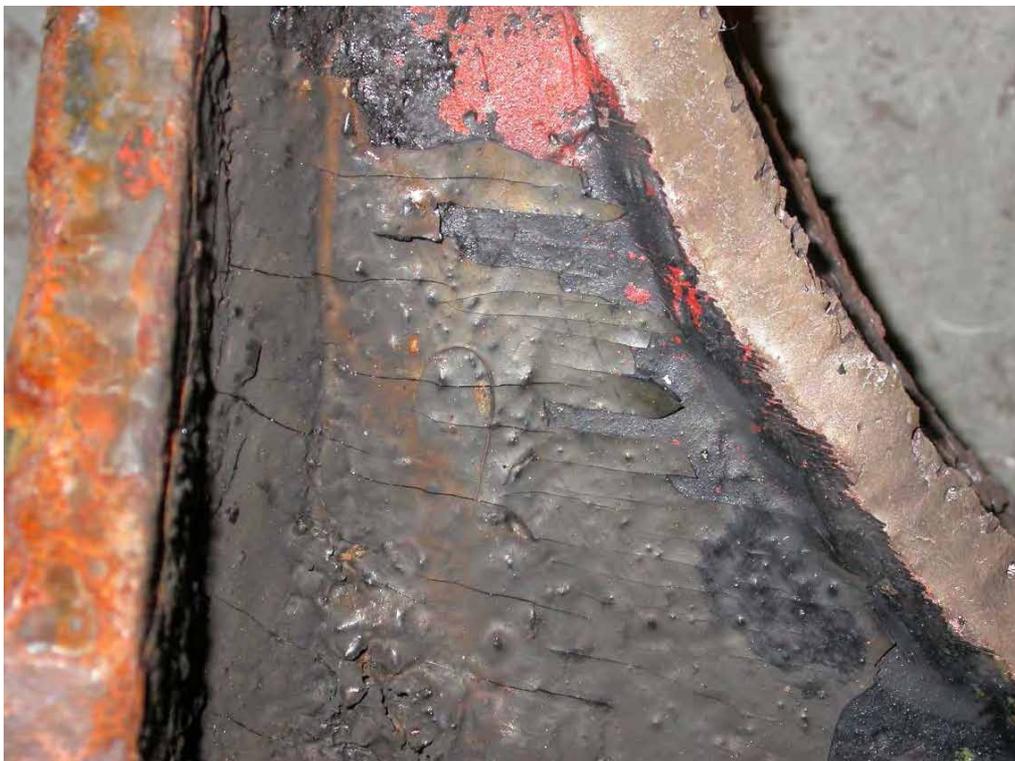
Figure 12: As figure 11, but viewed from the opposite plate side.

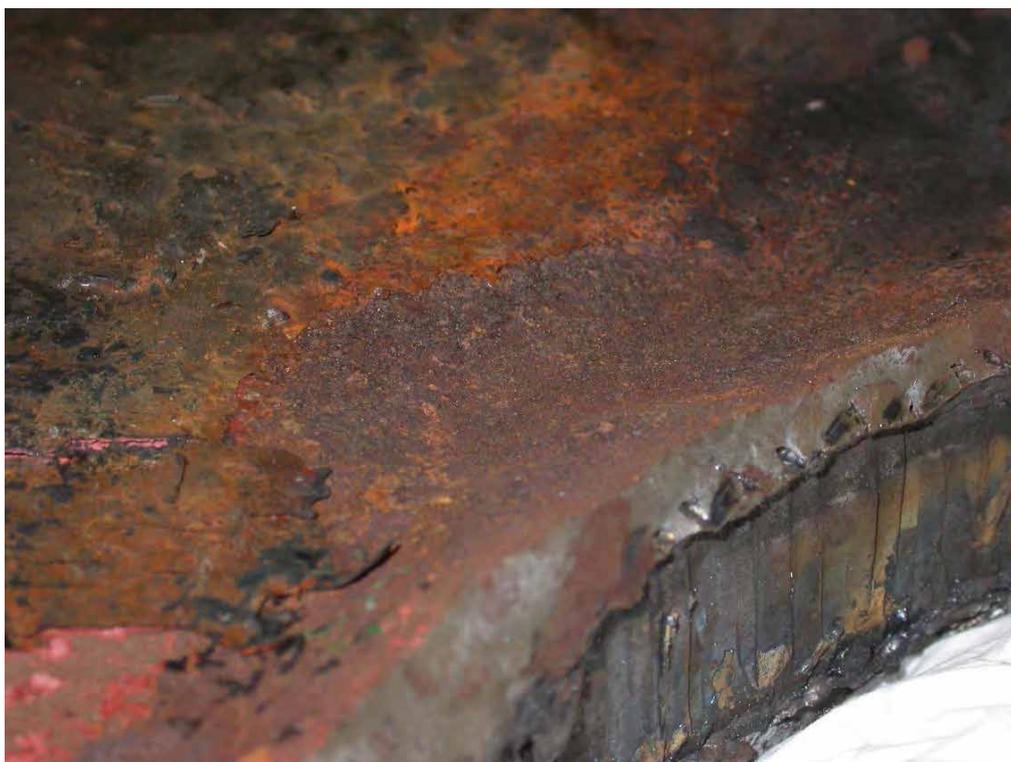
Evidence of earlier corrosion wastage was apparent on one of the plate faces adjacent to the fracture site (Figures 13 and 14). The wastage had reduced the local plate thickness by 3 to 4mm.

Figure 13: Port side plate, showing local corrosion wastage apparent at one of the plate faces adjacent to the fracture site.

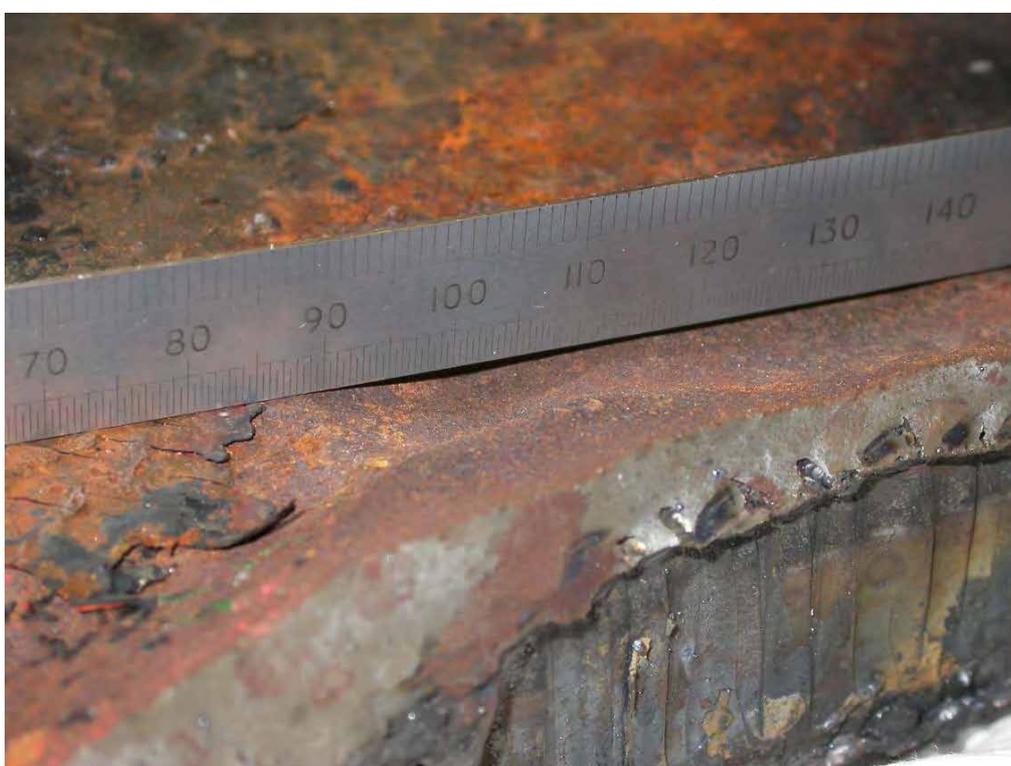
Figure 14: Detail of local corrosion wastage shown in figure 13.

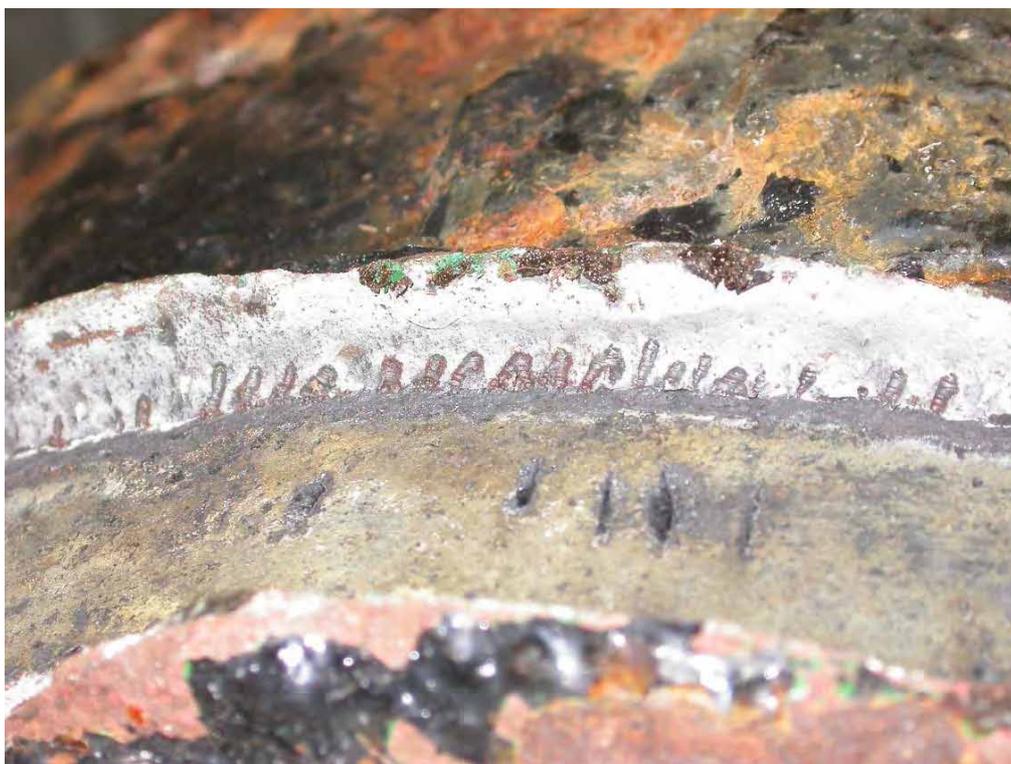
The two fillet welds retaining the ring had sheared through their weld throats, exposing some worm-hole porosity (Figure 15). The weld fractures were apparent over a 490mm length of the rings circumference and the average weld throat thickness was of the order of 10mm.

Figure 15: Sheared port ring retaining fillet weld, showing root worm-hole porosity.
