Report on the investigation of the contact by

Isle of Arran

with the linkspan at Kennacraig

Report No 13/2010
October 2010

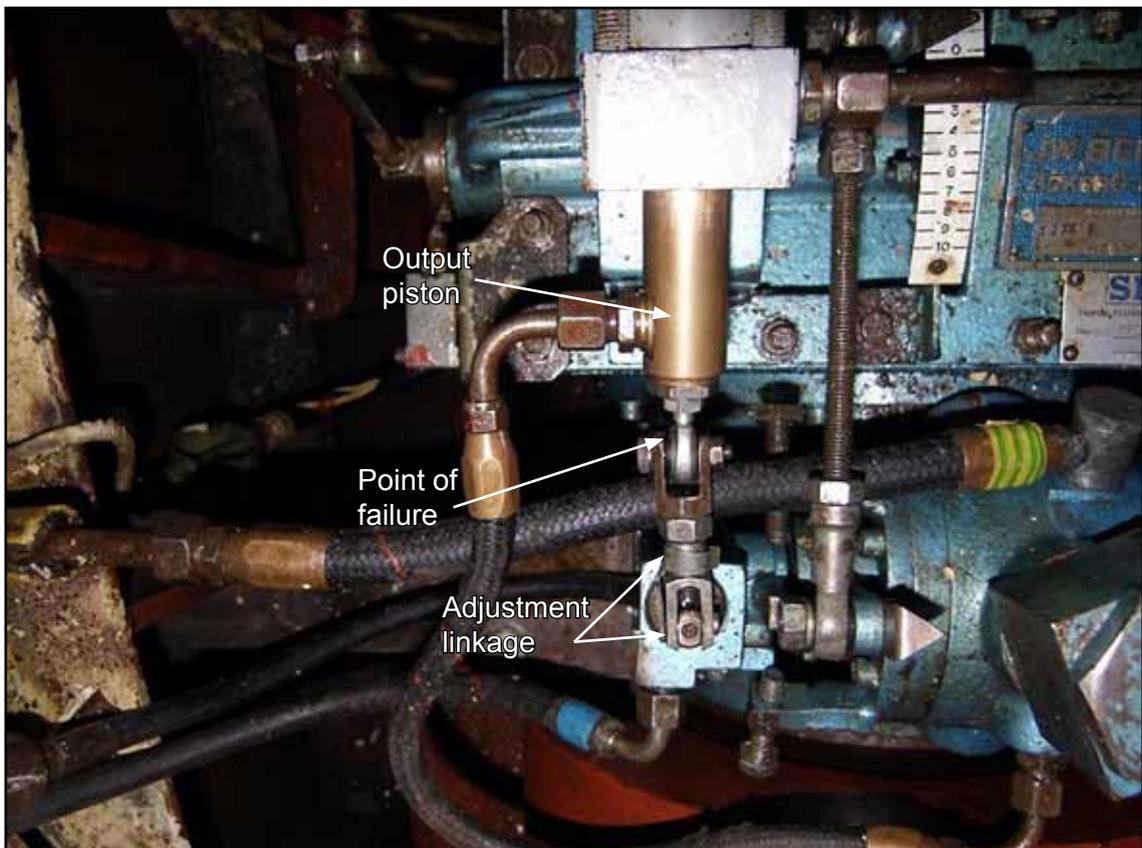
Figure 7

After impact, *Isle of Arran's* stern swung to starboard until she was about 30° to the pier (**Figure 6**). The port engine was stopped and shore lines put out fore and aft. Inspection of the starboard oil distribution (OD) box revealed a control linkage failure (**Figure 7**). A spare linkage was fitted by the second engineer and was adjusted to allow operation of the starboard CPP.

Starboard OD box control linkage and point of failure

It is evident from the metallurgical analysis of the failed components, together with the service agent's inspection report, that the failures of the output piston rod-end of the starboard OD box in September 2009 and on 6 February 2010 were caused by an unintended bending moment. It is also evident that the bending moment was induced by the incorrect adjustment of the clevis linkage on the servomotor's output piston rod-end, causing the clevis link adjusting thread to foul on the pitch-shedding piston rod.

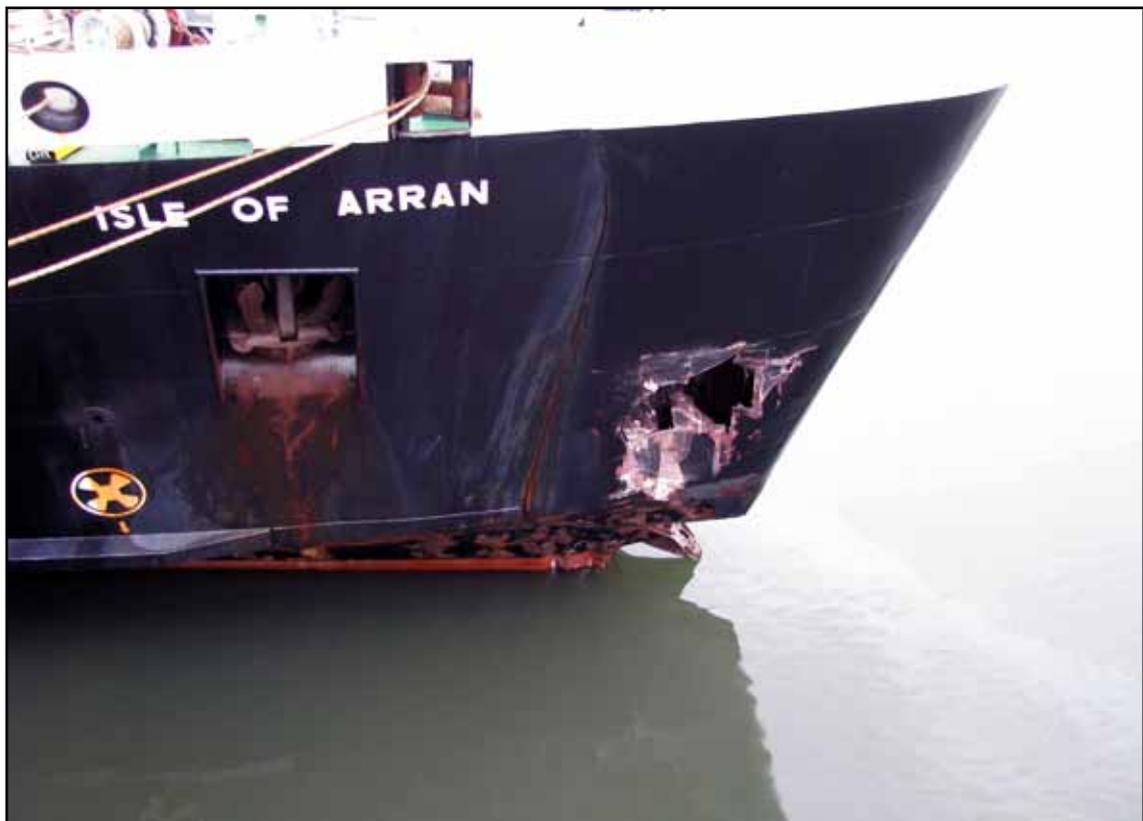
Figure 8

Isle of Arran's bow suffered considerable damage in way of the visor, the visor space and the forepeak tank (**Figure 8**). The starboard side of the visor was penetrated by the inner linkspan arm, which caused a jagged hole of between 4m² and 6m² (**Figure 9**).

Bow visor damage

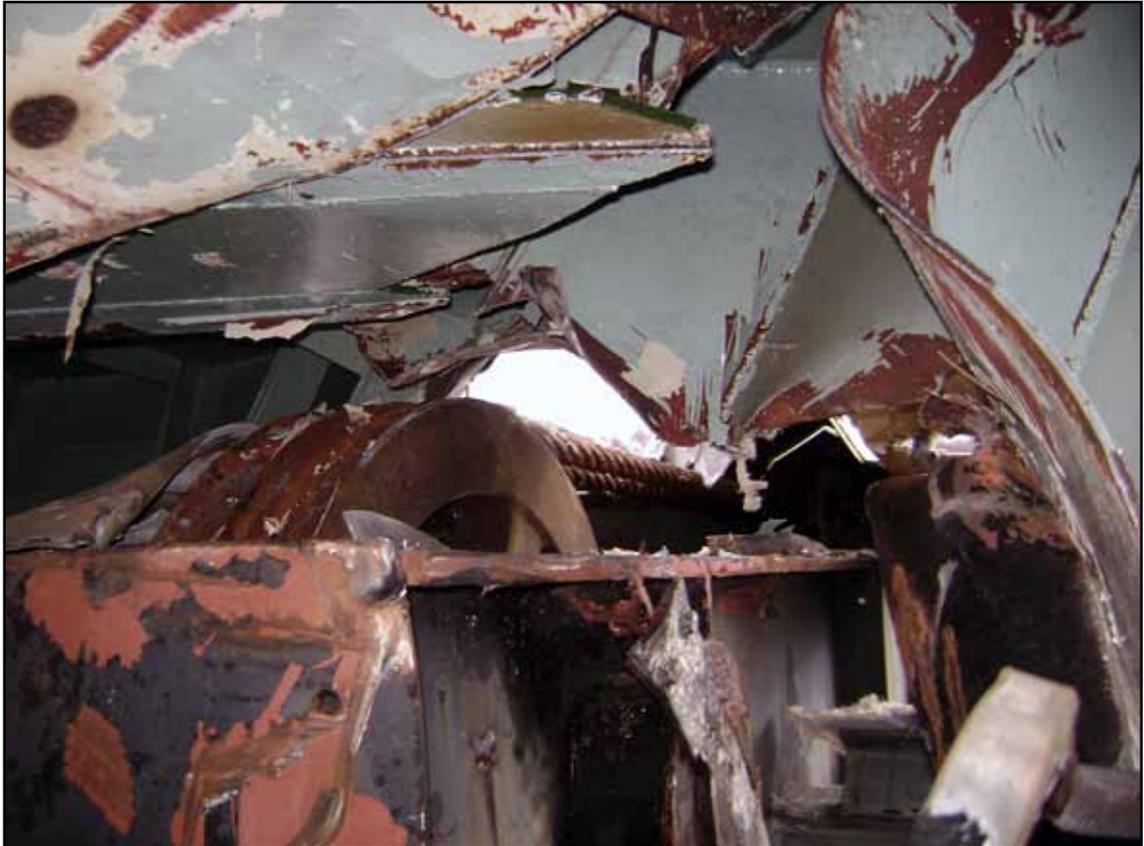
Linkspan arm penetration of bow visor

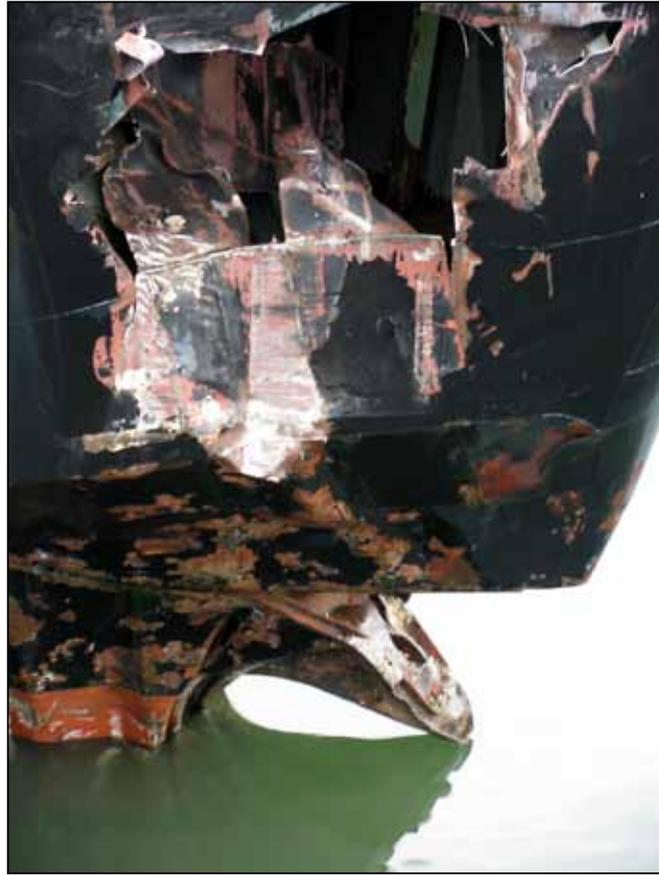
Figure 10

The visor deck within the visor space was crumpled longitudinally and athwart ships back to the vehicle ramp. Its leading edge, which formed the upper part of the forepeak tank, was bent downwards (**Figure 10**).

Bow visor and forepeak damage

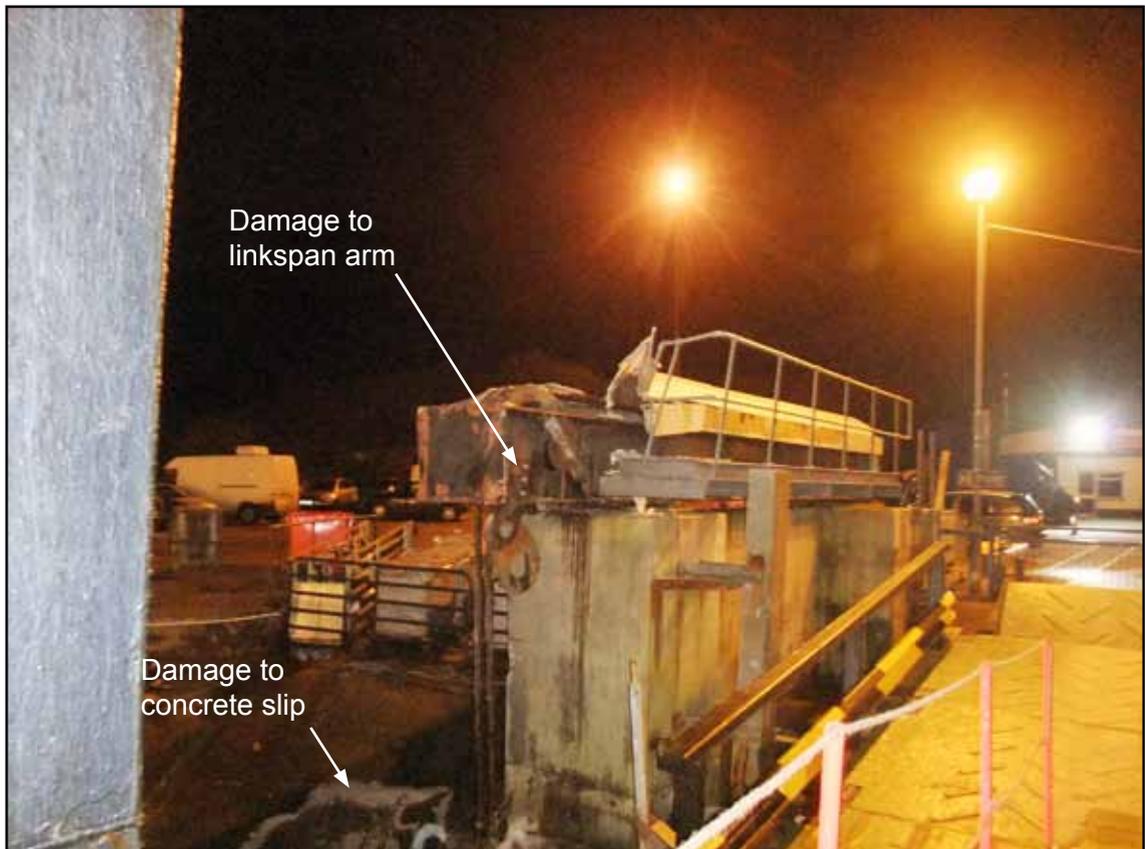
Figure 11

The vessel's contact with the pier damaged the pier's rubber fendering and her impact with the linkspan caused damage to the inner linkspan arm, the concrete ramp (**Figure 11**), the passenger gangway, and the linkspan, which was moved sideways and lifted from its roller guides.

Damage to
linkspan arm

Damage to
concrete slip

Kennacraig ro-ro berth damage

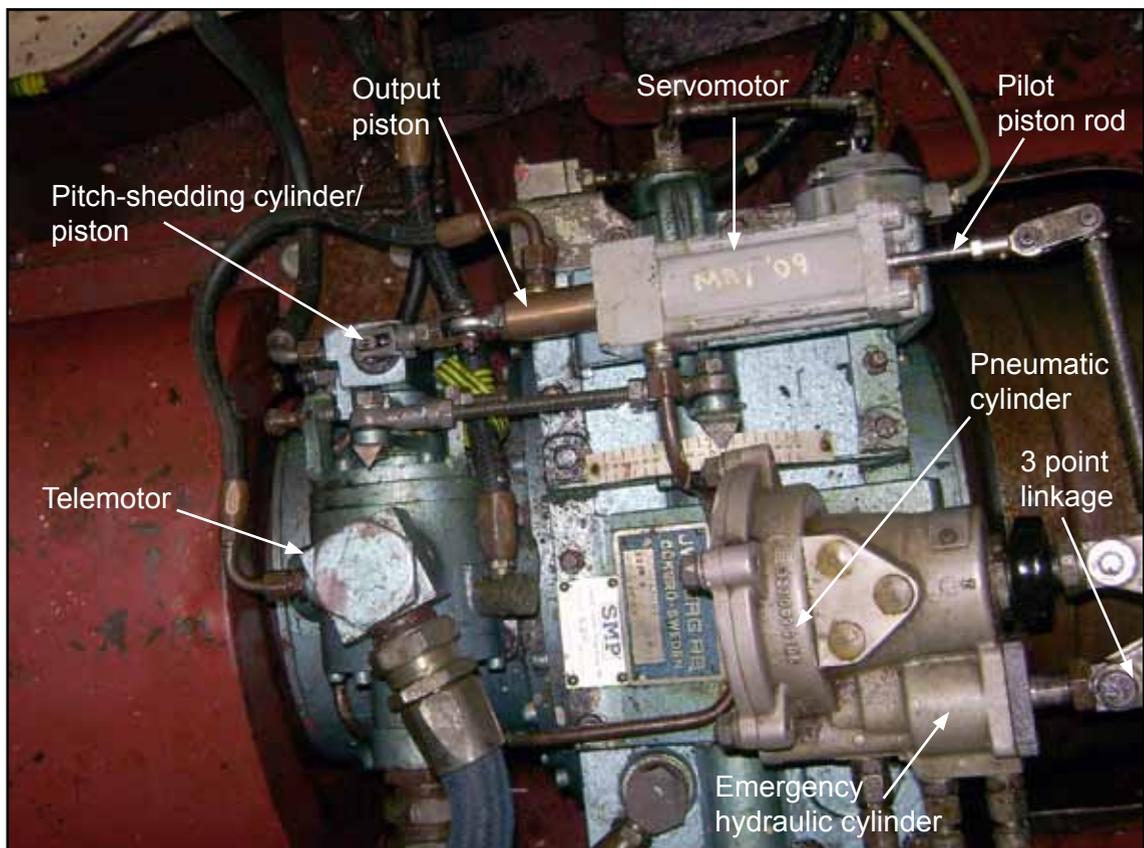
Figure 15

A further linkage connected the servomotor cylinder output piston rod to the hydraulic telemotor via a pitch-shedding or load reduction cylinder. This linkage comprised a spherical rod-end bearing at the end of the piston rod, and two swivel hinge links, or clevis pins, on a threaded adjuster rod (**Figure 15**).

Starboard OD box

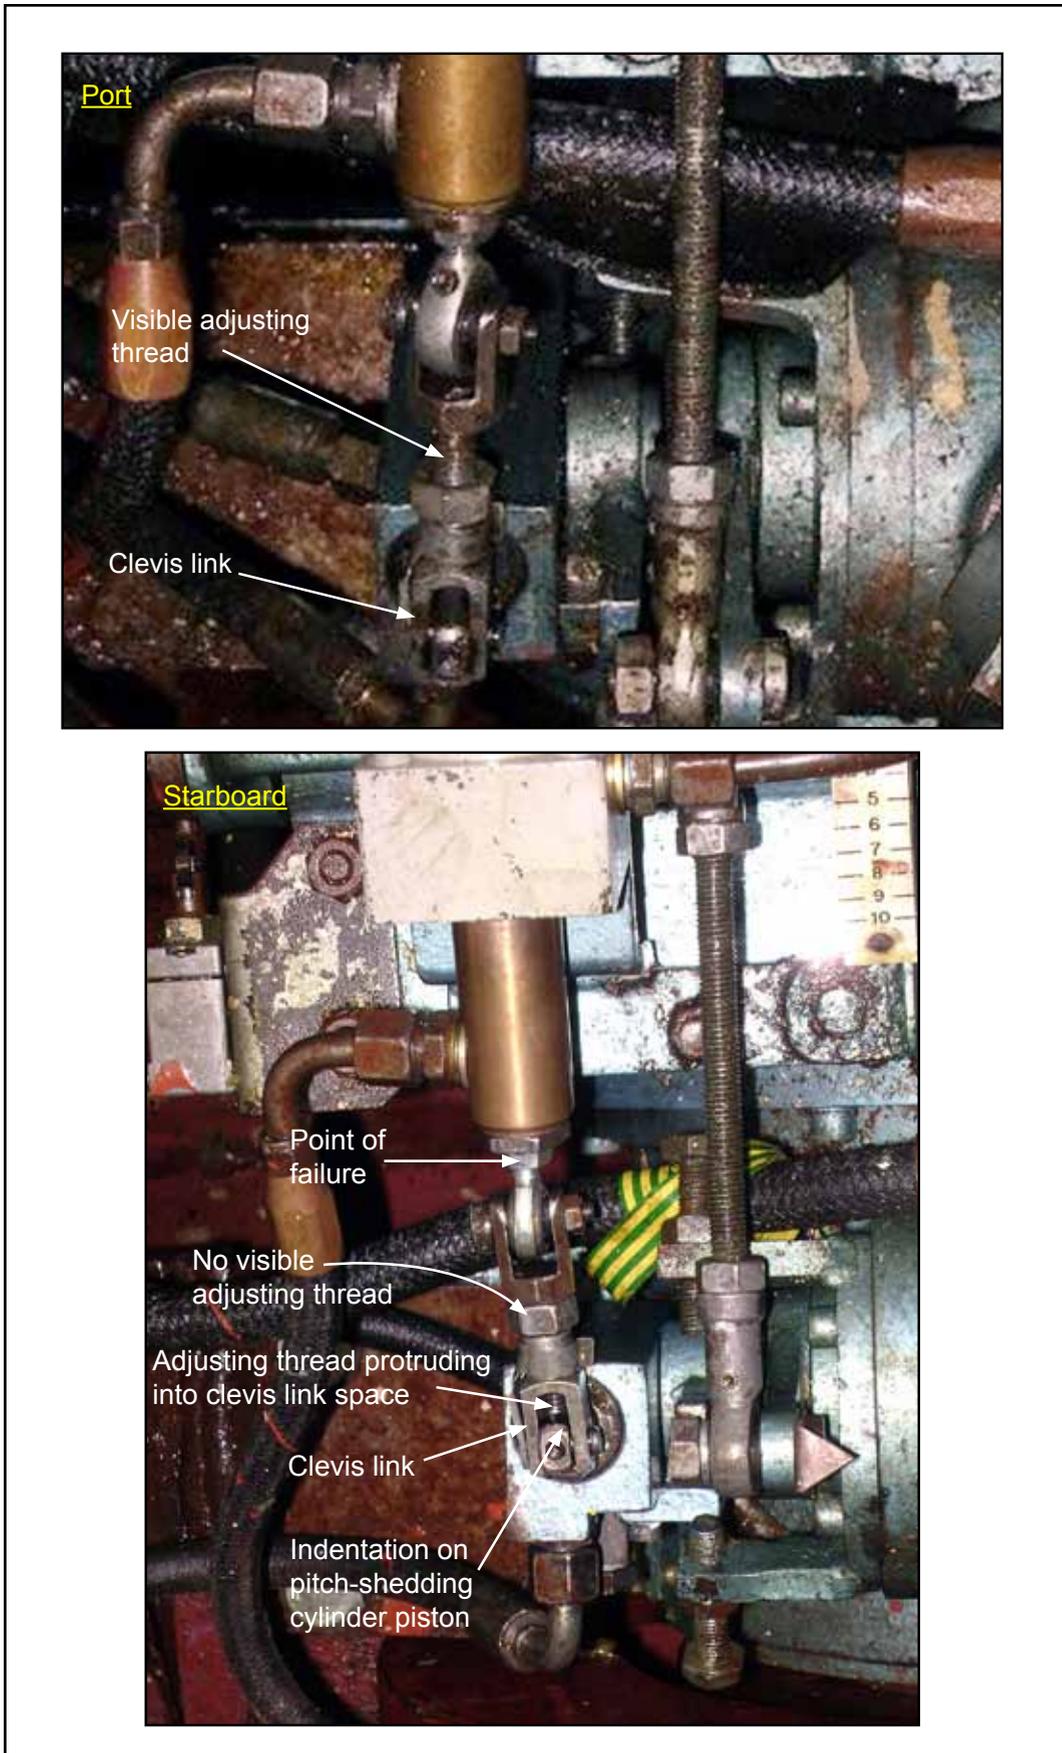
Harris Pye, based in Penarth, South Wales has been the authorised UK service agent for Berg CPP systems since 2009. Its investigation report of the failure of the starboard OD box (**Annex B**) highlights that an indentation on the pitch-shedding cylinder piston, where the clevis pin or link claw was attached, resulted from the adjusting screw protruding too far through the clevis link and fouling the piston rod when the pitch-shedding piston operated. This contact induced a bending force on the servomotor rod-end that caused the linkage to fail. The difference in the positions of the adjusting screws on the port and starboard systems is shown in **Figure 19**.

Comparison of port and starboard OD box adjustment linkages
