Report on the investigation into  
the failure of the stores crane on the dredger

***Sand Falcon***

at West Thurrock, River Thames

**Report No 16/2010**  
**November 2010**

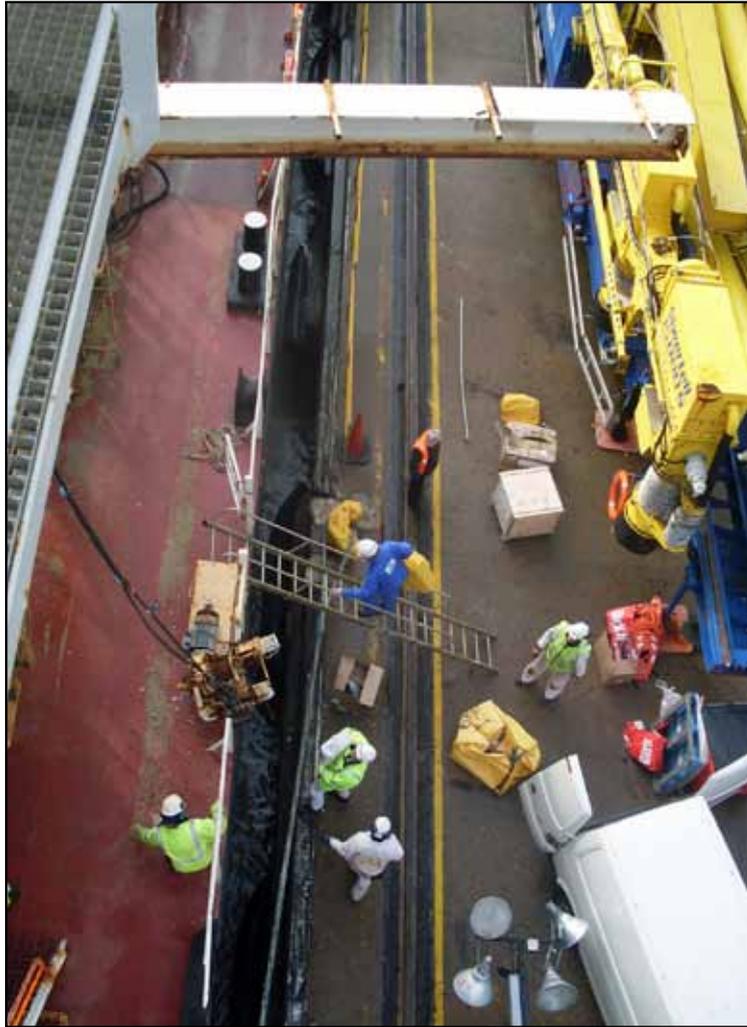
Six members of the crew and the delivery driver were all standing close by, either on the deck of the ship or on the jetty (**Figure 1**). Fortunately, none of them was standing directly beneath the crane and no-one was injured, but the crane trolley was severely damaged.

Main deck and jetty shortly after the accident

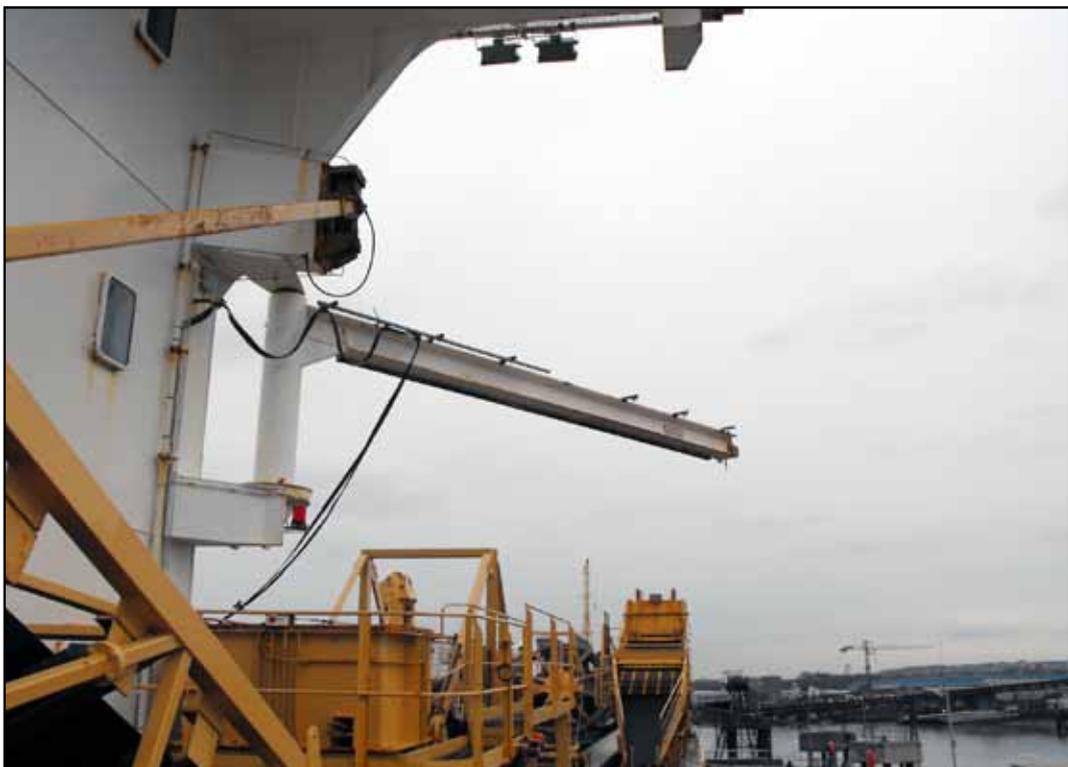
Figure 2

The design of the stores crane was similar to the equipment more commonly used in engine rooms for moving machinery components. An I-beam was attached to a slewing mechanism mounted on the starboard-forward corner of the accommodation structure (**Figure 2**). The trolley was fitted with four flanged wheels which bore on the top side of the lower flange of the I-beam to allow it to traverse along the gantry. Both the lifting and traversing motors were fitted onto the trolley. Neither motor was braked as the friction of the worm reduction gearing maintained the equipment in position when the motor was stopped. A single pinion at one corner of the trolley engaged in a rack on the beam to drive the trolley along. The trolley was located on the beam by the flanges on the wheels; there were no secondary restraints to attach the trolley to the beam.

Stores crane

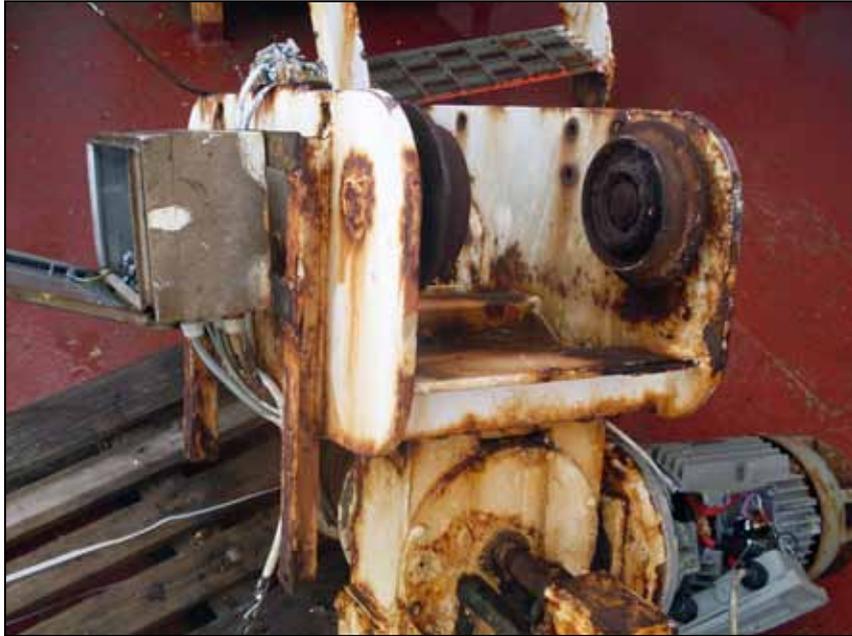
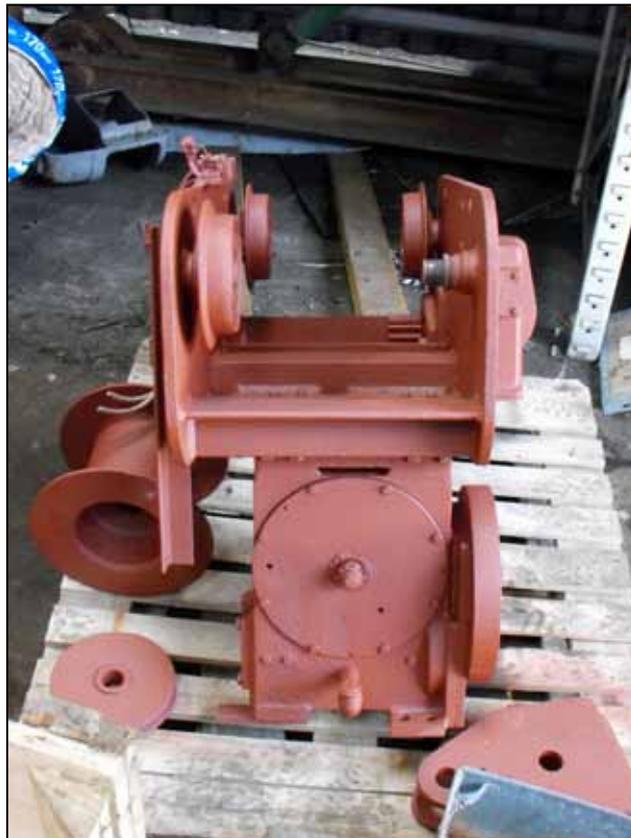
The gearbox for the double fall lifting wire was offset from the centreline (**Figures 3a & 3b**), but the standing end of the wire was secured on the opposite side of the trolley so that the weight of any load would be shared equally by all four wheels. Both the motors and gearboxes were offset to the same side of the trolley, and it is unlikely that their weight would have been completely counter-balanced by the electrical cabinet on the other side (**Figure 4**).

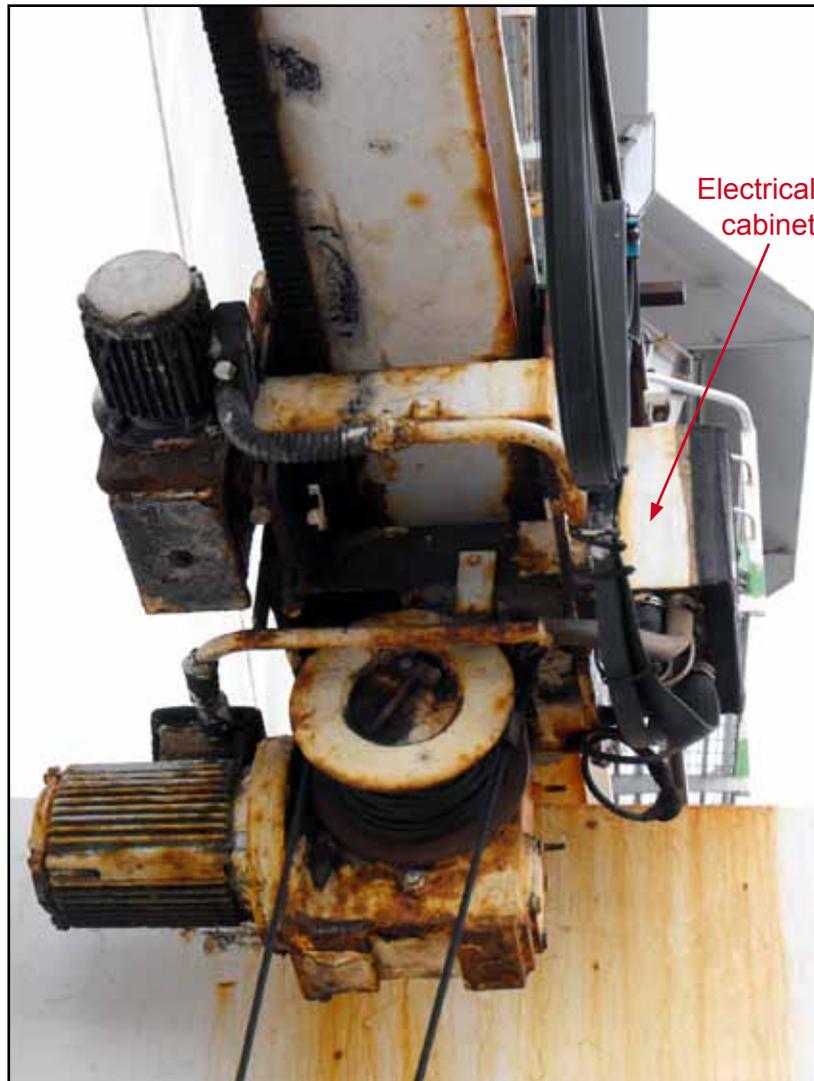
Figure 4

Gantry-trolley

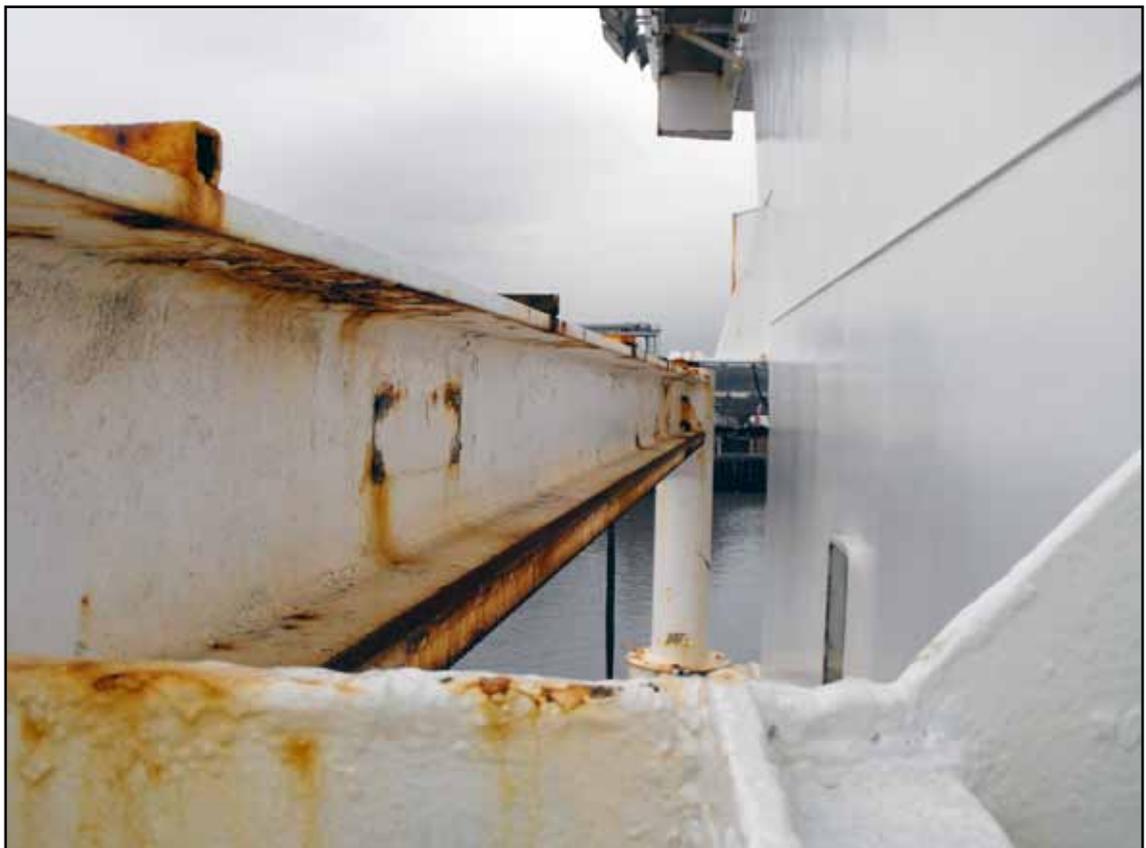
Figure 5

The I-beam was found to be in good condition, but with some deterioration of the paint from the effects of corrosion. The lower flange was the correct width throughout (**Figure 5**), and a plate was fitted to prevent the trolley from running off the end of the beam.

Gantry I-beam

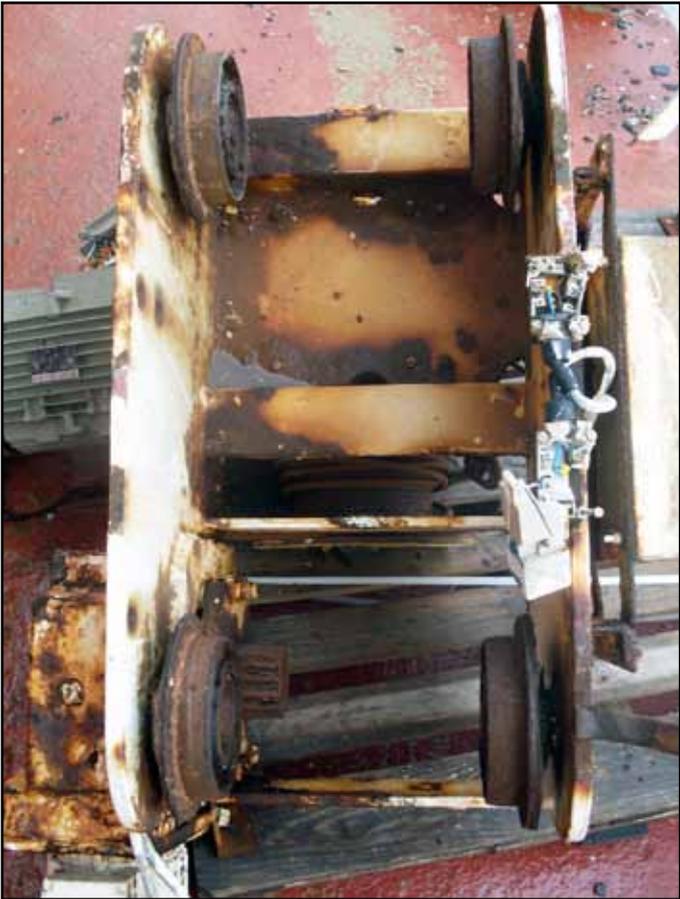
Figure 6

ACTA calculated that the trolley weighed about 416 kg. It was corroded but was not deformed and, specifically, the chassis plates holding the wheels in position had not been splayed apart. The trolley wheels were severely corroded (**Figure 6**). The wheel bearing covers were missing and a combination of corrosion and the products of the dredging processes had built up in the bearing races so that the wheels would not turn. Flat spots had been worn on the wheels where they had been dragged across the I-beam (**Figure 7**).

Gantry-trolley chassis and wheels

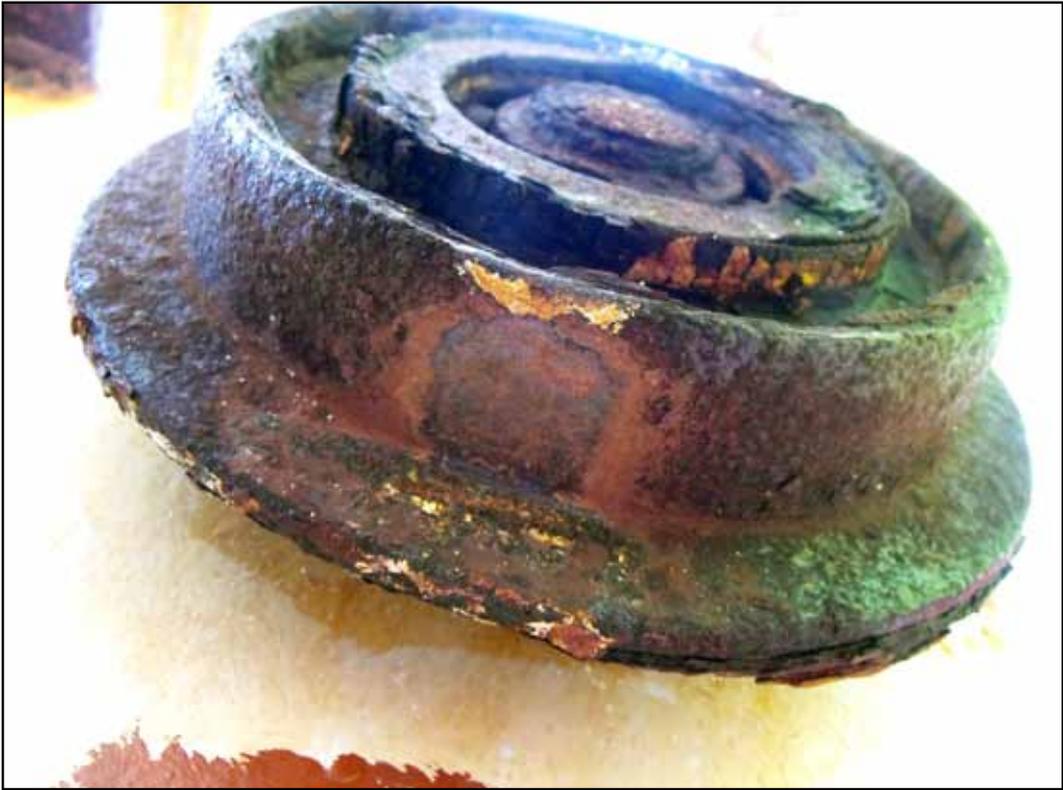
Figure 7

Flat spots worn on wheels

It is also possible that the flat spots that had been worn on the wheels might have caused the meshing clearances between the traversing rack and pinion to increase, as was evident on the similar, but older, crane fitted to *Sand Heron*. Had this been the case on *Sand Falcon's* crane, the increased meshing distances could have led to the pinion slipping or striking the teeth of the rack, producing yet more uneven force on the trolley.

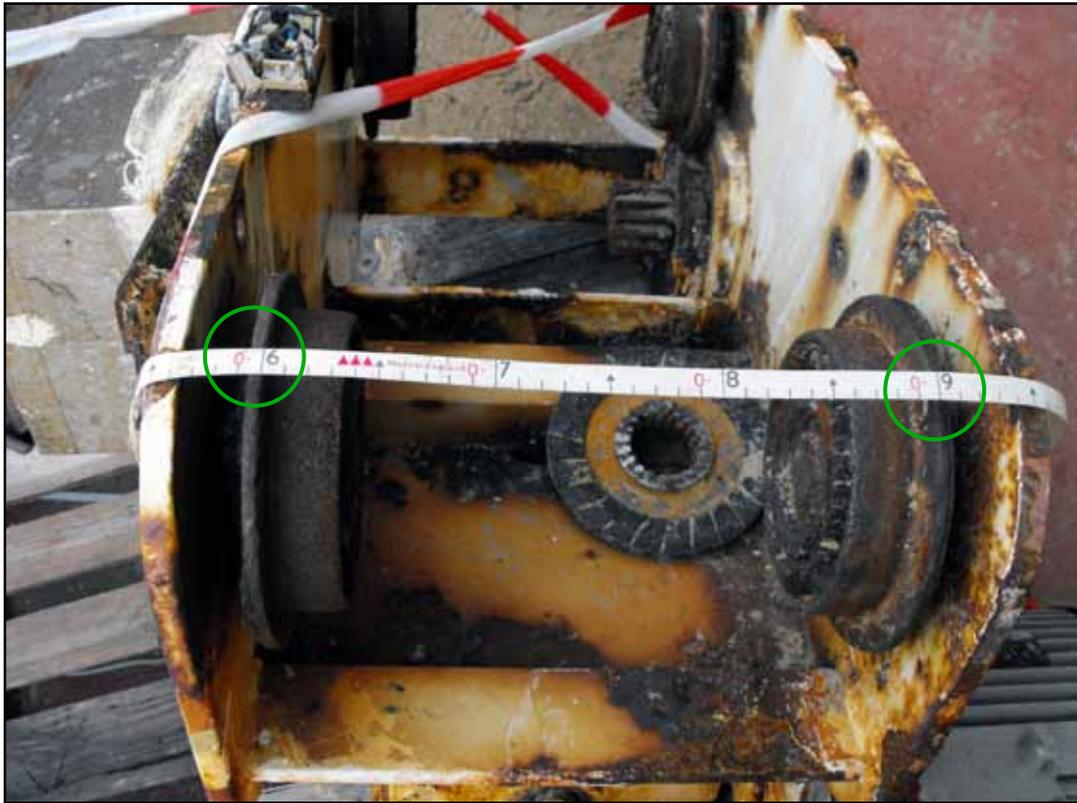
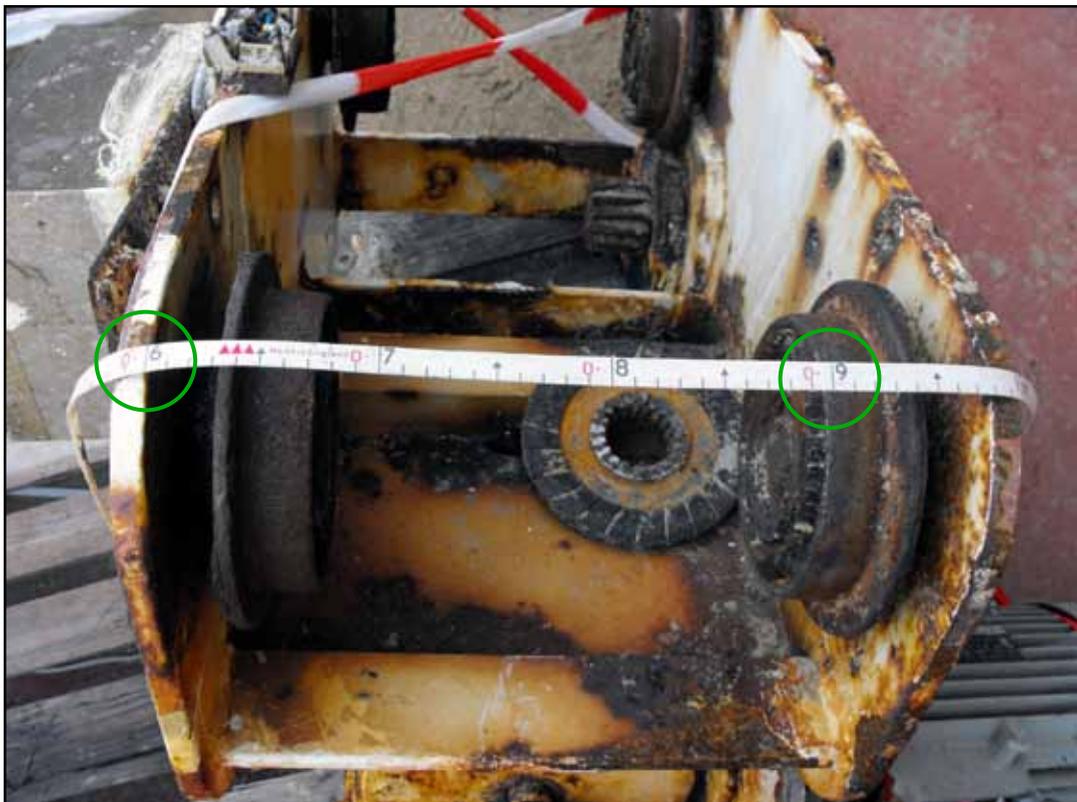
Distance between trolley wheels and chassis side plates

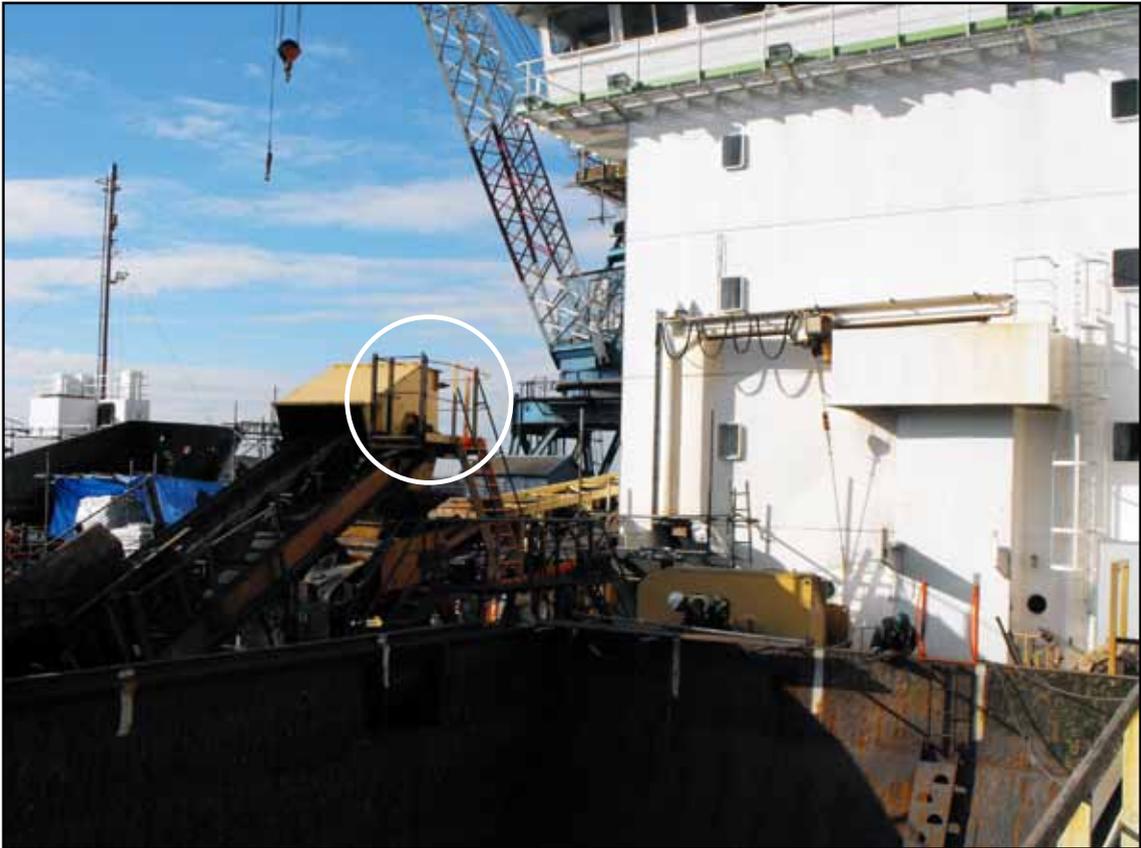
Figure 9

Access arrangements on *Sand Heron* ('H' class)

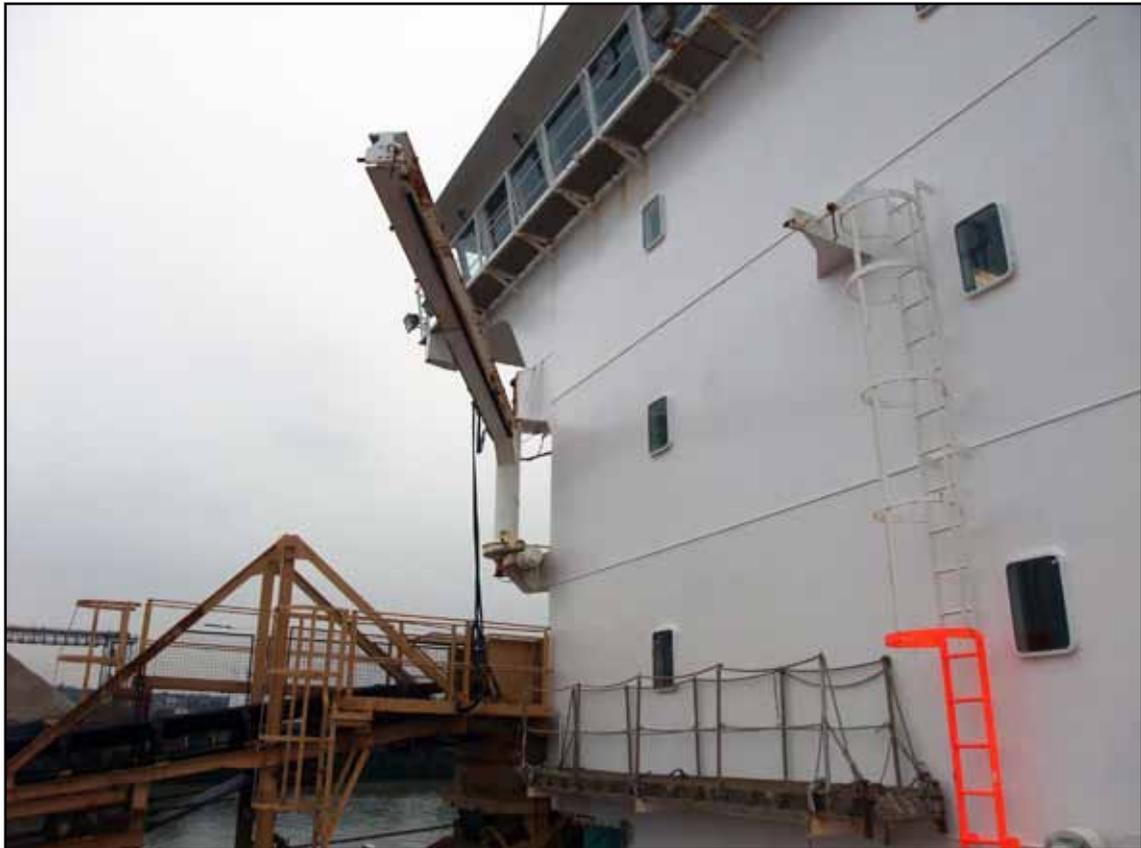
Figure 10

Access arrangements on *Sand Falcon* ('F' class)

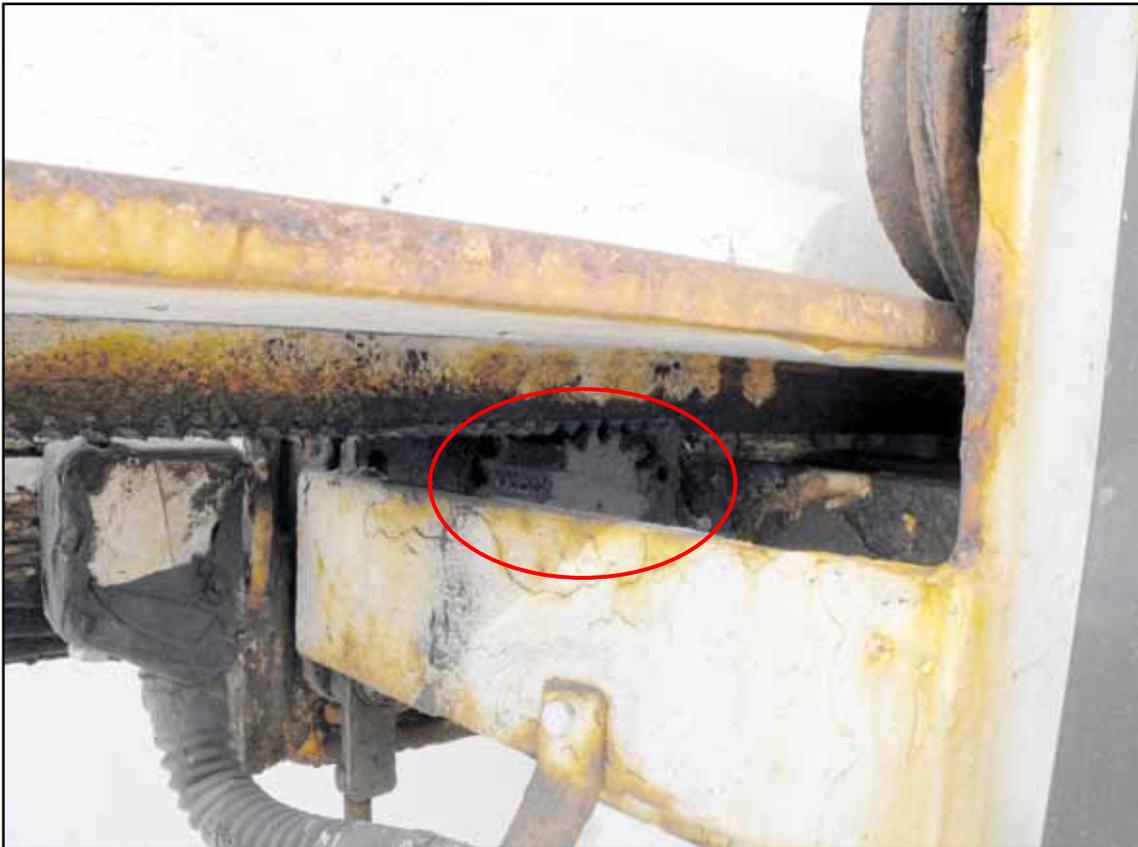
Traversing rack and pinion mesh (*Sand Heron*)

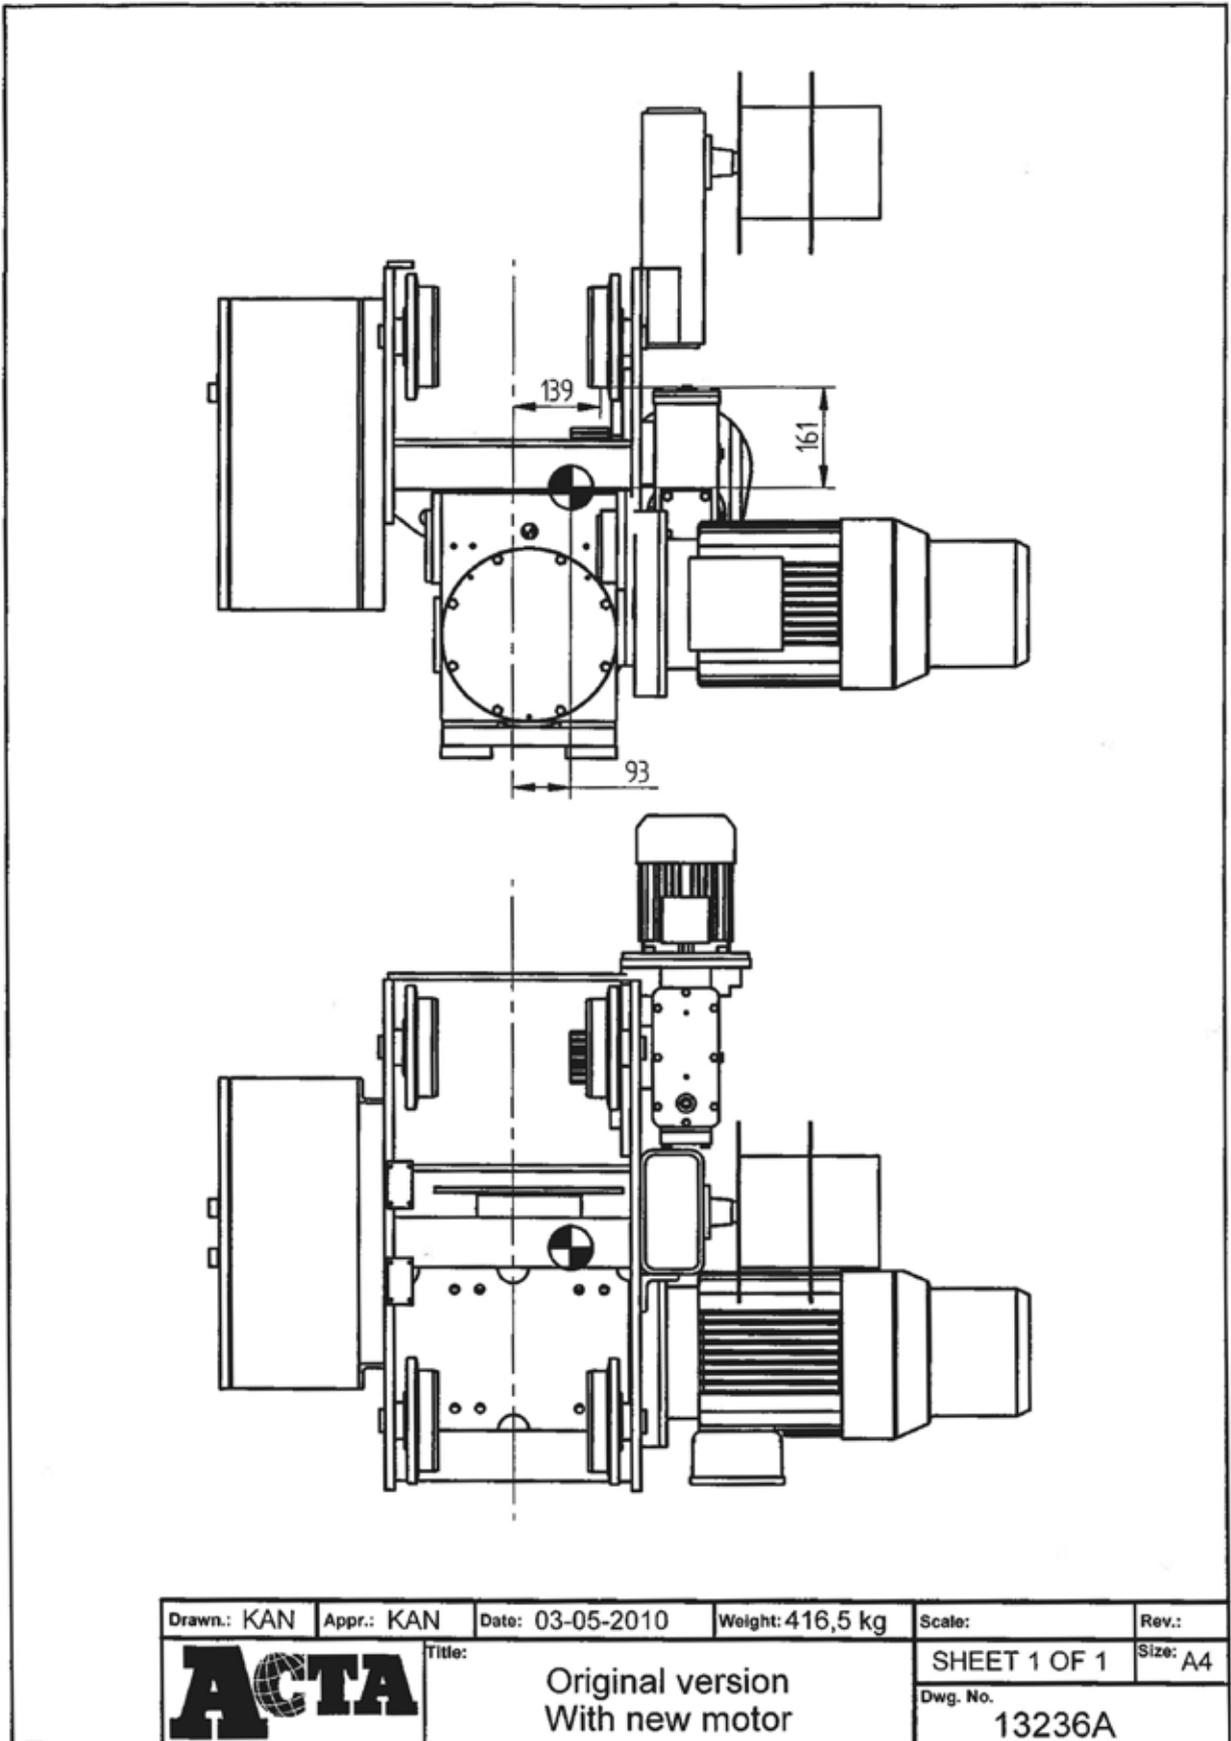
The crane trolley was, by design, not balanced unless it was carrying a load, and ACTA has calculated that the extra weight of the replacement lifting motor would have further offset the trolley's centre of gravity (**Figure 13**). This meant that while the crane was not carrying any load, the wheels on the side furthest away from the motors would have been lightly loaded. These were the wheels that witnesses saw 'climbing' up onto the beam.

Effect of replacement motor on the gantry trolley's centre of gravity

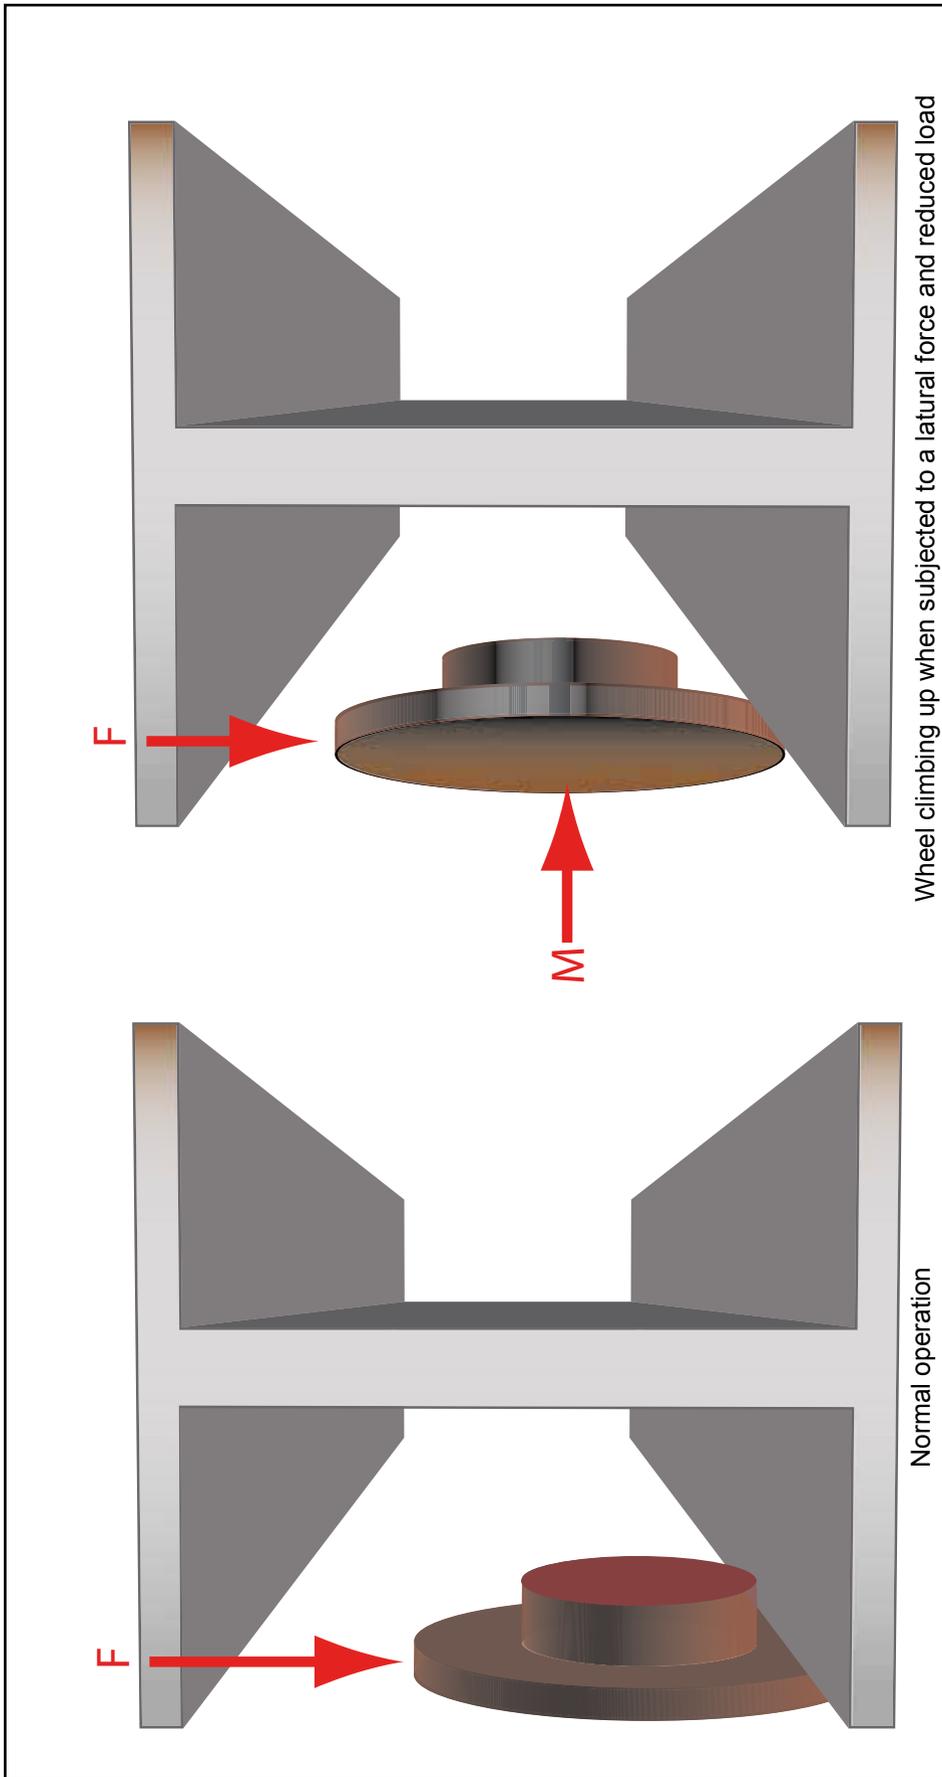
Figure 14

Railway accidents have shown that flanged wheels can climb onto rails (in this case the lower flange of the I-beam) if the weight pushing them into contact with the rail reduces and they are subject to a sideways force (**Figure 14**). The trolley was known to traverse the gantry beam in jerky movements, and the crew thought this was its normal motion. However, it is more likely that the erratic motion was caused by the combined effect of the seized trolley wheels being dragged across the beam and the pinion driving at only one corner of the trolley. This offset drive would have set up twisting forces in the trolley, generating the sideways force needed for the more lightly loaded wheel flanges to climb on to the beam.

Wheel climbing up when subjected to a lateral force and reduced load
